THE RUINS AT BUSHIRIBANA, ARUBA CIRCA 1872

A PRELIMINARY INVESTIGATION INTO ARUBA'S GOLD MINING HISTORY

October 1999

By Helen Ross

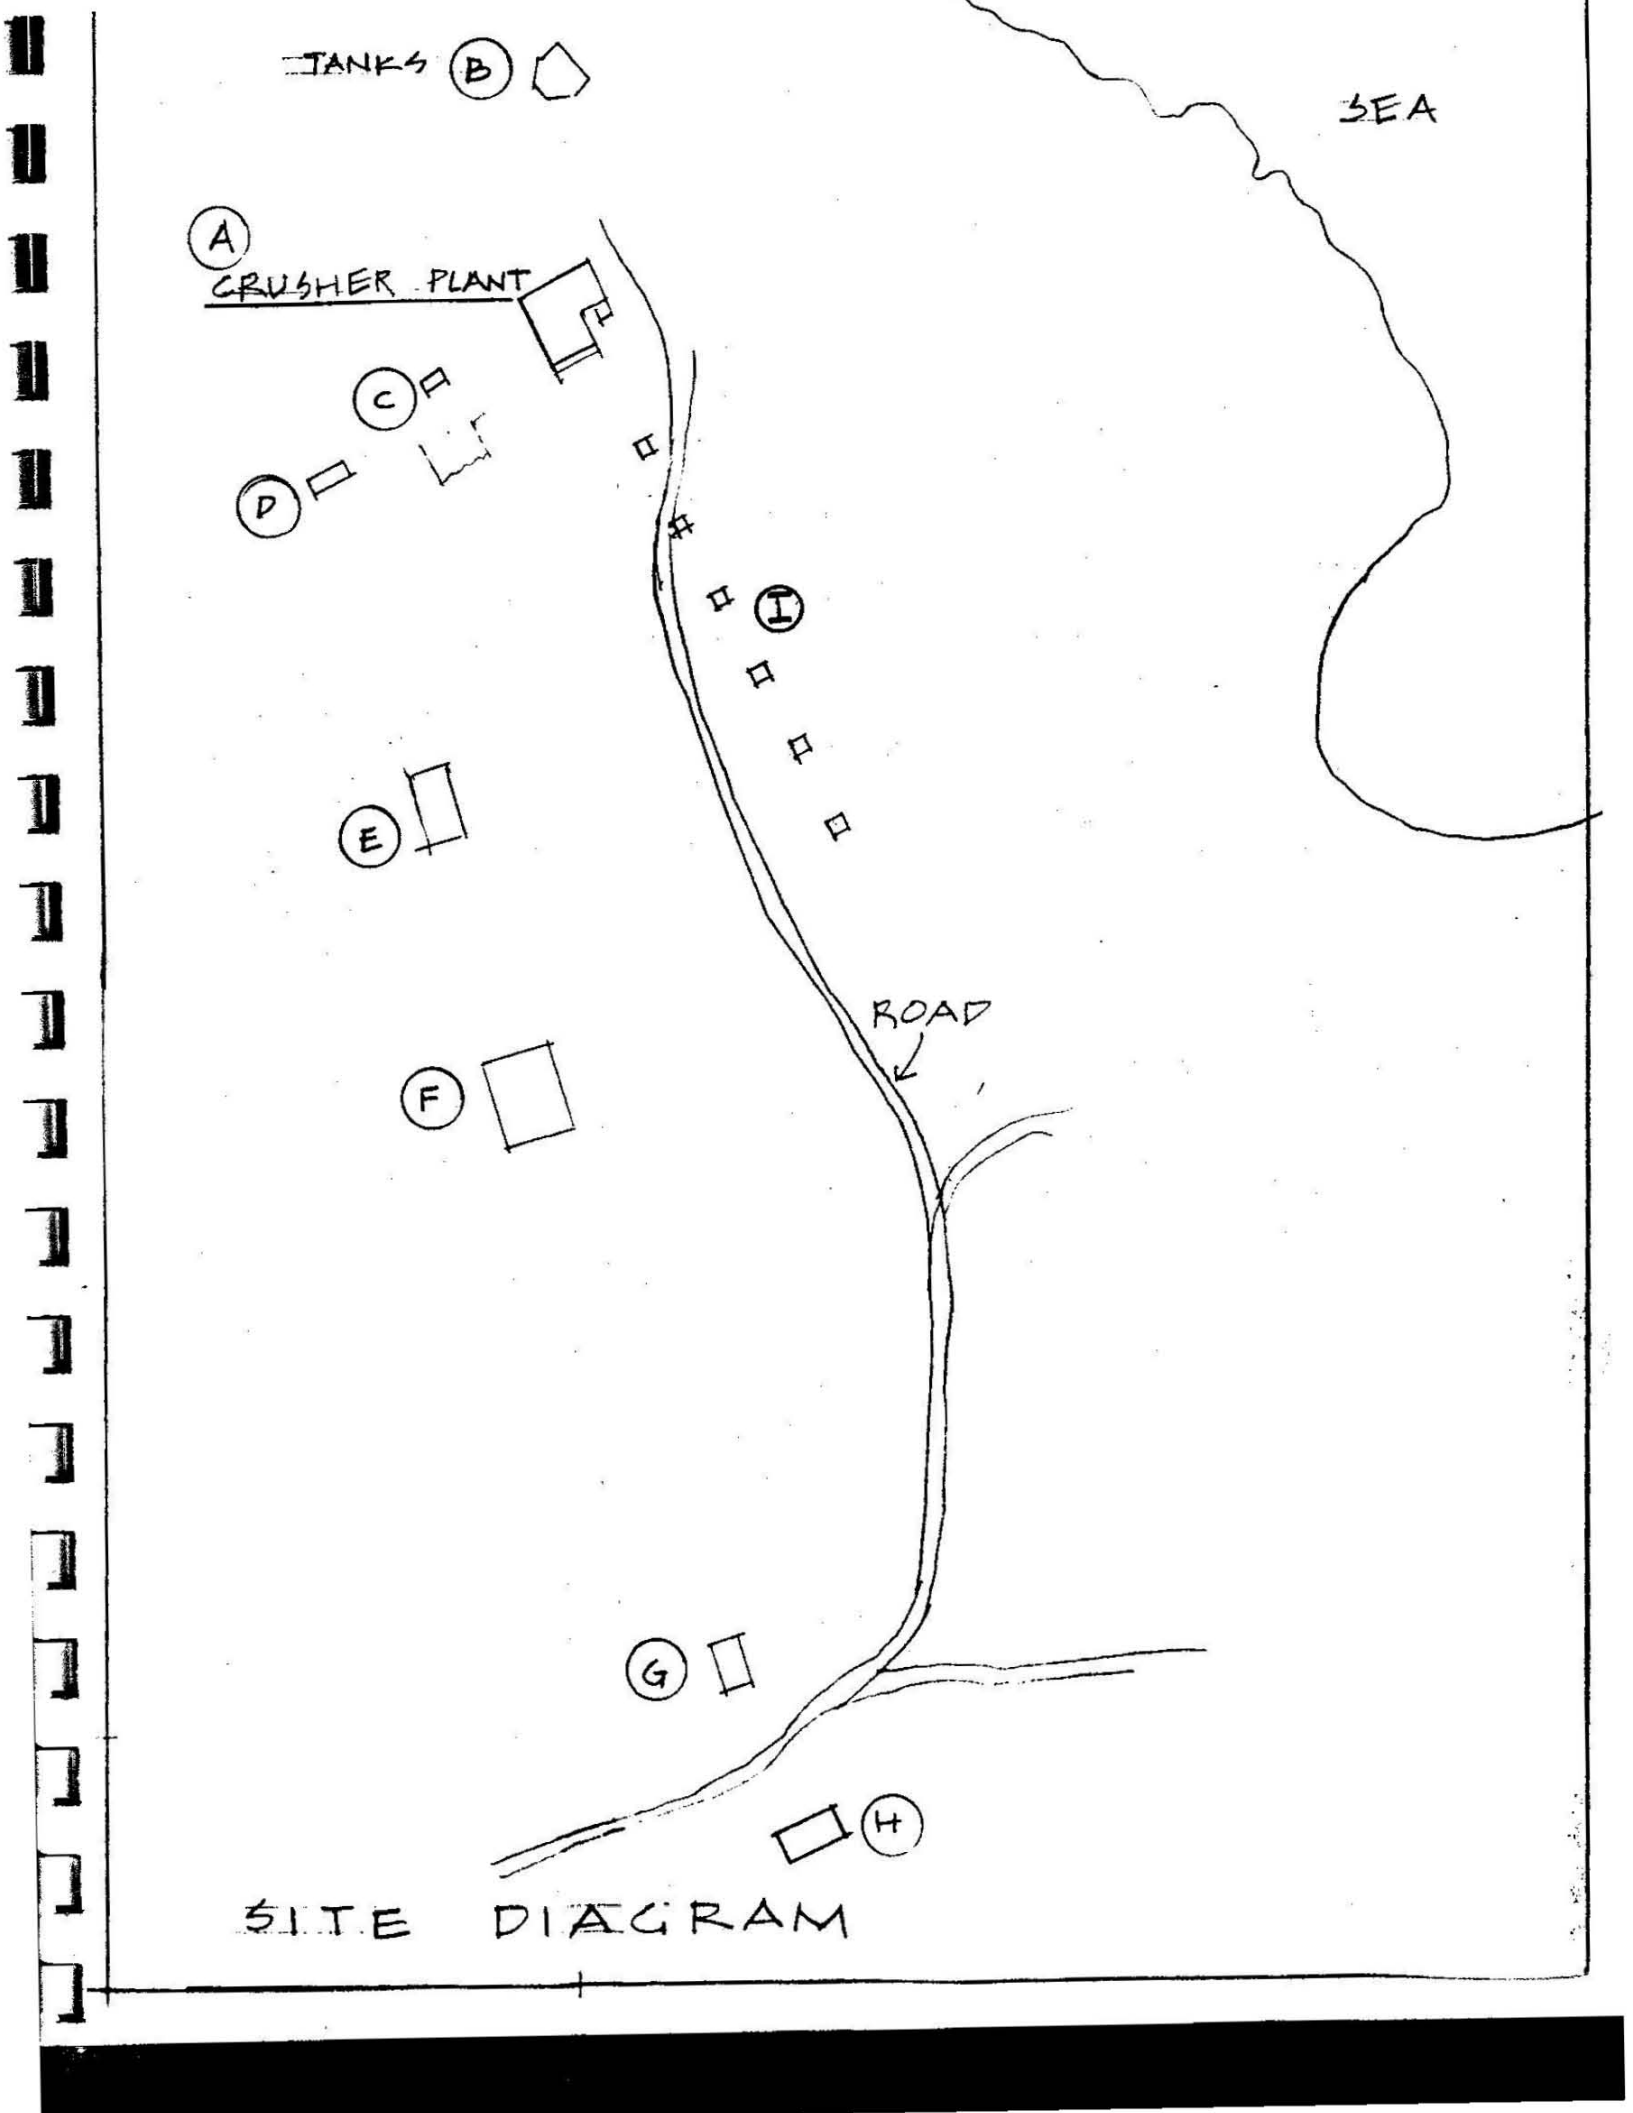
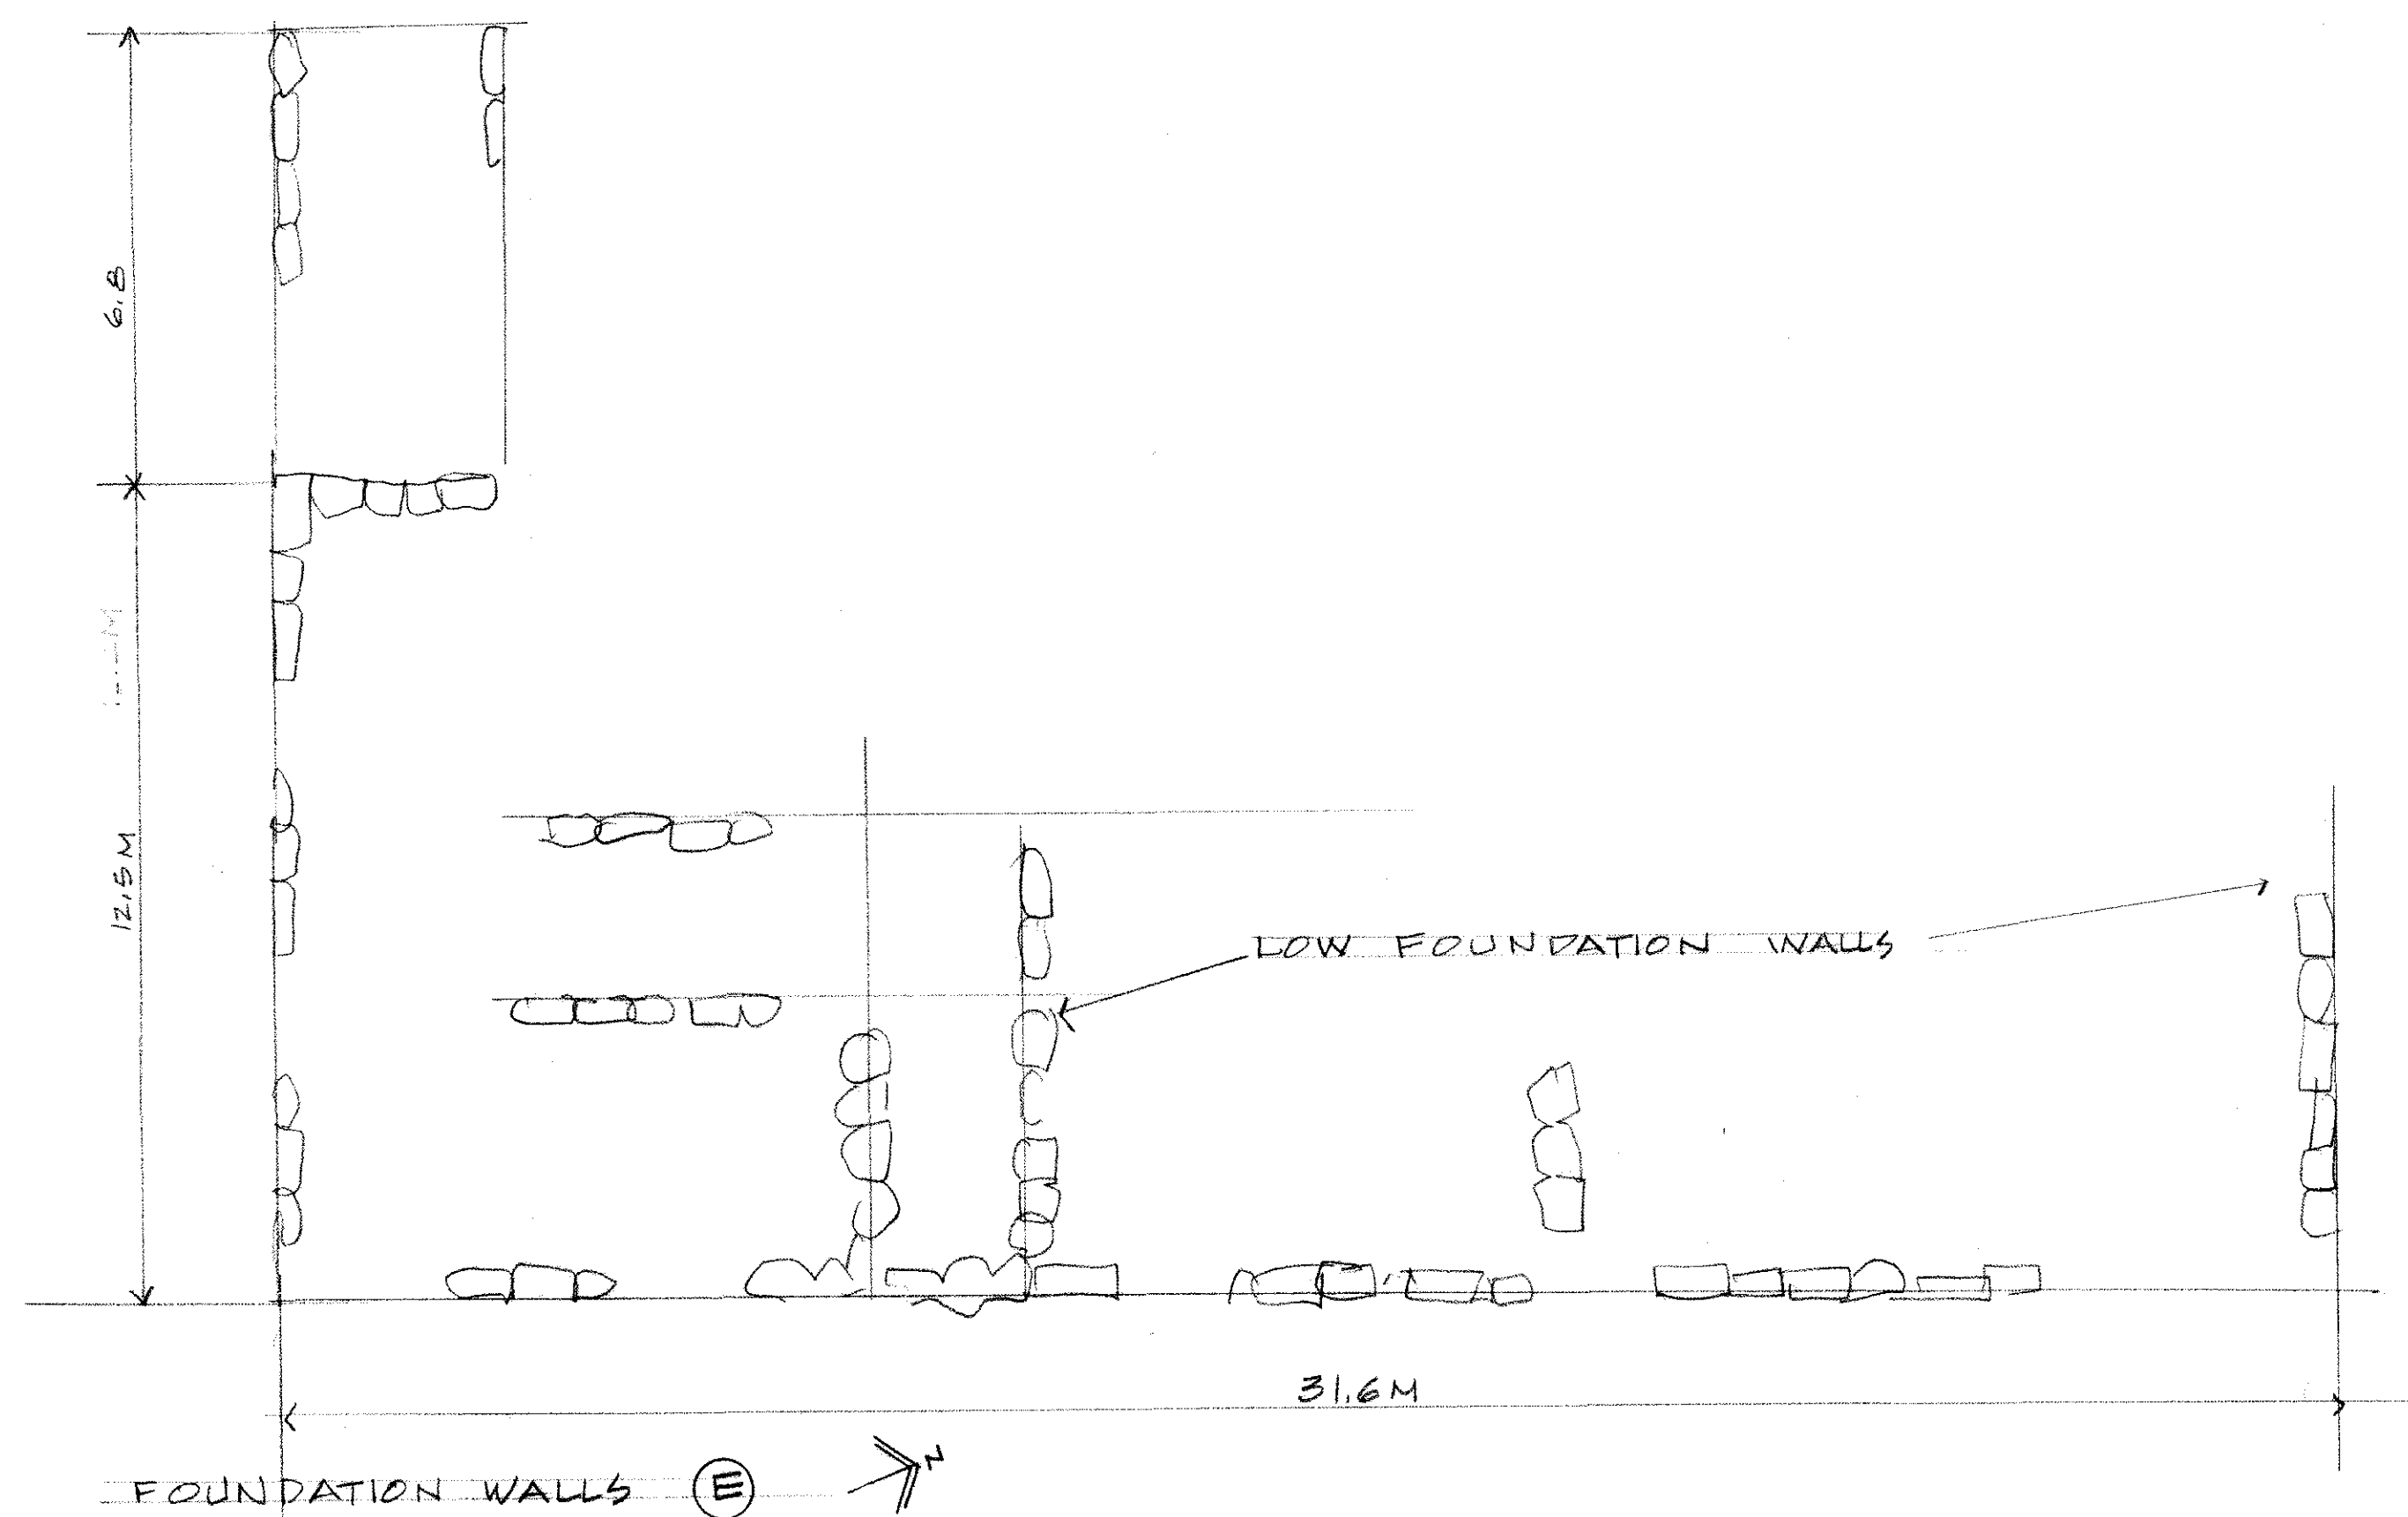
SITE DIAGRAM

Situated west and south of the crusher plant are the low and crumbling stone foundations of six buildings (C-H), see plan sheet 1. They range in dimensions from the smallest 5.3 meters by 8.0 meters (C) to the largest that measures 19.3 meters by 31.6 meters (E). Most likely the buildings housed a laboratory and the site managers and engineers. Many of the local laborers would have lived with their families in nearby dwellings.

A row of square ruins (I) run parallel to the existing road and is perpendicular to the south facing elevation of the crusher plant. The dimension of one is mirrored six times. Each one with a size of 3.7 meters by 3.7 meters. The wall thickness is approximately .64 meters and there is a distance of 19 meters between each one. These features may have served as the foundations for windmills which supplied the power for the crushing operations.

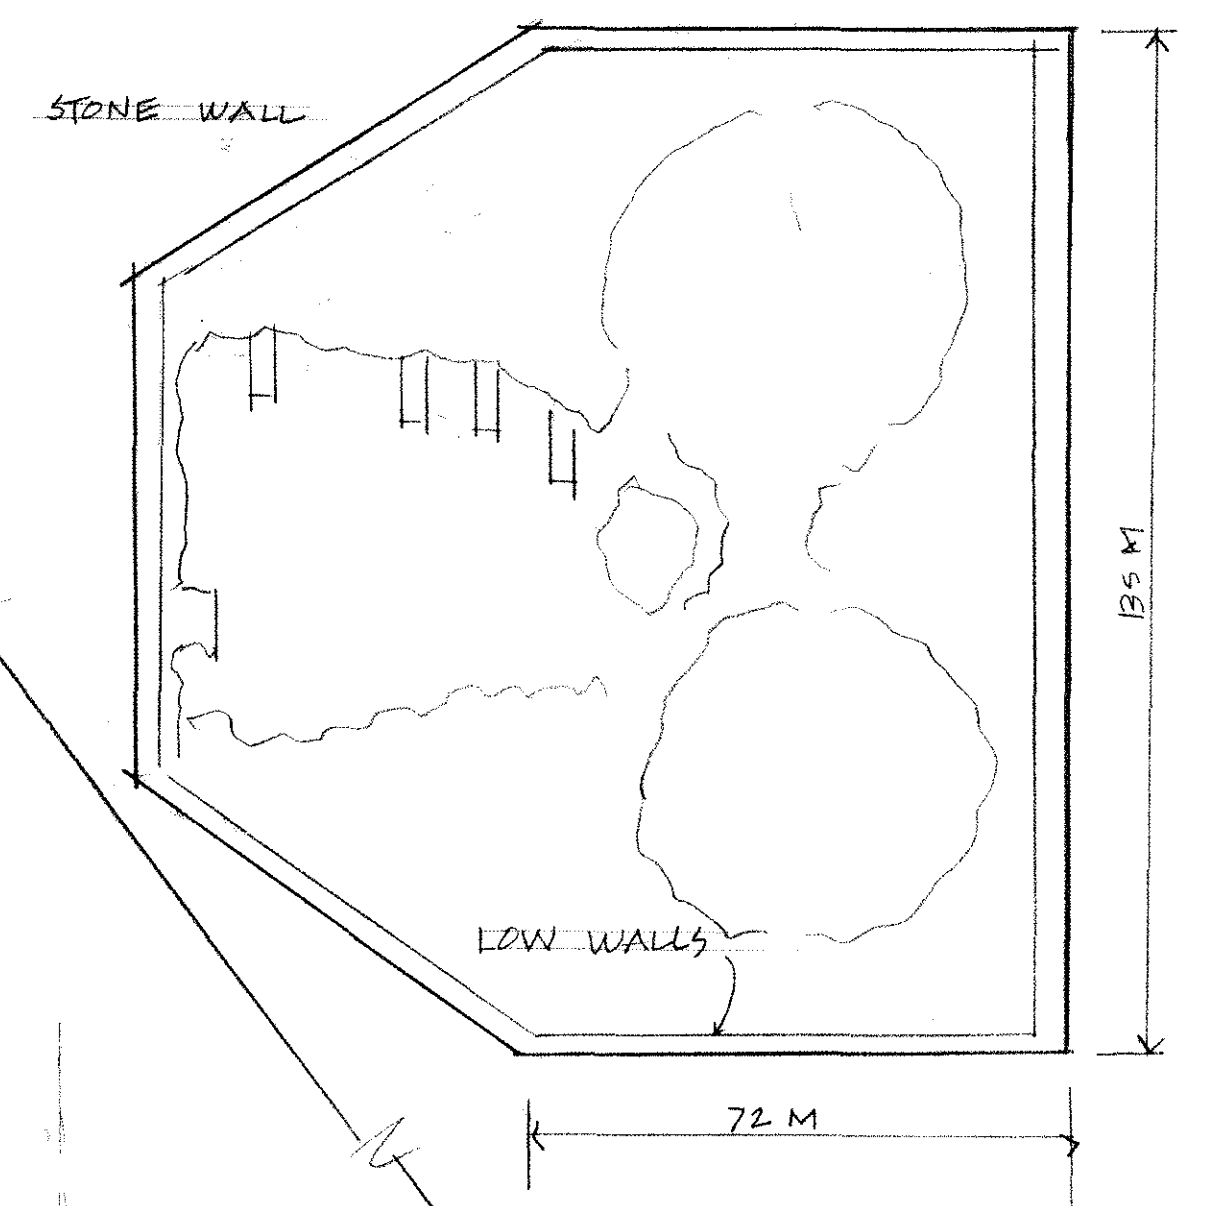
WALLS (B)
1:100

Located north and east of the main elevation, near the ocean, is a five-sided, stone walled, low lying feature once used for the storage of zinc. Here in three round tanks, after crushing the gold would have been combined in a water and zinc solution so that the two would bond to one another. The walls are built into the limestone rock and some appear to have a coat of rough plaster. Exposure to the elements, especially the winds, has reduced the once sharp and finished detail to this feature.
