DOCUMENTATION OF RUINS  
AT THE WYLLY PLANTATION  
CLIFTON, NEW PROVIDENCE ISLAND  
BAHAMAS

November 1993

By  
CVE  
Caribbean Volunteer Expeditions  
Box 388, Corning, New York 14830

For  
Bahamas Department of Architves  
Ministry of Education

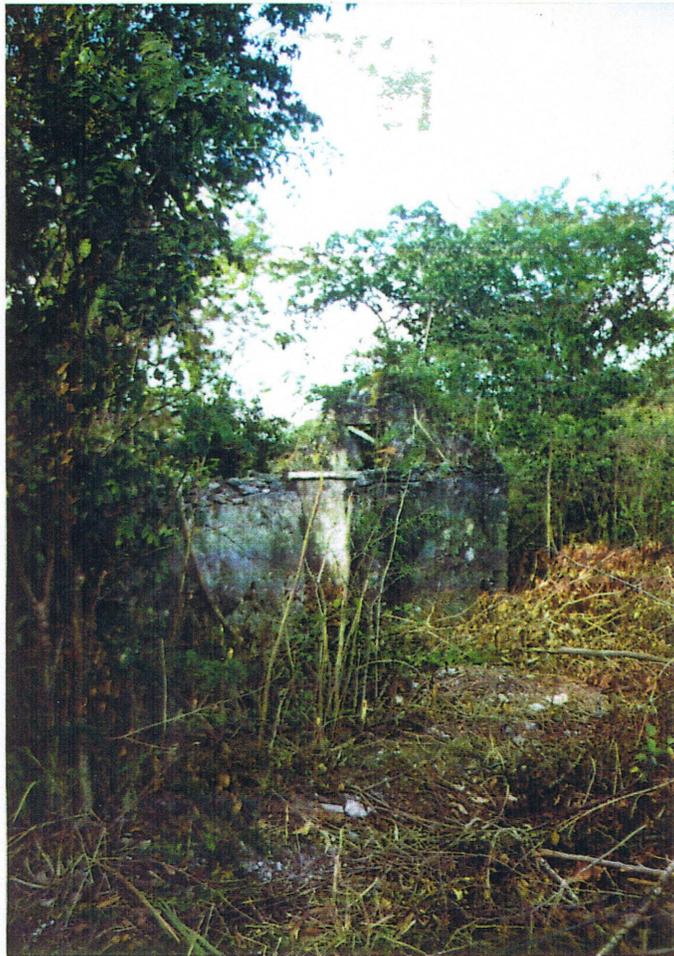
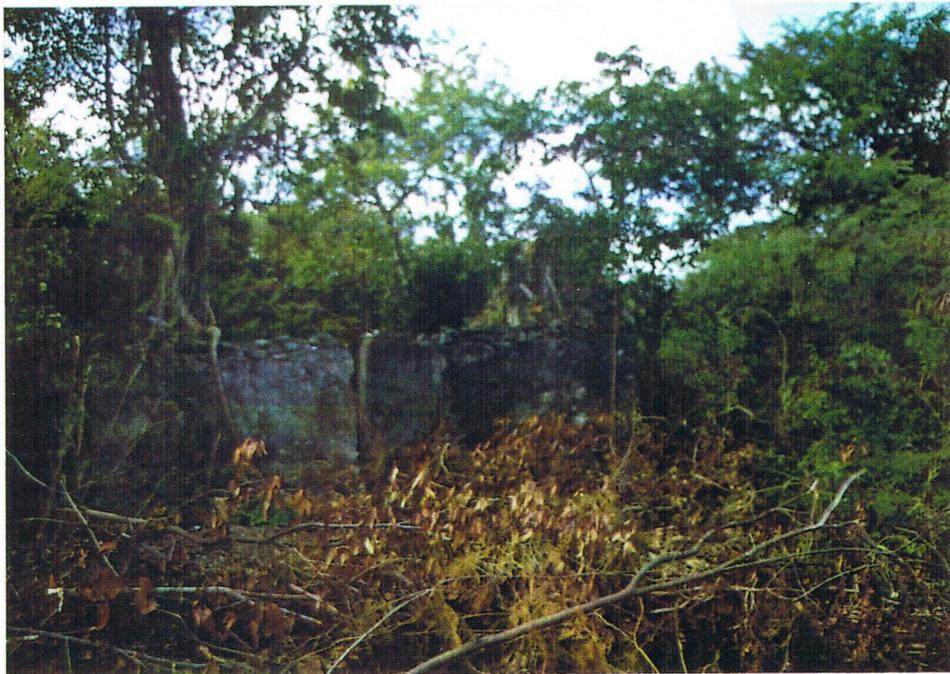
BUILDING # 1 SLAVE HOUSING

**Building #1.** This building measures 15 feet x 20 feet with 18 inch wide plastered stone walls. This building is in fairly good condition, with all four walls intact. A high window exists in the north gable end, as well as a window opening in the south end.

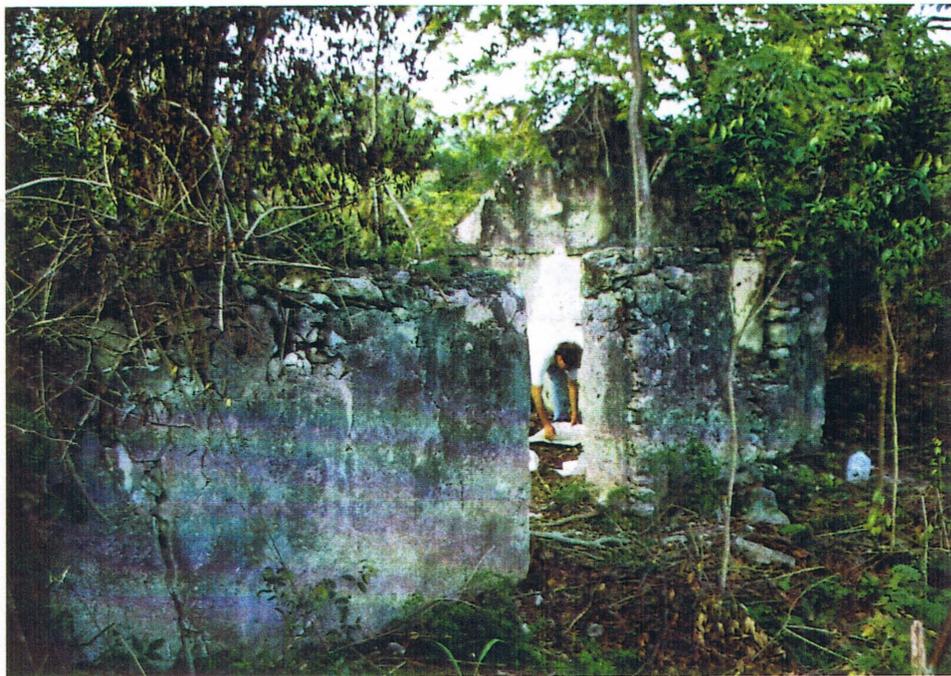
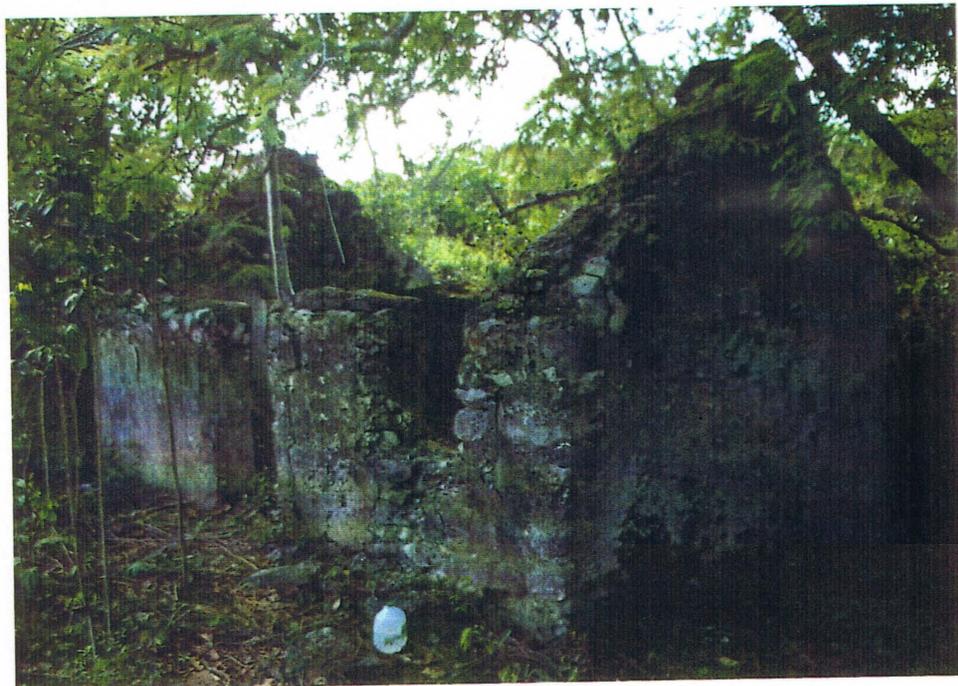
BUILDING # 2 SLAVE HOUSING

**Building #2.** This building is also about 15 feet x 20 feet outside dimensions. Again we find intact gable ends on the north and south, and door openings on the east and west walls. There are two windows - one on the south wall and one on the east wall. In the east wall, on the

northern window jamb and incised in the plaster is a sailing craft.. In the same wall, on the other side of the door are indecipherable letters.

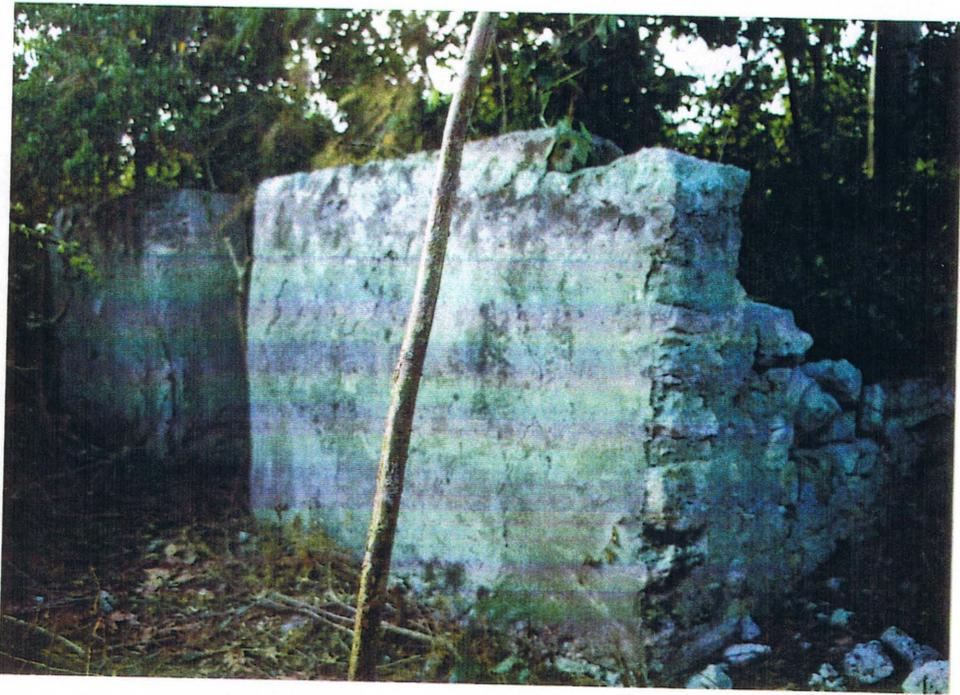
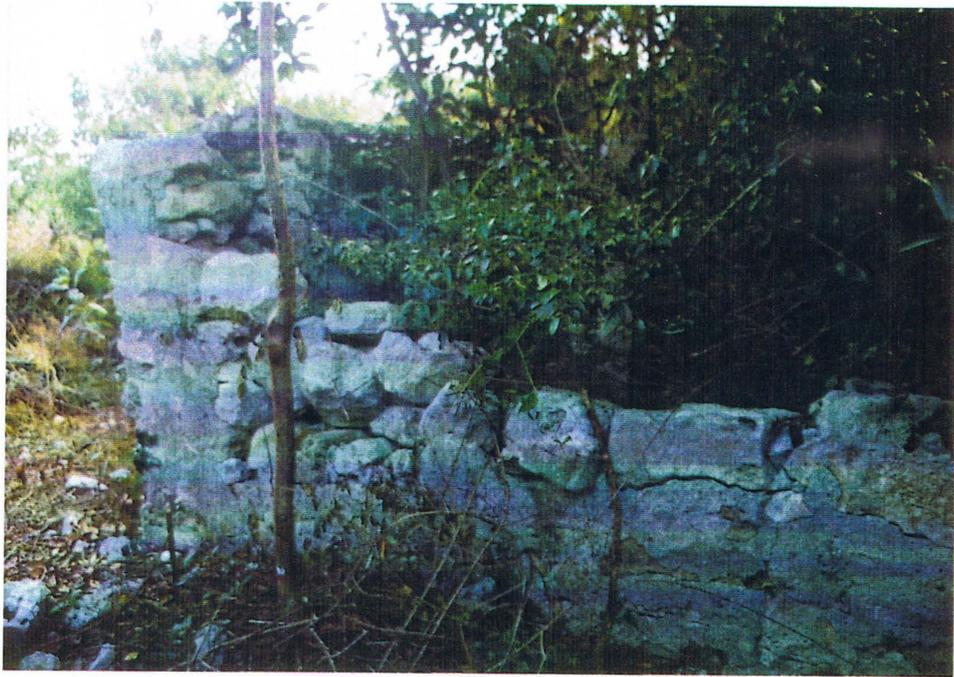
BUILDING # 3 SLAVE HOUSING

**Building #3.** Again we find a 15 feet x 20 feet rectangular building, with plastered stone walls 18 inches thick. The northern wall had been heavily damaged and was only 32 inches high; no gable remains on the south wall.

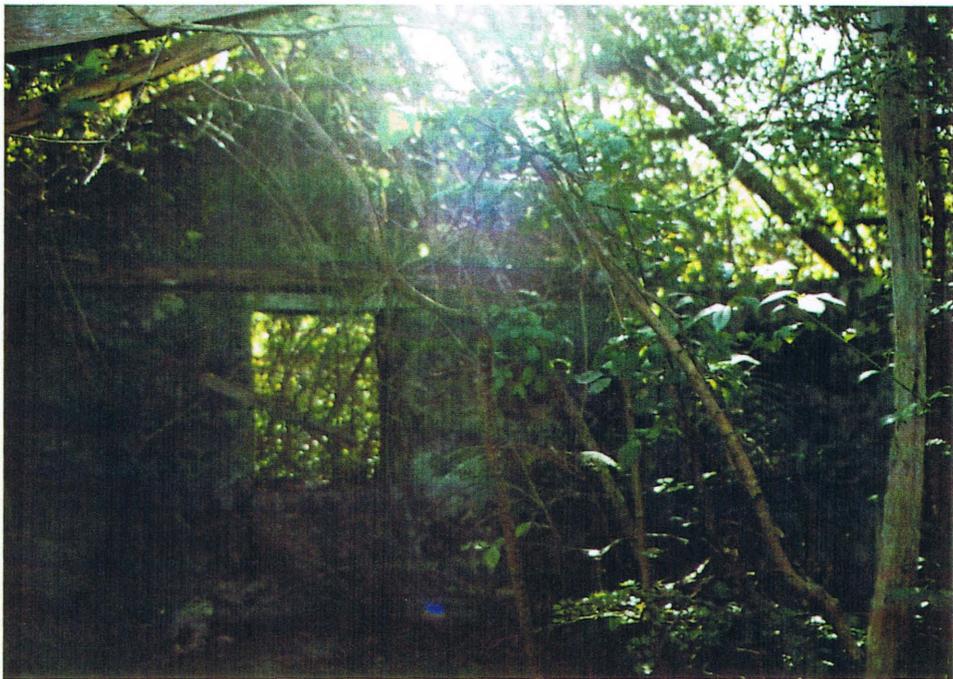
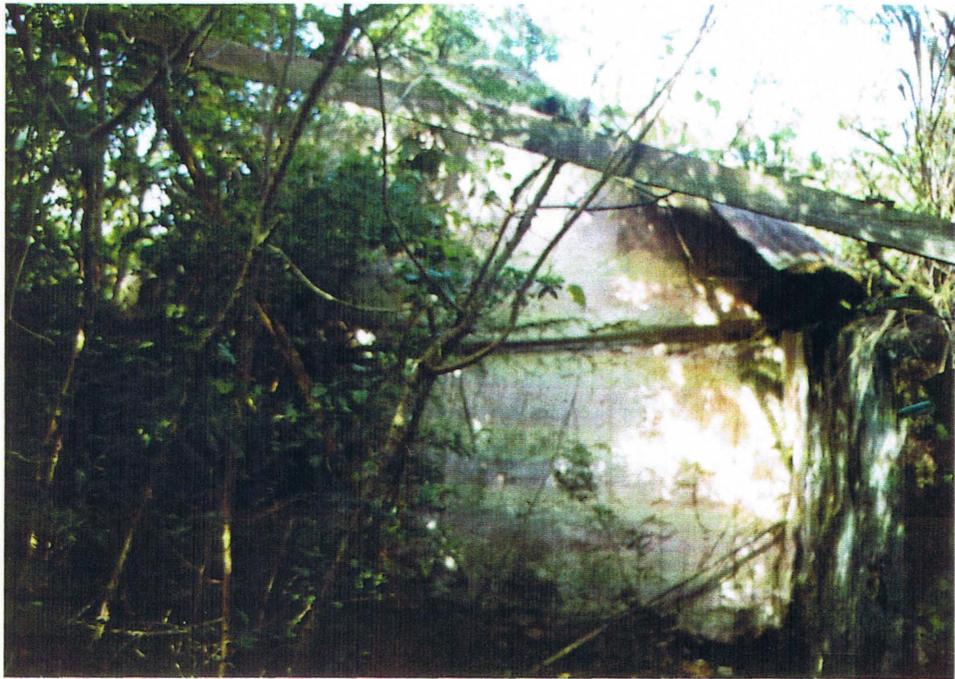
BUILDING # 4 SLAVE HOUSING

**Building #4.** This building, again, 15 feet x 20 feet, is in the best condition of all these ruins. Rafters and corrugated siding (modern) exists on part of the roof. The building has the usual east and west doorways and a south facing window. The gable ends are intact. The building was heavily overgrown and measurements were too difficult to undertake with out substantial clearing,

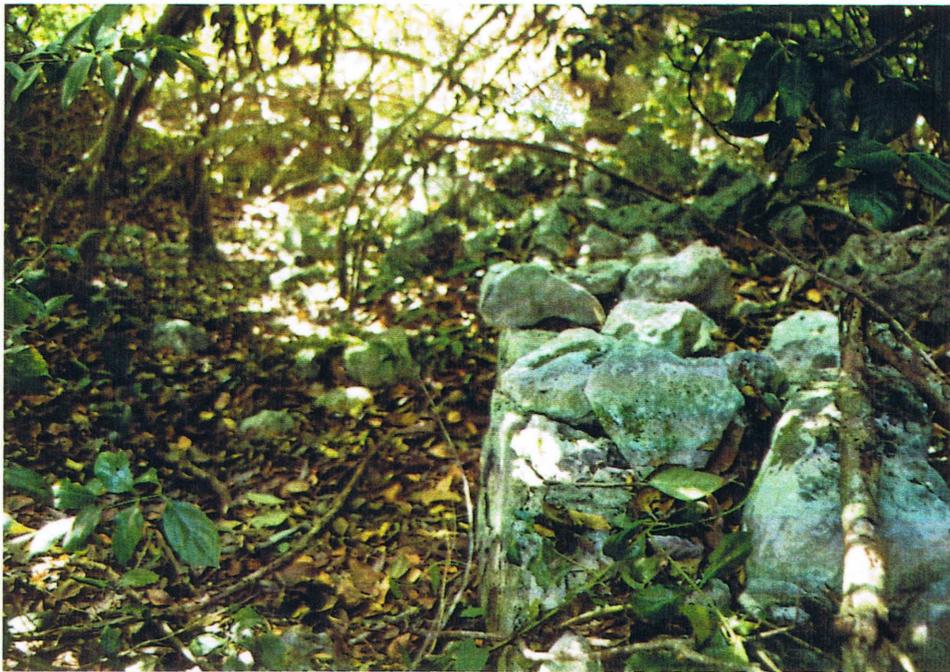
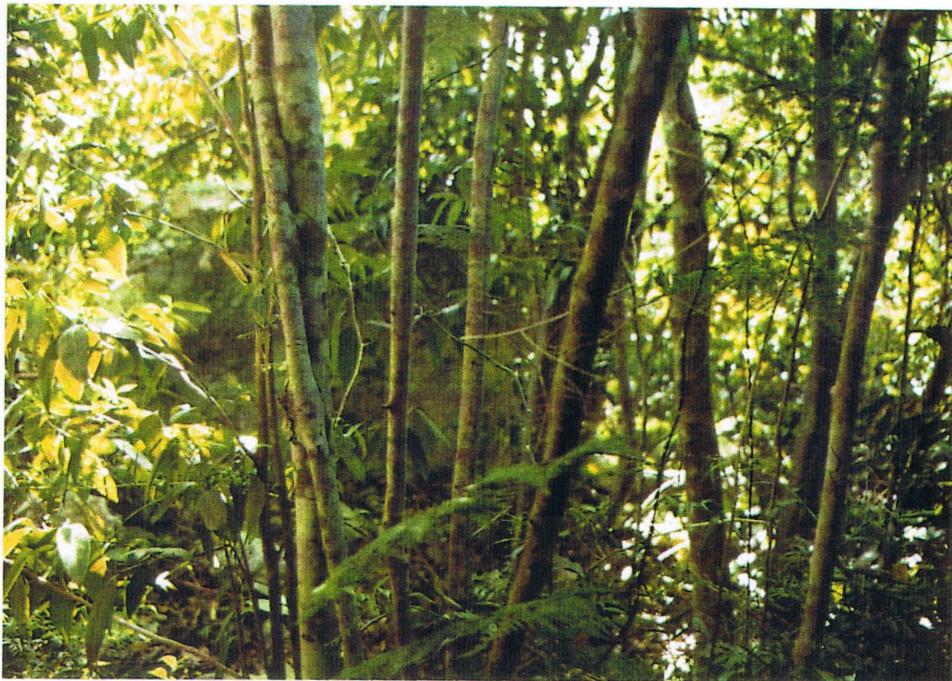
BUILDING # 5 SLAVE HOUSING

**Building #5.** This building is in poor condition with only a few four feet high wall fragments from the southwest and northwest corners remaining. Foundation edges remain and the building appeared to be larger than the first four dwellings - about 27 feet 6 inches x 17 feet 4 inches outside dimensions.

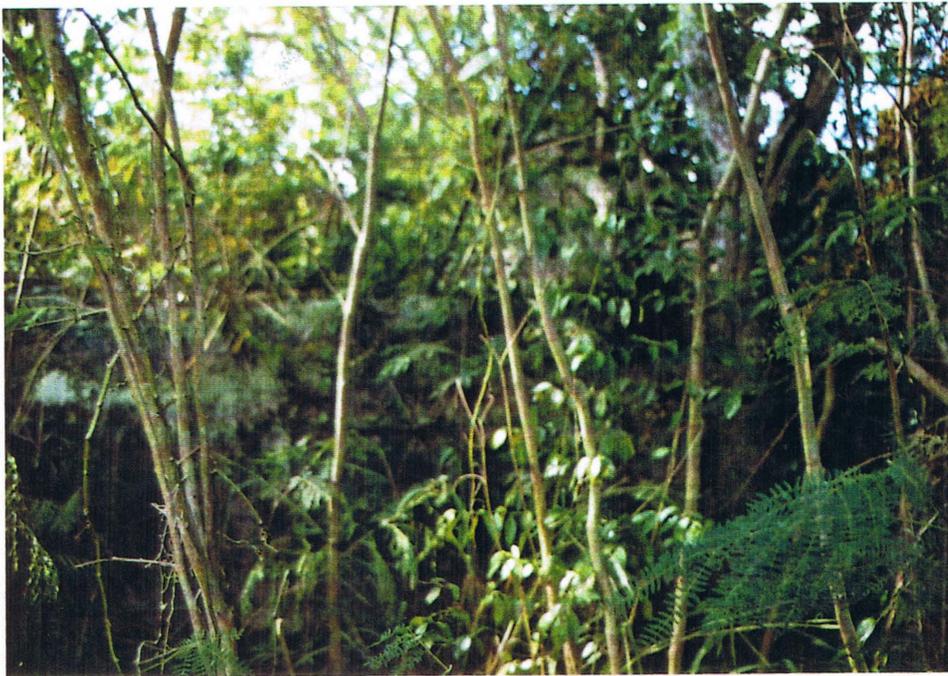
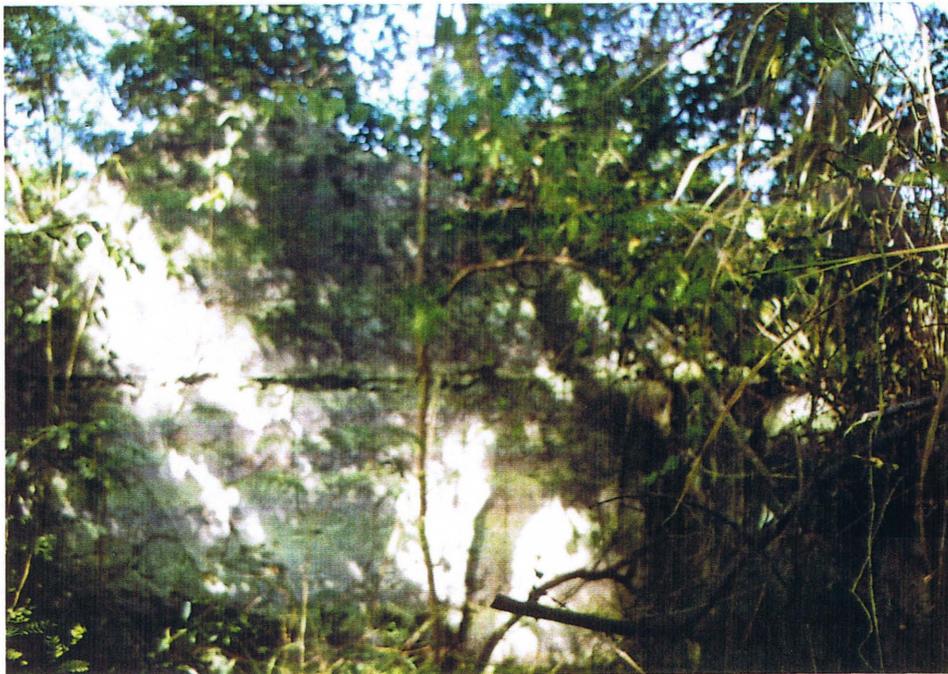
BUILDING # 6 SLAVE HOUSING

**Building #6.** This 15 feet x 20 feet building is also in fairly good condition with its east and west wall gable ends 5 feet 6 inches high. The building was heavily overgrown as was #4, 5, 7, and 8, and measurements and photographs were difficult.

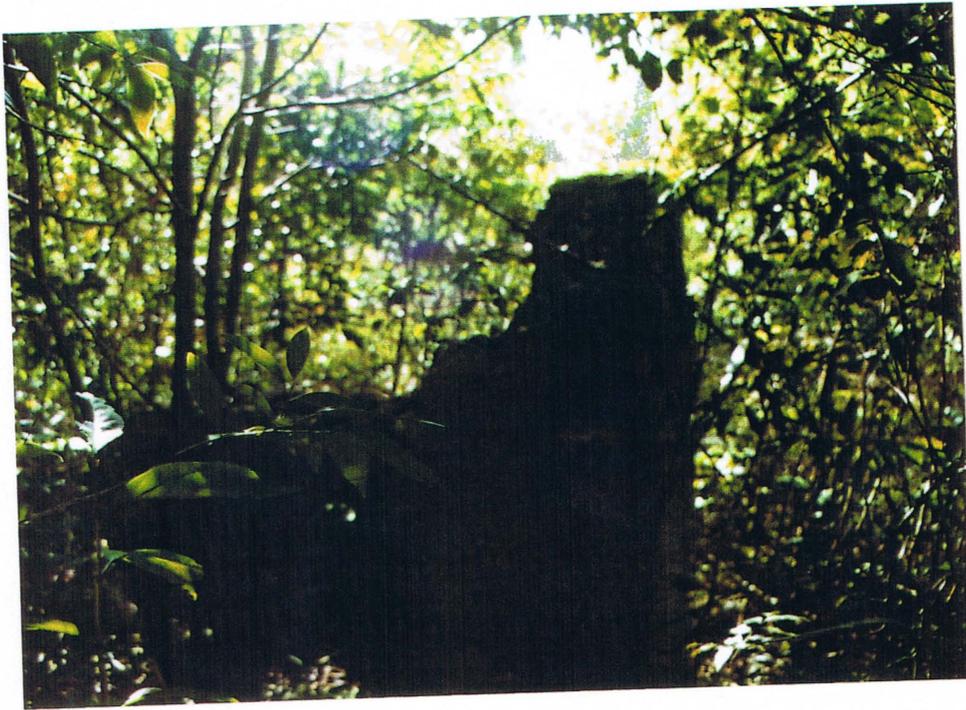
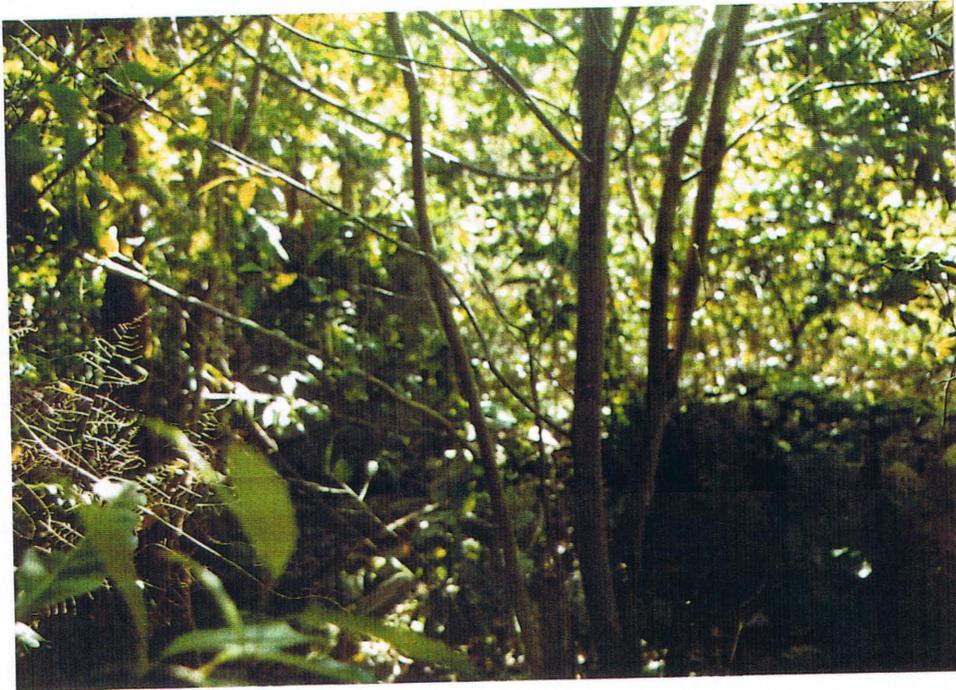
BUILDING # 7 SLAVE HOUSING	Date: 11/1993
WYLLY PLANTATION CLIFTON, NEW PROVIDENCE ISLAND BAHAMAS	
Caribbean Volunteer Expeditions Box 388, Corning, New York 14830 USA

**Building #7.** This building is in poor condition with only 4 foot high fragments existing on the south and west walls. The building appears to have been 27 feet 6 inches long and 17 feet wide -larger than some of the other buildings.

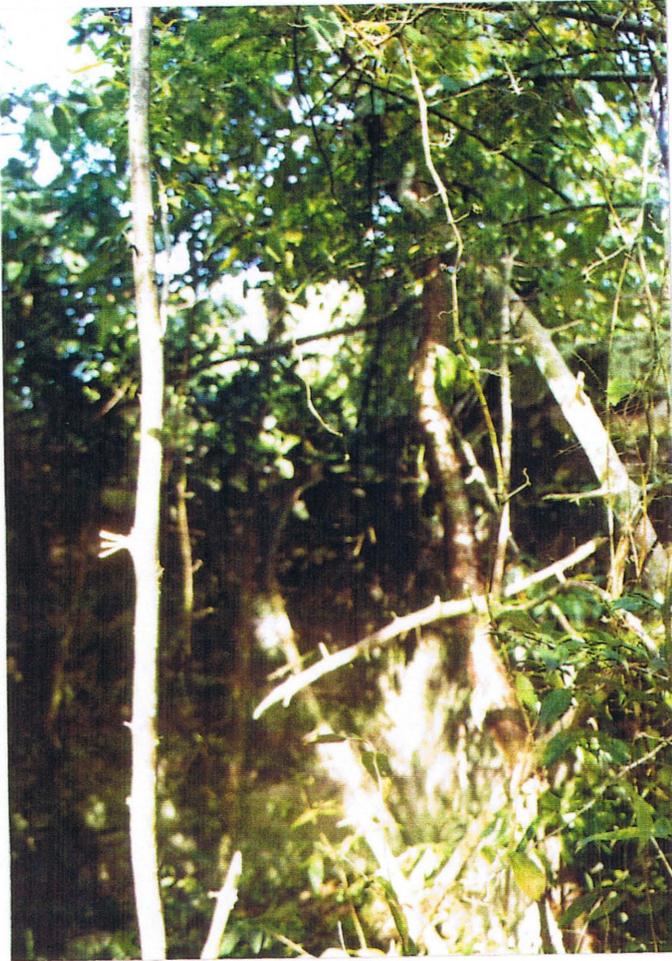
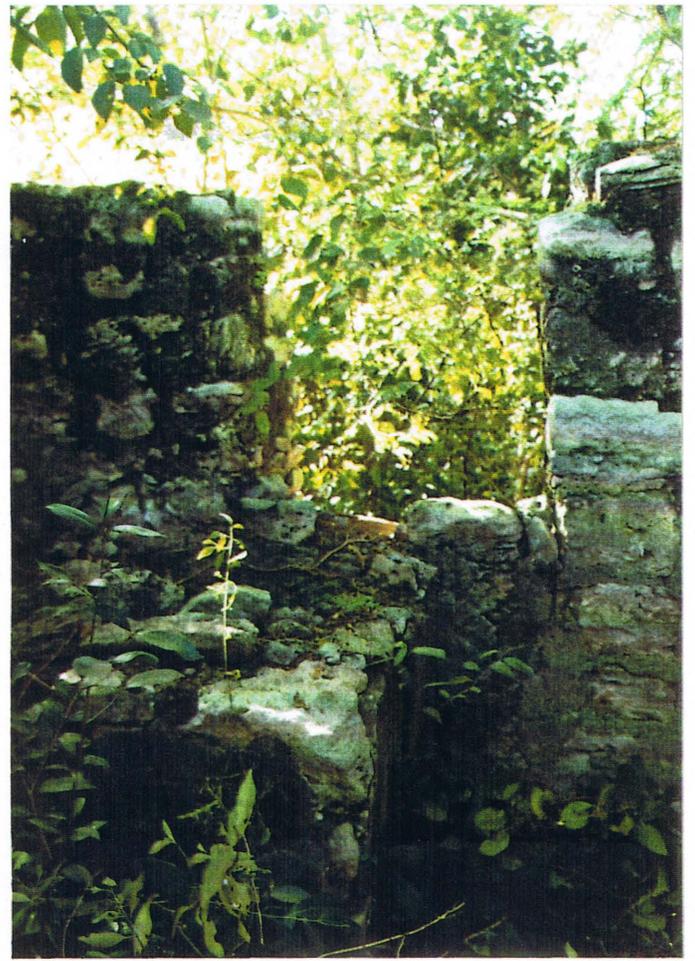
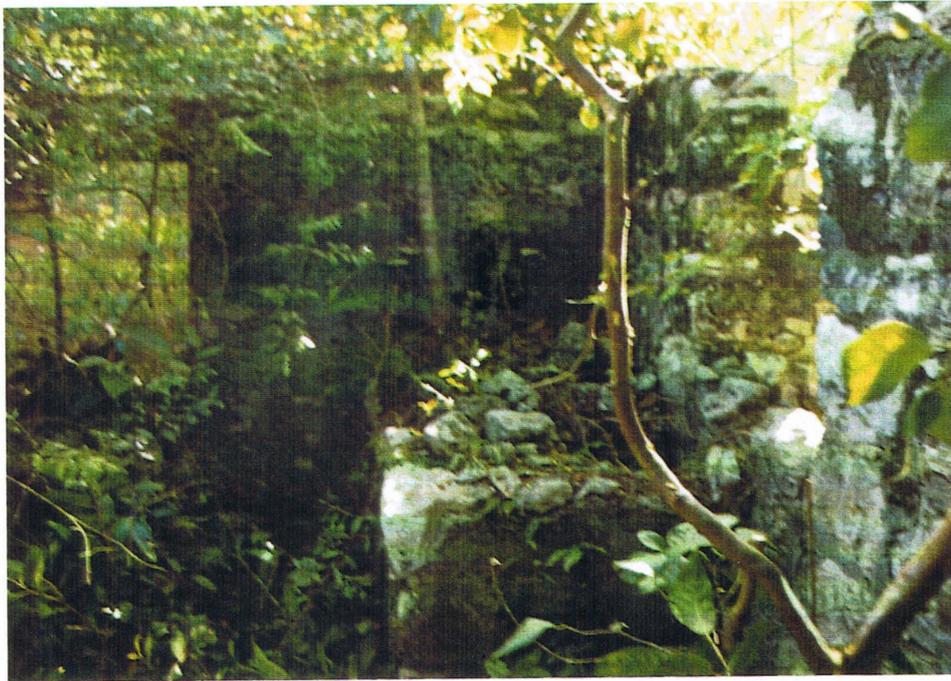
BUILDING # 8 SLAVE HOUSING

**Building #8.** This building is 24 feet directly west of Building #7. It is in quite good condition with 5 foot high walls on four sides. The tops of the north and south walls are flat, which indicates that there were no masonry gable ends.

The building is about 27 feet 6 inches long by 17 feet wide and has an east and west centrally located doorway as well as four window openings on the west, south, and east walls. 3 feet x 6 feet x 30 inches high stone platform exists in the southwest corner.

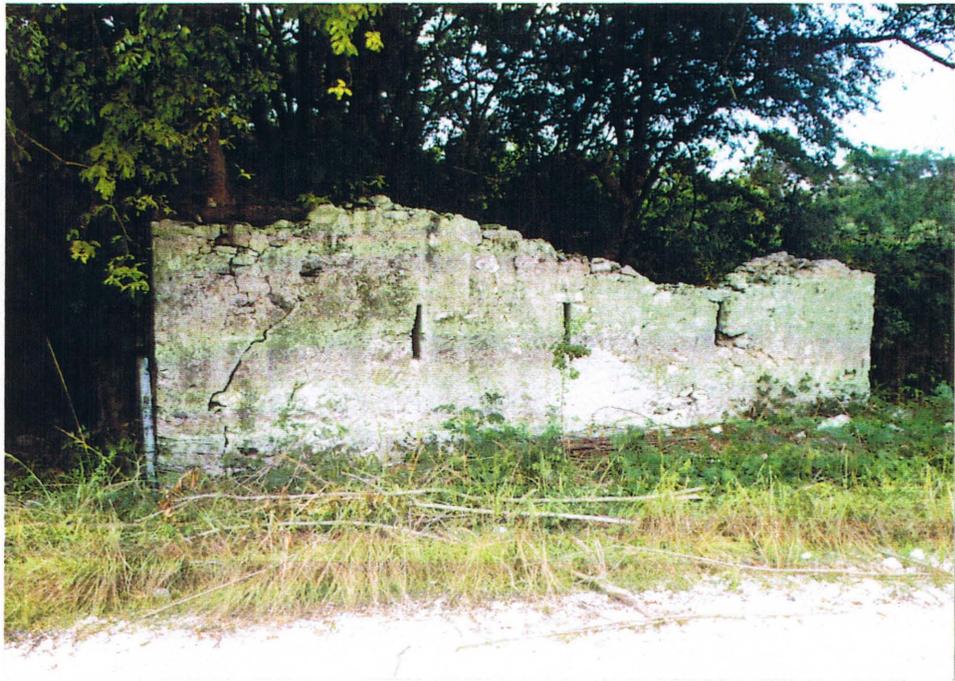
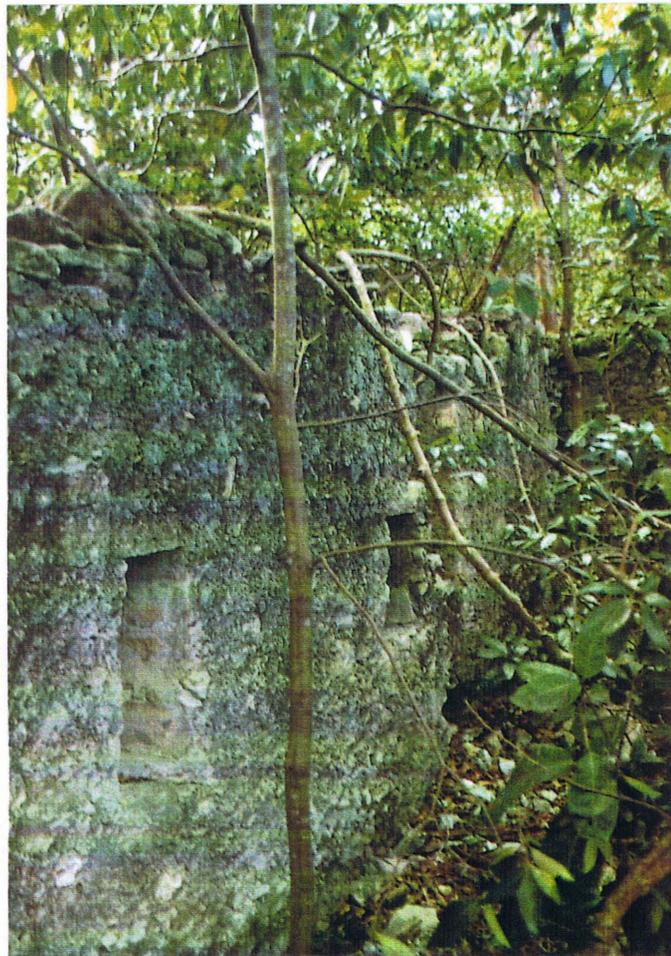
BUILDING #9 BARN

**Building #9 - Barn.** This building is across the road from the house and kitchen: the building measures about 44 feet by 24 feet. The walls were about 22 inches thick made of plastered cut stone. On three sides are ventilation slots which are about 3 inches wide on the exterior and 12 inches wide on the interior. The building has a pier in the center. Two exterior stone walls extend to the west and south. The wall height on the barn is about seven feet and part of the northern wall has fallen down.

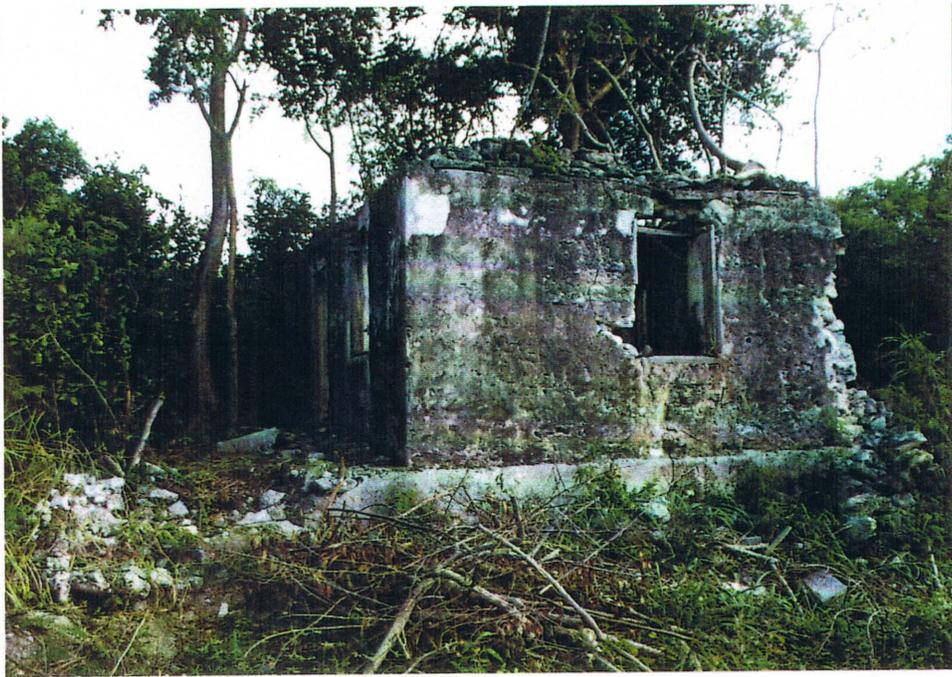
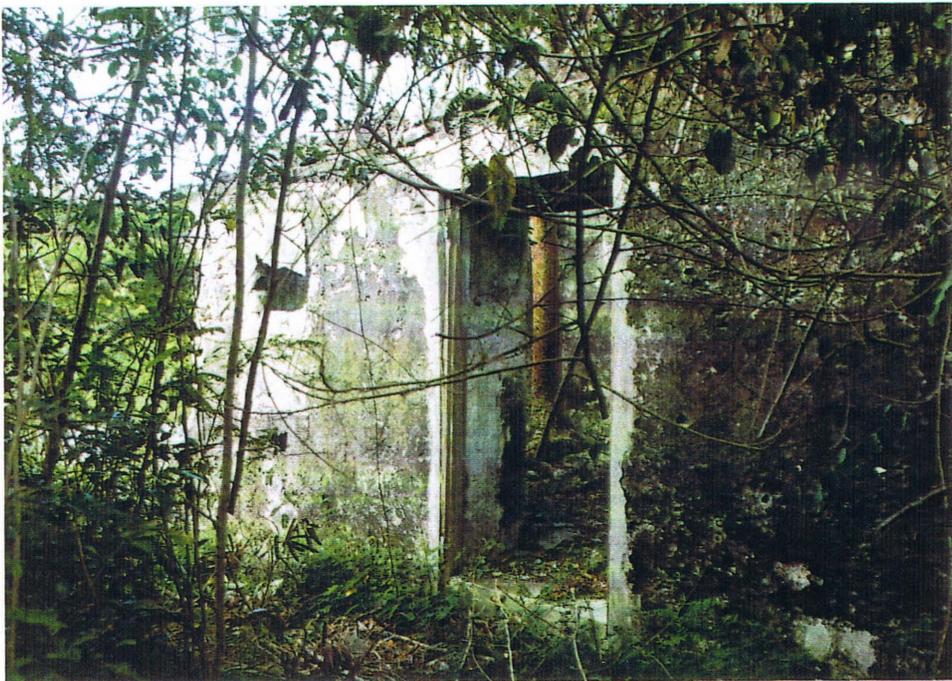
BUILDING # 10 OUT BUILDING

**Building # 10 - Building.** This building as located north and a little to the east off the Main House. The plan is 16'-9" by 20' - 10" in dimension. The walls are comparatively in good condition and there is no indication of a gable end. There is in indentation (well?) in the interior on the floor, which is cut stone. On the north side is a stone floor on grade, which may

have been a type of porch. The walls are 2'-2" thick- much thicker than other walls of other buildings surveyed. This building may have been used in conjunction with food preparation, or with the great house.

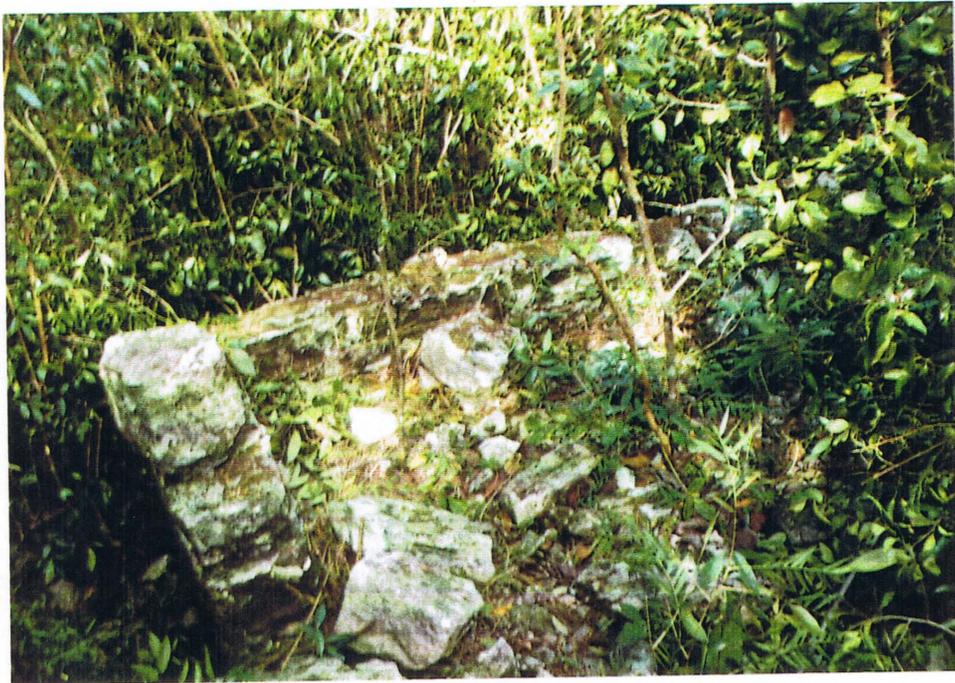
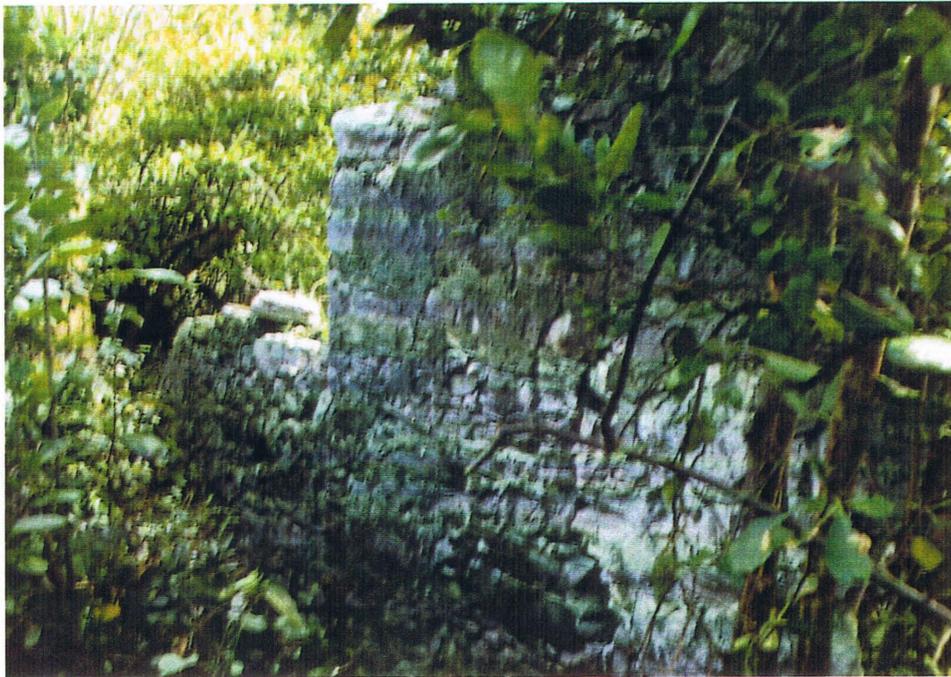
BUILDING # 11 KITCHEN

**Building #11- Kitchen.** This building is approximately 32 feet from the Plantation House. The building measures about 32 feet 6 inches x 16 feet 6 inches and has part of a dividing wall, separating it into two rooms. The building was constructed of cut stones, some measuring 19 inches x 12 inches x 10 inches. The walls were plastered and were about 12 inches thick. Many of the walls have fallen down. There was a remnants of a chimney near the center of the building.

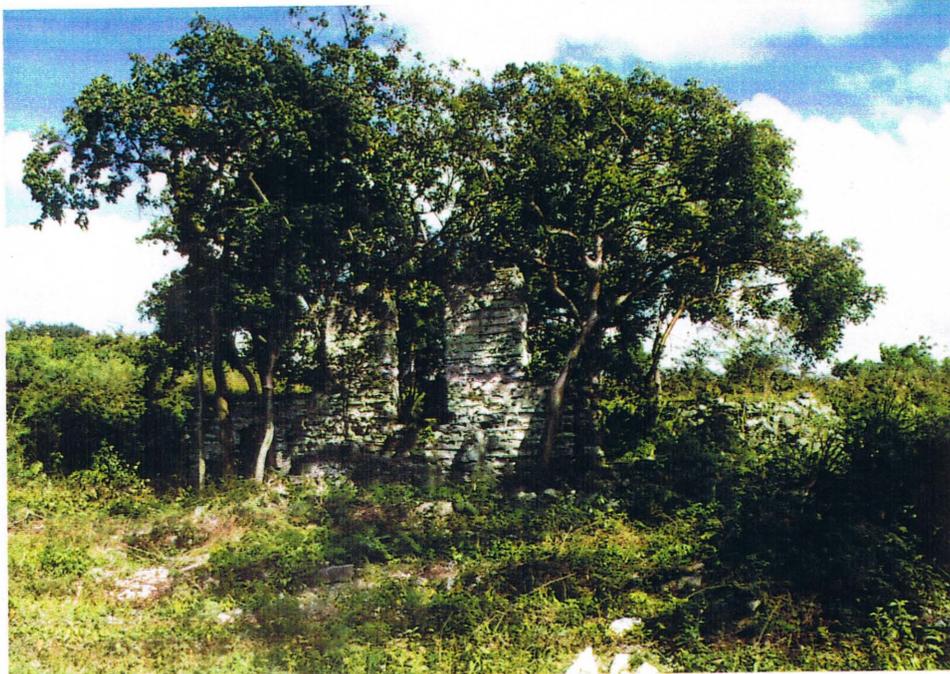
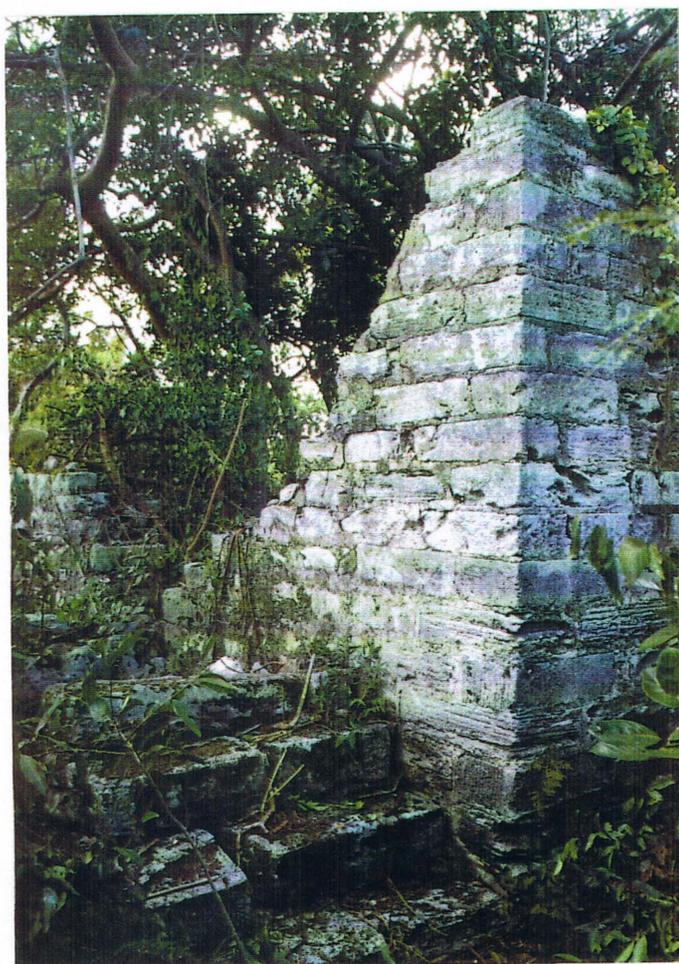
BUILDING # 12 PLANTATION HOUSE

**Building # 12 Plantation House.** This building is 48 feet long by 24 feet wide, with 2' - 11" thick interior walls dividing the space into three sections. The west elevation has a 10' - 3" wide porch with a 5' - 3" wide stair centered on the 48 foot elevation. A 5' - 2" wide door opening is also centered at the top of the porch. On either side of the door are walls rising approximately 10' - 8" from the sill. The east elevation is further deteriorated and has a porch with a 45" wide stone staircase which is off center. There is another 45" wide stair which leads to the out-buildings. To the south of the building is a good deal of rubble which appeared to have been walls that started at the building's corner. The building is mainly constructed of cut stone approximately 5" tall and 20" long with a plaster finish. A cut keystone was found that made up the lintel above the crawl space vent opening.
