**HISTORIC BUILDINGS
HAMPSTEAD ESTATE
DOMINICA**

AUGUST 2000

By Caribbean Volunteer Expeditions
Box 388, Corning NY 14830

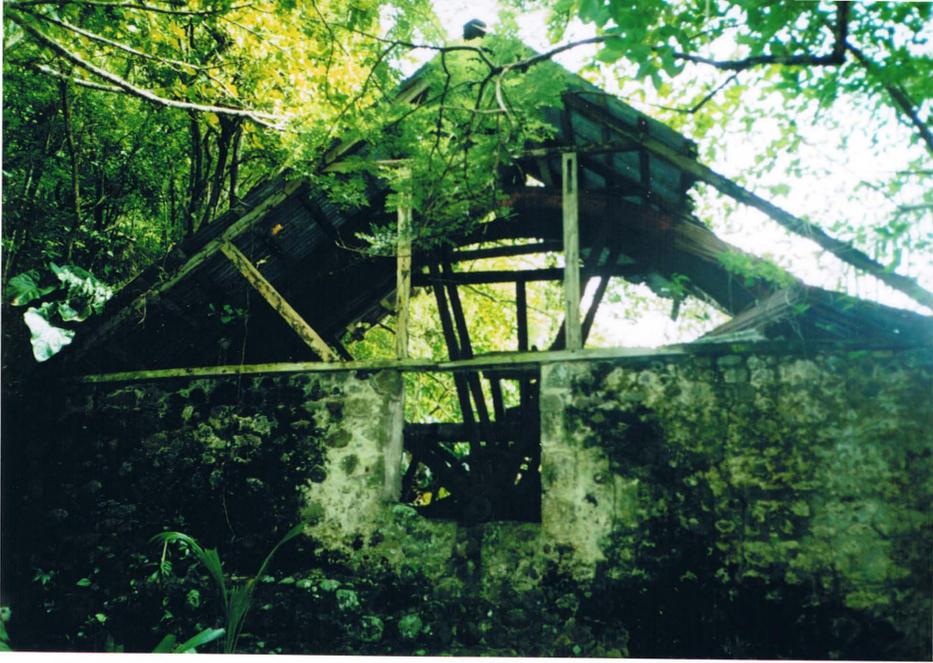
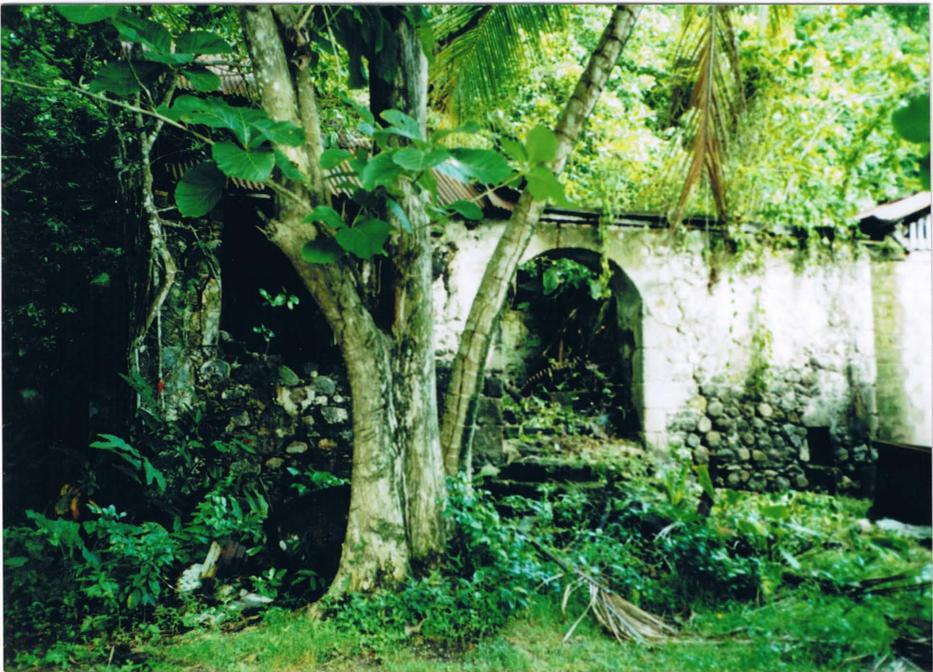
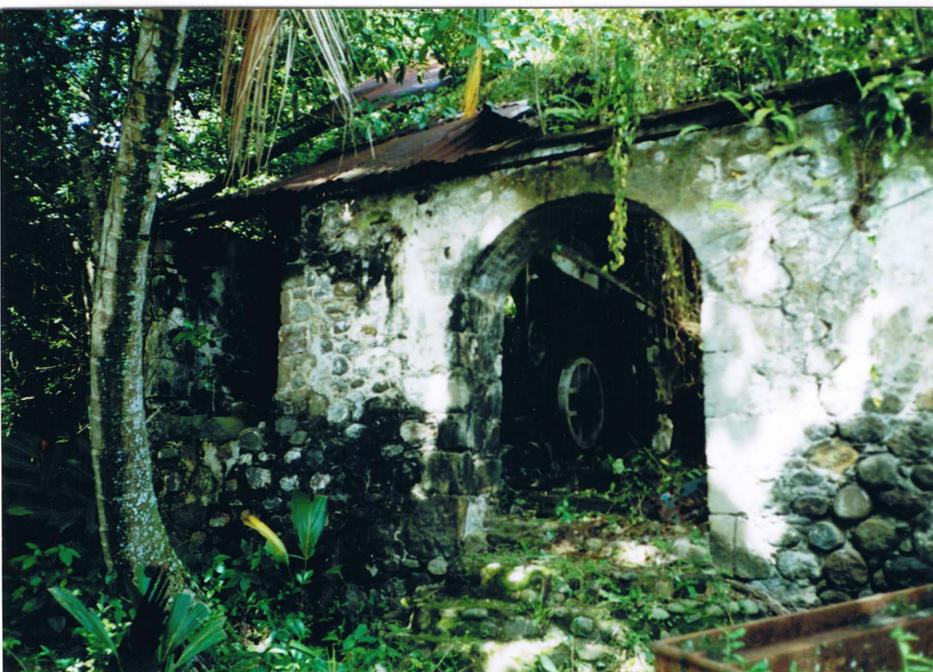
Building A
Hampstead Water Wheel
Dominica Aug. 2000

This houses the water wheel which is a unique and important feature of the site. The building is about 31 by 33 feet with 28 inch thick stone walls. The walls have large cut stone quoins at the corners and at door jambs, and plastered stones between. On the east side is the water wheel, which sits in a large pit. An arched structure leads to a canal which fed water from the stream. In the interior of the building are various pieces of debris and machinery. The roof is partially intact, and one can still see the large timbers forming a truss system. There are three arched door openings. The water wheel itself has about a 13 foot radius; there are two connecting gears- one wood and the other metal- connected to a crushing device.
- **Condition and Recommendations**

This building and the water wheel are the most important historic features on the site, and stabilization and restoration of these should be the first priority. The walls are in relatively good condition, with some cracks, but need stabilization-pointing, and the replacement of missing stones. There are trees and plants growing

from the walls, and the roots are damaging the walls. These should be removed carefully. The deteriorated roof needs to be removed; a new roof structure should be installed, using the same timber structure and galvanized roofing. This roof will help stabilize the walls, and preserve the machinery inside. The machinery should all be cleaned up; making the water wheel operational would be a major undertaking, and may not be necessary.

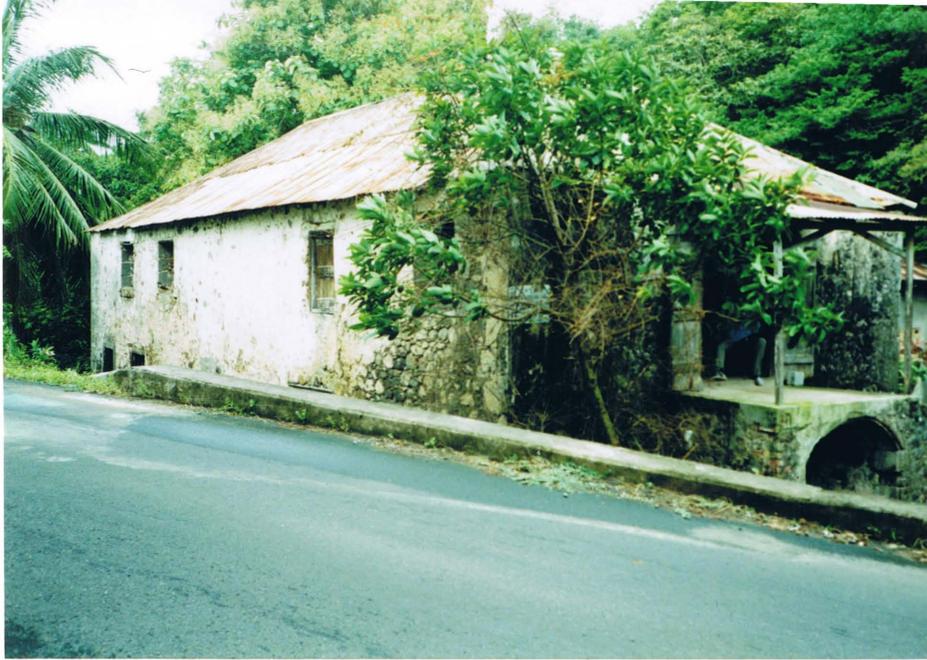
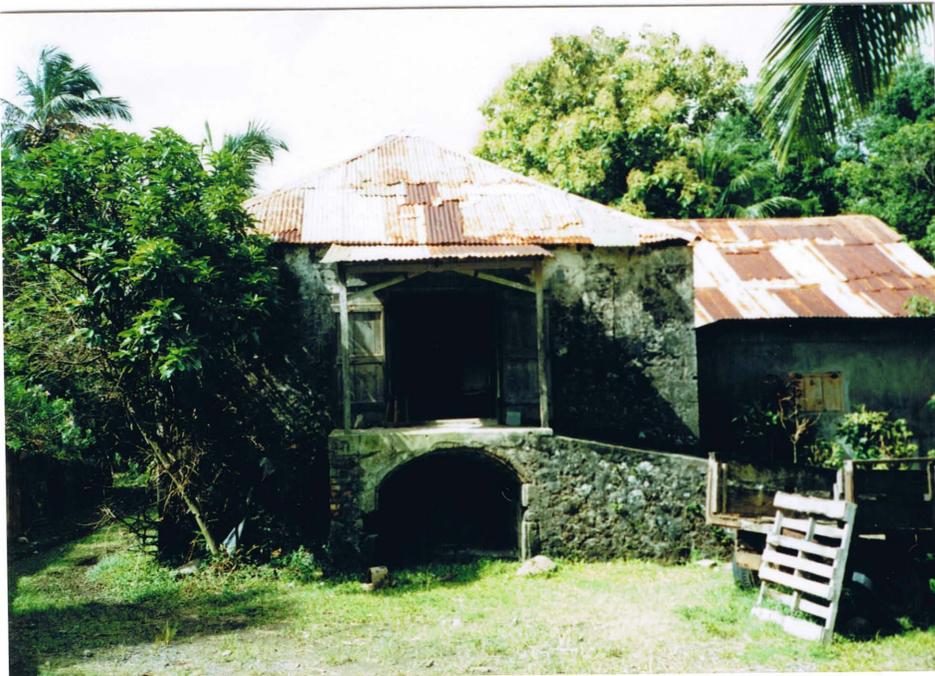
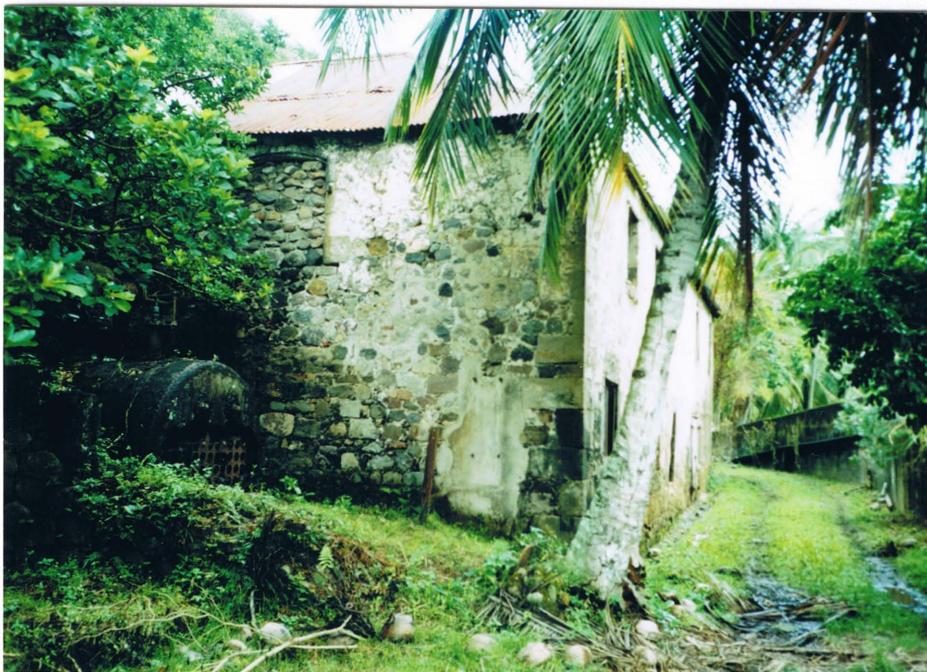
Building B
Hampstead, Dominica
Aug. , 2000

- **Description**
This building, which sits nearest the road, is about 57 by 27, and is two story. The upper floor is raised off the grade, and is accessible via a long ramp. The roof is also a large timber truss system, with galvanized roofing. The floor is framed in wood, with a wood deck; a concrete system of beams and columns has been installed on the lower level to help support this floor. There are numerous openings- some have iron grates, and some had wood and glass sash, now in deteriorated condition.

- **Condition and Recommendations**
The walls again are in relatively good condition. The roof and floor framing systems appear to be sound but should be thoroughly examined for termite or rot, and deteriorated members should be replaced. Hopefully the large timber roof trusses can be saved. The galvanized roofing is in poor condition, and needs to be replaced. There is a serious bat problem in this building which has to be remedied. Rotted floor decking or roof decking needs to be replaced. The deteriorated window and door shutters should be replaced.
This building and Building C- Boiling House are second priority items to be restored.

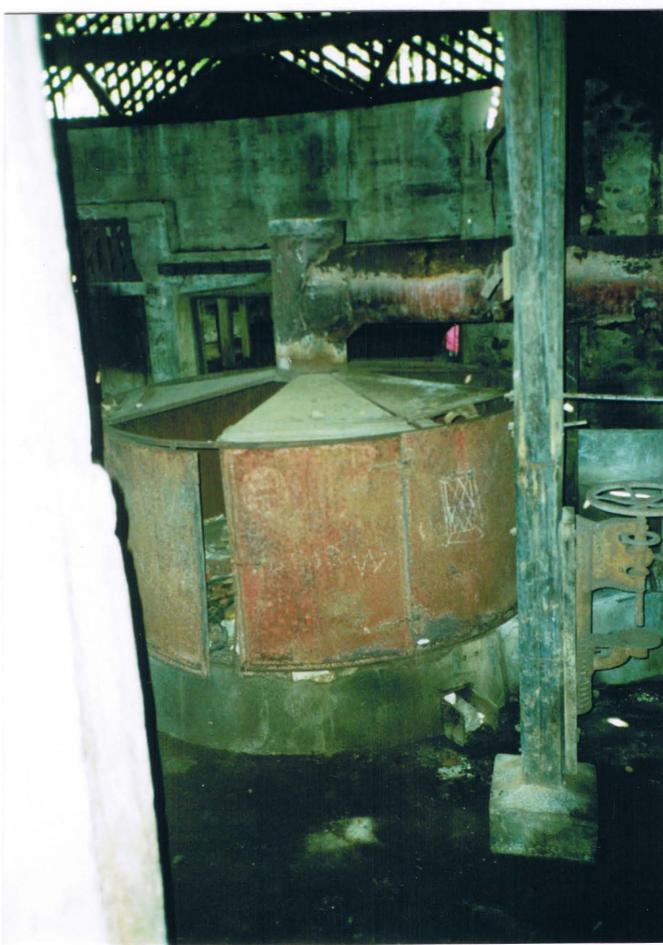
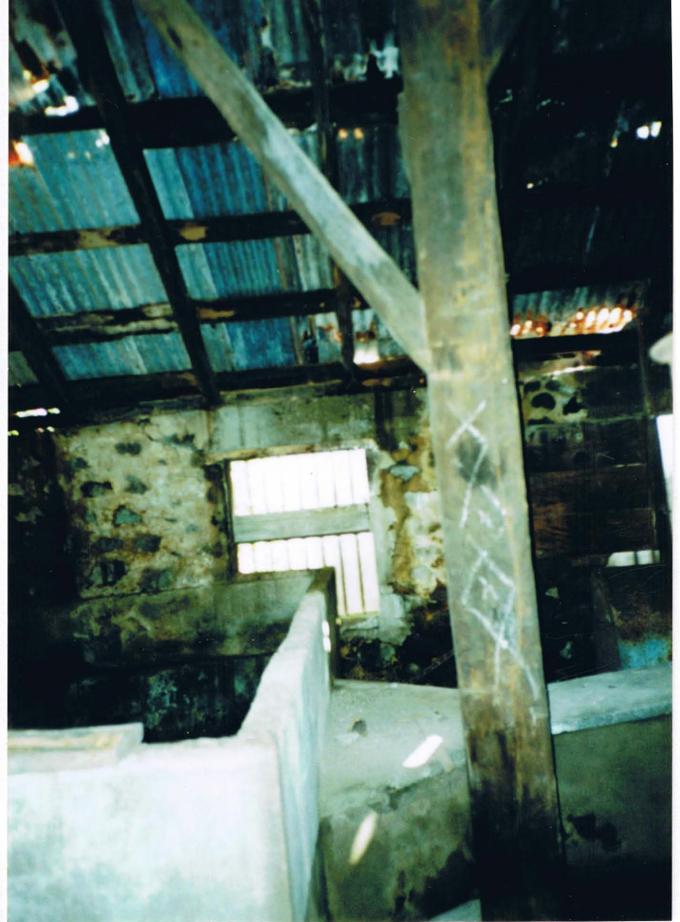
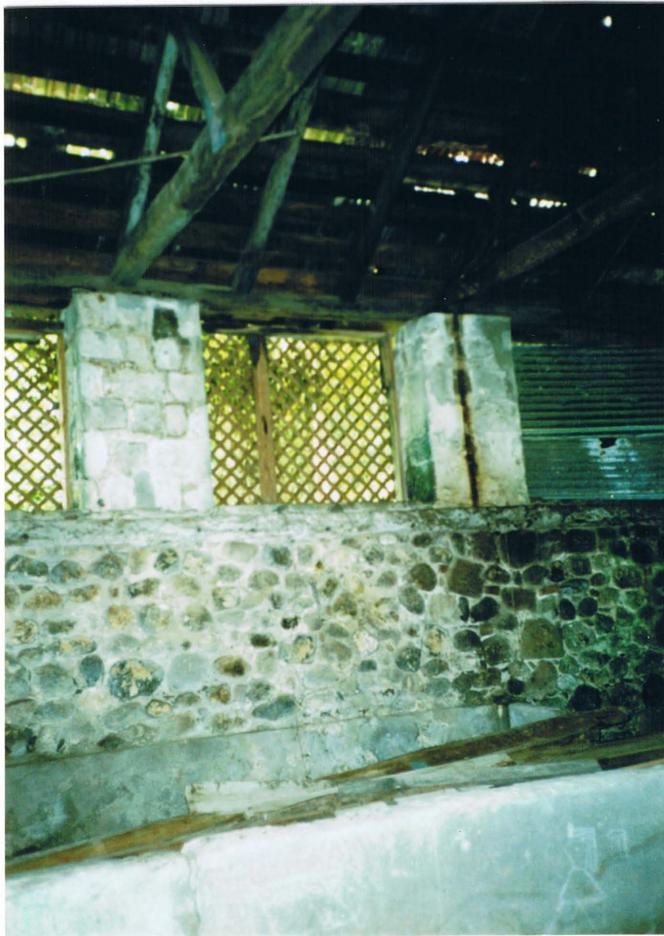
Building C
Hampstead, Dominica
Aug. , 2000

- **Description**
This was the former sugar boiling house and one can see arched openings for draft and fires along the east side of the building. Unfortunately the sugar coppers are no longer in place. The building had been adapted to many other uses- cocoa and copra production, and there is a large unique metal bin in the center of the space which had been used for copra. The walls are again 26 inch wide stone with large cut stone quoins at corners and jambs. The roof is framed with trusses made of large wood members, with galvanized roofing. There are large opening above the former boiling area, now covered with lattice, and smaller windows on the west with metal grates. The floor is concrete.

- **Condition and Recommendations**
The roof framing should be examined, and deteriorated members should be replaced; the galvanized roofing is badly rusted, and should be replaced. Window shutters need to be replaced.
The more modern concrete floor has holes, and cracks and needs to have a new surface.

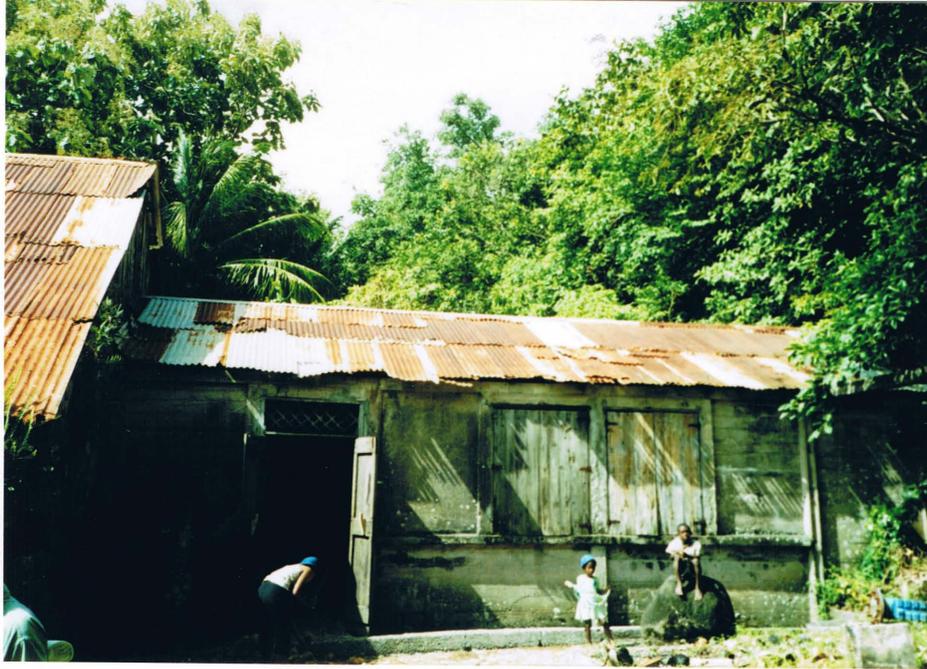
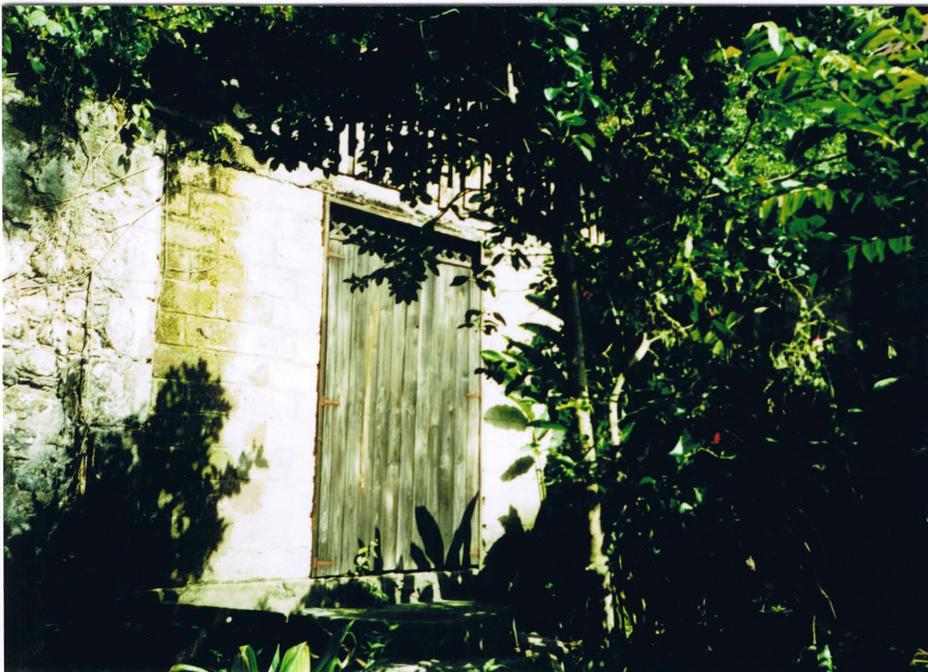
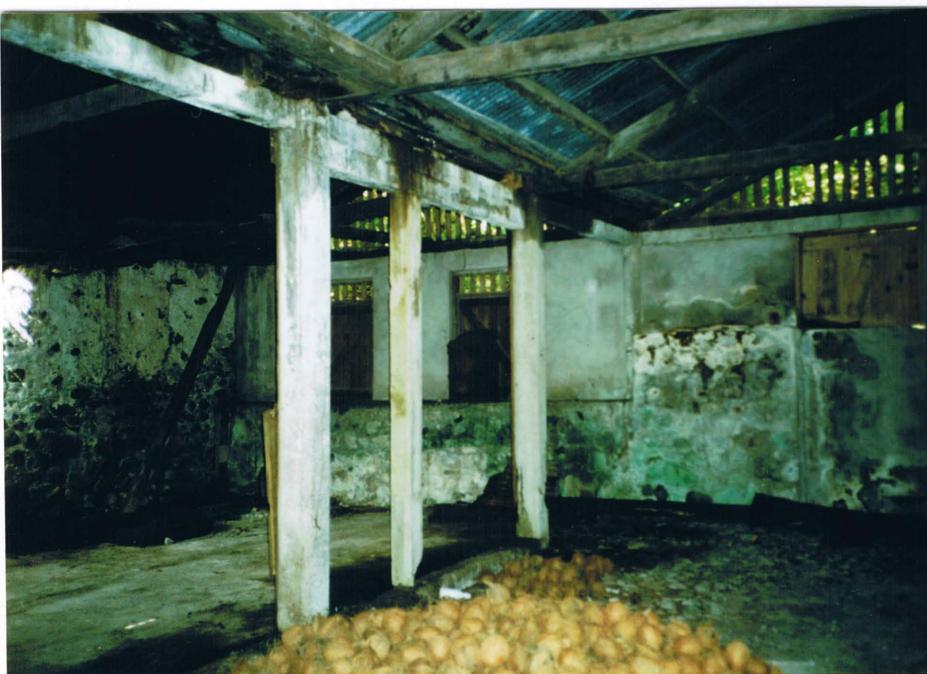
Building D
Hampstead, Dominica
Aug. , 2000

- **Description**
This is a more modern concrete structure. It is presently used for coconut storage. The floor is concrete with large round stones recently installed. The roof is wood framed with galvanized metal.
- **Condition and Recommendations**
The concrete is badly cracked in places, and the concrete columns and beams have spalled so their reinforcing rods are showing. All this has to be replaced. Some of the wood roof rafters may be able to be replaced, but the galvanized should be replaced.

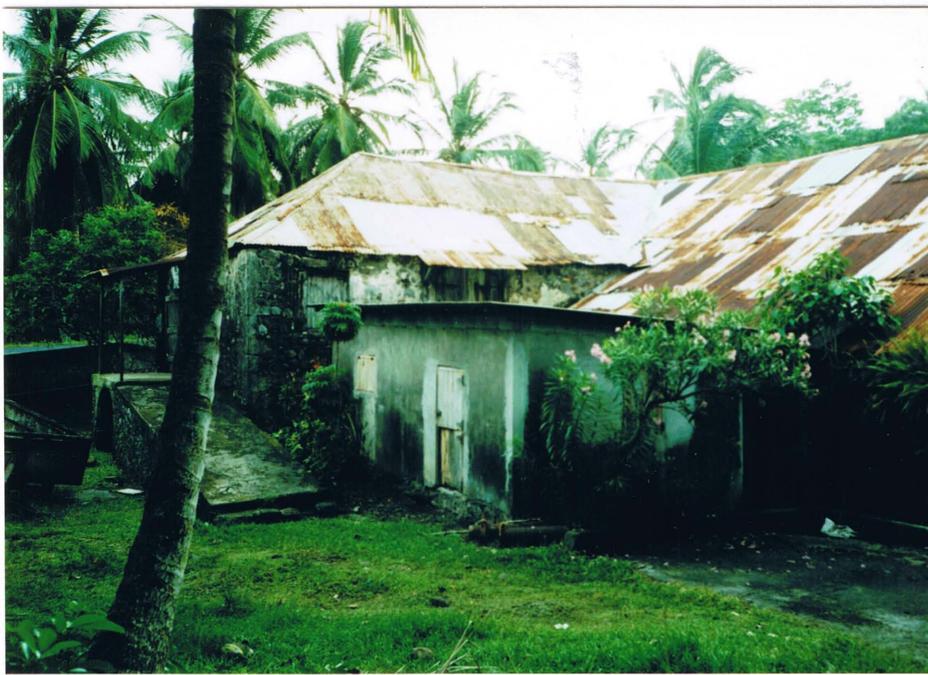
Building E

- **Description**
This building is a more recent concrete block building with shed roof. The building is about 14 by 21 feet, and sits in an alcove between the storage building and boiling house.
- **Condition and Recommendations**
Though the building is in relatively good condition, it does not contribute to the historic nature of the site, and in fact detracts from the building behind it.

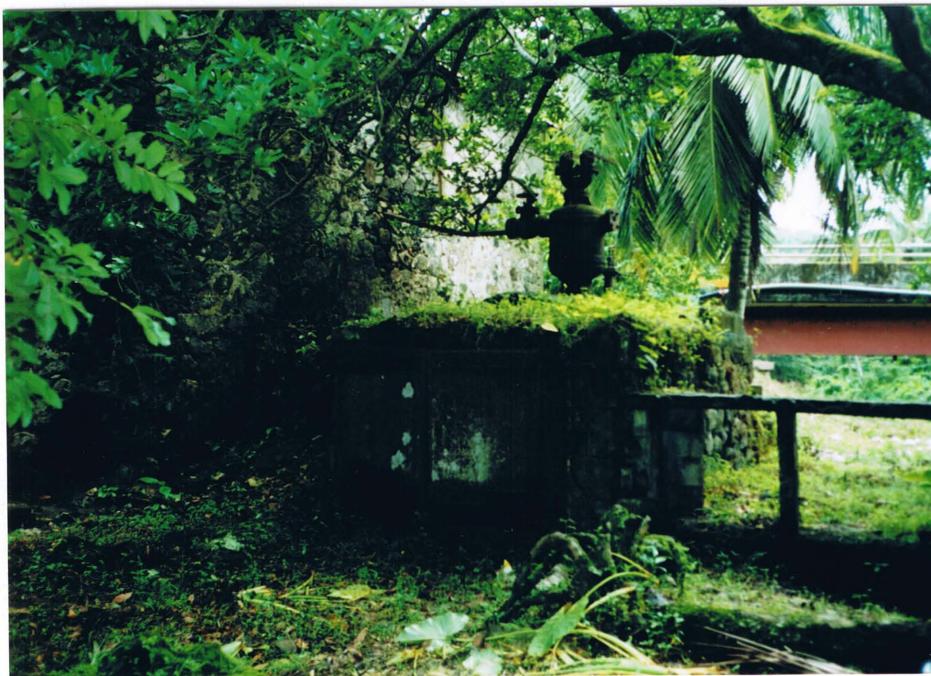
F- Still

- **Description**
To the east of the storage building is a boiler with small still on top.
- **Condition and Recommendations**
These pieces of machinery should be cleaned up, and stabilized. The recent concrete block and concrete counter should be removed.

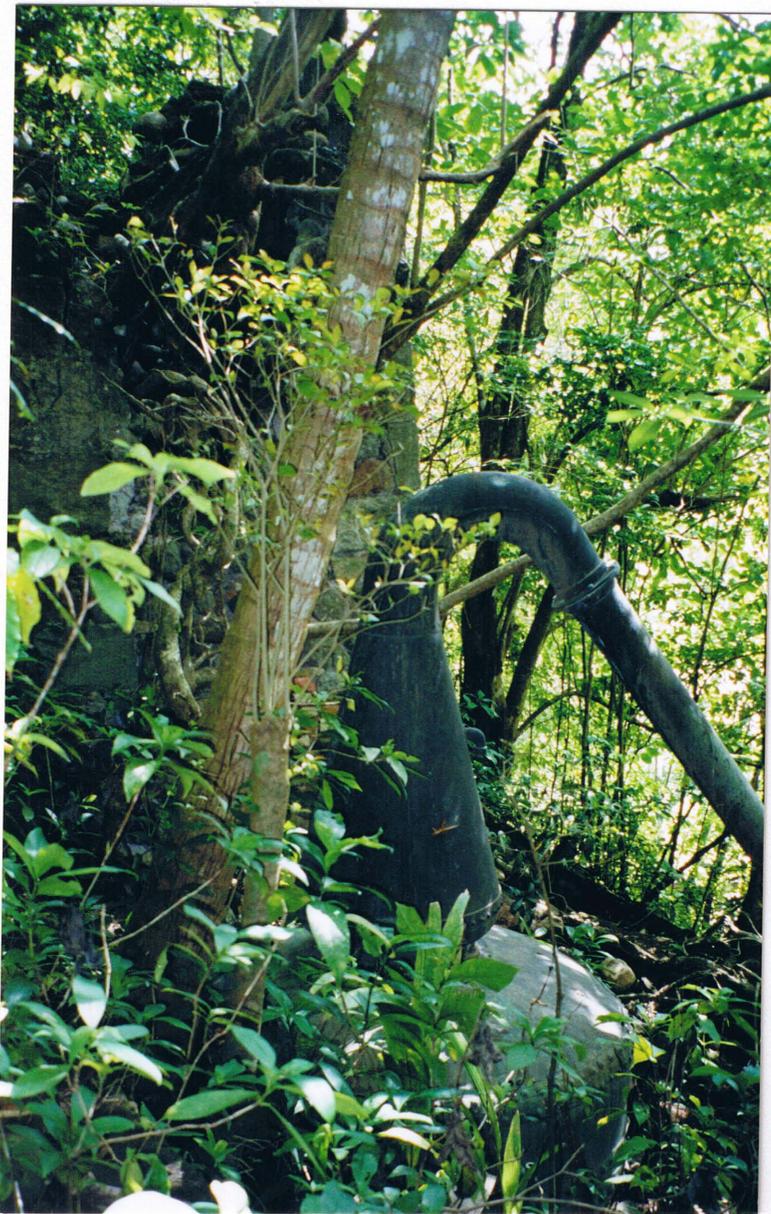
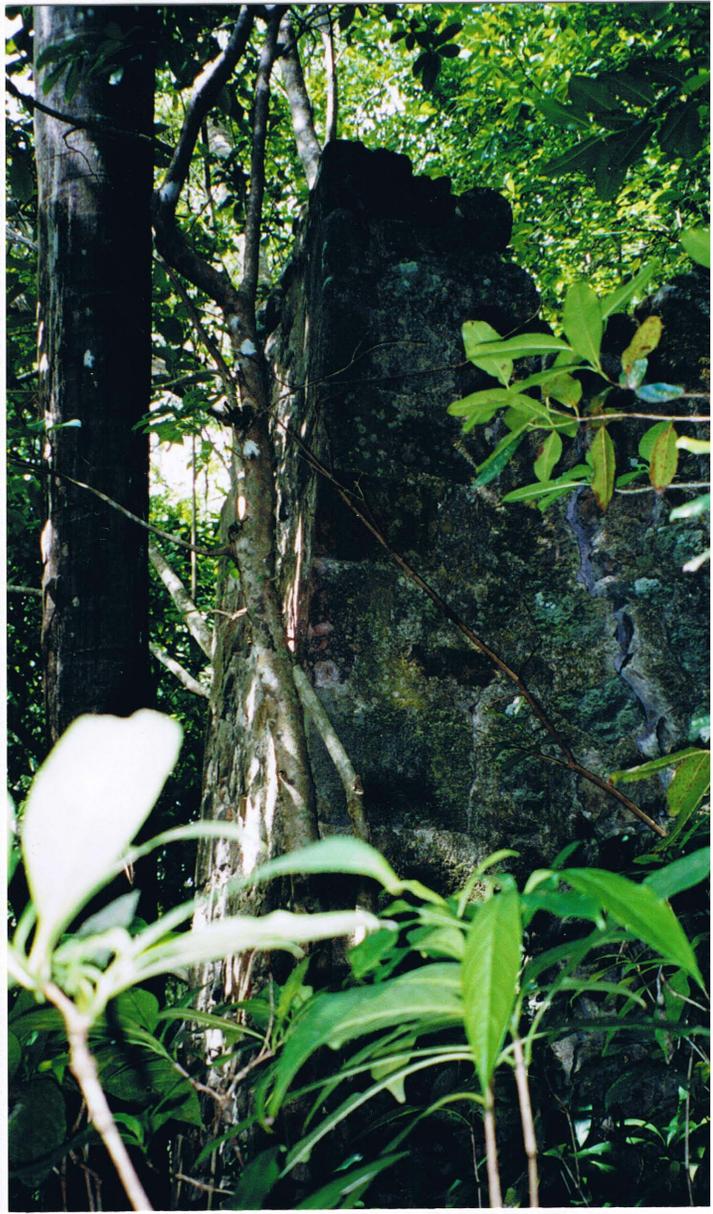
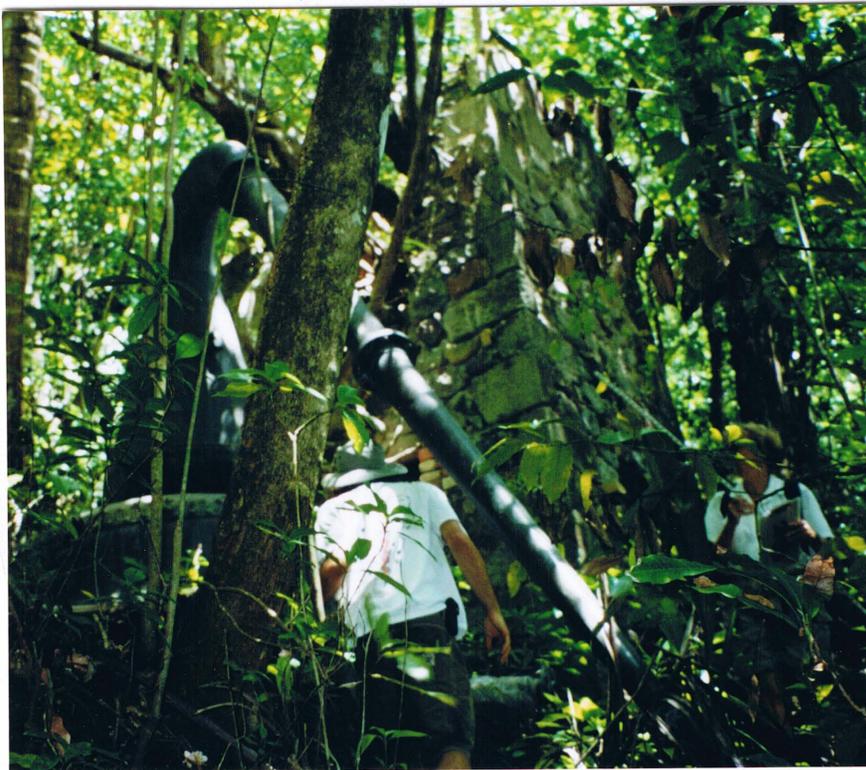
G Chimney and Still
Hampstead
Dominica Aug 2000

- **Description**
About 40 feet up the hill is a large still, and massive square chimney.
- **Condition and Recommendations**
The still seems to be in relatively good condition. The chimney has missing stones on one side, and needs to be stabilized and repaired.
