**ANDREW VERSUS HUGO – DAMAGES TO
RESIDENTIAL COMMUNITIES**

UFL/COEL-93/001

Andrew Versus Hugo - Damages to Residential Communities

Coastal and Oceanographic Engineering Department

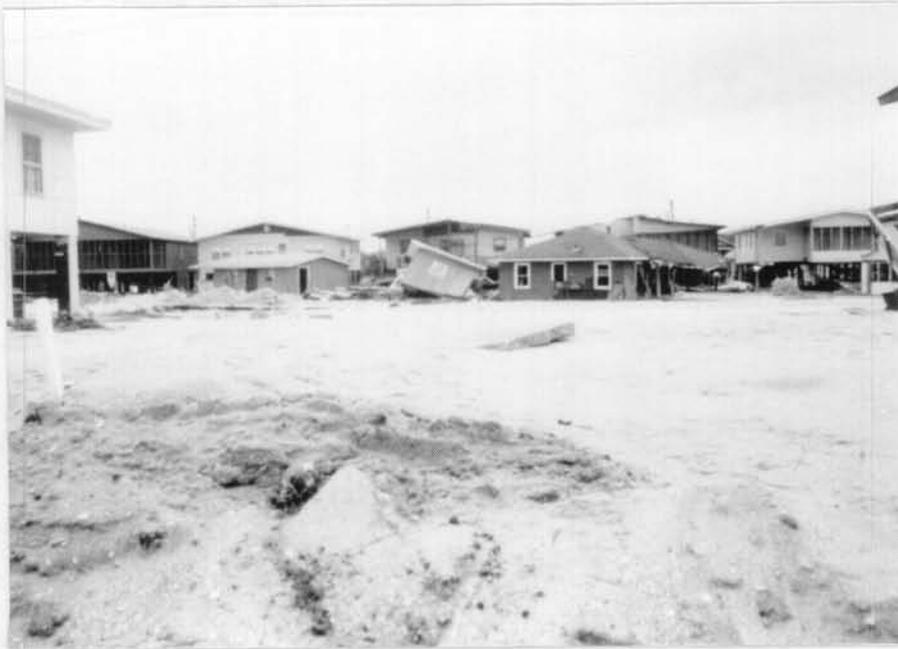
Fig. 6. Sand washover over 2 ft deep along Surfside Beach.

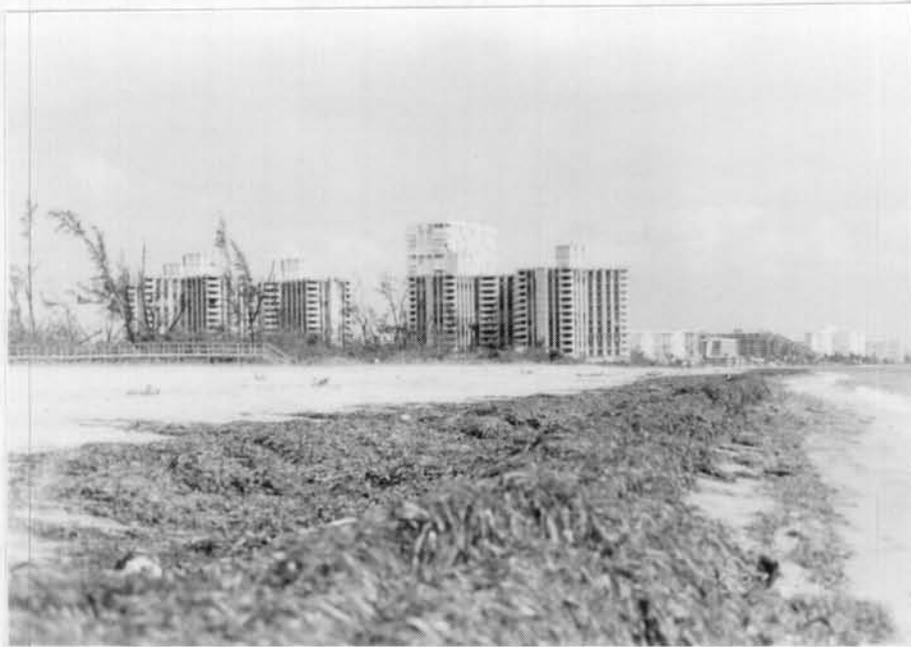
Fig. 7. Andrew caused little or no beach erosion. Heavy debris line is the common sight along the beaches.

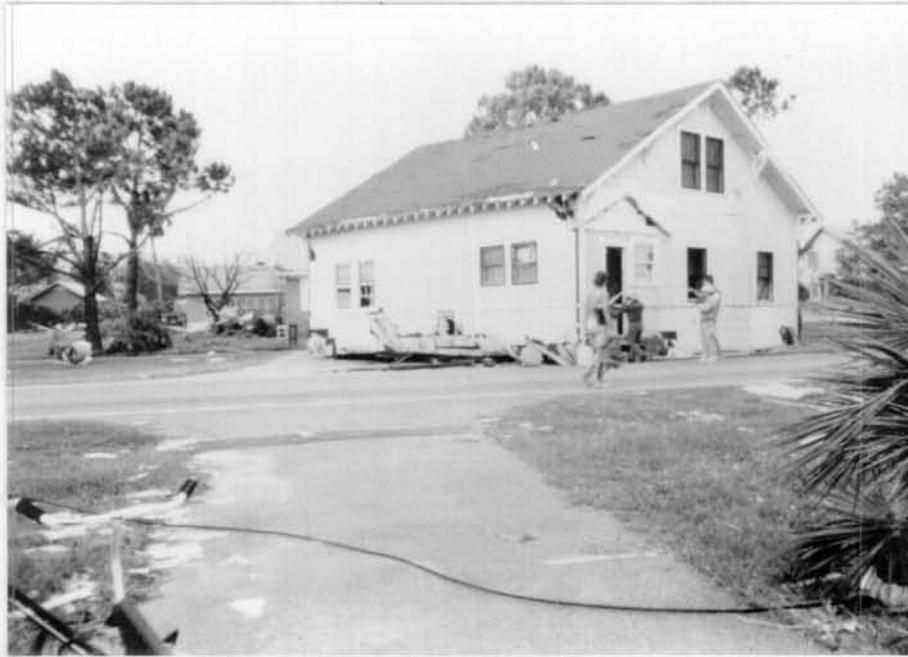
static force as far as buildings and structures are concerned. The most dramatic effect of storm surge is to cause houses to separate from their foundations and float away. Figure 26 shows a slab-built structure floated away from its original site and deposited over 100 ft away across the street. The steady nature of this force is demonstrated here in that all the kitchen interior remained undisturbed. Most of the structures uprooted in this fashion were, of course, less fortunate as they crushed into other buildings, trees, etc. or simply disintegrated. The uplift force produced by storm surge is immense and most residential types of construction will be unable to withstand it. Force induced by a foot of storm surge, for instance, is approximately equivalent to that produced by 150 mph steady wind. Although the most dramatic effect is the uproot of entire structures the most prevailing storm surge damage is associated with flooding, as water once penetrates into a building the buoyancy effect is greatly reduced. As the hurricane passes, the storm surge retreats more rapidly than the rising stage owing to the aid of gravity. It is also a potent damage stage as the water now carries a large amount of debris towards the lee side of the structures.

Fig. 26. (a) Structure built on slab floated away from foundation and deposited 100 feet away across the street.

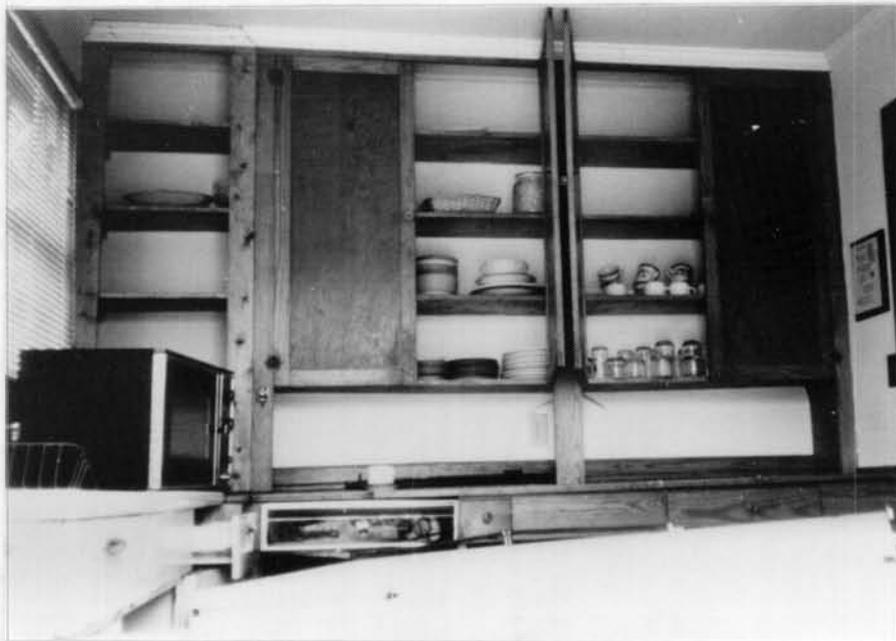
Fig. 26. (b) The arrangement inside the kitchen remained undisturbed in the house showing the static nature of the surge force.

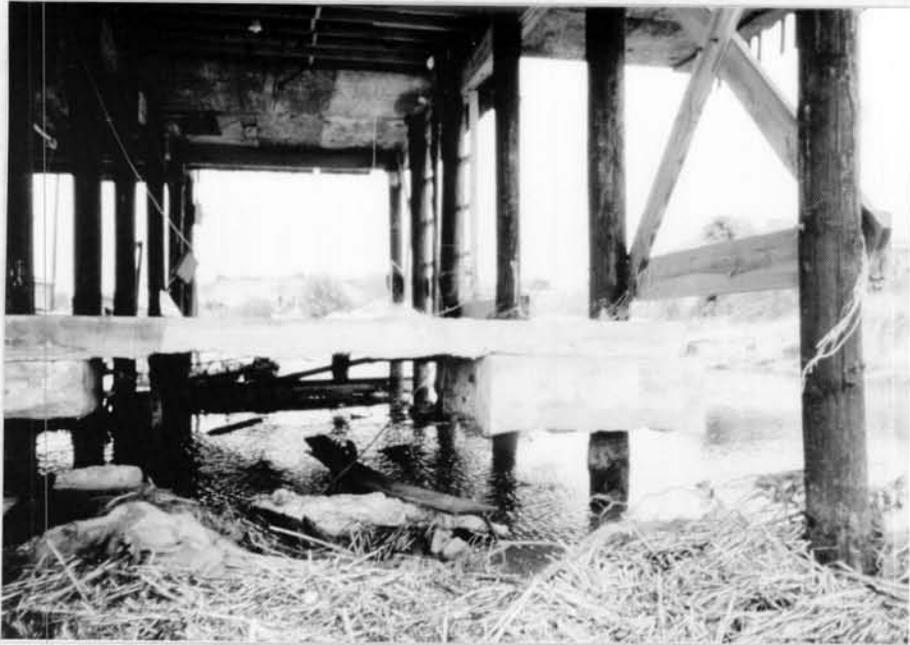
Figure 27 shows that erosion has exposed the pile foundation of this frame structure. Figure 28 shows the foundation material being completely scoured away around a bulky shallow footing. Shallow pier footings were exposed and eventually uprooted as shown in Fig. 29. Figure 30 shows the comparison of a residential structure before and after Hugo. The extent of the dune erosion was estimated to be about 60 ft in this case, exposing the structure in a vulnerable position. In addition to foundation scouring, erosion also led to the crumbling of porch slabs and garage floors and exposing utilities such as sewer lines, telephone lines, water mains and septic tanks.

Fig. 27. Pile foundation erosion due to waves.

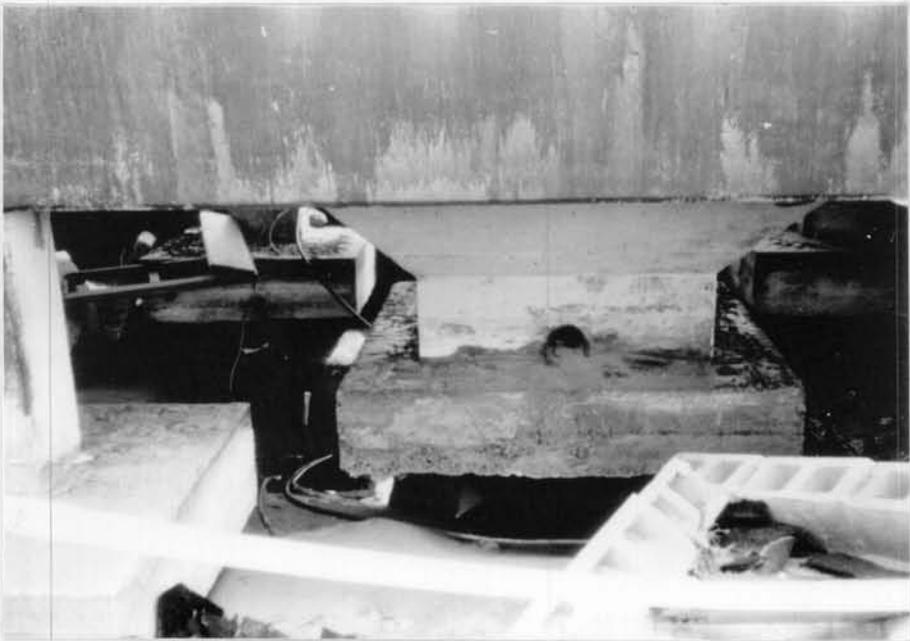
Fig. 28. Bulky foundation promoted scouring around it.

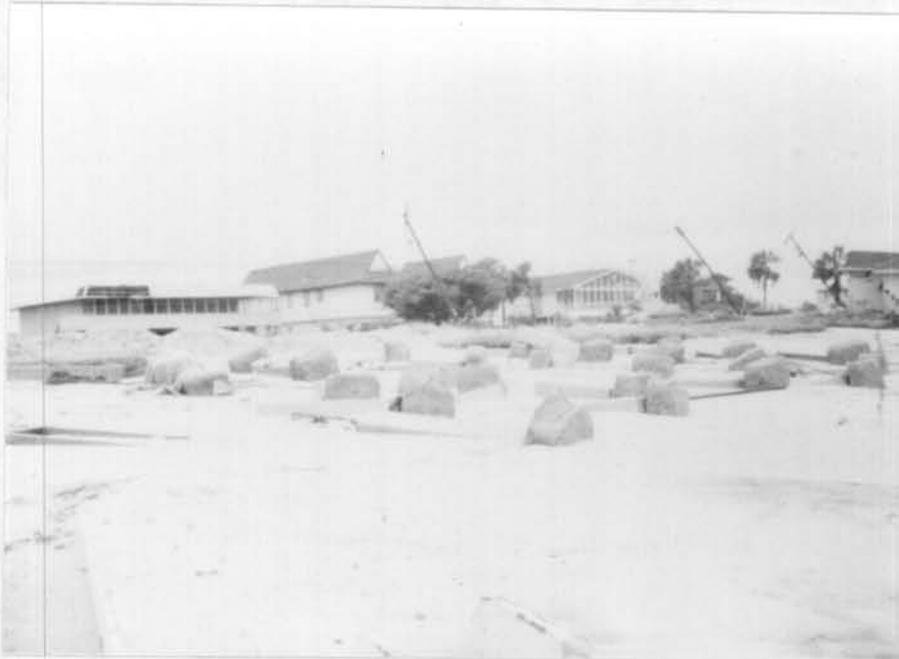
Fig. 29. Shallow pier footings uprooted.

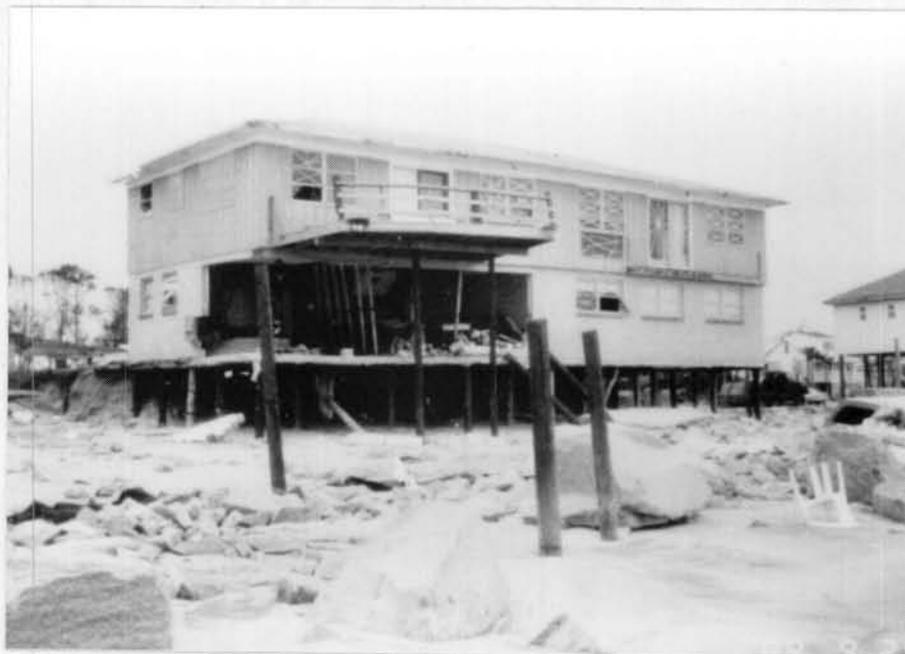
Fig. 30. (b) After Hugo the protective dune was gone and the access ramp was washed into the house due water force.

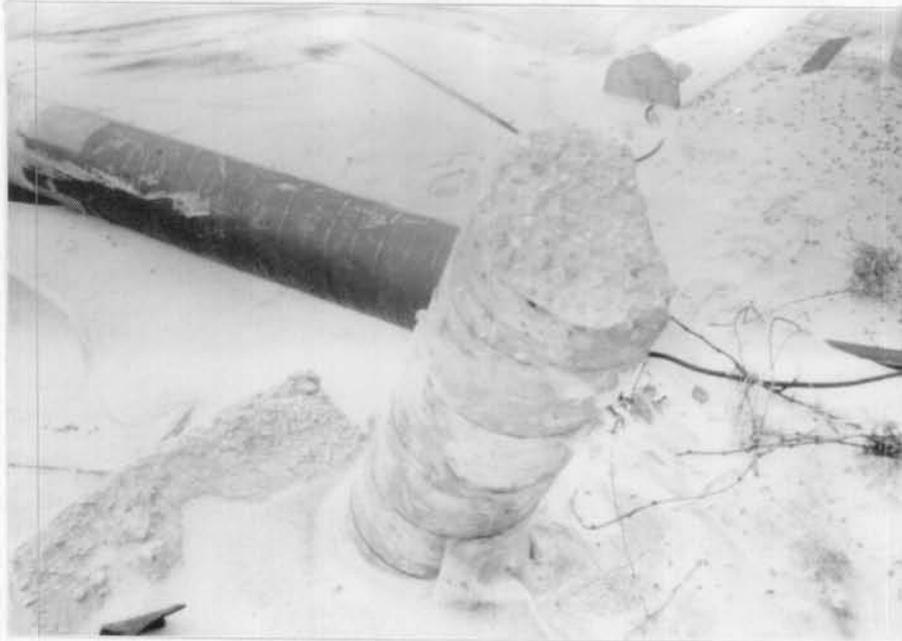
Fig. 31. Pier foundation broke by wave impact.

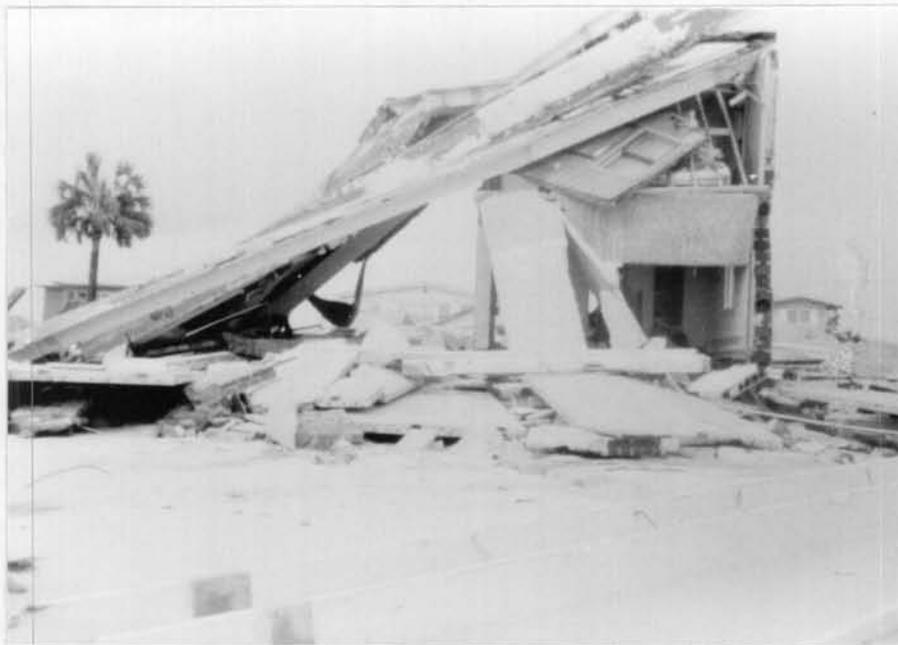
Fig. 32. The load-bearing masonry wall was destroyed by wave force.

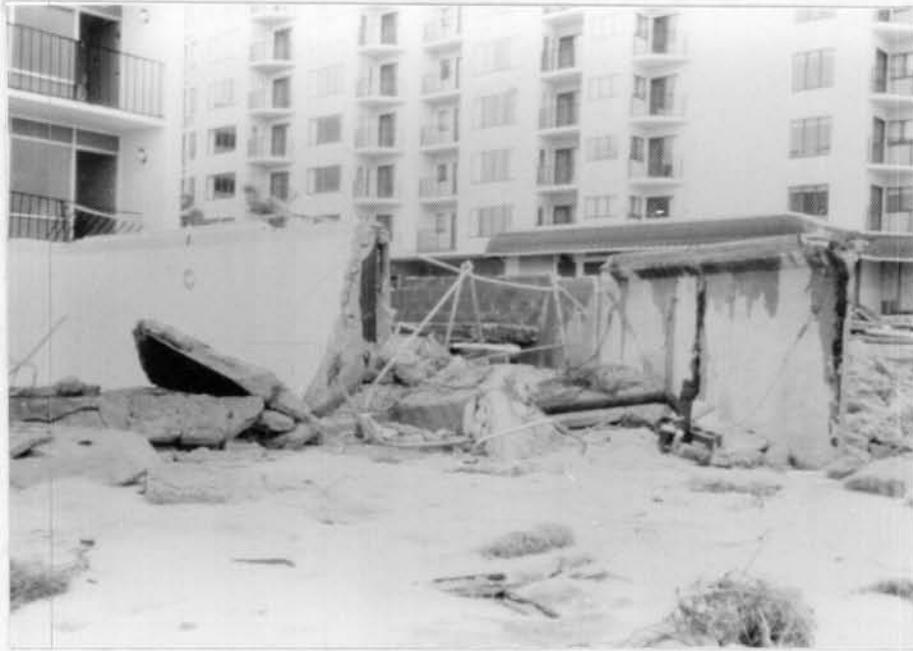
Wave loadings involve three forms: wave impact, velocity-related force commonly known as drag force and acceleration-related force also known as inertial force. Wave impact occurs when breaking wave slams on structures. The magnitude of this impact force is tremendous but hard to estimate. On the basis of field and laboratory measurements, the wave impact force on a flat surface could be as large as 3 to 6 times the incoming wave height. This is to say that a 3 ft wave would induce an impact loading up to 500 to 1,000 lb/ft². Clearly no residential-type structure can be designed to withstand this force. Un-reinforced or improperly reinforced piles or piers are also vulnerable to this type of loading. During Hugo, damages caused by wave impact were prevalent in the exposed area. Figure 31 shows piers broken by the wave impact. Figure 32 shows an entire masonry wall collapsed under wave loading. Seawalls of inadequate strength or backing also often fail under wave impact such as the case shown in Fig. 33.

Fig. 33. Seawall failure due to wave impact loading.

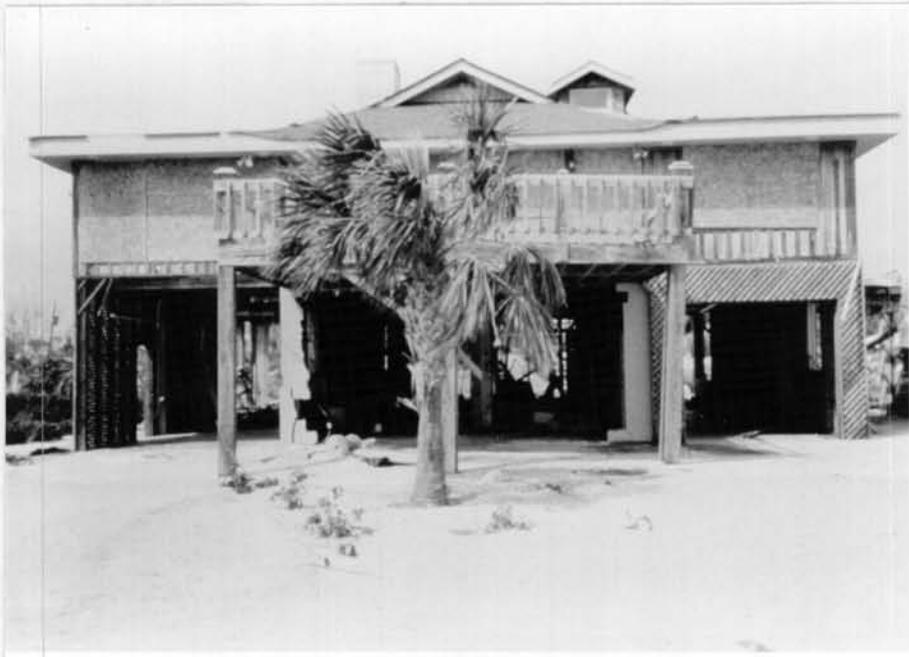
Fig. 34. First floor breakaway walls completely gone due to bore-like water motion (the house is on the second row in the water runup zone).

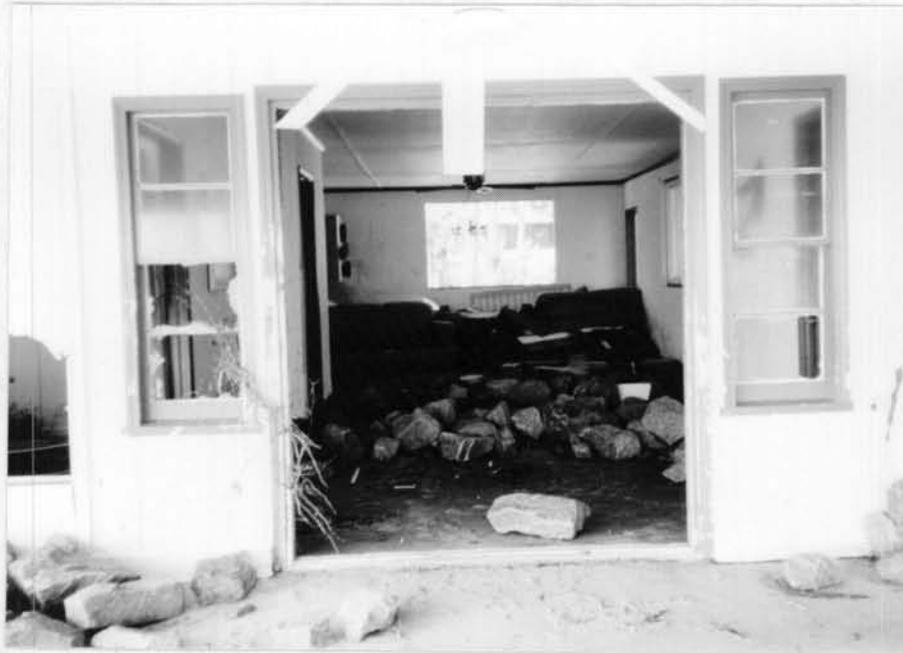
Fig. 35. Stones from revetment thrown by waves into the house supposed to be protected by it.

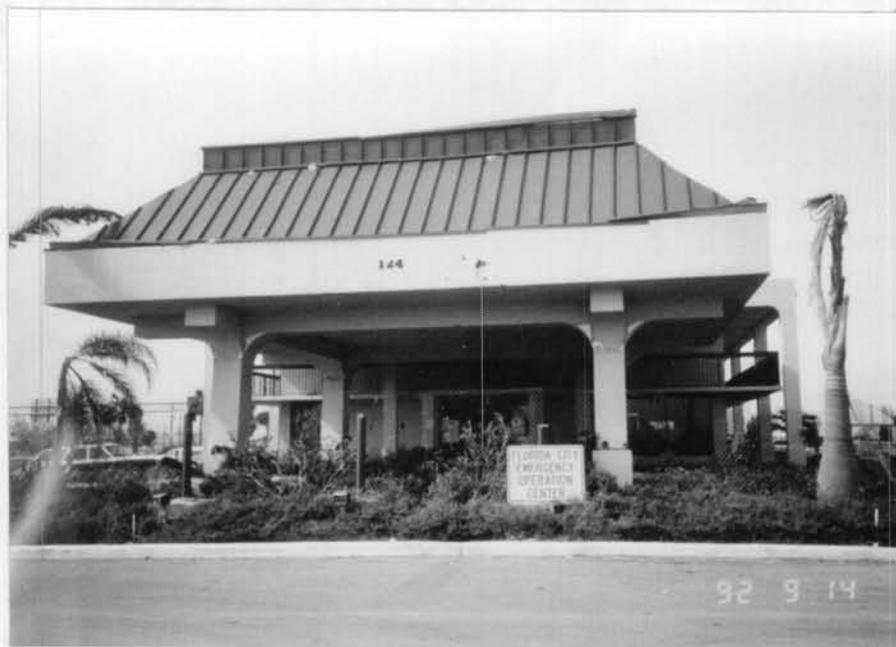
tile roofs. Failure of tile shingles was mainly caused by inadequate mortar bound and improper installation of the mortar pads or underlayings. Metal roofs such as shown in Fig. 36 appeared to be a viable alternative for low cost roofs in high wind regions as many of them, both in Hugo and in Andrew, remained intact.

Fig. 36. Metal roofs usually require simpler connection to sheathing appear to perform better in hurricane winds.

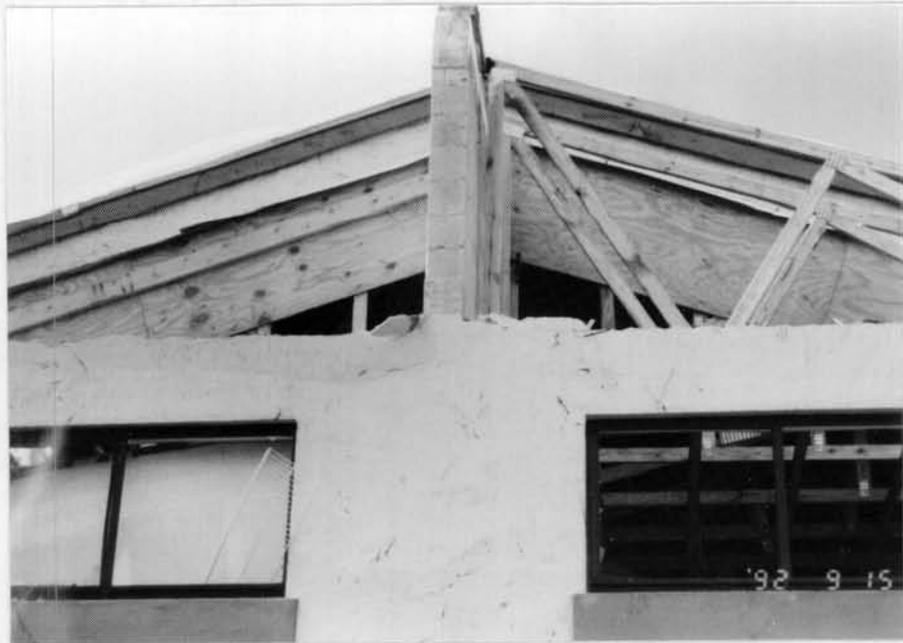
Fig. 37. Gable end failures were most common due to weak lateral bracing, causing lateral collapsing of roof frame.

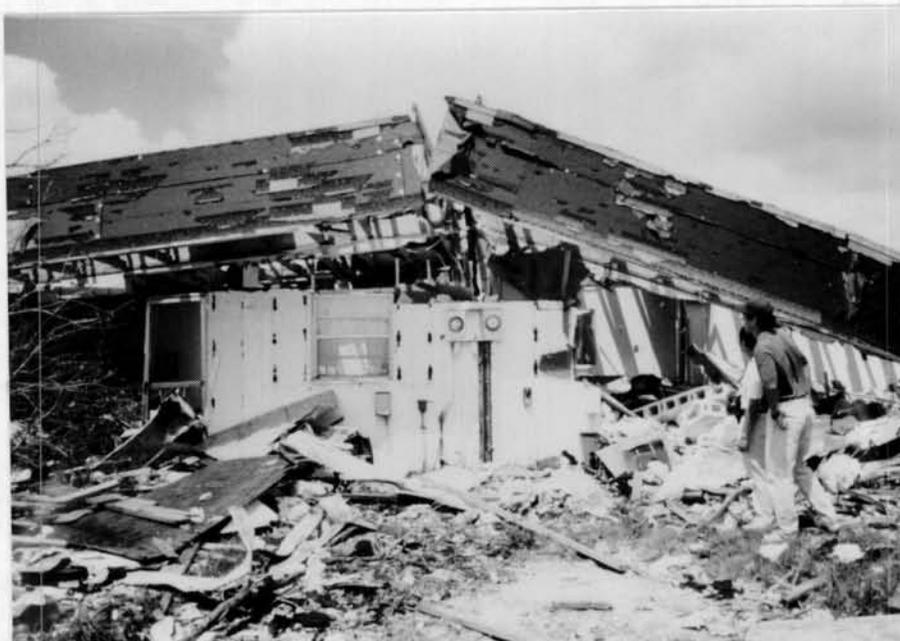
Fig. 38. Vertical roof collapsing due masonry wall failure.

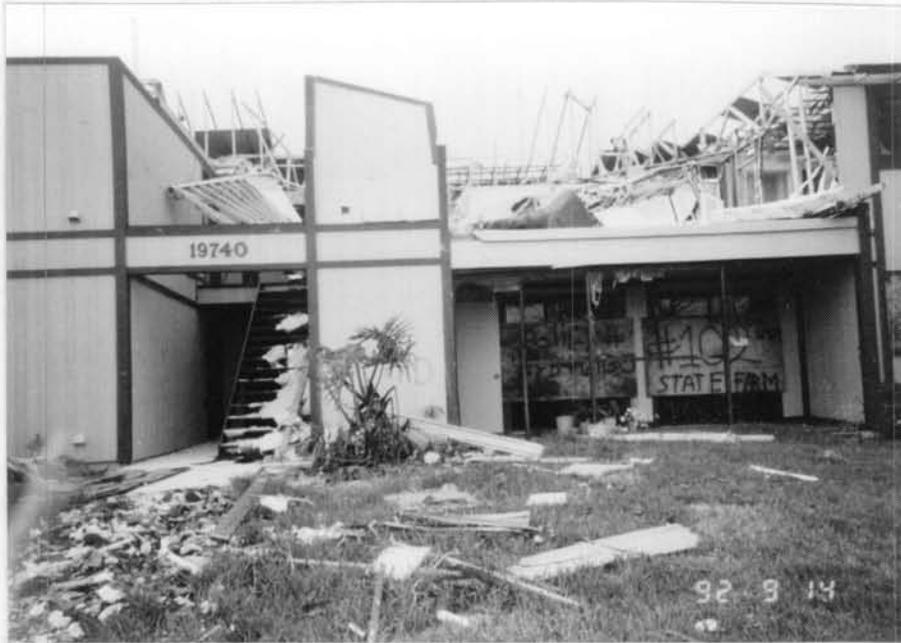
Fig. 39. Framed wall failures led to vertical roof collapsing as well.

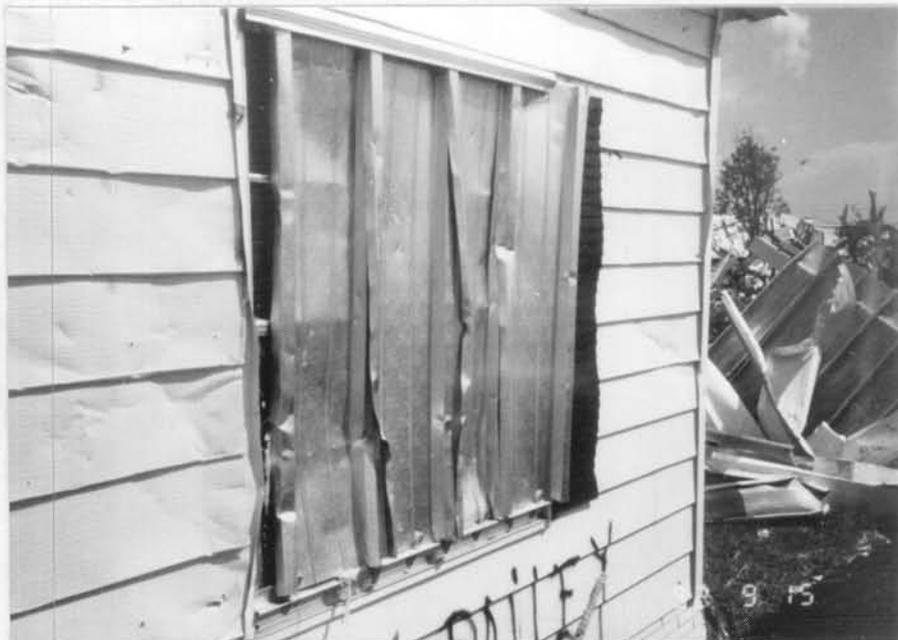
Fig. 40. Even marginal hurricane shutter helps.

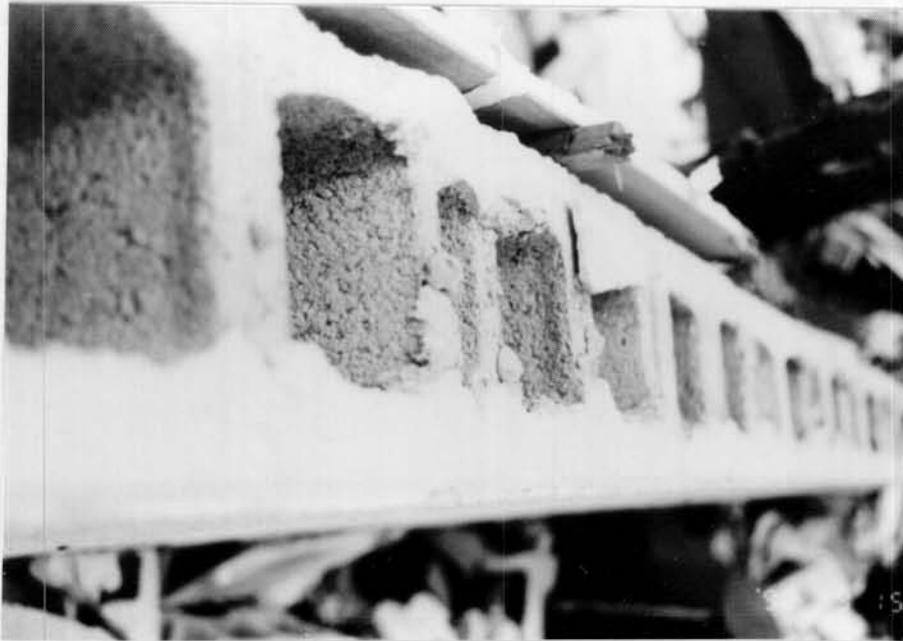
Fig. 43. Inadequate material strength led to this devastating wall failures of a multi-storied building.

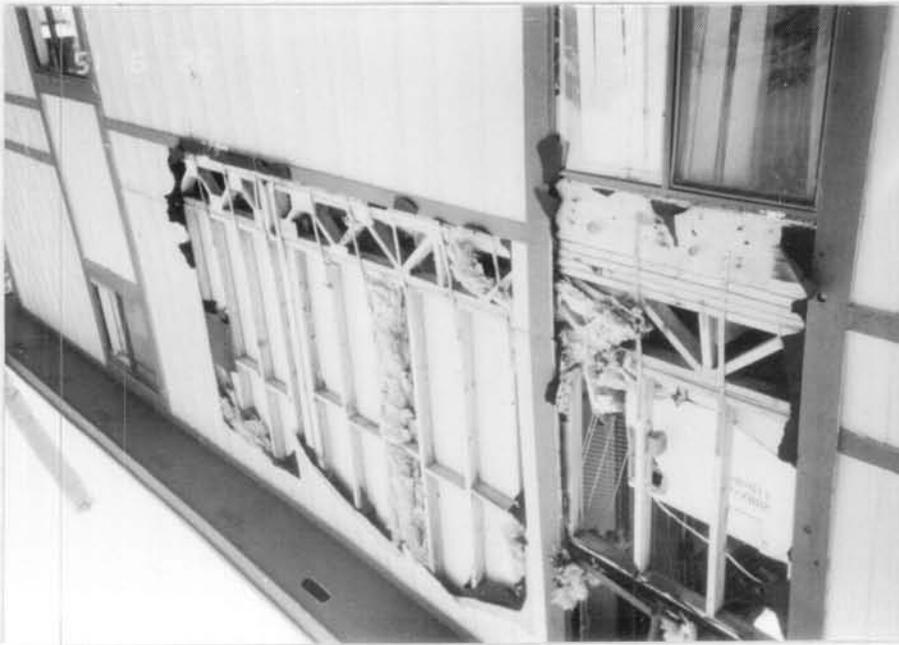
Fig. 44. Damage to exterior wall due to inadequate material strength of the manufactured board.

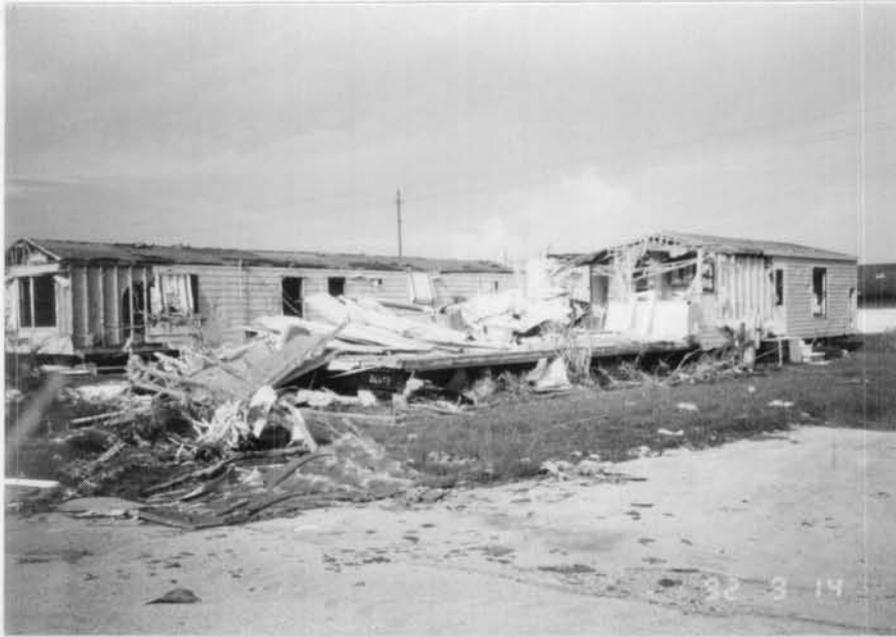
Fig. 46. Destroyed mobil home unit with a damaged unit in the background.

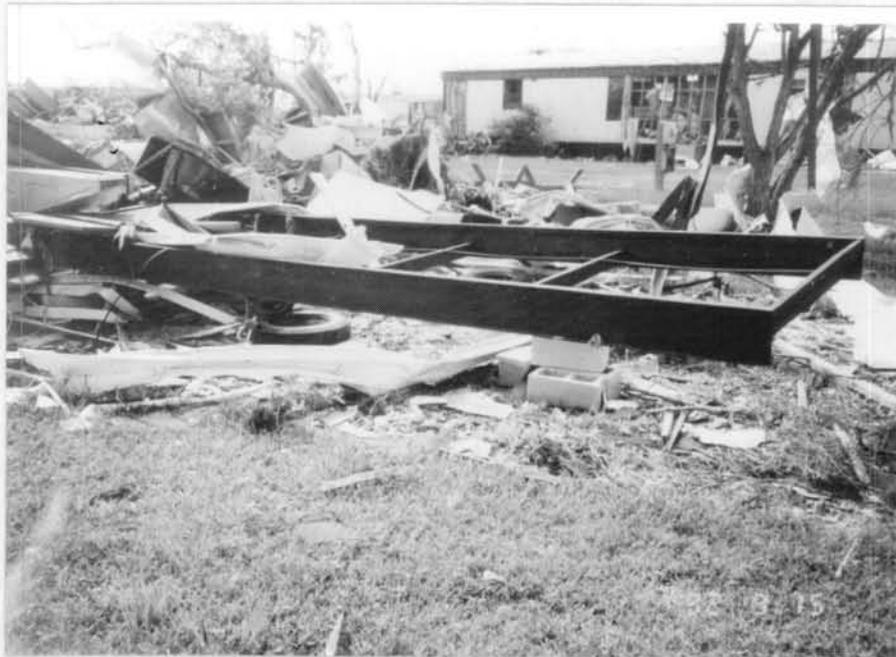
Fig. 47. Mobile home foundation frame and pier footings.

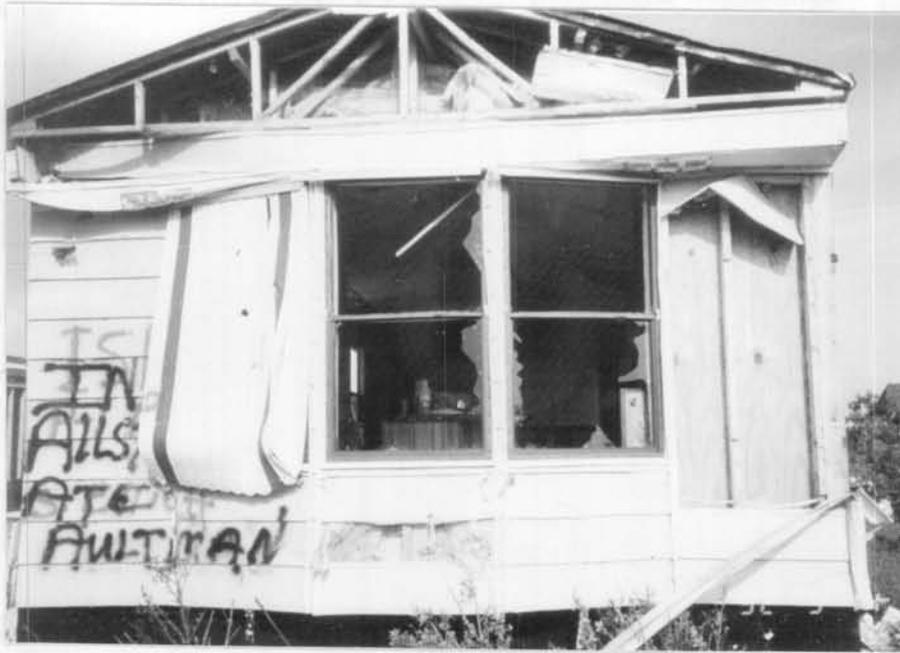
In summary, in contrast to conventional structures, the failure of manufactured homes is mainly due to inadequate material strength rather than weak connections. In fact, manufactured homes often exhibit superior connections than many of the conventional residential constructions in the region devastated by Andrew. This is particularly evident in the roof system (the light roof framing and the metal roof covering often remained intact). Similar situation was observed in modular homes which actually fared better than on-site erected housings. Failure related to foundation is largely due to under-designed tie-down strips, inadequate footings.

Fig. 48. Typical construction of mobile home revealing the nature of light wall frames, roof structure and material.

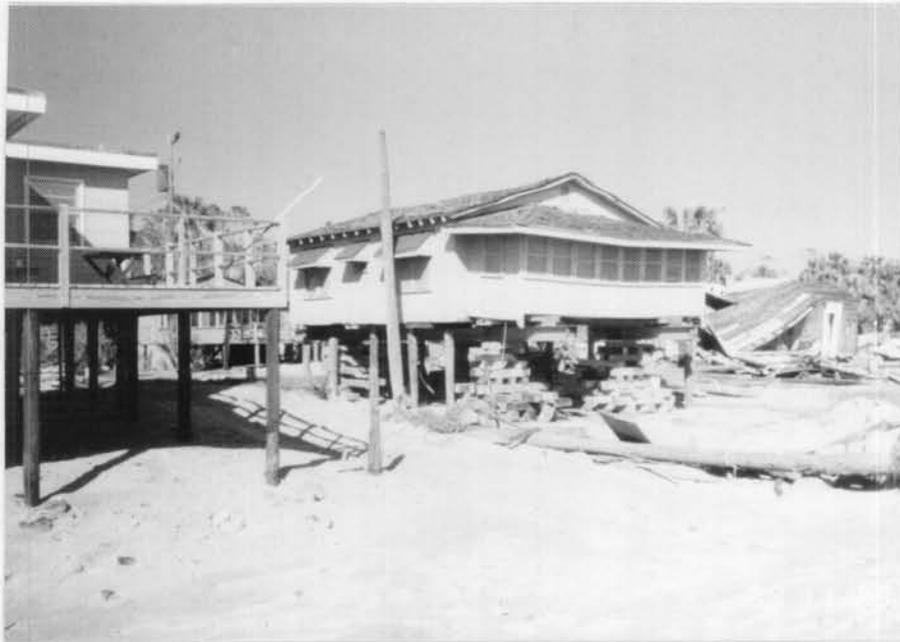
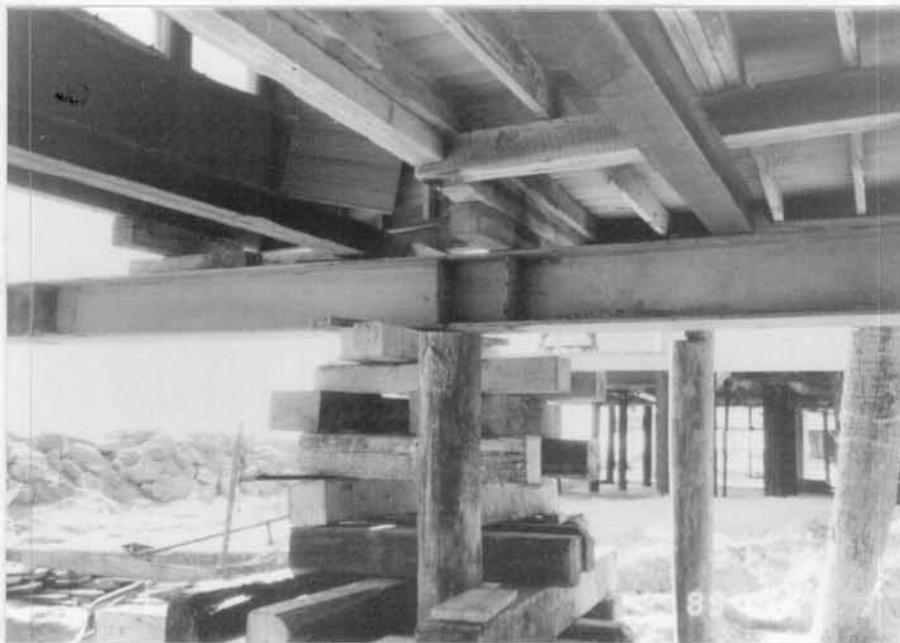
Fig. 49. After Hugo, there was a sense of urgency to raise the elevation the structures without parallel effort to reinforce the structure.
