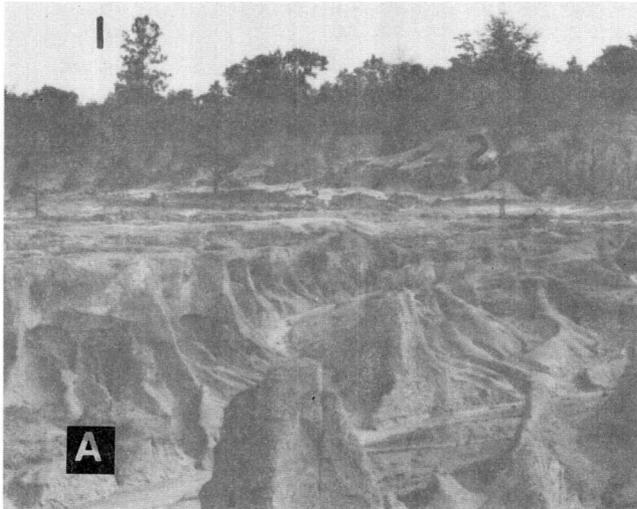
Figure 9. This site had eroded into a disastrous system of gullies. This is the property before soil restoration, 1985. Note reference tree (1) and cliff (2).

The two-phase management plan first called for stabilizing the severe gully erosion in the borrow pit. A retention dam was built with a standpipe outlet in the sediment settling basin. Land contouring upstream from the basin included small diversion channels leading to a central grassed waterway to intercept and filter overland runoff. The smoothed land was mulched, seeded to grass and planted with loblolly pine. The second phase of the management plan addressed the less eroded but bare sites of the remaining 60 acres by establishing loblolly pine.

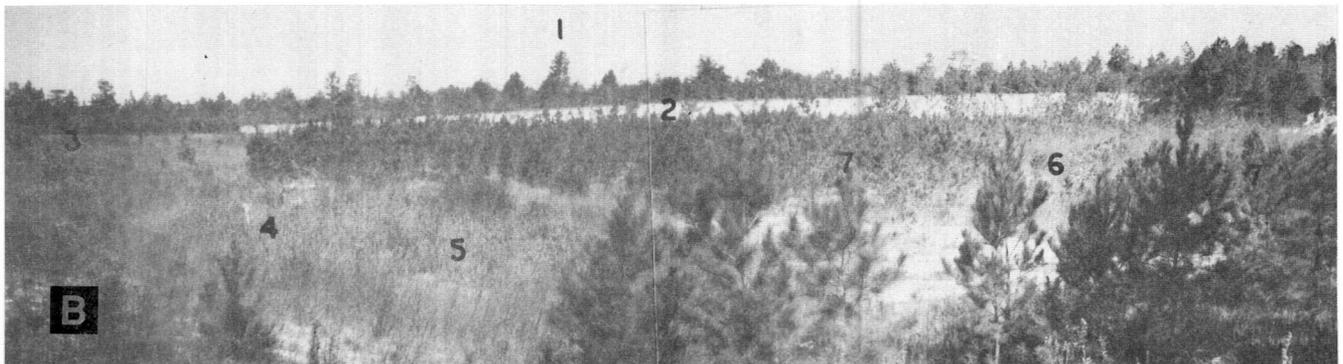
Figure 10 of the borrow pit was taken from approximately the same location as Figure 9 (note

the reference trees and bluff in the background) and shows the results four years after soil rehabilitation and revegetation. The retention dam at the left curves from the bluff toward where the observer stands near the other end of the dam. The outfall standpipe was mostly buried by the accumulated sediments, but is still visible as a white control structure amidst the luxurious grasses in the settling basin in front of the dam. The grassed waterway leading into the settling basin is clearly visible at the right, but the small runoff diversion channels cannot be seen amongst the trees in the background. It is evident that the effort was successful and that the pine stand has become well established on the stabilized soil.

Figure 10. Soil rehabilitation and revegetation by forest stewardship and soil conservation practices has improved the site in Figure 9, in 1990. This view is from the dam. Note reference tree (1); cliff (2); retention dam (3); outlet stand (4); sediment settling basin (5); grassed waterway (6); and pine tree planting (7).
