Recommendations and Master Plan for
Hillsborough Estate
Dominica, West Indies

Caribbean Volunteer Expeditions
January 4-9, 2004

C.V.E. Caribbean
Volunteer
Expeditions

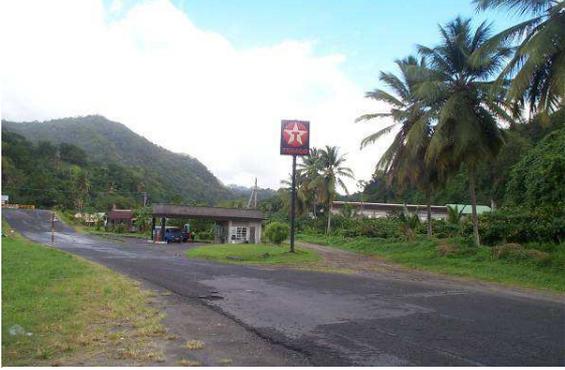
View of current entry to Historic Yard from road. Filling Station and Layou River bridge are visible at left.

maintained as an access road for the Tobacco Building, Container Shed, and the estate's upriver agricultural areas. Visitors will then access the site by an expanded entry that is slightly to the south of the Layou River bridge. Currently there is an access point in this area, however, the master plan shows the new entrance approximately ten feet to the south. The reason for this shift is to allow visitors

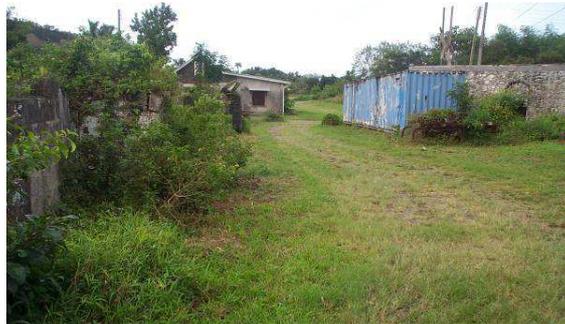
View of Yard, looking west. Overgrown cobblestone paving can be seen at right.

As there is a significant amount of existing stone paving among the older buildings, it is recommended that similar stone paving be used in areas that must be paved. The proposed patio behind the restaurant adjacent to the river will need paving. Another is a pedestrian connection to the front of the Visitor Centre (Building A) to the intersection of the existing stone paving in the center of the site. The farm road could receive some gravel leading to the Demonstration Plots and the Pig Pens, as there are some muddy portions after

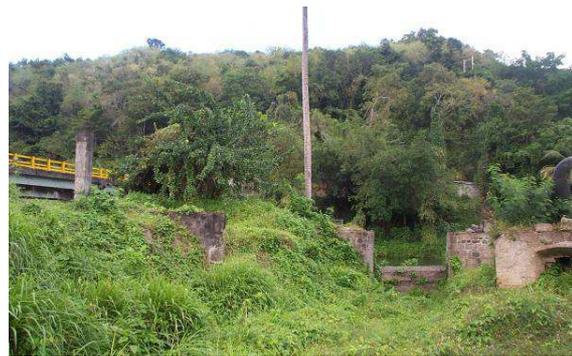
View looking down overgrown cobblestone ramp to river.

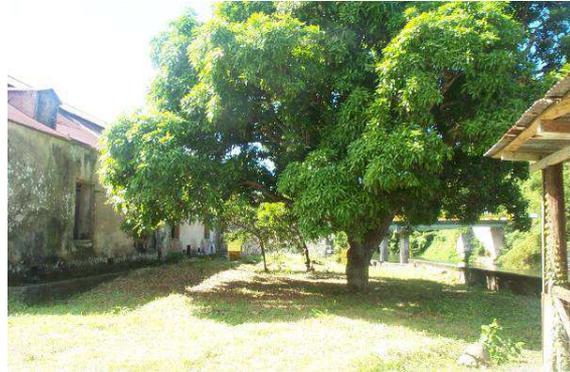
Proposed outdoor dining area between Storage Building (Bldg. F.) at left and Layou River.

Because of the Estate's open nature, gathering areas abound throughout the property. One outdoor space that should be developed is an uncovered patio between the proposed restaurant and the river. The patio should be immediately adjacent to the building, which would permit diners to view the rushing water, but would allow them to go inside in the event of rain. This area could be connected to the main cobblestone paving of the centre by a path around the east side of the restaurant.

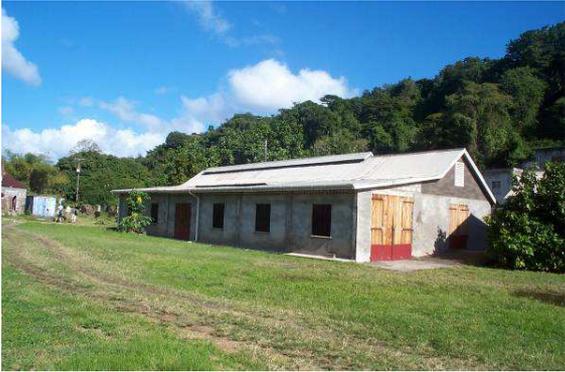
A. Visitor Center (Former Storage Building)

The building (90 feet by 40 feet) had been used for rum and general agricultural storage. A more recent addition to the north of about 16 feet now houses vehicles and a boat. The building has stone walls which have been parged with Portland cement, and the new section is parged with block. The roof is framed with wood with galvanized sheeting, and has a ventilation strip at the ridge. There is also a large

The windows on the south can be enlarged to doors for easier access to the building. In the interior, the dry wall should be removed to expose the wood rafters. The gable ends, now covered with asphalt shingles should be replaced with wallaba shingles.

The corrugated roofing appears to be in good condition, but could be painted. There are now in place attractive wood shutters on the windows and doors. These could be used for the new openings as well.

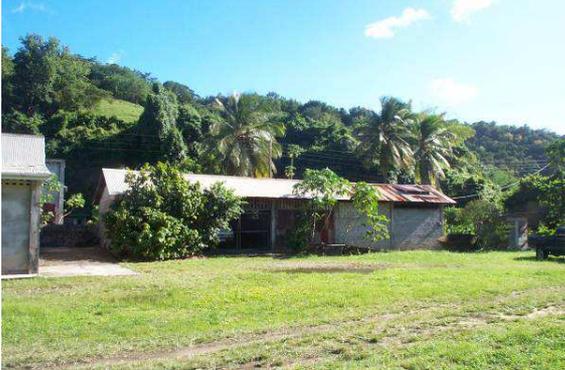
B. Agricultural Processing and Storage Building

This 75' x 22' building is currently used for storage and for cocoa processing. The building is one story with stone and concrete block walls with large openings. The stone walls on the south are about 5 feet high with an open wood or metal screening above. The north side has screening as well as corrugated metal between concrete piers. The roof is an unsymmetrical gable shape framed with

The block and stone should be patched, plastered and painted. Galvanized metal on walls should be removed. New screening and wood slats should be replaced. Further work can include new rafters and metal roofing.

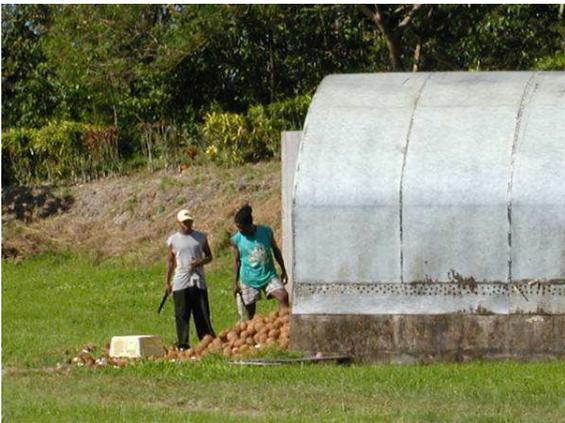
C. Solar Drying Building

This recent building, 28 feet long by 15 feet wide, is used for drying copra. The building will continue to be used for current agricultural purposes. The building has fiberglass roofing in a curved shape above a concrete base.

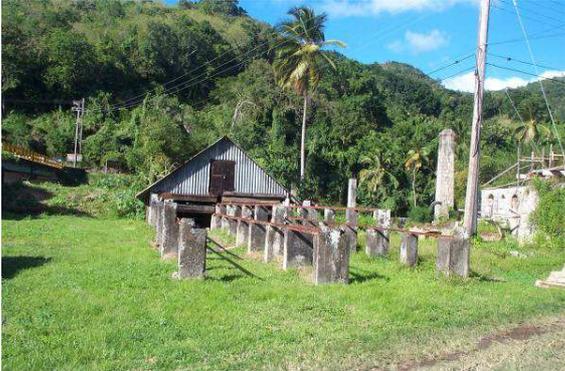
D. Cocoa Dryer

This is an excellent example of a cocoa drying building. The building includes an 18' by 38' area covered by a steep gable roof. Wood trays roll out on metal rails to the south of the covered area. There are two sets of rails about 53 feet long.

The building needs to remain for cocoa drying, and again could be a feature for visitors to witness this agricultural process. The building is in serviceable condition and minor repairs should be made to improve the aesthetics.

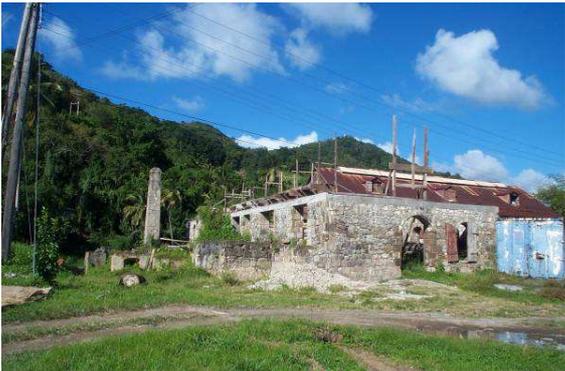
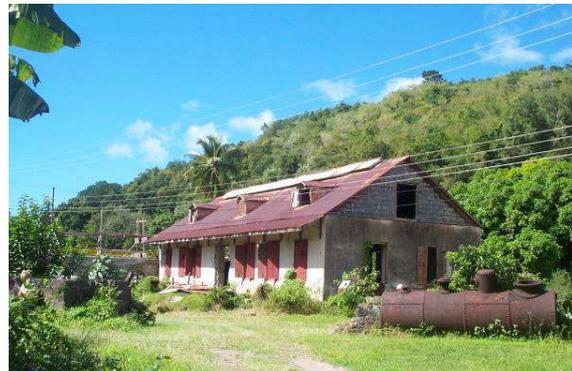
The rum still is on the west, and the chimney is intact. Parts of the metal distillation equipment remain. The sugar factory building is connected to a large storage building which forms a T shape. The storage building is about 70 feet by 30 feet and is more recent.

The stone walls of the factory, with large rectangular stones forming the corners, had originally been white washed. The floor next to the coppers is terra cotta tile and brick. The roof was in poor condition and was recently removed.

The storage building has parged stone walls, wood rafters and corrugated metal roofing with a ventilation cupola at the ridge and three dormers. The building is currently filled with all sorts of machinery, building

and agricultural materials, which should be removed. There may also be historical equipment in this area which should be saved for display and interpretation.

A hip roof and new galvanized should be installed on the building and work on this has already begun. A new wood floor needs to be installed over the basement.

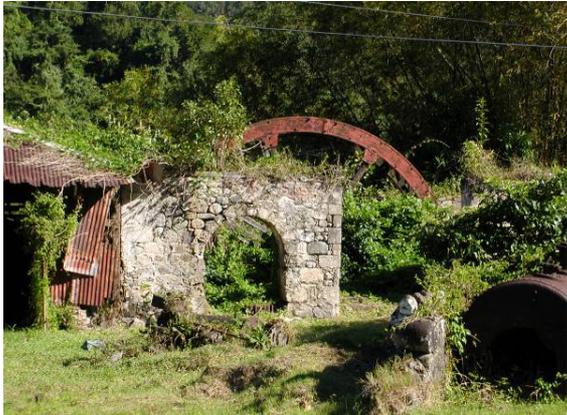
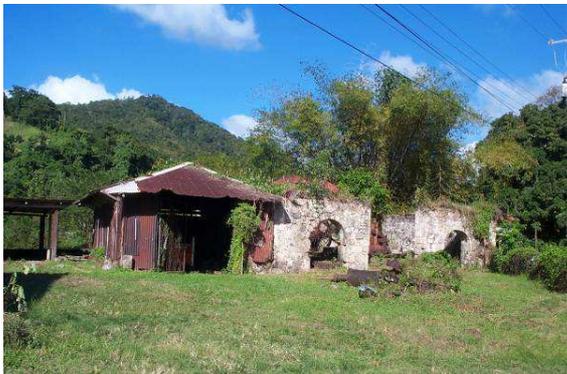
G. Shed and H. Water Wheel

At the west end of the site, is the waterwheel which was housed in a building. The wheel and much of the machinery remain. The stone walls of the building at the wheel remain.

Next to the water wheel is another storage shed with low stone walls and a dilapidated wood framed roof with metal sheeting.

The water wheel is one of the unique attractions of this estate. We recommend repairing the water wheel and repairing part of the aqueduct so that the wheel could turn again. The crushing machinery, now frozen, could be brought back to working condition. The storage building can house additional machinery and displays related to sugar or lime processing.

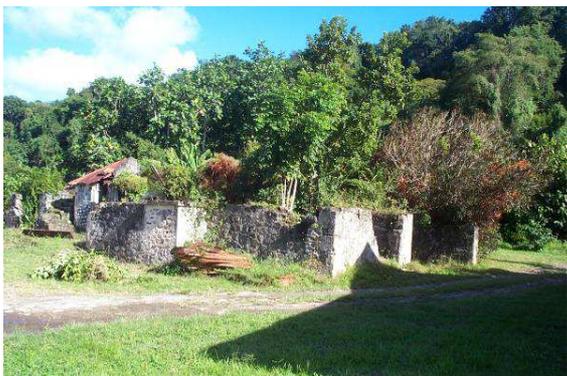
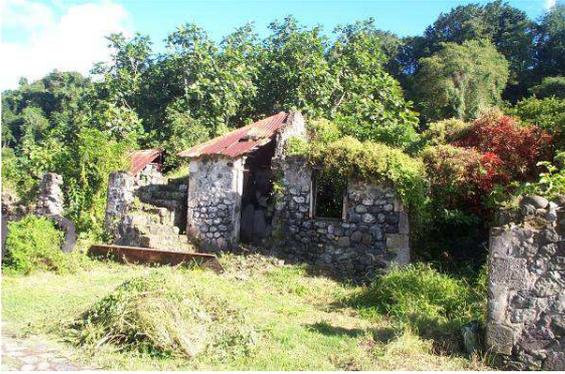
Ia; Ib; Ic; Id Toilets, Display and Shops (Former latrine, hospital, kitchen, offices)

This complex to the southwest of the factory and storage buildings contains the remains of four structures. The one at the west was reportedly a hospital at one point. Clearing revealed the remains of a kitchen facility and toilet. The owners reported that one of the buildings was used for an office. Two of the structures were two story with stone bases and former wood second stories, and five sets of staircases remain. Two of the buildings were one story. Remnants of the wood rafters and rusty galvanized roofing remain.

Two of the buildings were one story. Remnants of the wood rafters and rusty galvanized roofing remain.

two story structures can be rebuilt with wood studs, and lapboard siding. Hip wood framed roofs with galvanized corrugated sheeting would be typical.

We recommend that the building to the southeast be used for toilet rooms for the restaurant and general public visiting the site. Other uses can include more shops, display or a caretakers dwelling.

The stone walls need to be stabilized, and re-pointed. The upper floors of the former

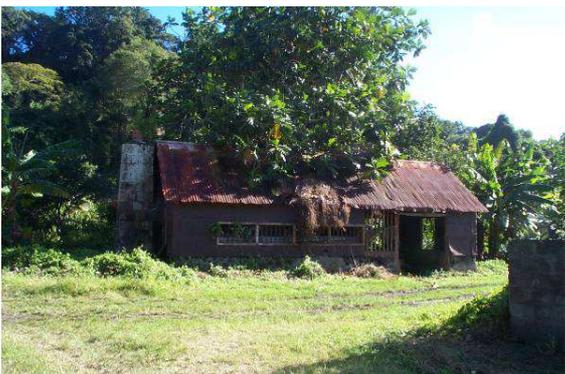
J. Ruin with Chimney

This building is 15 feet wide and 38 feet long. There is a stone chimney at the west end. The walls consist of stone up to three feet, and presently have metal sheeting above. There is also a boiler nearby. The roof is a gable and has metal roofing.

Further archeological and historical investigation is required here. The stone walls should be pointed, and repaired. The upper walls and roof rafters probably need to be rebuilt at some point. New galvanized roofing and new siding should be applied.

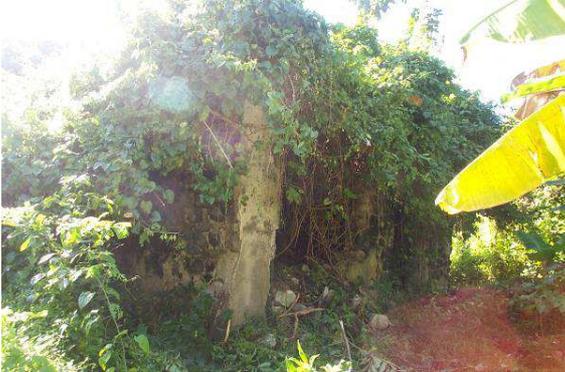
K. Ruin

This building had high walls, and is 25 feet by 19 feet, which might have had to do with a drying process.

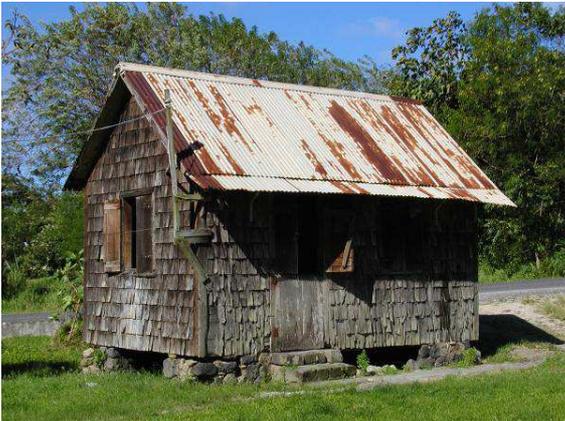
L. Workers Cottage

This 16 by 10 wood chattel house is typical of residences of Dominica and the Caribbean of about 100 years ago. The building has wood shingles on the walls, metal roofing, and wood shutters.

We recommend locating it near the garden

area. The building, however, is in very poor condition. It may be possible to rebuild the roof, floor, add new wood shingle, and new shutters.

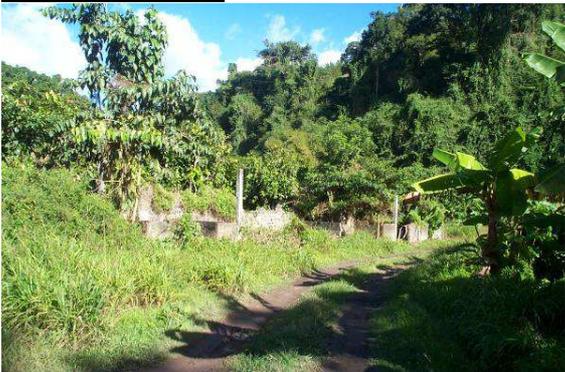
M. Animal Pens

This building of about 93 feet long by 15 feet wide had animal pens. The walls are stone, block, and concrete, and appear to have been built over time. There is no roof now, but apparently there had been a shed roof.

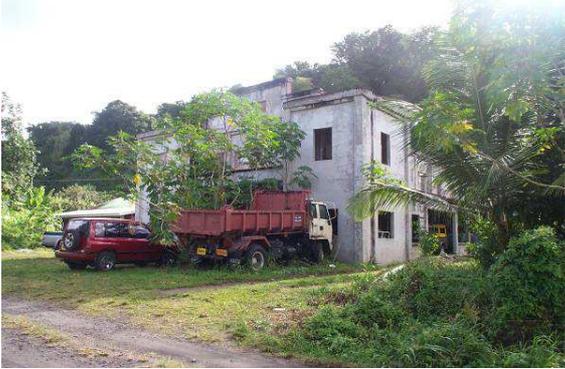
N. Tobacco Storage Building

This large two story building has a more recent front section added onto old stone walls.

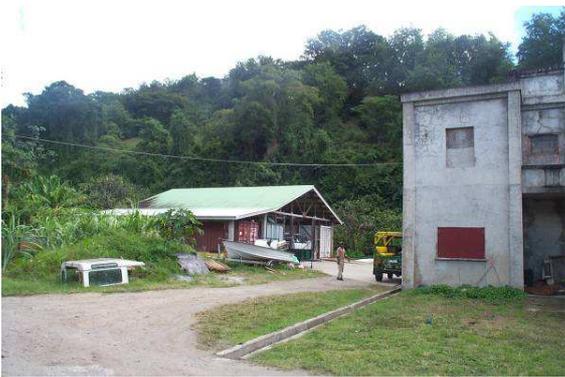
O. Vehicle and Container Storage Building

Across from the Tobacco Storage Building is an open building housing containers, vehicles, and equipment used by the owner's tour company.

The building serves a current purpose and should remain as is. Views from the farm road should be screened by fencing and gates. For additional recommendations,

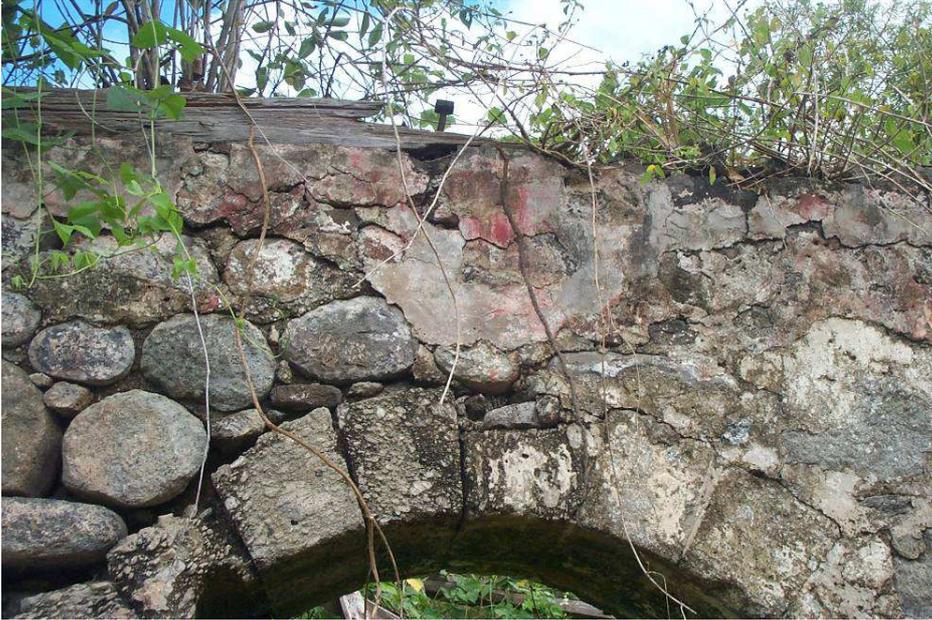
It is important to clear all vegetation from stone walls, The roots are causing serious decay. The stone also needs to be stabilized; Old mortar should be removed, missing or dislodged stones should be repaired. New mortar high in lime content should be used for pointing. Traditional whitewash should be applied.

Figure 2-Remnants of old stucco and paint over stone archway of mill house.

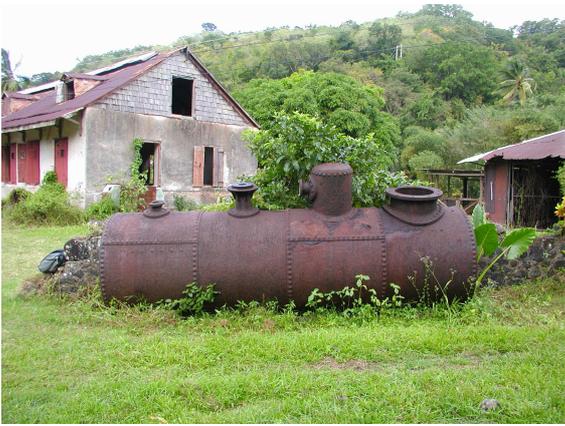
Item 1-Boiler

Description: 12'L x 3' - 4"W

Recommendation: Preserve in place to serve as “industrial sculpture”, or group with other machinery to illustrate agricultural production processes. Identify boiler with small signage. Other antique machine parts exist in the areas adjacent to the boiler. If enough of the parts exist, and adequate documentation is available on how the machinery was originally assembled, restoration may be possible for display purposes.

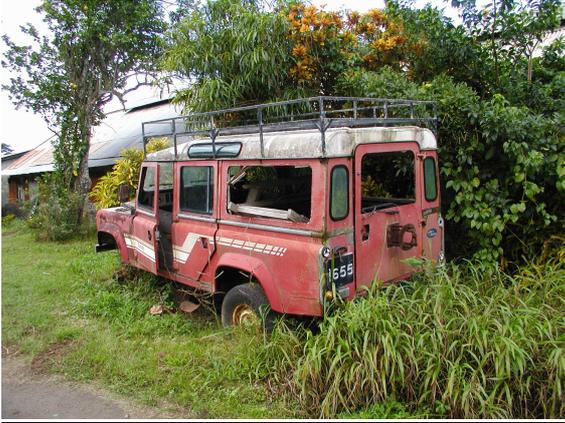
Item 17-Land Rover

Description: Rusted, Plate #1655

Recommendation: Remove from public view.
