Reducing Mishaps by 50%

The Naval Safety Center's Aviation Maintenance Magazine

Vol. 43, No. 4 Fall 2004

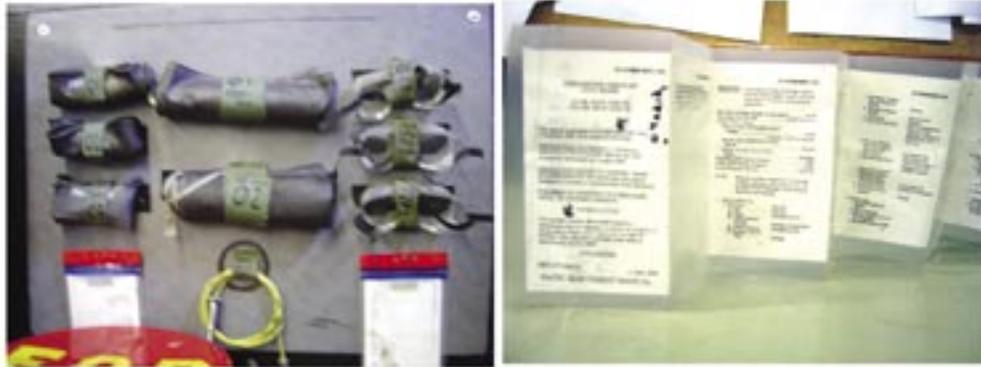
Bad: The NAMP (Volume 5, Chapter 13, paragraph 13.4.2.d) outlines the requirements for multi-piece tools. This magnet shows a good example of improper peening. In this case, the bolt was too long for the “peening” to be effective (only the last couple of threads and bolt had been bent). The nut backed off, resulting in a three-piece tool. The best solution is either to spot-weld or cut and grind the bolt to length before peening.

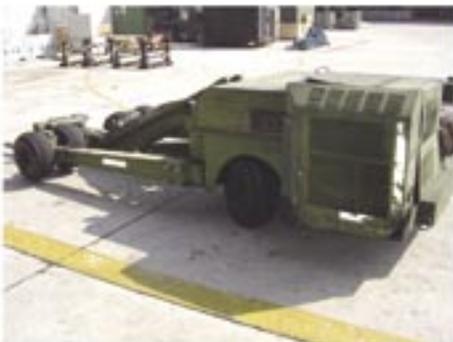
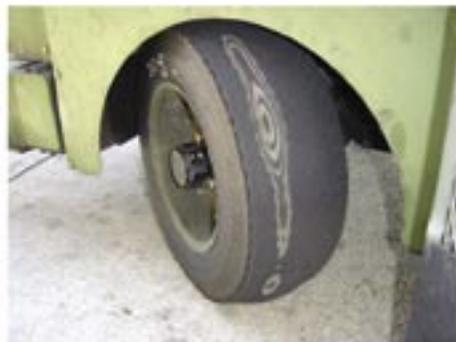
Ugly: What's wrong with this picture? This weapons loader apparently is ready to go; however, a closer look shows the tread on the 12-ply tire has worn through four layers. How far can you go before the tire blows? Not too far, and I hope not while loading or carrying ordnance!

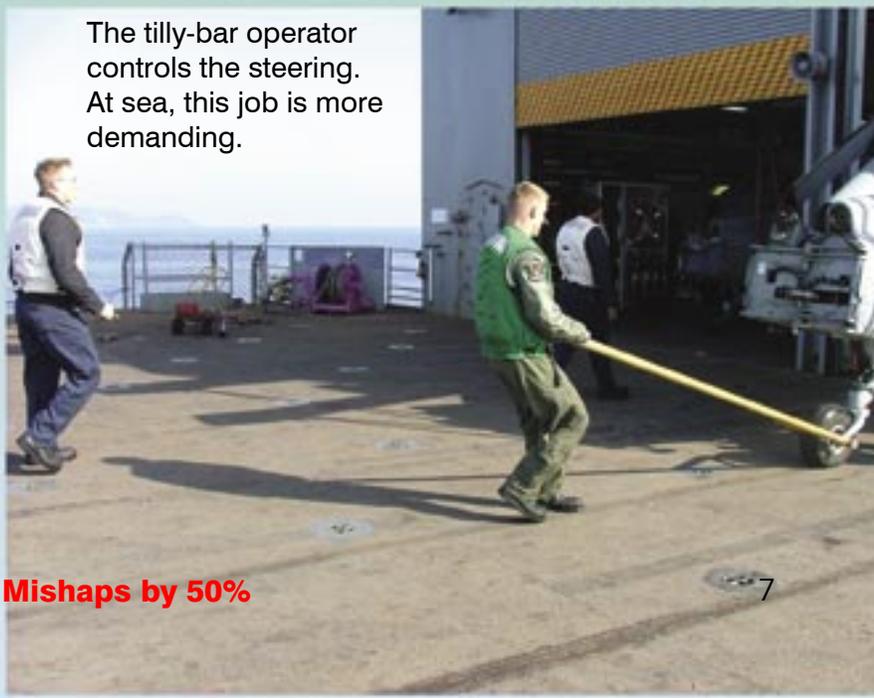
The trolley operator controls the steering. At sea, this job is more demanding.

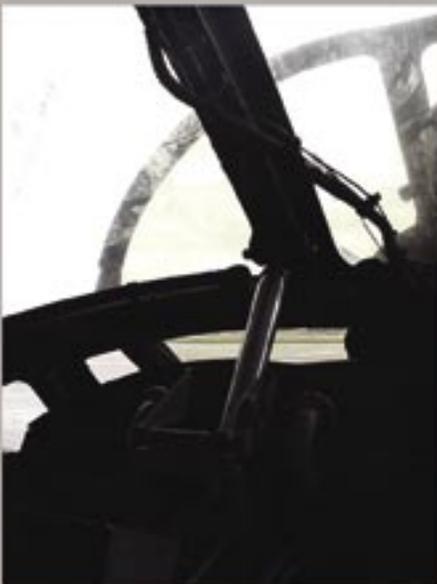
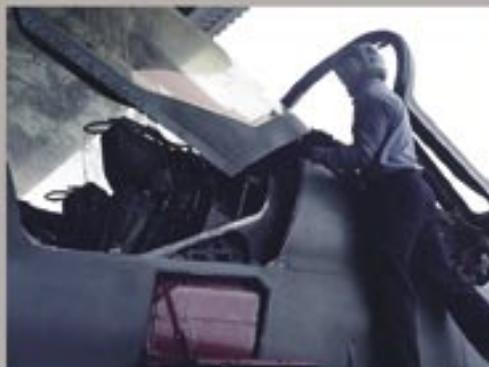
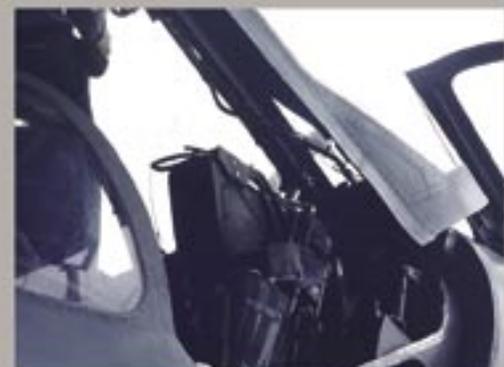
As shown in this sequence, reinstalling a canopy is a relatively safe process; however, you must be alert at all times.

For those who don't know, a "lollipop" is a piece of metal at the end of the actuator, with a hole in the center for the bolt to go through. To do this step, I had to put the actuator back up and guide it into a slot in the canopy frame. I lifted the canopy lever to make the actuator move up and then guided the lollipop toward the slot. I never will forget, for years to come, what happened next.

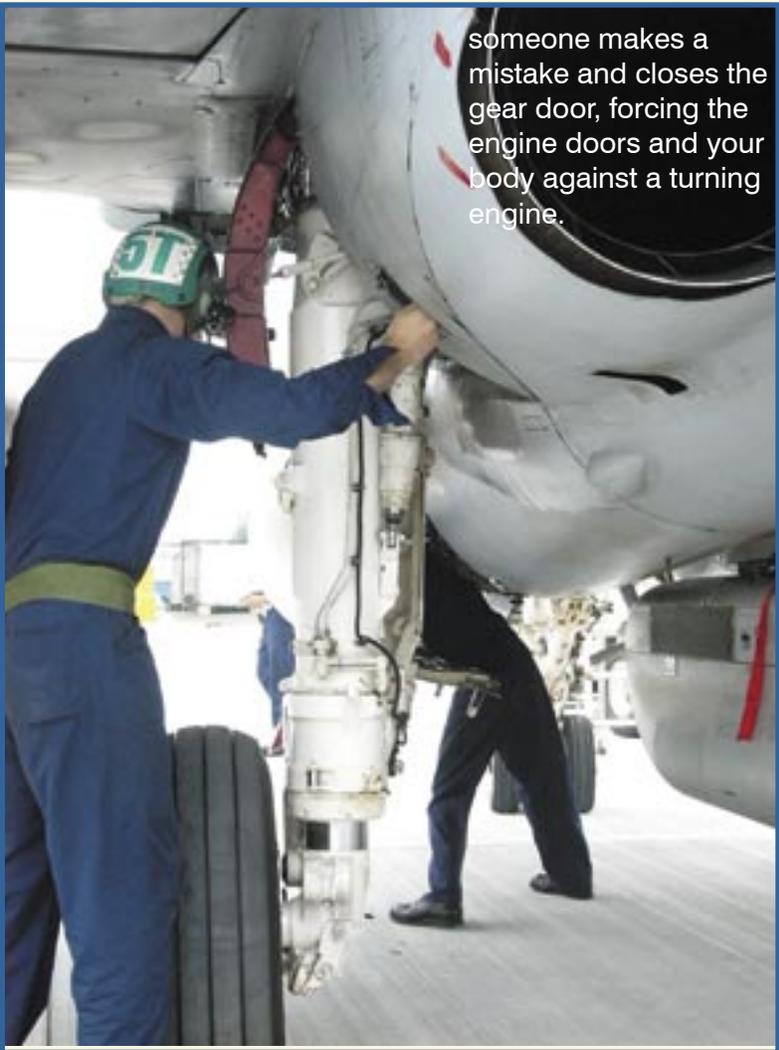
someone makes a mistake and closes the gear door, forcing the engine doors and your body against a turning engine.

During this task, you normally close the forward, main landing-gear doors, which are open for preflight inspections and servicing. Because of a unique maintenance requirement, we didn't follow the normal sequence.

Power plants had to do a leak check on the port engine, and they needed the engine-bay door to be open to prevent anyone from closing the forward, main landing-gear door. I had not briefed my trainee on this point before the starts, and that error was my first mistake. I had assumed my trainee knew this process.

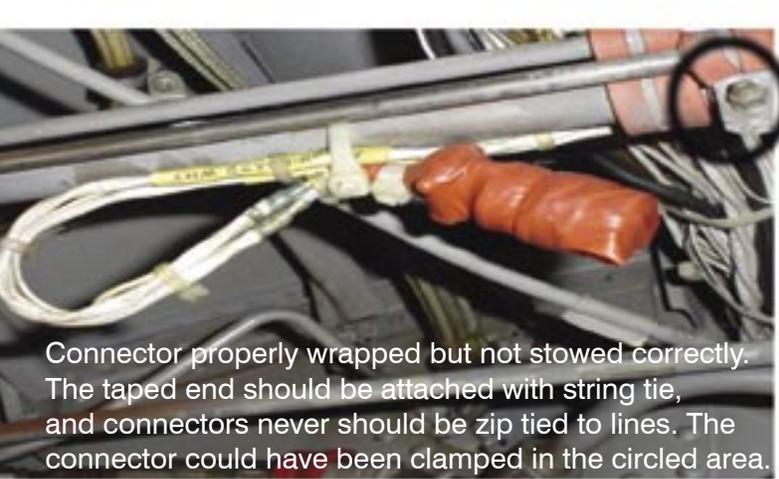
Connector properly wrapped but not stowed correctly. The taped end should be attached with string tie, and connectors never should be zip tied to lines. The connector could have been clamped in the circled area.

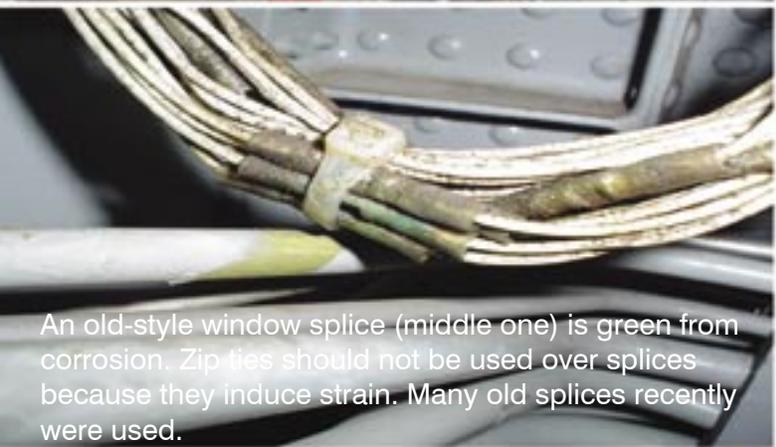
An old-style window splice (middle one) is green from corrosion. Zip ties should not be used over splices because they induce strain. Many old splices recently were used.

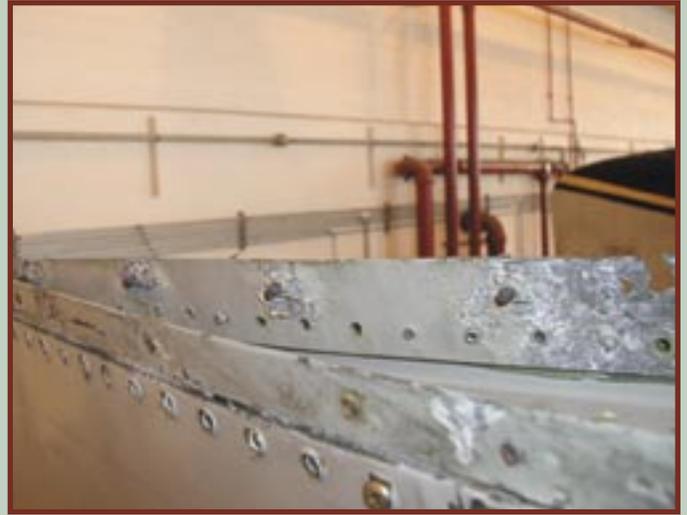
The corrosion types are evident, including exfoliation.

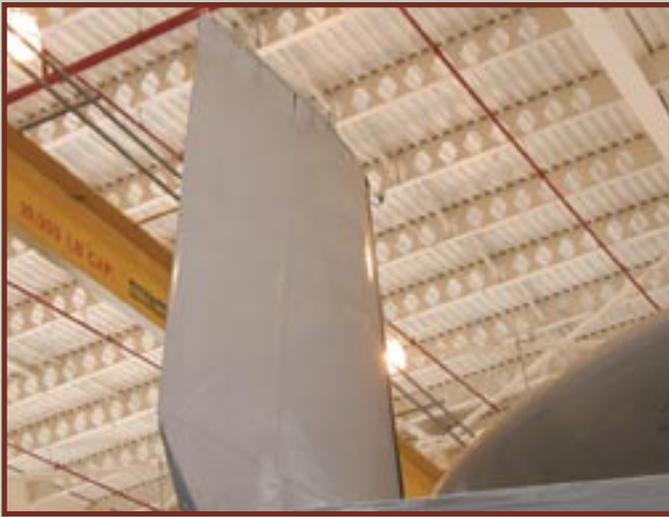
The upper cap assembly is not a corrosion-prone area.

underneath it. The corrosion manual (NAVAIR 01-1A-509) does not list this area as corrosion prone. During 800-hour inspections, we remove all movable rudders and tabs to inspect the bushings and bearings. They then are replaced. However, the Hawkeye's port, upper, inboard, vertical fin is not a movable rudder. It has no bushings or bearings to replace, and it is not subject to this inspection. We often treat this area with the saying, "If it isn't broke, don't fix it."

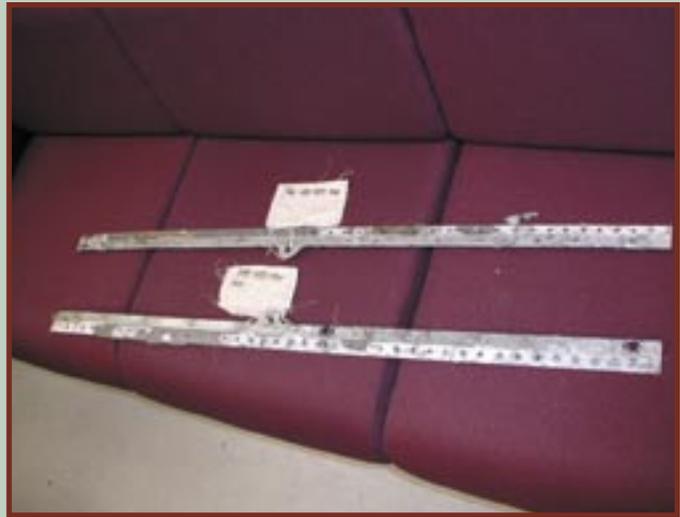
The doublers show the extent of damage.
