# Mech

The Navy and Marine Corps Aviation Maintenance Safety Magazine

**Vol. 44, No. 4 Fall 2005**

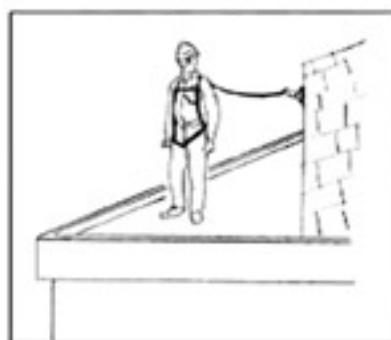
**Body Restraint System**

**Body Restraint System:** An application of the fall protection equipment, in which horizontal travel is restricted, preventing exposure to fall hazards. The system consists of a strap device, such as chest harness or full-body harness that can be secured around a worker and attached to a load-bearing anchorage in order to restrict travel and limit fall hazards. The strap can be single or multiple. (See figure below.)

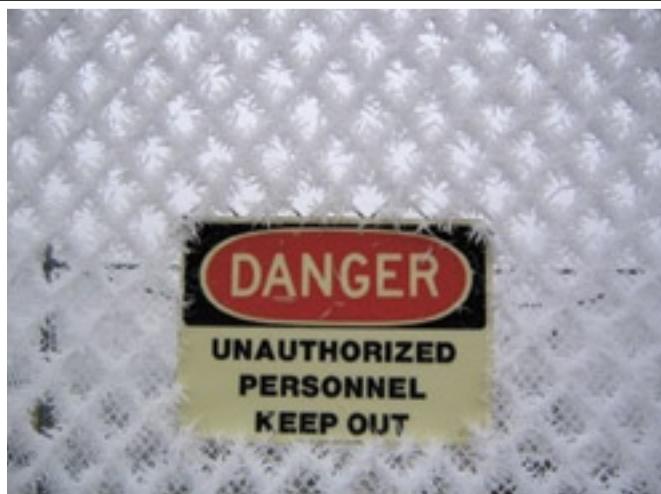
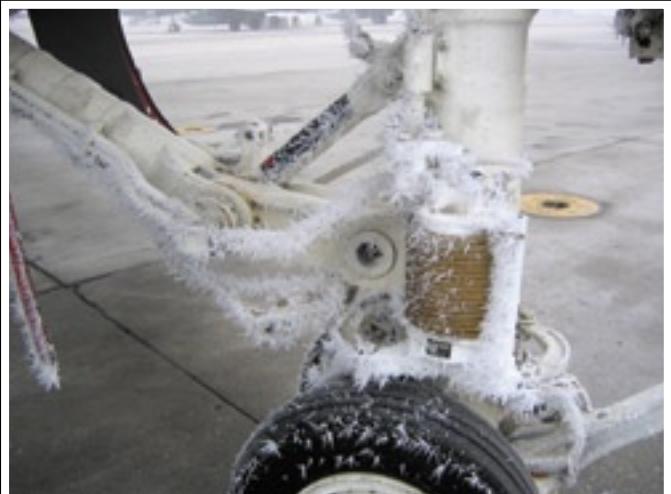
**H**ave you ever seen icing like this? I hadn't until I made a detachment to NAS Fallon in January 2005. This icing is called "pogonip," a meteorological term originally used by Native Americans to describe the frozen fogs of fine ice crystals that settle on trees, fences and plants. NAS Fallon normally only sees one pogonip episode per year, and it usually lasts only one or two days. However, two significant episodes occurred during the winter of 2004-2005. This particular incident started around Jan. 15 and continued into February. A temperature inversion settled over the valley, trapping the cold, moist air between the Sierra Nevadas. Meanwhile, warmer El Nino air from the south moved over the dense, cold air, packing it down and holding it.

What does NATOPS say? It prohibits operating the J52 motor in ice-fog conditions, unless operational necessity dictates. Most commanding officers will agree that training missions do not qualify as operational necessity, so NAS Fallon airwing events don't launch in ice fog. NATOPS warns specifically of rapid ice build-up on engine-inlet vanes and blades in extreme low temperatures, high humidity, or visible moisture conditions. The engine's anti-ice capability cannot overcome the tremendous ice-producing capability of ice fog being sucked through the high-velocity inlet of a Prowler intake.

Interim Rapid Action Change (IRAC) 34 to the EA-6B General Information and Servicing Manual changed the temperature/ humidity restrictions for turning a J52-P408A/B motor. It says, "at temperatures between 28 and 42 degrees Fahrenheit, with a relative humidity above 50 percent, engines being turned with FOD screens should be monitored constantly for ice build-up on the screens. If ice starts to form, the engine should be shut down immediately." Common sense would dictate that, in any extremely low temperature, high-humidity, visible-moisture conditions, constant monitoring of the engine inlet/FOD screens should be the norm.

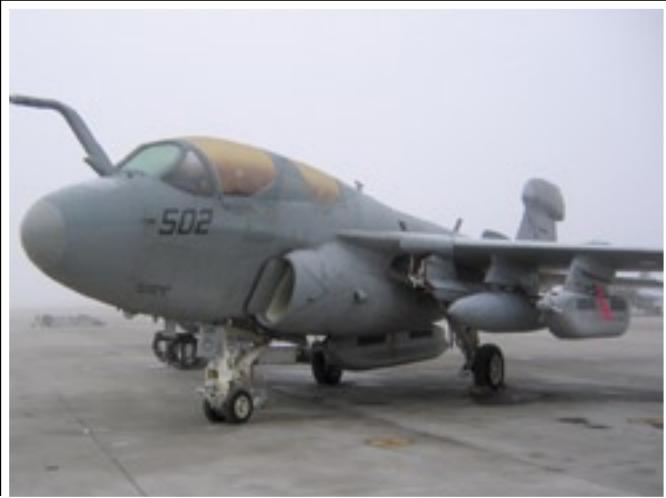
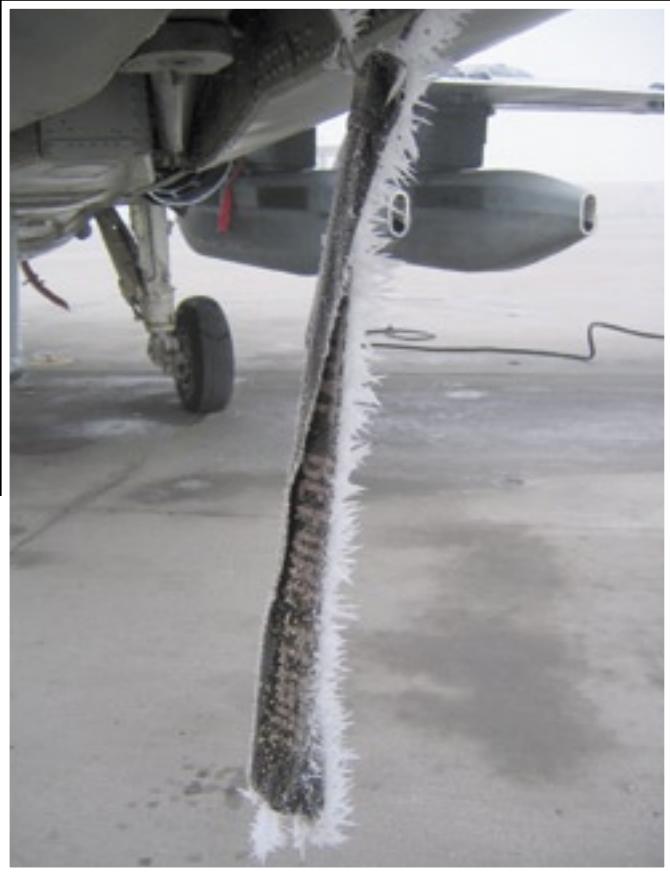
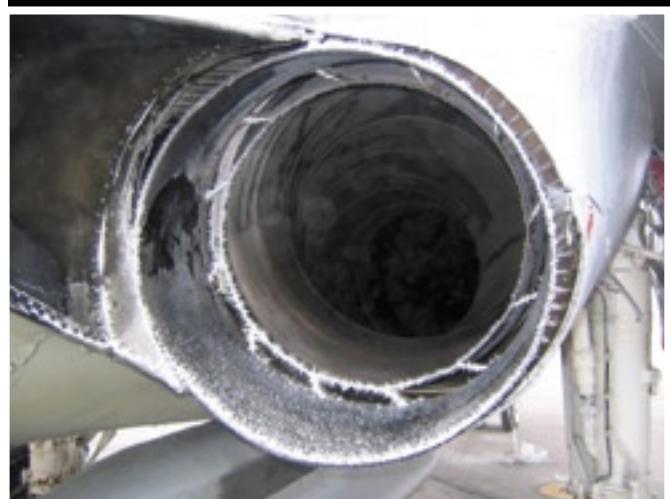
ditions without monitoring engine FOD screens. Now, observation of the screens offers a better chance of detecting ice build-up, which could cause FOD damage to the motor.

What else can you do? During times of operational necessity, you can take a few steps to limit the motor's exposure to damage from ice build-up. Once anti-ice/deicing steps have been taken, you must limit deck operation to four consecutive minutes at idle rpm. After four minutes, the engines should be run up to full power, retarded to 75 percent, and stabilized for one minute. Then, the engines can be retarded to idle and the four-minute counter reset. Also, NATOPS says to run engines for a minimum of five minutes before moving any control surfaces; this will limit damage to hydraulic lines and seals. Cold hydraulic fluid moving through cold rubber seals can cause leaks. NATOPS also warns of oil-pressure problems in extremely cold temperatures and recommends running the engine at idle for a short time after initial start-up. This initial idling should pre-heat the engine oil and increase its viscosity, allowing easier pick-up by the oil pump and easier movement through oil bearings and injector heads.

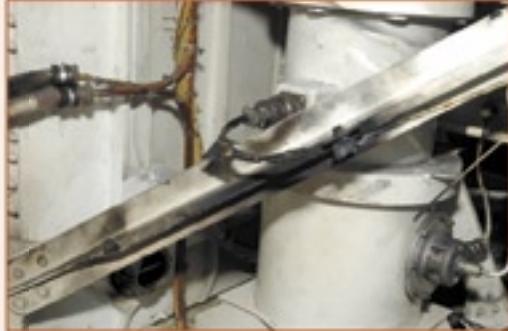
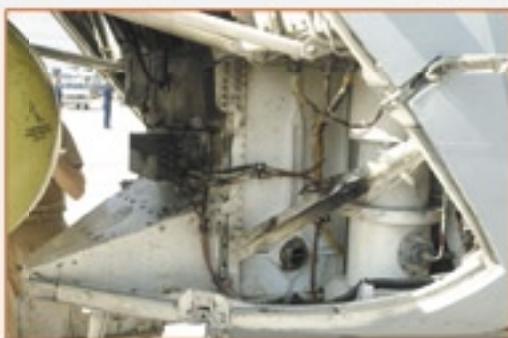
Once clear of the aircraft, smoke was visible around the radome. The groundcrew quickly released the radome latches, moved to the windward side of the aircraft, and got ready to raise the dome. Airman Juan Tapia was standing next to the aircraft with a Halon fire bottle. It was charged and ready to go should flames be visible. When we opened the radome, oxygen was introduced to the fire triangle, and the fire erupted. Airman Tapia was ready, and he put out the fire with a two-second burst of Halon. This entire incident lasted only 60 seconds, from start to finish.

The culprit was the Kapton wire that led to the forward avionics fan. The wire had chafed and shorted on an Adel clamp. When the troubleshooter tried to reset the circuit breaker, the wire arced and ignited the radar absorption blankets. We initiated a subsequent inspection of all other aircraft but didn't find any more discrepancies.
