Winter 2007-08

Mech

In this issue:

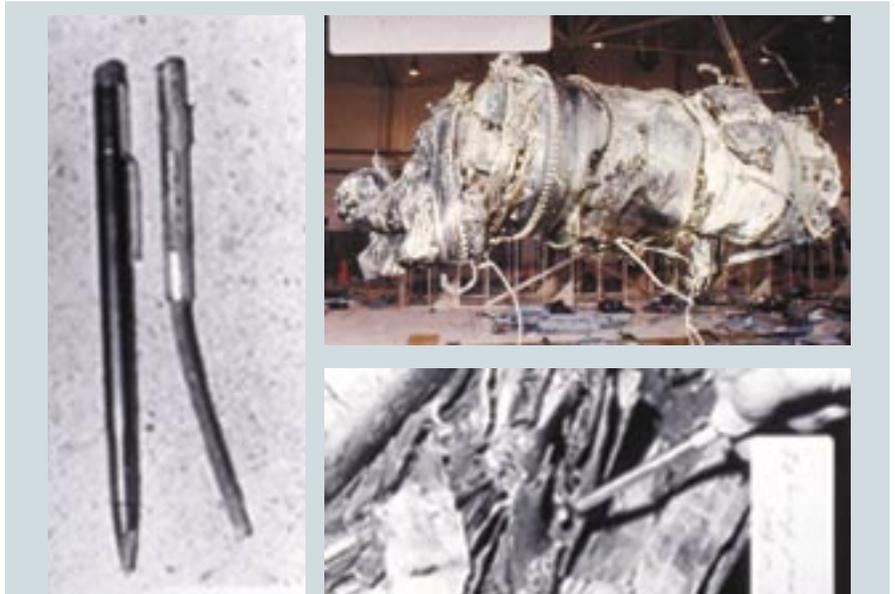
Tools can bring down aircraft, like this hex wrench found in the wreckage of an A-6 Intruder.

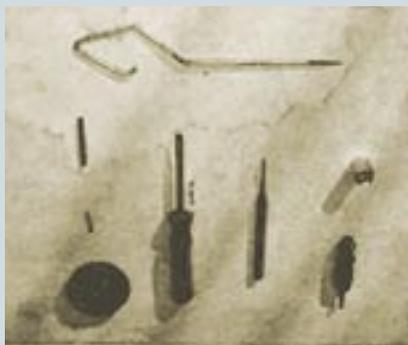
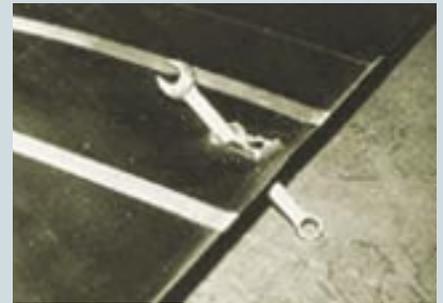
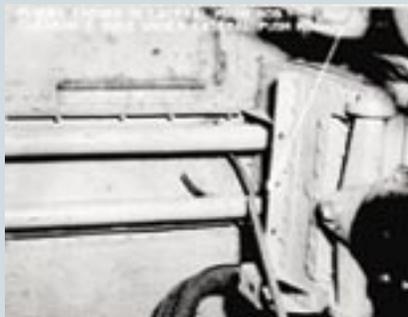
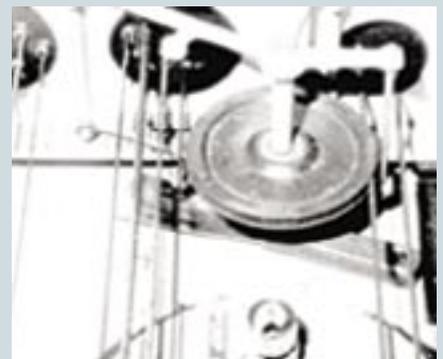
Missing tools end up in the strangest places. Can you find them all?

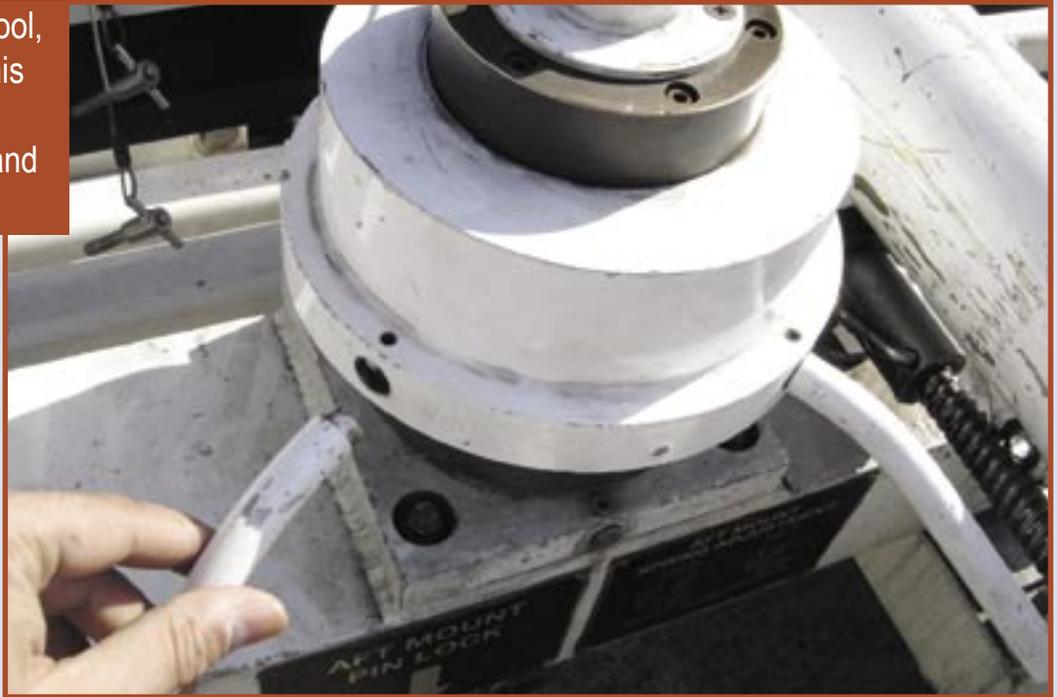
Although not really a tool, the crank handle for this engine trailer must be accounted for before and after use.

To make matters worse, I didn't do a pre-operational inspection on the engine trailer. Of course, I didn't have an SE license for this piece of gear, either.

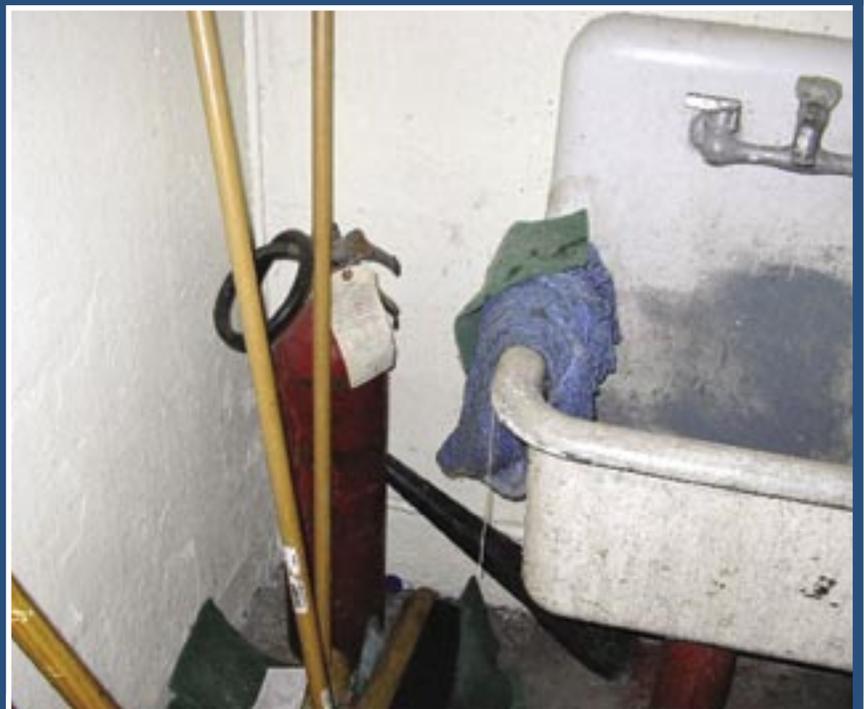
Bad

Fire extinguisher not
in the right place and
poor housekeeping.

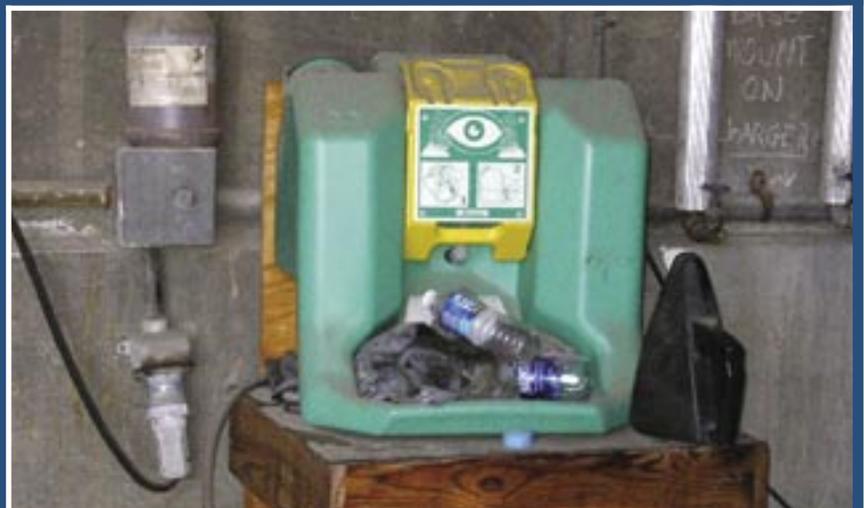
Ugly

How do you use this
eyewash station?

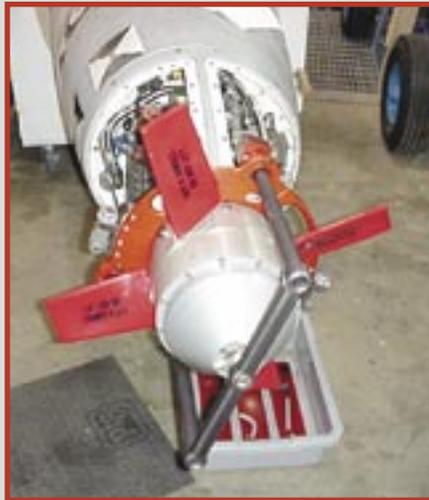
Before you play with this “new kid on the block,” beware that the new aerial refueling store improved power system (ARSIPS) ram air turbine (RAT), which will be installed on your old aerial refueling buddy store, weighs twice as much as the present one. The old RAT has been through a few changes, but it has been No. 1 degrader for the system. It even has slung a few blades, nearly causing serious mishaps.

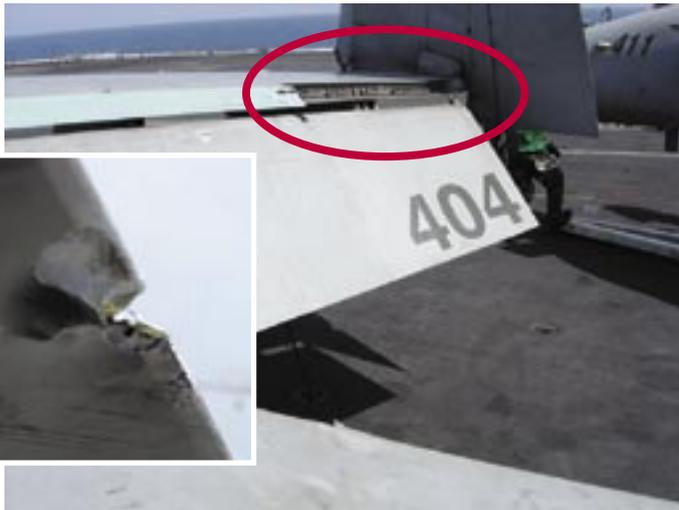
The missing shroud and other damage to the aircraft is visible in these photos.

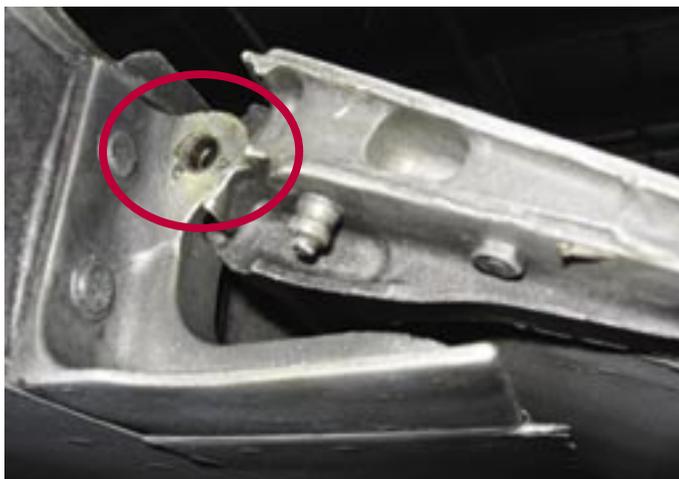
A missing pin is a simple mistake that can cause huge problems.

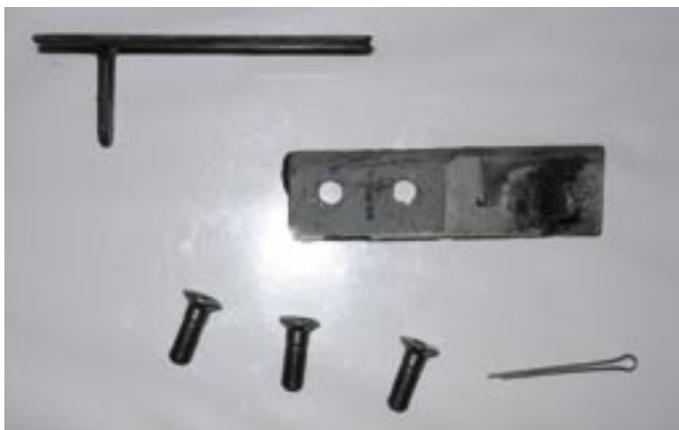
The right hardware can mean the difference between success and failure.

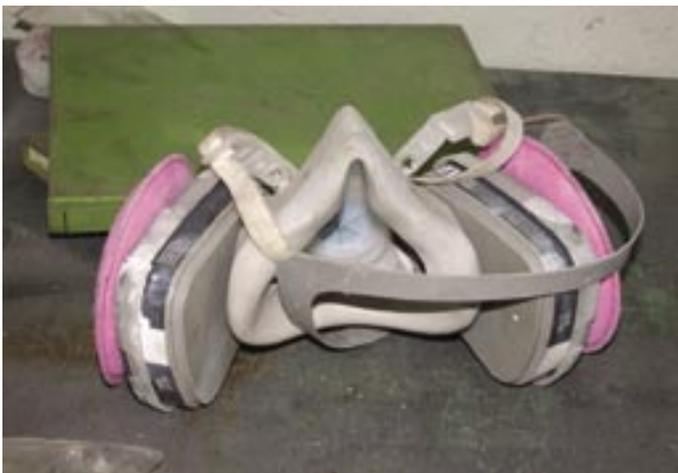
Problem: Almost half of the commands surveyed in FY-07 did not store respirators properly. This error can lead wearers to inhale particulate matter, or the respirator becoming distorted to the point that it no longer provides adequate protection.

Solution: OPNAVINST 5100.19E, Paragraph B0609 tells users to place respirators in a clean plastic bag or other container. It goes on to say that zip-lock bags are preferred, and users should make sure the respirator is completely dry to prevent mildew. It also addresses the fact that they should be stored “flat” in a clean, dry and uncontaminated area, urging that users not “crowd them” to avoid distorting the face piece. This hint especially is true for respirators that are not used frequently—like those in small composite repair facilities or those used for fit test.
