Spring 2008

www.safetycenter.navy.mil

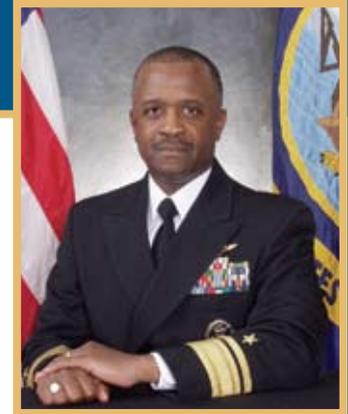
Sailors Helping Sailors, Marines Helping Marines

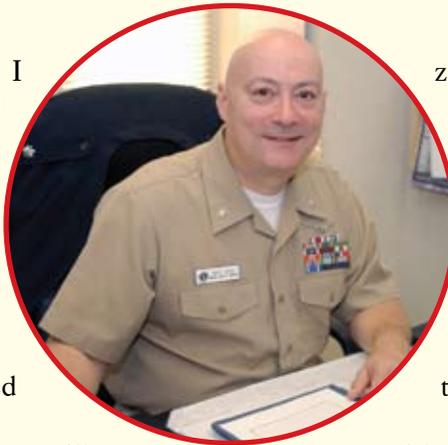
In this and every issue of *Mech*, you will read stories of woe from the maintenance world. I believe most of these incidents could have been mitigated through proactive use of ORM. Whether the long, deliberate five-step process or on the fly, time-critical type, maintainers must identify the hazards being faced, assess the risk, make risk decisions, implement controls, and supervise, supervise, supervise.

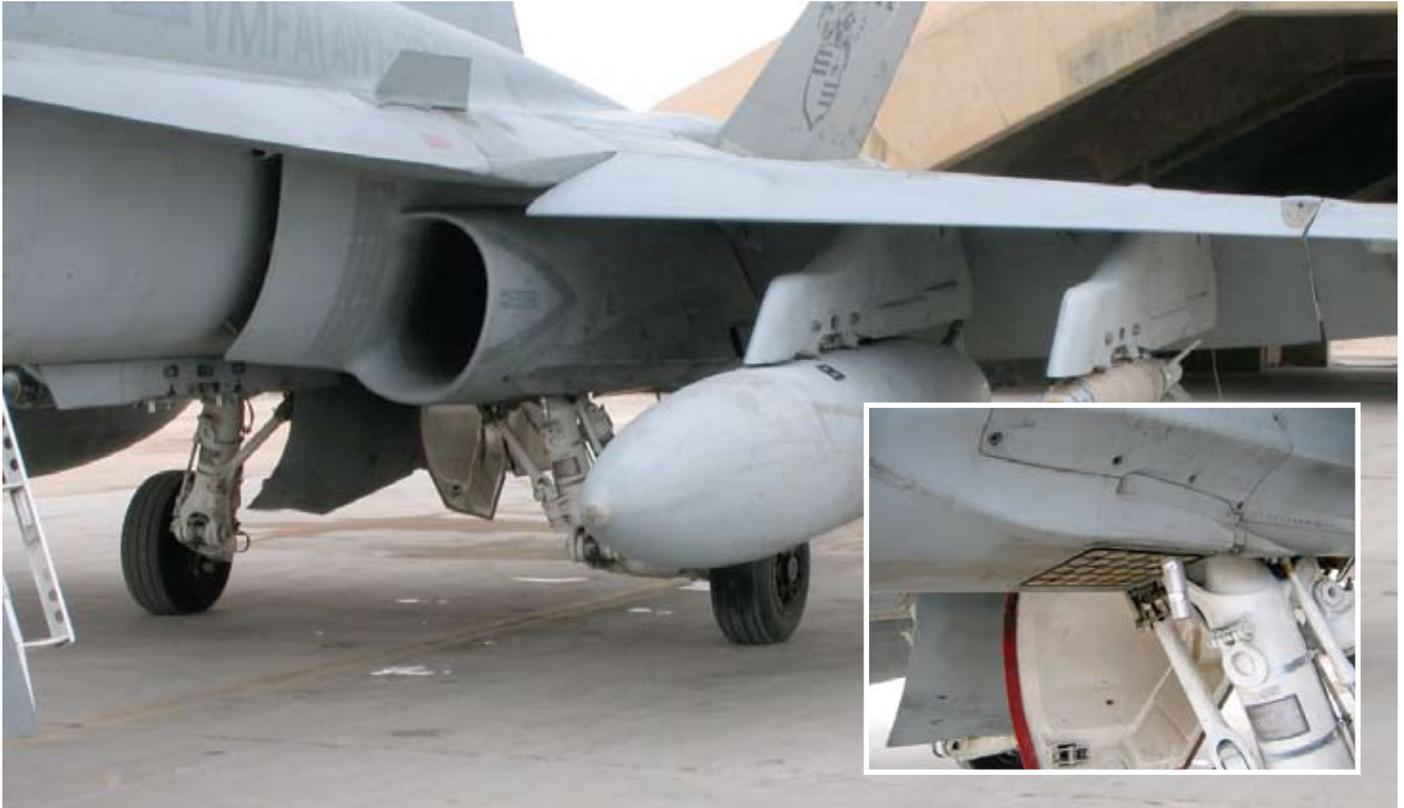
This message pointed out a few things that can and should take place. However, another step that might help prevent problems that maintenance technicians cause would be to have them sign a statement on the MAF before going out to the aircraft. The statement would say: I will check each dispenser on the aircraft for magazines. I will not do maintenance on an aircraft with magazines installed in a dispenser. This one simple statement may make them more aware and less likely to have a problem.

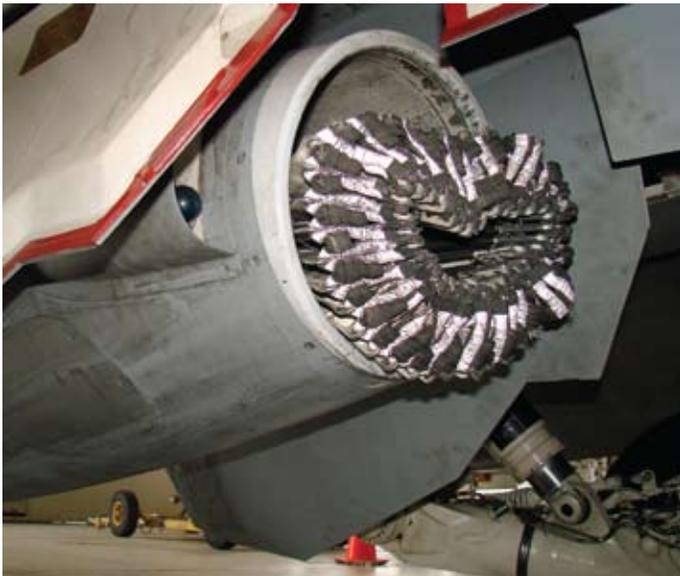
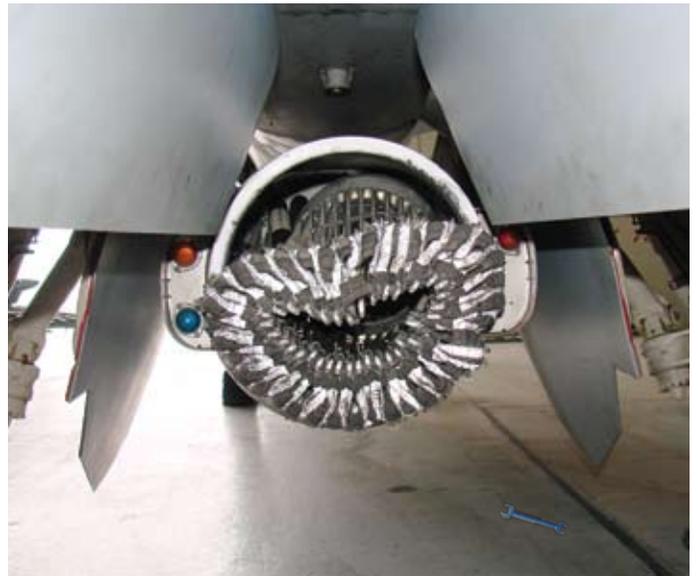
checks, so my team member and I signed out our tools, went to the roof, found the jet, and went to work. We did not put our job into “work” in NALCOMIS before we left maintenance control. We found 106 and assumed the jet was not armed; we implicitly trusted our ship-mates to leave the jet unarmed before the tests.

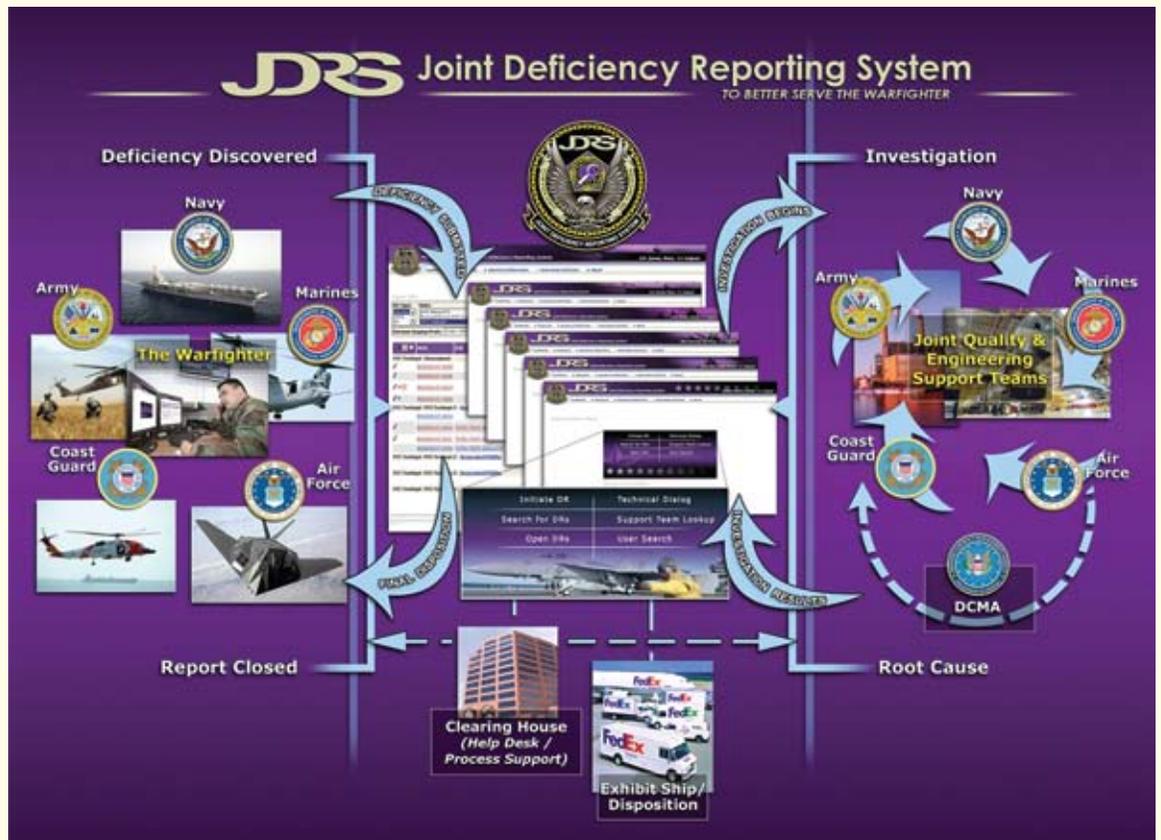
JDRS provides a common, seamless solution to report, track and resolve technical deficiencies that the fleet identify across the Aeronautical Enterprise. JDRS is a cross-service, web-enabled, automated tracking system designed to initiate, process and track deficiency reports from the fleet through the full investigation process.

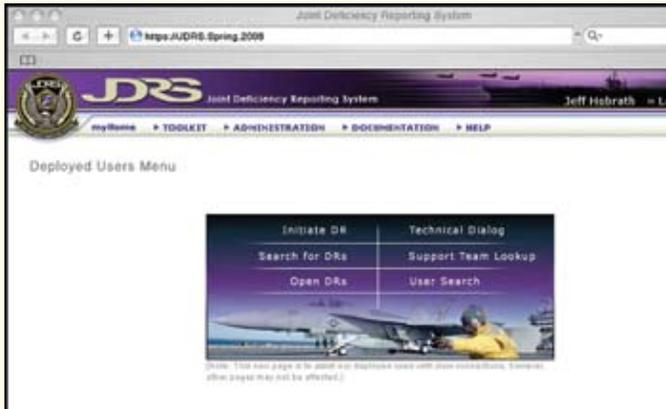
NAVAIR's NAMDRP/JDRS development team consists of senior programmers, functional requirement experts, application testers, and various program-support personnel at NAS Patuxent River, Md.

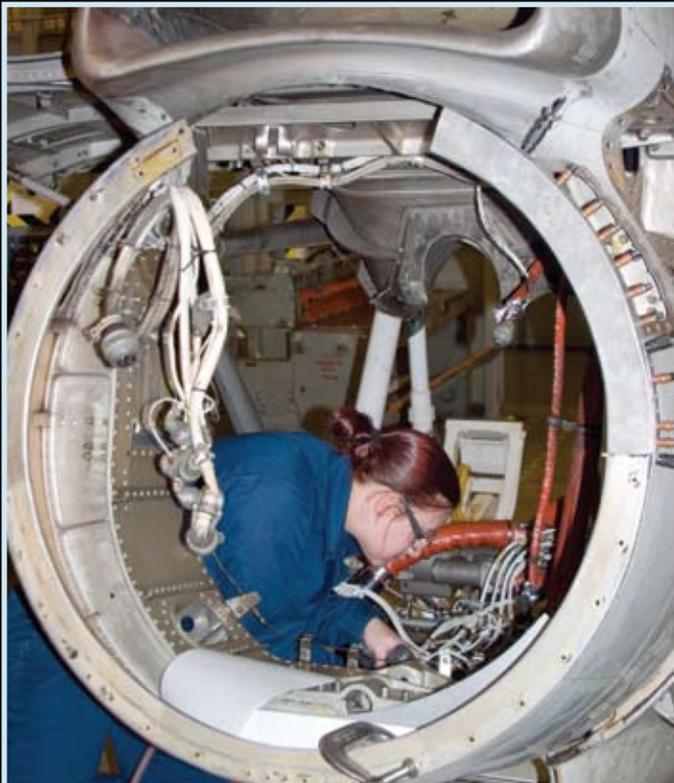
AMAN Miranda Long makes repairs to a P-3C Orion engine housing at Fleet Readiness Center (FRC) Northwest aboard Naval Air Station Whidbey Island (NASWI). Navy photo by MC2 Jon Rasmussen

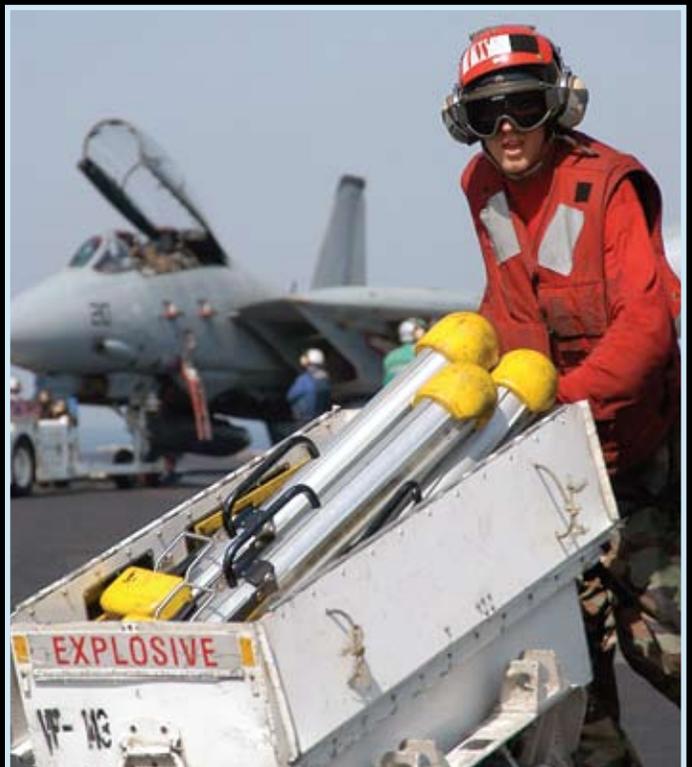
AO3 Joseph Little moves Bols chaff loaders across the flight deck aboard USS *George Washington* (CVN-73). Navy photo by PHAN Jessica Davis

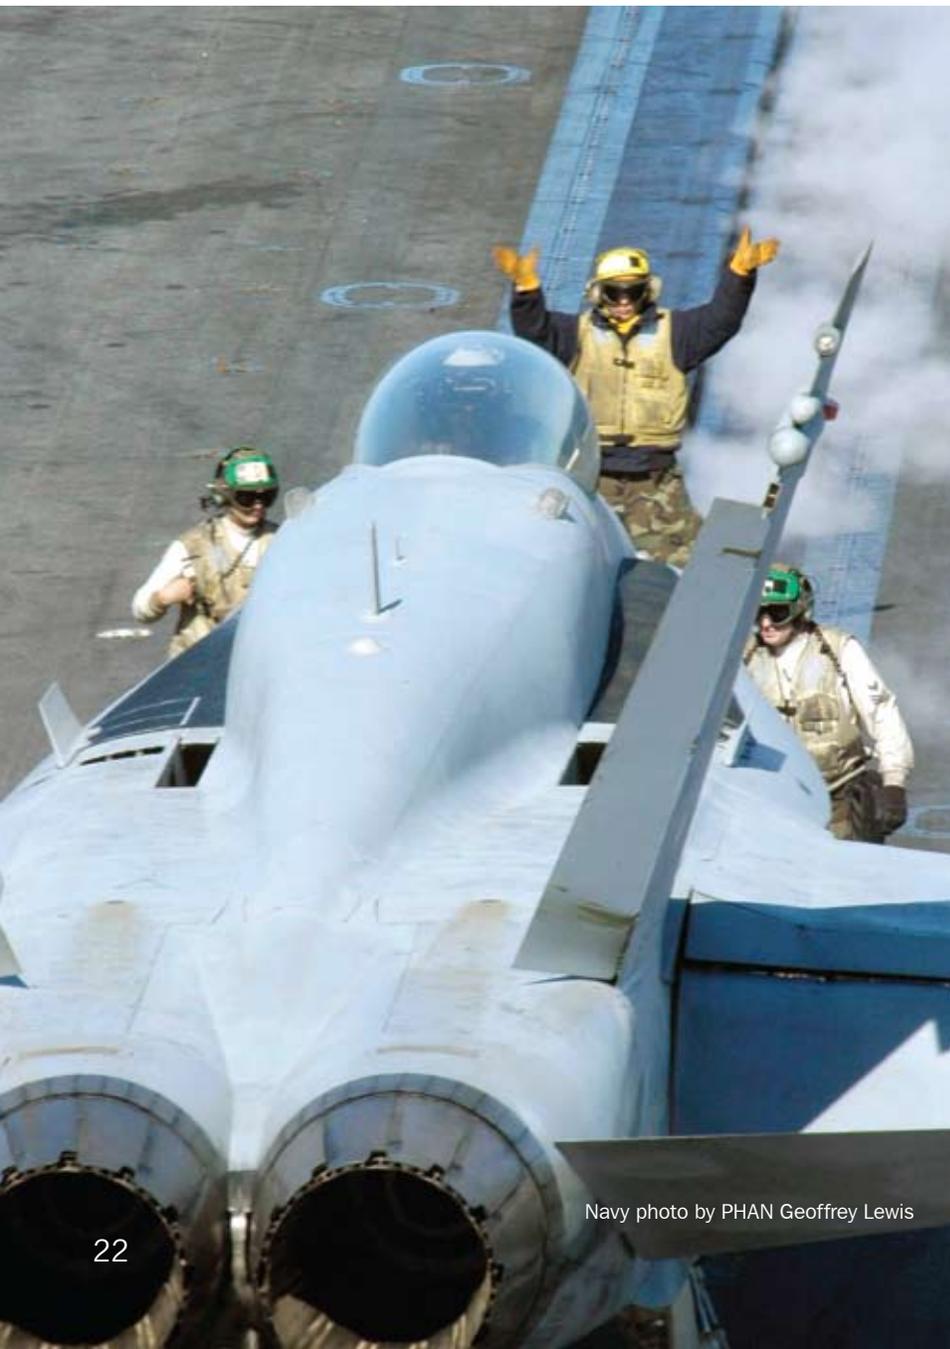
Navy photo by PHAN Geoffrey Lewis

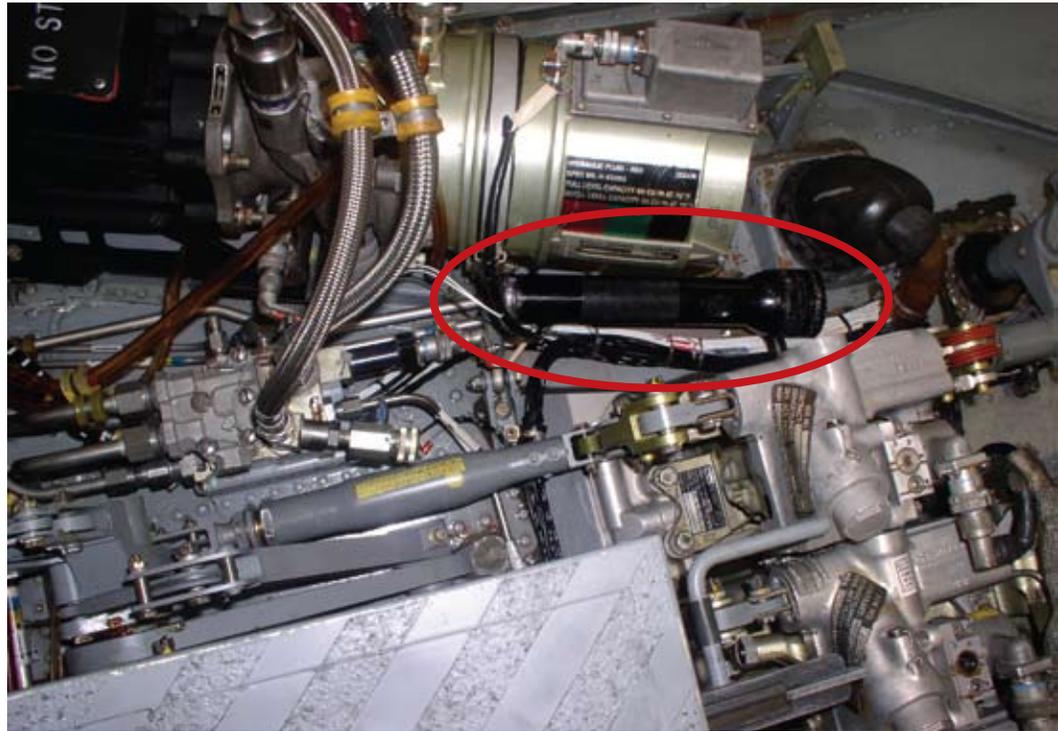
The flashlight was found in the hydraulics bay of an H-60.

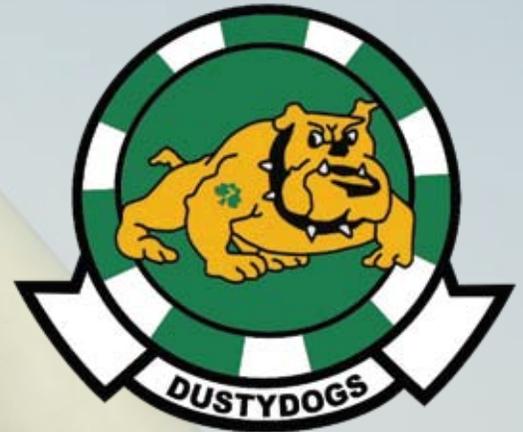
AMAA Ryan Marshall HS-7

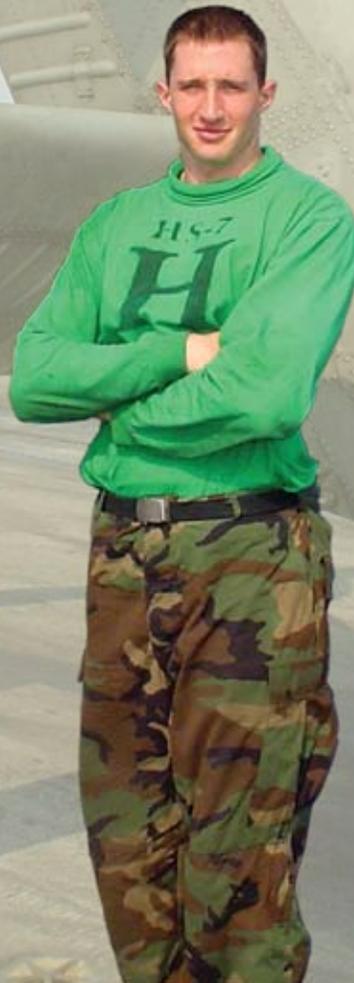
While doing a turnaround inspection on aircraft 617, airman apprentice Marshall determined one of the tail-rotor blades felt loose, compared to the others. He did a “teeter test,” which checks for spar integrity and a delaminating tail rotor. He then found a few cracks near the blade cuff and notified QA. After removing the outboard retention plate, a QAR found the composite fiber layers of the blade spar had started to separate from each other, causing the tail rotor spar to crack along the retention plate. Had the delamination and cracks gone unnoticed, the tail-rotor blade likely would have failed during the next flight.

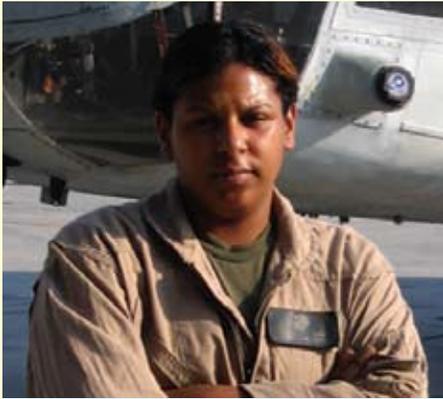
**Cpl. Sophia Reiser
HMM-365**

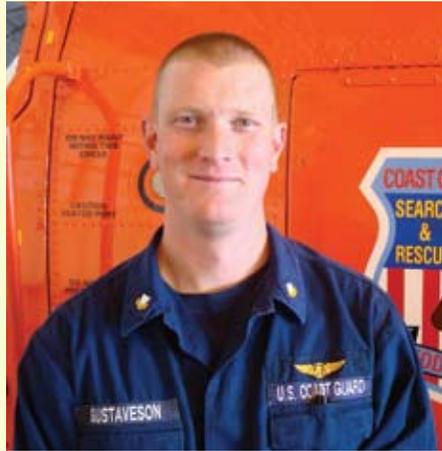
**AMT2 Michael
Gustaveson
CGAS Kodiak, Alaska**

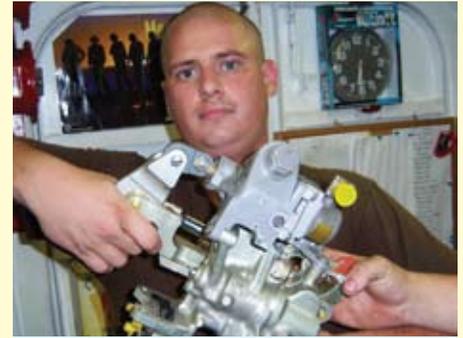
**AM2 Dustin Maxey
HSL-42**

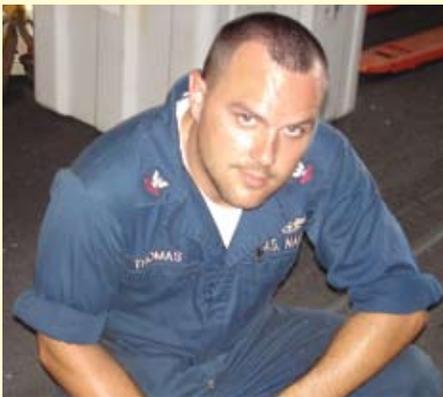
**AM2 Mark Thomas
HSL-44**

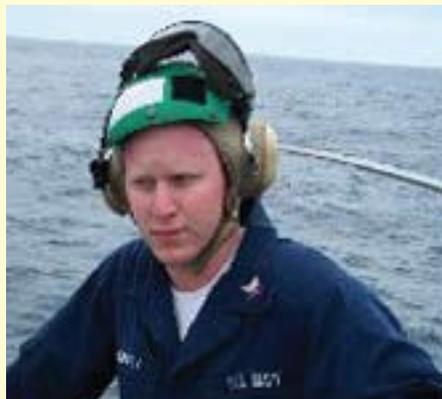
**AE2 Daniel Coffey
HSL-42 Det. 1**

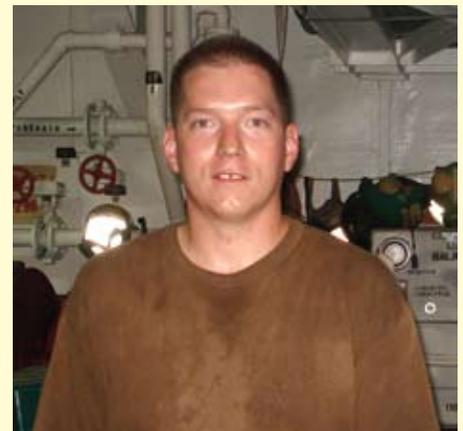
**AT2 Tyler Vidas
HSL-42**

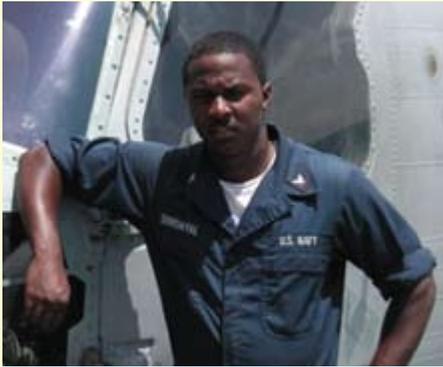
**AM3 Trevor Shivdayal
HSL-37 Det. 2**

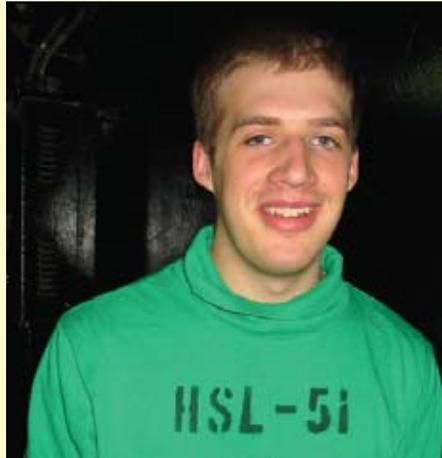
**AN Chad Helstrom
HSL-51**

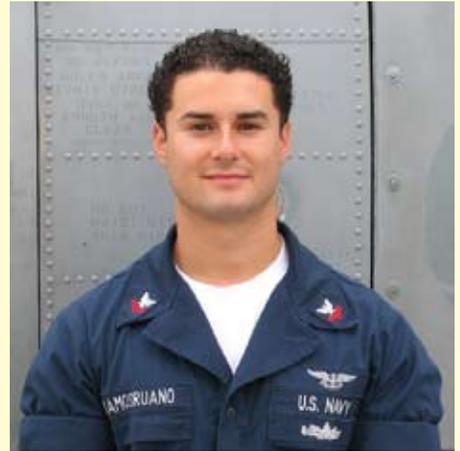
**A02 Alex Ramosruano
HSL-37**

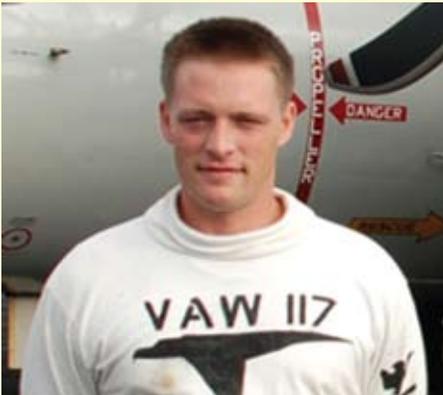
**AM2 Phillip Boykin
VAW-117**

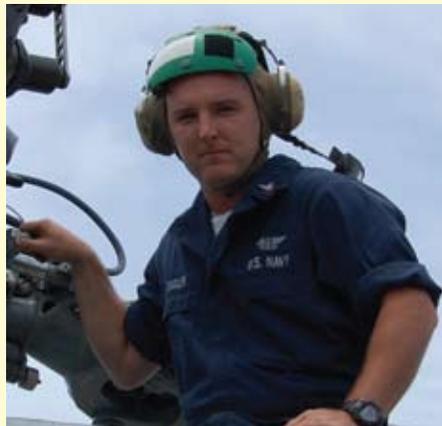
**AM2(AW) Philip Sadler
HSL-37 Det. 2**

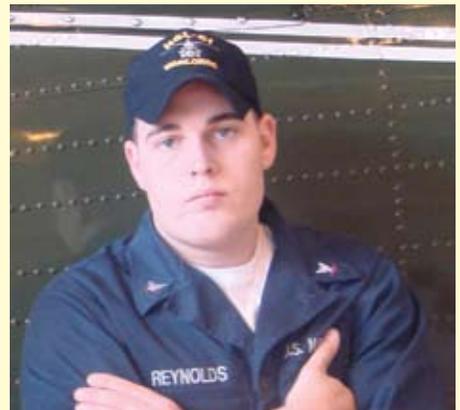
**AD3 Brian Reynolds
HSL-51**

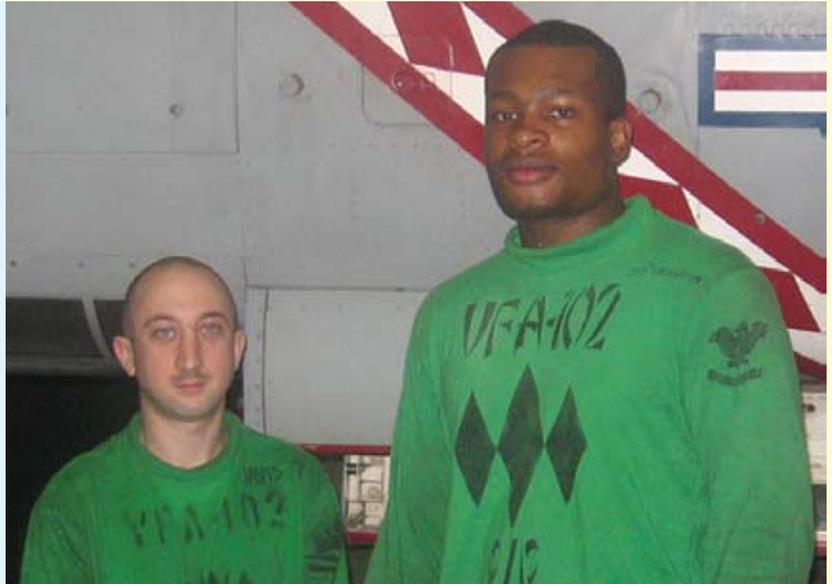
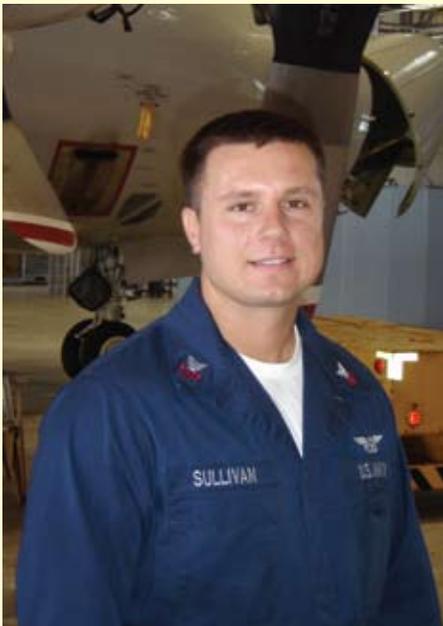
**AD1 Joshua Sullivan
VPU-2**

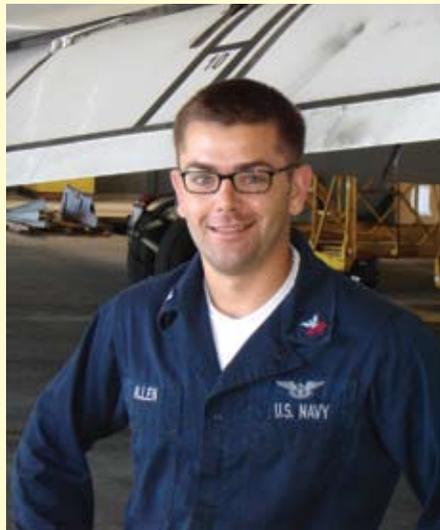
**AM1 Matthew Allen
VPU-2**

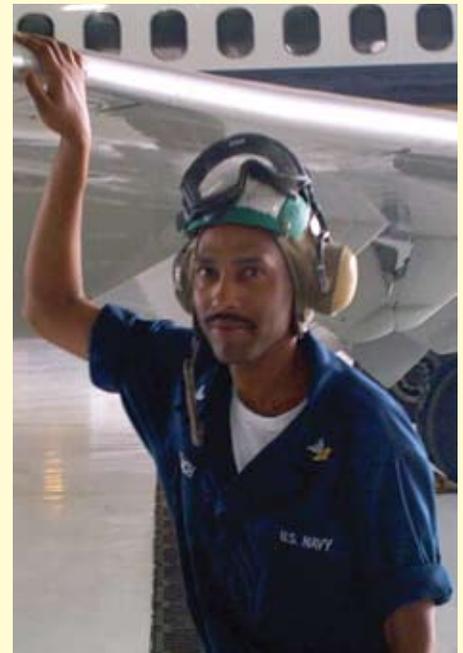
**AE2(AW) James Beach
VR-56**
