INFORMATION CIRCULAR NO. 17

FLOOD OF JUNE 9, 1957, AT PERRY, FLORIDA

By
Rufus H. Musgrove
Hydraulic Engineer, U. S. Geological Survey

Prepared by
U. S. Geological Survey
in cooperation with the
Florida Geological Survey

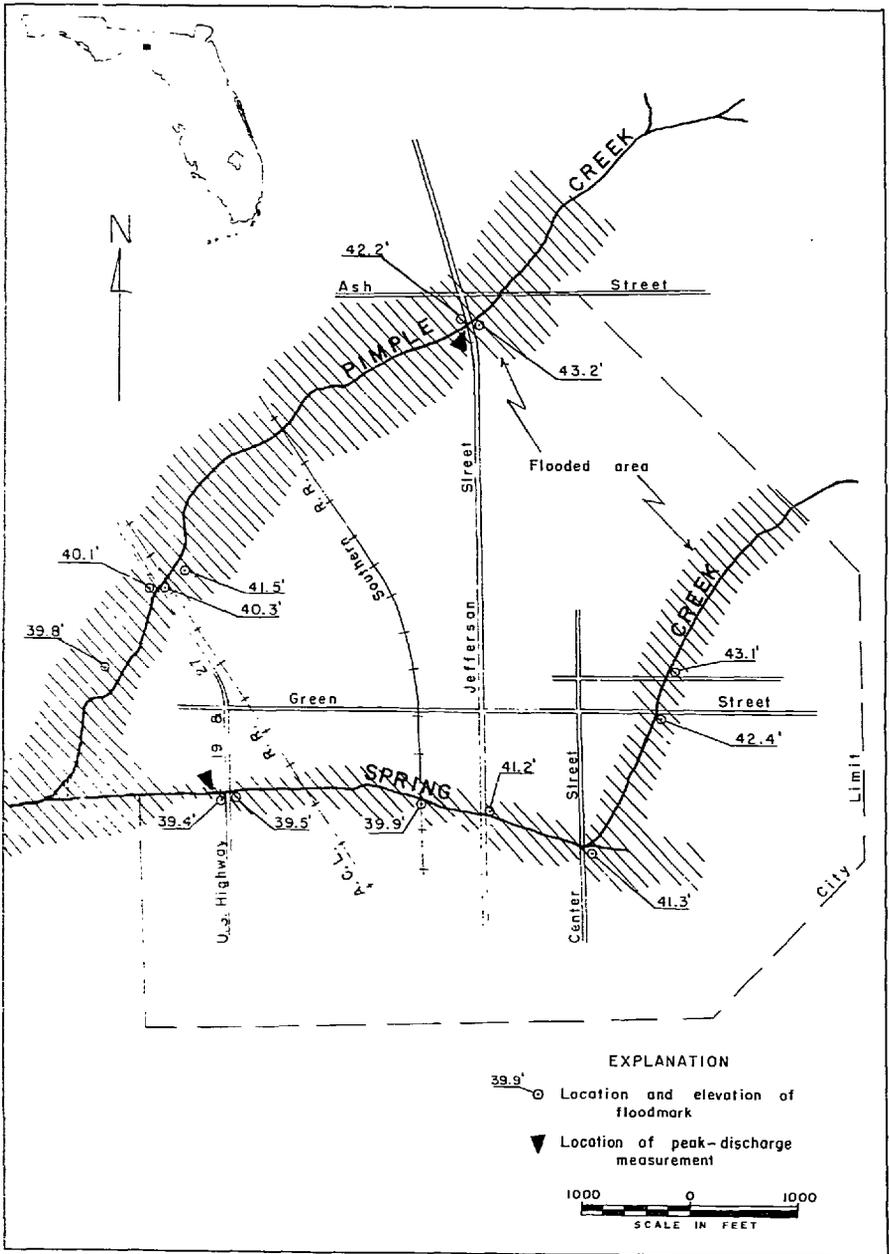
Figure 1. Map of the Spring and Pimple creeks in Perry, Florida, showing flooded area, points of peak-discharge measurement, and high-water elevations, in feet above mean sea level, for flood of June 9, 1957.

Floods occurred on streams in the vicinity of Perry, Taylor County, Florida, on June 9, 1957, as a result of heavy rains from a tropical disturbance. Serious flooding occurred in Perry along Spring and Pimple creeks as outlined by the shaded area in figure 1, requiring the evacuation of about 200 families from the lowland area. No loss of life was reported. The damages to residential and commercial properties were estimated at several million dollars. Most of the damage was confined to residential areas (fig. 2); however, several stores in the area were damaged by flood waters (fig. 3).

An indirect measurement of peak discharge was made on Spring Creek at a point downstream from U. S. Highway 19 and U. S. Highway 27 (fig. 1) where the entire flow was confined by high banks. The peak discharge of 1,360 cubic feet per second was computed by Manning's formula from data collected after the flood waters had subsided. A channel roughness (n) of 0.045 was selected for this section and a water-surface slope of 0.0011 foot per foot was measured from high-water marks. A mean velocity of 3.2 feet per second was computed for this section of channel.

An indirect measurement of peak discharge was made on Pimple Creek at the North Jefferson Street crossing (fig. 1). Jefferson Street was flooded (fig. 7) to a depth of half a foot for a distance of 500 feet and a fall across the street of 1.0 foot was measured from high-water marks (fig. 8). Flow over the street was computed using U. S. Geological Survey procedures developed from Yarnell and Nagler data. Flow through the bridge opening was computed by two methods, flow-through-culvert and contracted-opening, with comparable results. The peak discharge through the bridge opening was 1,610 cubic feet per second, and over the street, 250 cubic feet per second, giving a total peak discharge of the stream of 1,860 cubic feet per second.

Elevations in feet above mean sea level of high-water marks were measured at several points along the streams and are given in figure 1.

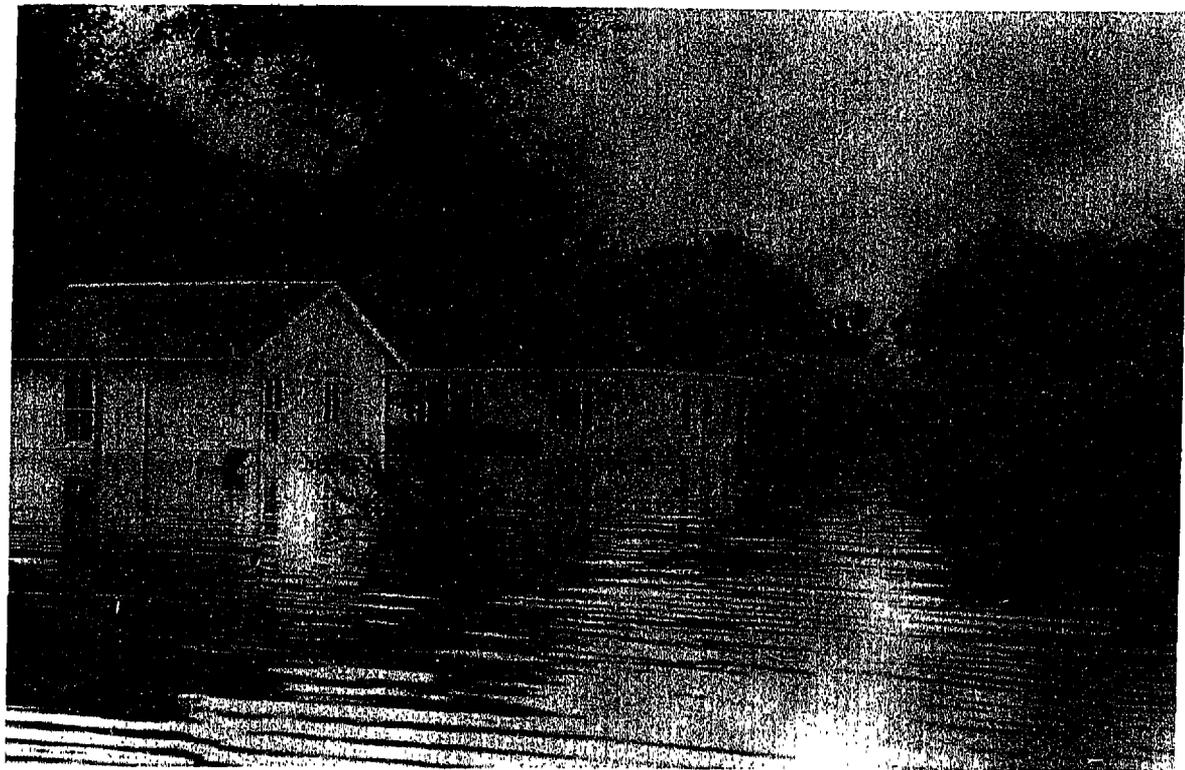
Figure 2. Flooded area in residential section in Perry, Florida, June 9, 1957. (Photo courtesy of R. M. Bryant)

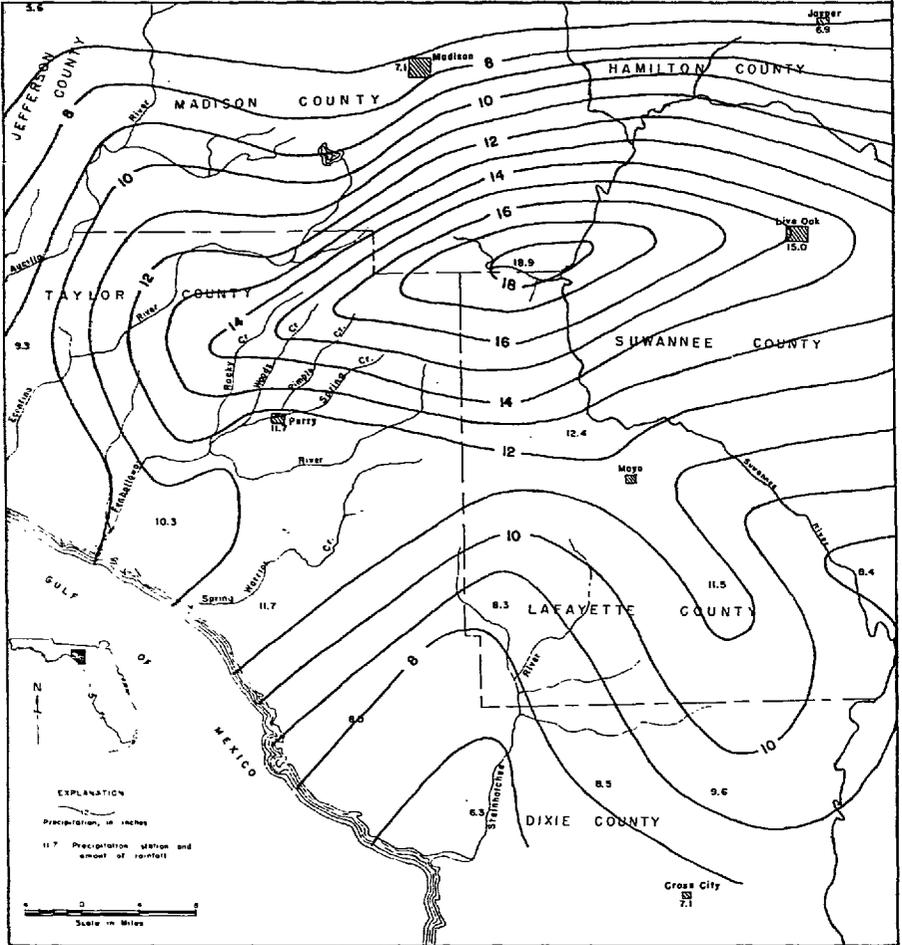
Figure 4. Isohyetal map showing total rainfall June 7-8, 1957, in the vicinity of Perry, Florida.

Rainfall records for the storm were collected at three recording and eight daily stations operated by the U. S. Weather Bureau, and at 14 daily stations operated by the Florida Forest Service. No record from a recording gage was available for the area of heaviest rainfall. Isohyetal lines shown on the map (fig. 4) were based on all available records.

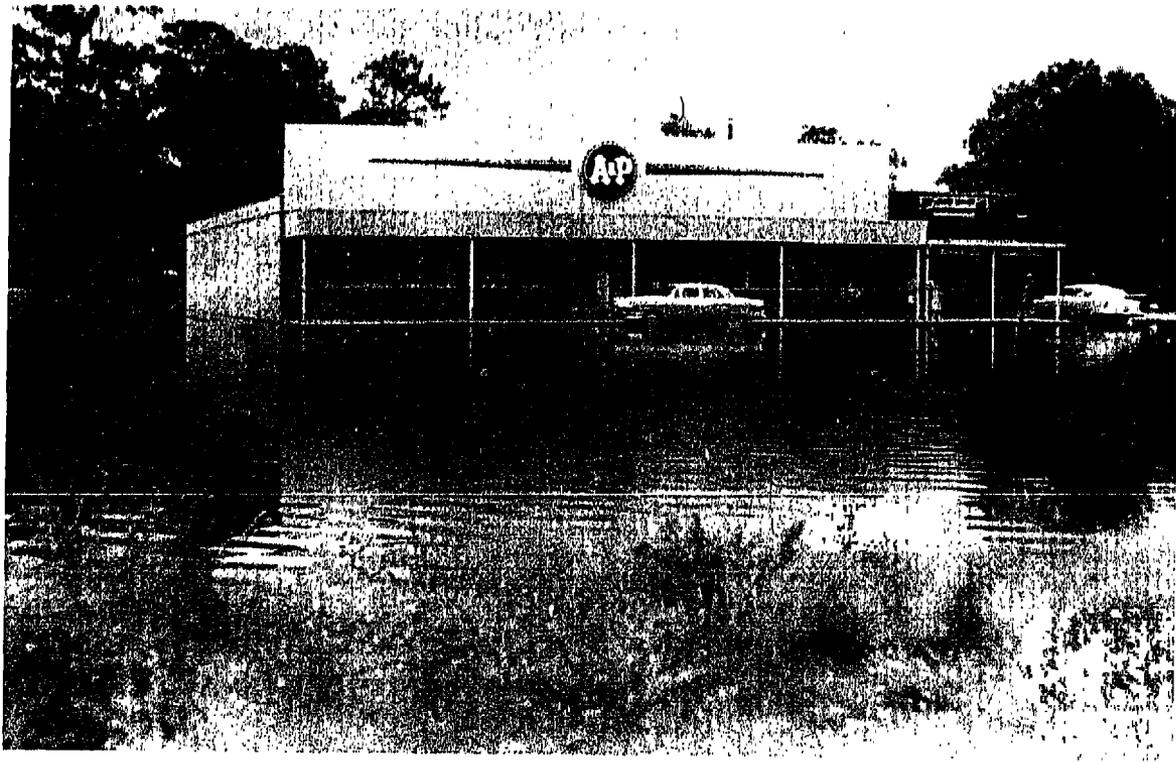
Figure 5. Flooded area along Spring Creek in Perry, Florida, June 9, 1957. (Photo courtesy of R. M. Bryant)

Spring Creek, flowing in a westerly direction through Perry, overflowed its banks, inundated several streets, and caused considerable damage to homes and business property. The flood water rose to a depth of one foot inside the supermarket and laundry just east of Center Street (fig. 5). Homes were flooded all along the creek from the northeast edge of town down through the Brooklyn area. Spring Creek reached a peak stage during the night of June 9.

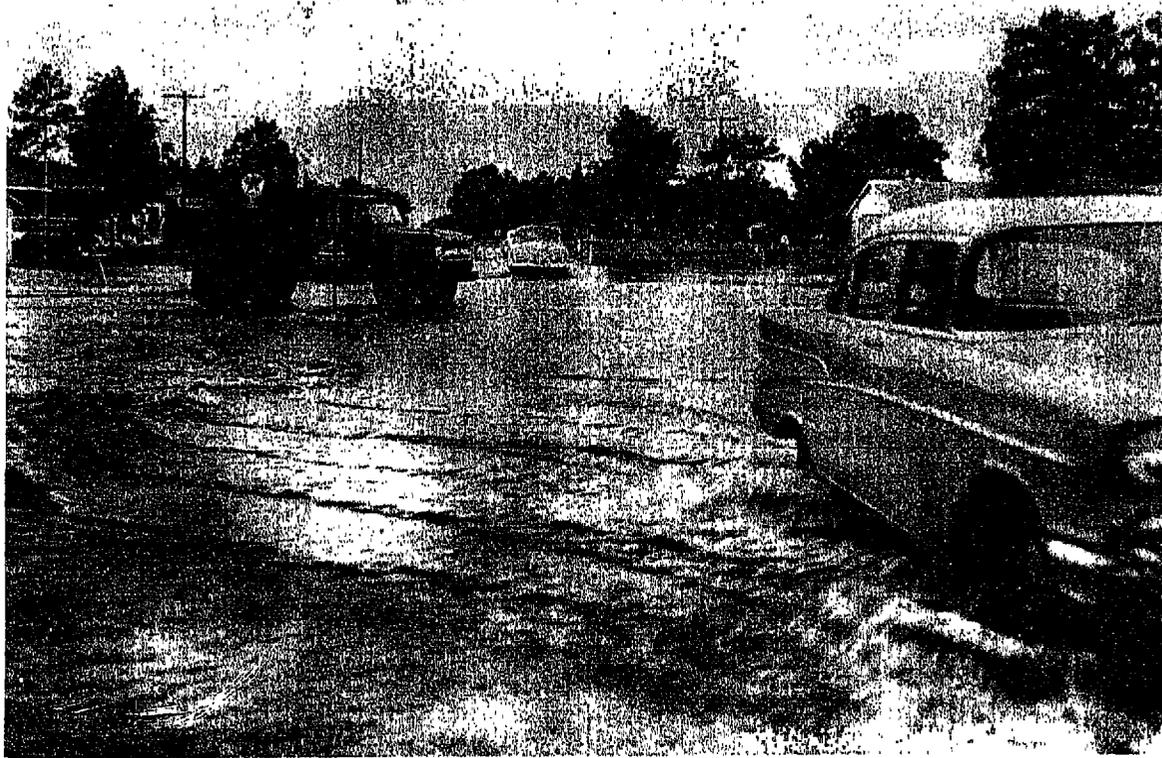
Figure 7. Flooding by Pimple Creek at intersection of Ash and Jefferson streets, Perry, Florida, June 9, 1957. (Photo courtesy of R. M. Bryant)
