University of Florida Conservation Areas Land Management Plan
Creeks and Ponds

Introduction

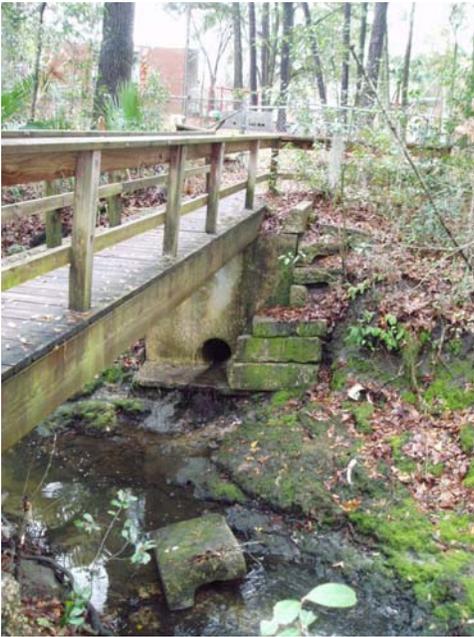
Bridge Jennings Creek

Jennings and Diamond Creeks - These two tributaries flow into Health Center Park which in turn flows into towards Lake Alice. Upstream areas that drain into the Jennings Creek include Broward, Mallory, Reid, Jennings and Beaty Towers residence halls. Diamond Creek is the receiving body for water draining from Sorority Row, a portion of the intersection of SW 13th Street and Archer Road, and from the parking garages on the east side of the Shands Hospital complex. Like most other creek systems on campus, this creek's flow is derived from a mix of both stormwater runoff and natural surficial aquifer seepage (which is at least partially the result of the University's irrigation system). The banks of the creeks are deeply incised by years of down-cutting from stormwater coming off of impervious surfaces. Of particular concern are areas along the Diamond Creek, adjacent to the intersection of SW13th Street and Archer Road. This area is eroding rapidly and is already a safety hazard. University staff have had discussion with Department of Transportation officials about placing railings along the sidewalks at this intersection to reduce the likelihood of an accident. As with most creeks within campus, these creeks would benefit greatly from upstream stormwater improvements. The Yulee Pit area, headwater area of the northern creek, appears to be an ideal location for a stormwater enhancement project like the SEEP (Stormwater Ecological Enhancement Project) to help reduce velocities entering the north creek. Additionally, the south creek begins just east of Sorority Row (this is same creek that runs at the base of Sorority Row), where some instream enhancements should be studied to see if water velocities could be slowed before they exacerbate the erosion mentioned previously.

Diamond Creek and Jennings Creek - The riparian corridors of these creeks are steep, which limits public use in these areas outside of the existing footpaths. Some consideration should be paid to mowing less of the edge in order to create a less accessible buffer for safety reasons, along Jennings Creek. Additionally, some creek stabilization counter-measures to prevent erosion as well as some stormwater outfall piping will be studied and potential implemented in the next year for both of these creeks. Habitat enhancements like bird and bat boxes and wildlife friendly plantings should be considered for these sites.

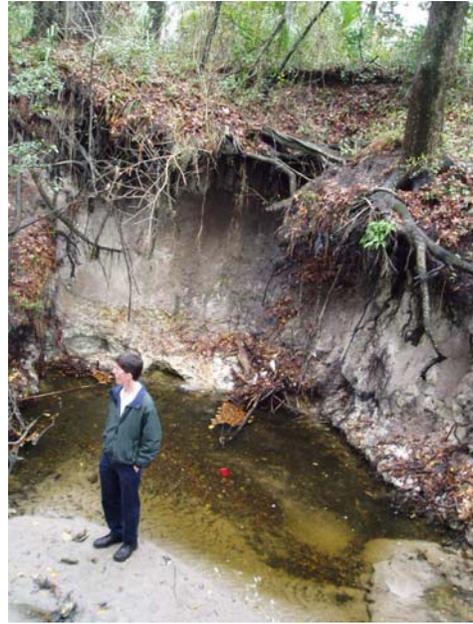
Erosion in Diamond Creek, adjacent to SW 13th

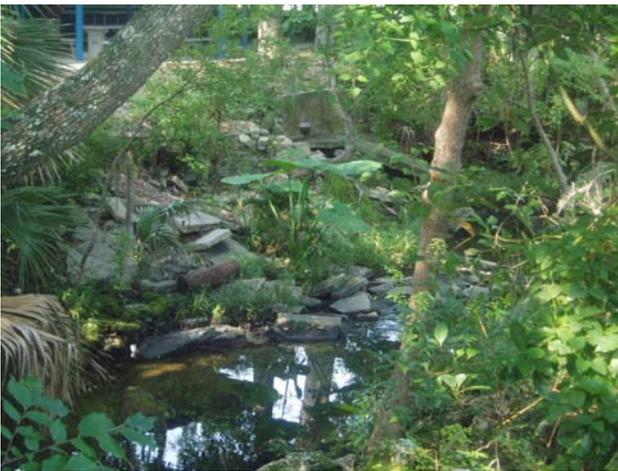
Tumblin Creek - In places, the banks of Tumblin Creek are deeply incised by years of down-cutting from stormwater which primarily originates in downtown Gainesville. The City of Gainesville has begun studying ways to reduce volumes and has in fact built some upstream retention areas that should help reduce velocities in the long term. In the short term, some measures need to be taken to reduce side-bank erosion that threatens buildings at P.K. Yonge. Recently, the University re-built the PK Yonge Auditorium after years of settling had led to major cracks that could no longer be patched. Other buildings on this campus also are showing signs of slippage. While side-bank erosion is not the primary cause of these foundation issues, it does play a role and will in the long-term cause additional problems. Thus, some in-stream measures should be identified to help ameliorate the problem, such as native chert stone (rip-rap) placed along areas of side-bank erosion.

Tumblin Creek at P.K. Yonge

Tumblin Creek – Some side bank erosion has been identified and may need to be stabilized with hardscape material such as chert riprap.

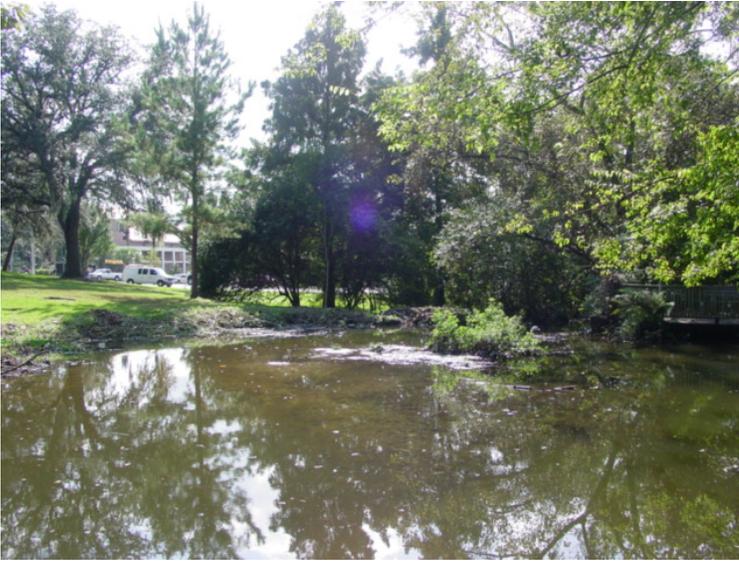
Gator, Ocala, Graham and Dairy Ponds are located on the older-more developed portions of campus. They are largely ringed by development and have been integrated into the university's stormwater system, providing functions similar to a wet retention pond. Additional background research needs to be completed in order to determine their respective origins as either natural sinkhole formations that were artificially or naturally plugged or as created retention ponds that were aesthetically improved to look natural. Each pond is surrounded by a small buffer of vegetation.

Graham Pond - The ad-hoc working group recommended that a no-mow / infrequent mow buffer be established around the eastern side of Graham Pond. Within this no-mow area and in the littoral zone of the pond efforts should be made to establish native aquatic plants that will help beautify the pond and potentially improve water quality.
