ADVANCED NONDESTRUCTIVE MONITORING AND EVALUATION OF  
DAMAGE IN CONCRETE MATERIALS

A THESIS PRESENTED TO THE GRADUATE SCHOOL  
OF THE UNIVERSITY OF FLORIDA IN PARTIAL FULFILLMENT  
OF THE REQUIREMENTS FOR THE DEGREE OF  
MASTER OF ENGINEERING

UNIVERSITY OF FLORIDA

2003

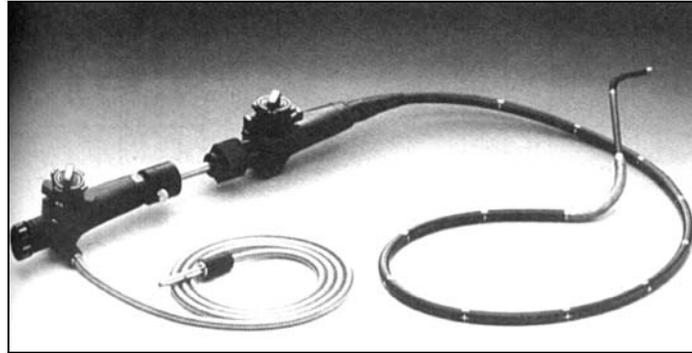
Figure 2.1: Flexible borescope (Hellier 2001)

2001). Without the use of borescopes, the inspectors' efforts would have resulted in an incomplete assessment of the structure. Figures 2.1-2.3 are photographs of the most commonly used borescopes.

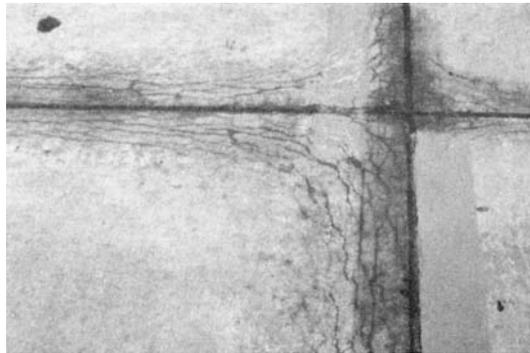
Figure 2.6: Cracks in concrete pavement with moisture present (ACI 201.1 R92)

However, it is possible to use water as an aid to detect surface flaws in concrete. Inspectors can apply water to a concrete surface and observe the rate of drying. As the water evaporates from the surface, areas containing cracks will hold moisture. As illustrated in Figure 2.6, these moist areas will result in local discoloration of the concrete, which facilitates the visual detection of cracks.

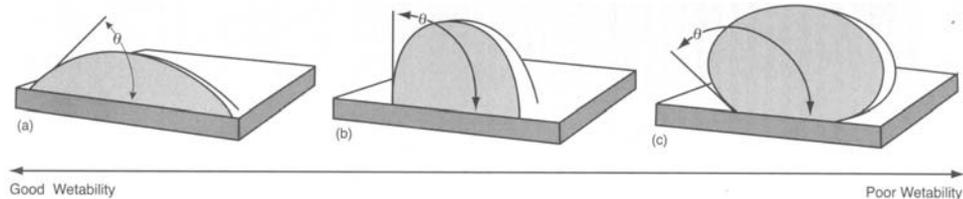
Figure 2.7: Contact angles for various liquids (Hellier, 2001)

The most important property affecting the ability of a penetrant to enter an opening is “wettability”. Wettability refers to a liquid's behavior when in contact with a surface (Hellier 2001). The angle created between the free surface of a liquid and a solid surface is referred to as the contact angle. It is an important characteristic related to the penetrability of the liquid. Liquids that have small contact angles have better penetrability than those liquids exhibiting large contact angles. Figure 2.7 depicts contact angles for various liquids.

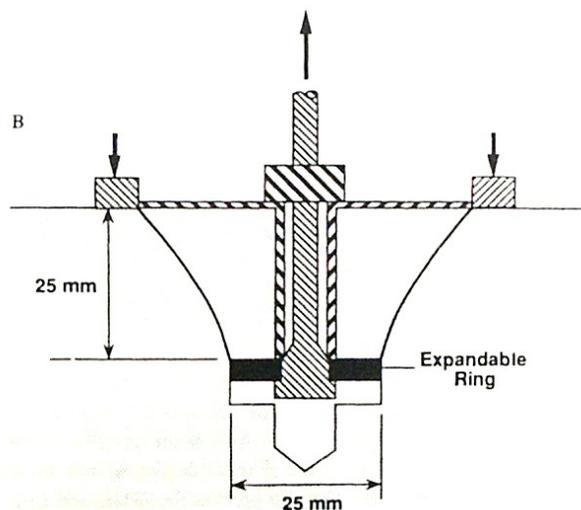
Figure 2.9: Illustration of typical pullout test (Malhotra & Carino 1991)

The pullout test, illustrated in Figure 2.9, uses a metal insert that is inserted into fresh concrete or mechanically installed into hardened concrete. The tensile or “pullout” force required to extract the embedded insert, and the core of concrete between the insert and the surface, can give accurate estimates of the concrete's compressive, tensile and shear strengths. The pullout test has become a proven method for the evaluation of the *in situ* compressive strength of concrete and has several industry applications. The pullout test is used to determine whether the strength of the concrete has reached a sufficient level such that post-tensioning may commence; cold weather curing of concrete may be terminated or forms and shores may be removed.

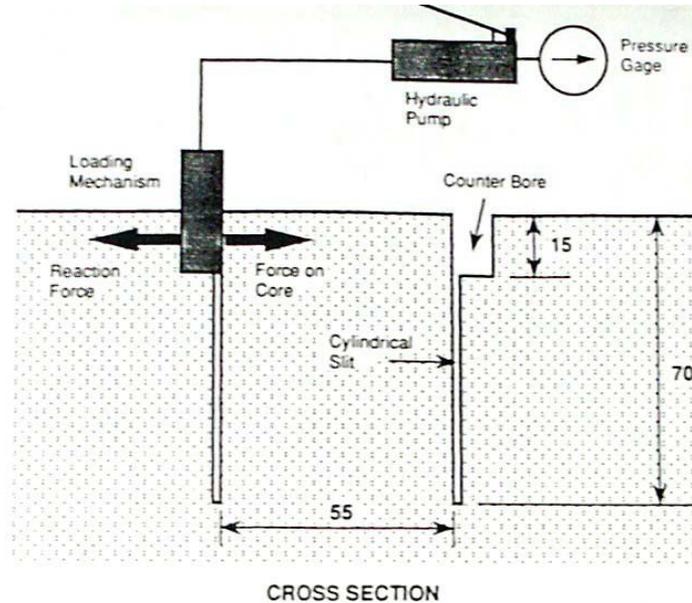
Figure 2.10: Typical cross section of the breakoff test, all dimensions in mm (Malhotra & Carino 1991)

drilled into hardened concrete using a core drill bit. The embedded cylinder size is usually 55mm in diameter and 70mm in height. Figure 2.10 illustrates a typical cross section of the breakoff test.

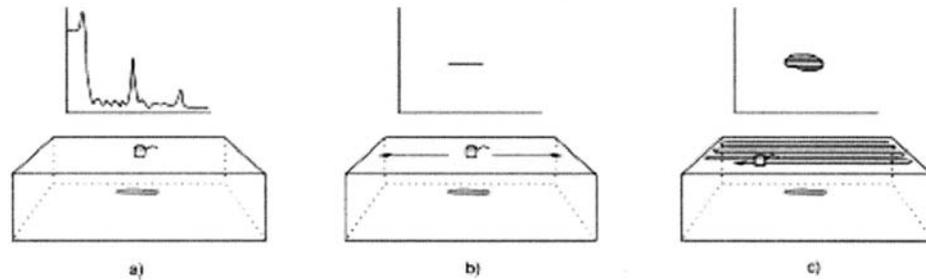
Figure 2.16: Idealized scans of a material defect: a) A-scan, b) B-scan, c) C-scan, (Kaiser & Karbhari 2002)

more complicated than B-scans because they incorporate a two dimensional grid system. C-scans are comprehensive scans that are most applicable to nondestructive testing of materials. Figure 2.16 illustrates the differences between these three types of scans.

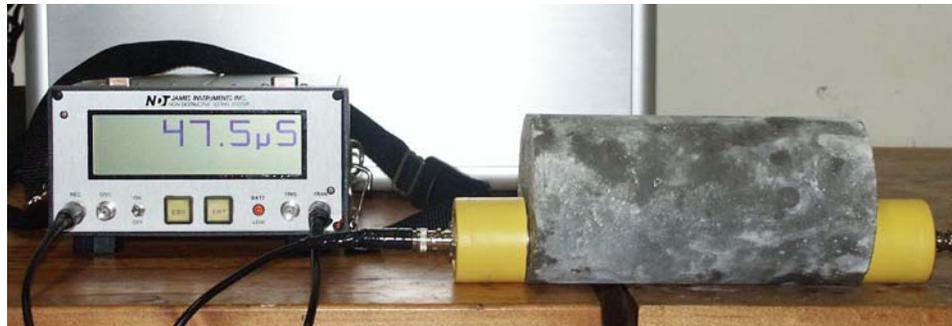
Figure 2.17: Typical ultrasonic test procedure

The acoustic velocity wave speed of a given concrete specimen can easily be obtained with the travel time of a stress wave and the length of the specimen. The pulse is sent from the sending transducer to the receiving transducer through the concrete specimen as see in Figure 2.17. The relationship of a specimen's acoustic velocity is simply calculated from a time and a length measurement. It should be noted that cracks, flaws, voids and other anomalies within a material specimen could increase time of travel therefore decreasing the materials acoustic velocity. However, assuming the specimen in Figure 2.17 is free of anomalies, its acoustic velocity can be calculated simply by. The length of the specimen is 200 mm.

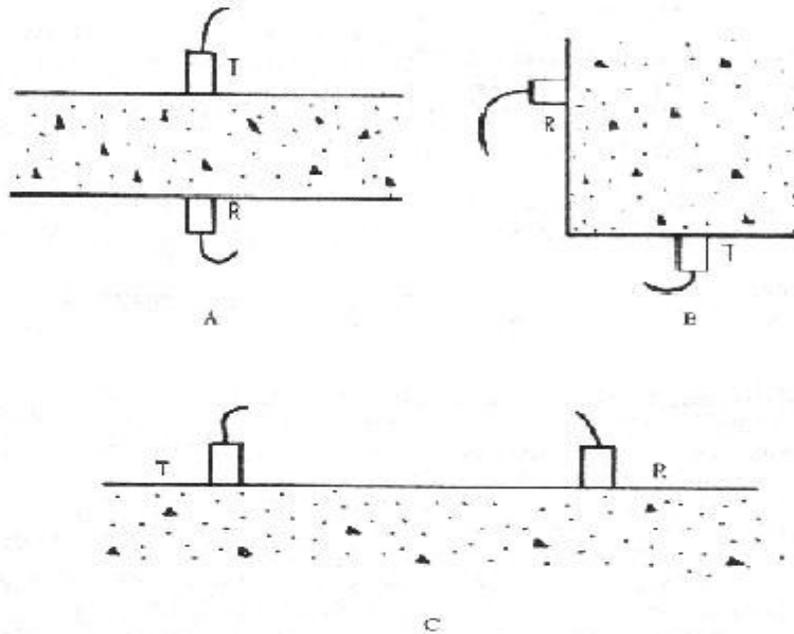
Figure 2.18: Methods of pulse velocity measurements: a) direct method, b) indirect method, c) surface method, (Malhotra & Carino 1991)

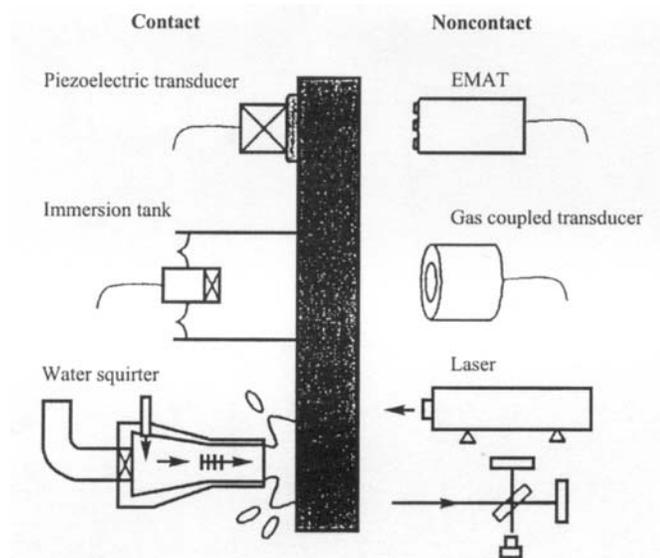
Figure 2.19: Illustration of contact and noncontact techniques (Green 2002)

are not yet serviceable for flaw detection and material investigation. However, the contemporary non-contact ultrasonic methods have been proven to be scientifically applicable in the aeronautics and metallurgical disciplines. A schematic representation of contact transducers vs. non-contact transducers is illustrated in Figure 2.19

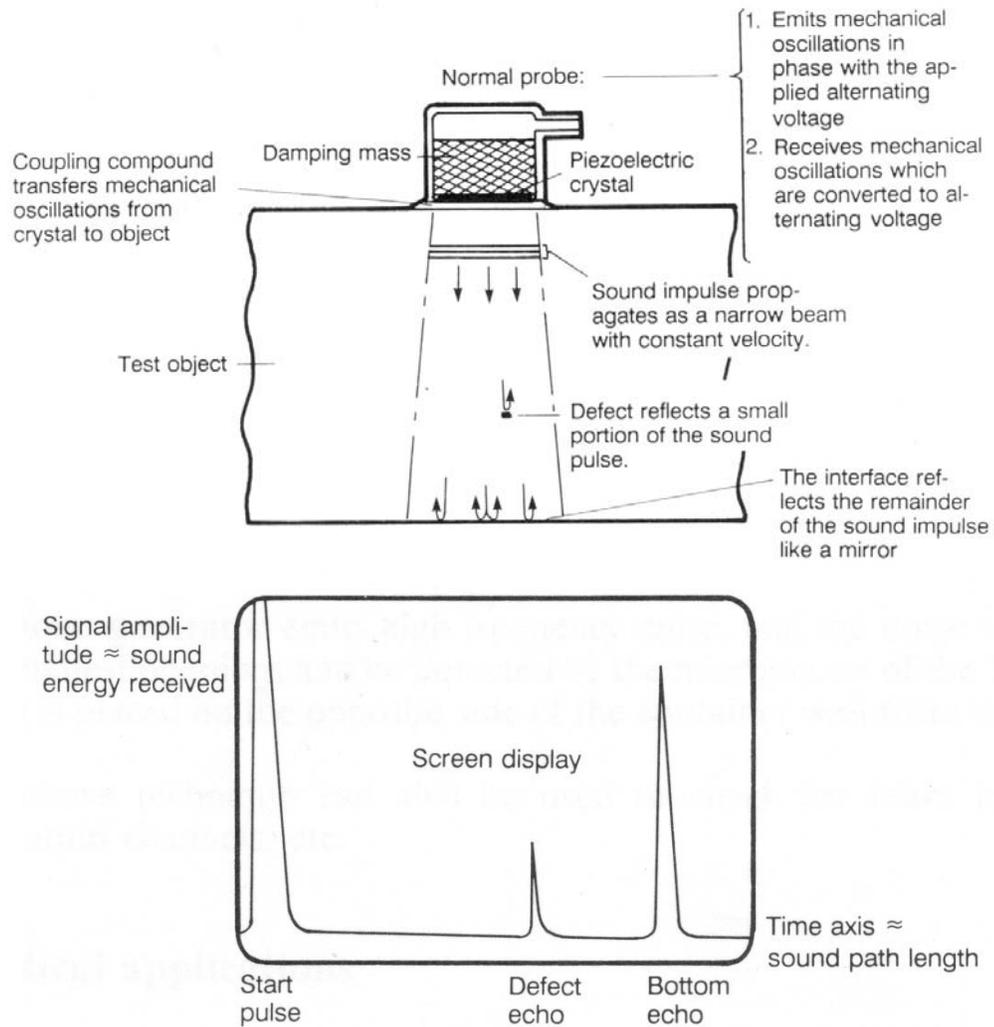
Figure 2.21: Pulse echo schematic (a)Typical test setup, and (b) resulting display (Boving 1989)

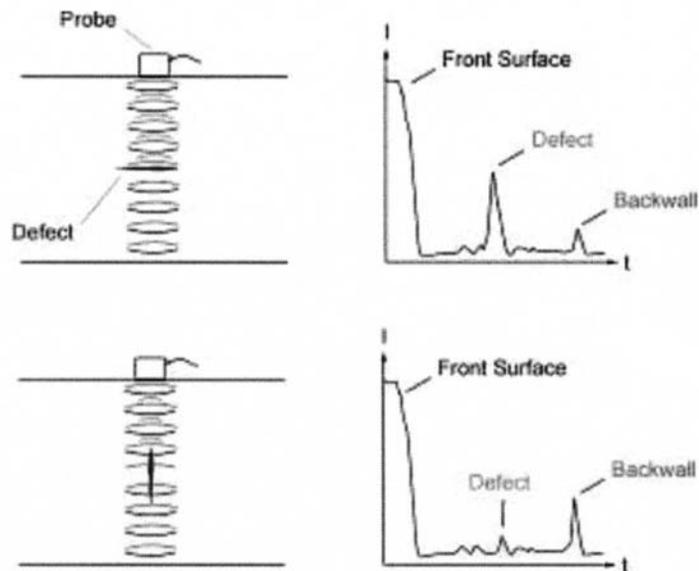
Figure 2.22: Reflections of stress waves from internal discontinuities (Kaiser & Karbhari 2002)

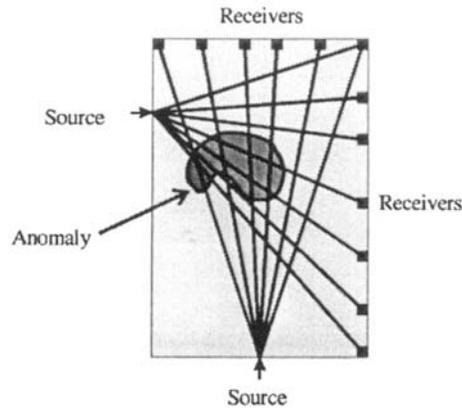
Figure 2.24: Setup of ultrasonic tomographic ray paths (Martin et al. 2001)

specimen. The basic concept is that the stress pulse on each projection travels through the specimen and interacts with its internal construction. Figure 2.24 illustrates the basic concept behind ultrasonic tomography. Variations of the internal conditions result in different times of flight being measured (Martin et al. 2001).

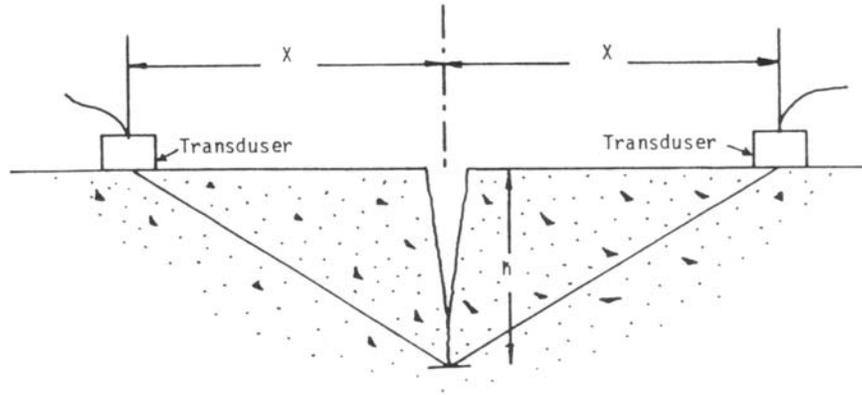
Figure 2.25: Measurement of crack depth (Malhotra 1991)

concrete, thus shortening the path length. Figure 2.25 illustrates the concept of crack depth measurement.

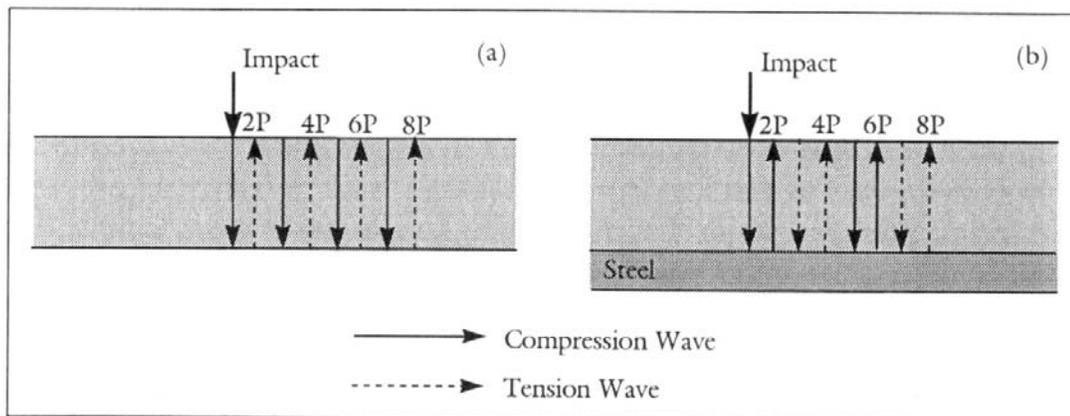
Figure 2.34: Impact echo ray paths (a) A phase change at both boundaries. (b) A phase change at upper boundary only (Sansalone & Streett 1997)

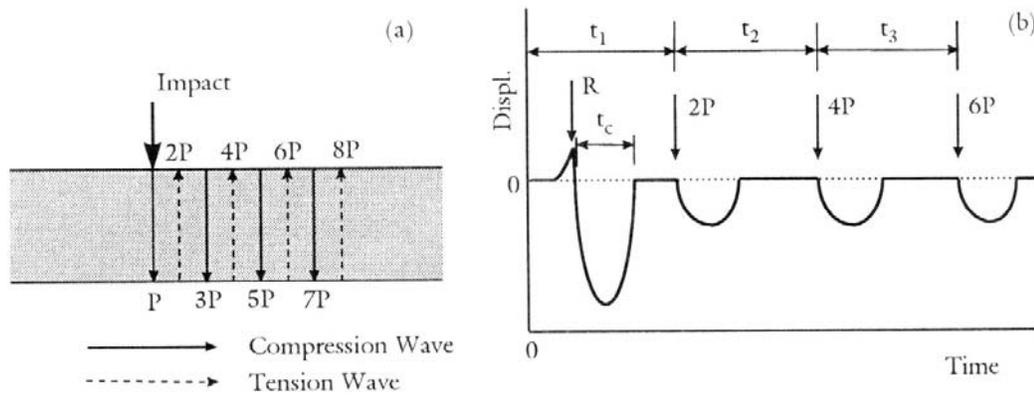
Figure 2.35: Schematic representations of (a) P-wave ray reflections and (b) the resulting idealized waveform (Sansalone & Streett 1997)

A common scenario in impact-echo testing is the testing of a solid plate with solid/gas interfaces at both concrete surfaces. As seen in Figure 2.35, the principle features of the idealized waveform detected by the transducer are those produced by the P-wave, which travels into the structure and undergoes multiple reflections between the two surfaces, and the R-wave, which travels outward across the surface (Sansalone & Streett 1997).

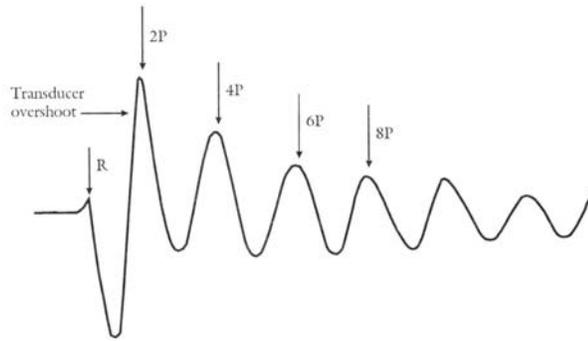
Figure 2.36: Actual waveform on an impact-echo test plate (Sansalone & Street 1997)

reflect due to the solid-gas interface, the receiving transducer experiences its own particle motions. This additional movement is referred to as “overshoot”. Overshoot causes the waveform displayed by the digital analysis software to have only the negative portion of each wave. This wave analysis software phenomenon is illustrated in Figure 2.36.

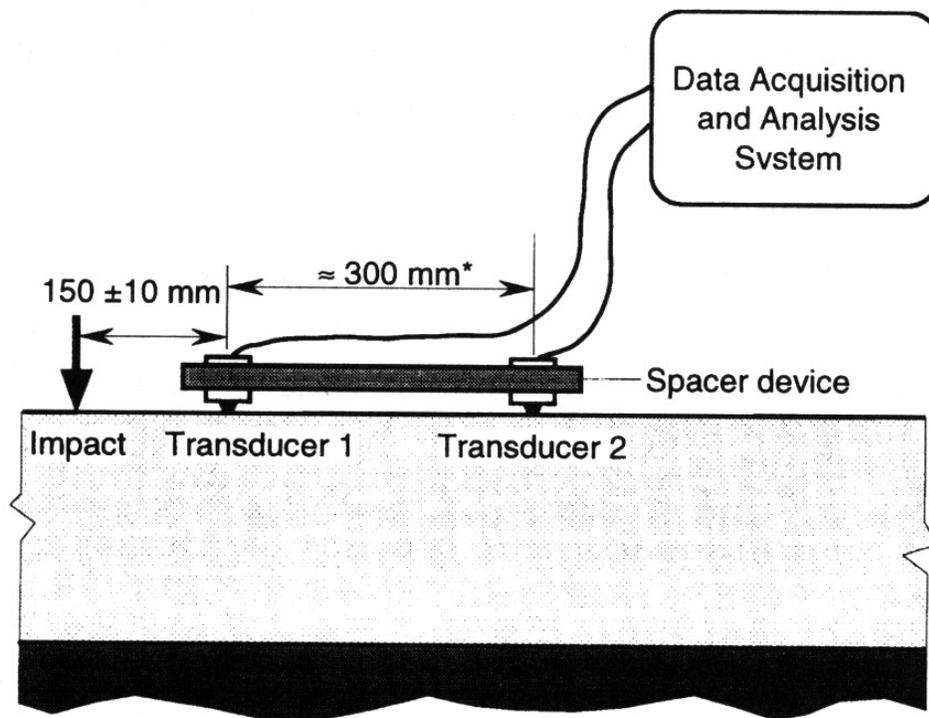
Figure 2.37: Schematic representation of the test set up for wave speed measurements (ASTMC 1383-R98a 2001)

In field-testing, it is crucial to establish the wave speed of the solid before specimen dimensions and qualities are to be tested. The most common method for directly measuring the wave speed of a solid is through the use of two receiving transducers. The transducers are commonly placed in a spacer device, at a known fixed length from each other. Once the transducers are properly spaced and fixed to the concrete specimen, a single P-wave can be used to measure the wave speed of the concrete. Figure 2.37 illustrates the typical test set up behind the measurement of wave speed. Figure 2.38 is an example of a typical output obtained in acquisition of the wave speed.

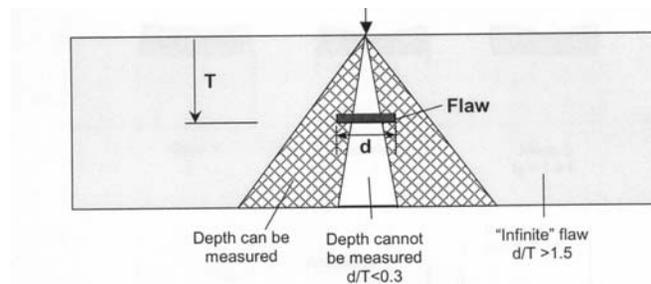
Figure 2.39: Illustration of the smallest detectable crack and its dependency on depth.

If the flaw is located entirely within the white area, the crack depth cannot be measured (Carino 2001) When larger cracks or voids are present, the impact-echo response will be essentially the same as if there was a solid/gas boundary at that interface. The test will produce results that represent the termination of the material at the depth of the flaw. A crack or void within a concrete structure forms a concrete/air interface. Laboratory experiments have shown that cracks with a minimum width (crack opening) of about 0.08mm (0.003 inches) cause almost total reflection of a P-wave. The responses from cracks and voids are similar, since stress waves are reflected from the first concrete/air interface encountered. Thus a crack at a depth  $d$  will give the same response as a void whose upper surface (nearest to the impact surface) is at the same depth (Figure 2.40).

As the depth of a void from the surface increases, the smallest size that can be detected also increases. Based on analytical and laboratory studies, it has been suggested that if the lateral dimensions of a planar crack or void exceed  $1/3$  of its depth, the flaw depth can be measured. If the lateral dimensions exceed 1.5 times the flaw depth, the flaw behaves as an infinite boundary and the response is that of a plate with thickness equal to the flaw depth (Carino 2001). Figure 2.39 illustrates the relationship between crack depth and detectability.

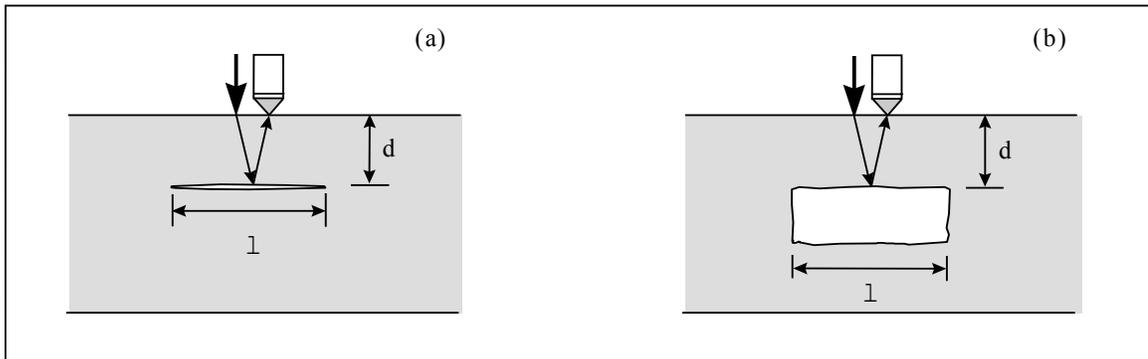
Figure 2.40: A crack at depth “ $d$ ” gives the same response as a void at that depth (Sansalone & Streett 1997)

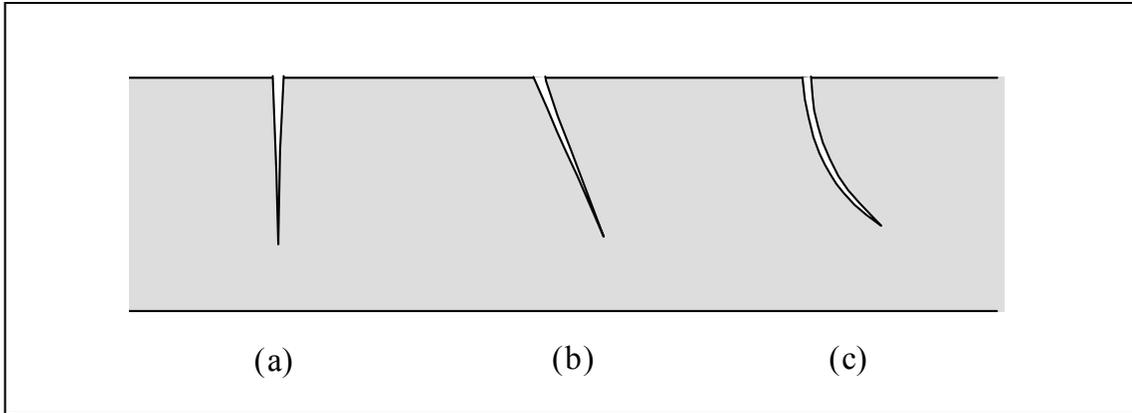
Figure 2.41: Surface-opening cracks: (a) perpendicular, (b) inclined, and (c) curved (Sansalone & Street 1997)

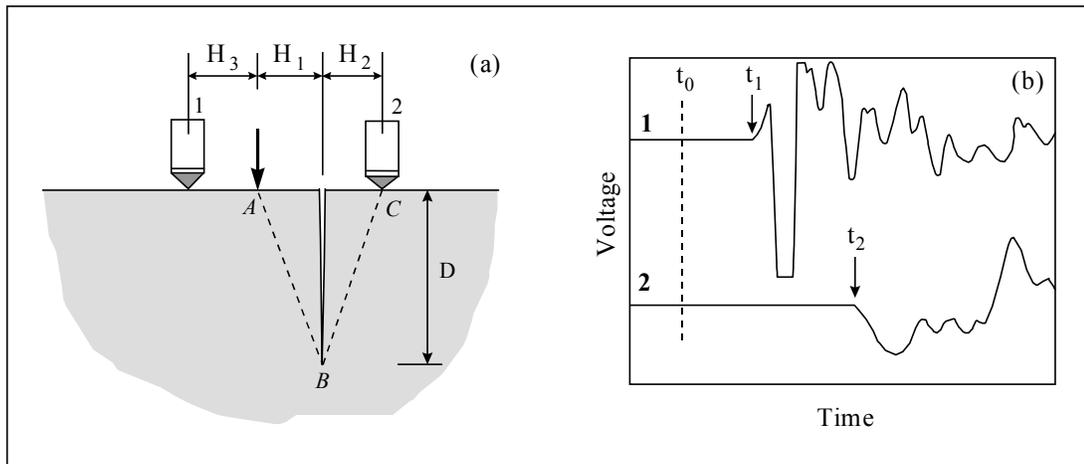
Figure 2.42: Measuring the depth of a surface-opening crack: (a) schematic of experimental test setup, and (b) sample waveforms (Sansalone & Street 1997)

The two waveforms, labeled 1 and 2, in Figure 2.42(b), are the signals from transducers 1 and 2 in Figure 2.42(a). The arrival of the direct P-wave, a compression wave, at transducer 1 causes an upward surface displacement and a positive voltage (time  $t_1$ ), while the diffracted wave that first reaches transducer 2 is a tension wave, which causes a downward displacement and a sudden voltage drop (time  $t_2$ ). The elapsed time between  $t_1$  and  $t_2$ , the wave speed, and the known distances  $H_1$ ,  $H_2$  and  $H_3$ , are used to calculate the depth  $D$ .

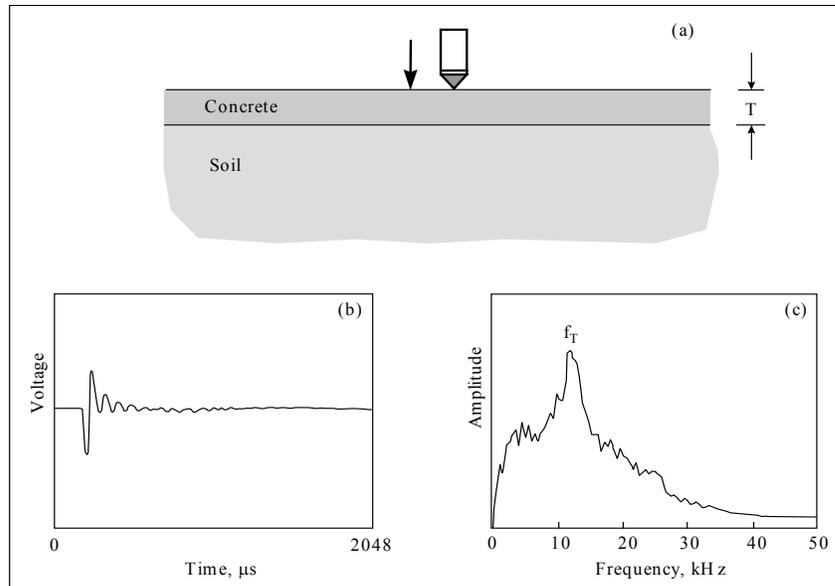
Figure 2.43: The impact-echo response of a concrete slab on soil subgrade: (a) cross-section, (b) waveform, and (c) spectrum (Sansalone & Streett, 1997)

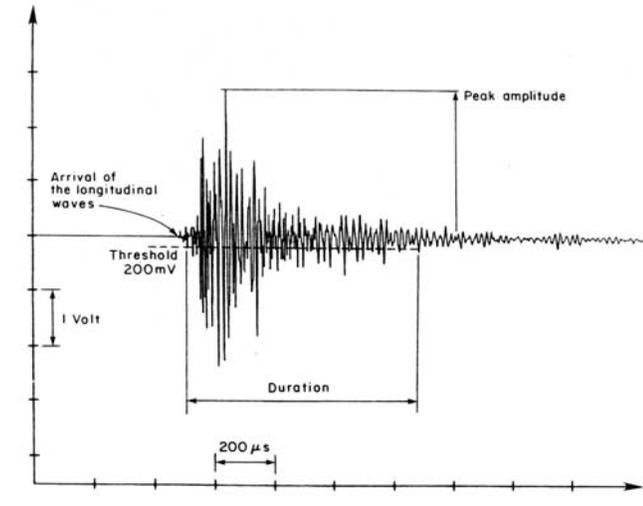
Figure 2.45: Burst acoustic emission signal with properties (Malhotra 1991)

There are two types of acoustic emission signals: continuous signals and burst signals. A continuous emission is a sustained signal level, produced by rapidly occurring emission events such as plastic deformation. A burst emission is a discrete signal related to an individual emission event occurring in a material, such as a crack in concrete. An acoustic emission burst signal is shown in Figure 2.45.

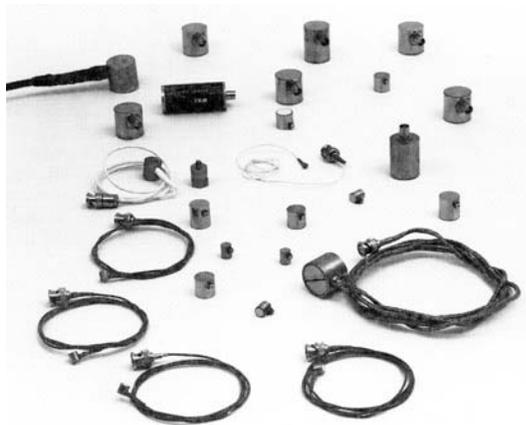
Figure 2.48: Various acoustic emission sensors (Miller 1985)

The acoustic emission transducer is more commonly referred to as a sensor. It is the most important part of the instrumentation. Sensors must be properly mounted to assure the proper configuration to attain the desired signal. Sensors are calibrated using test methods stated by societies. An array of different sensors is shown in Figure 2.48.

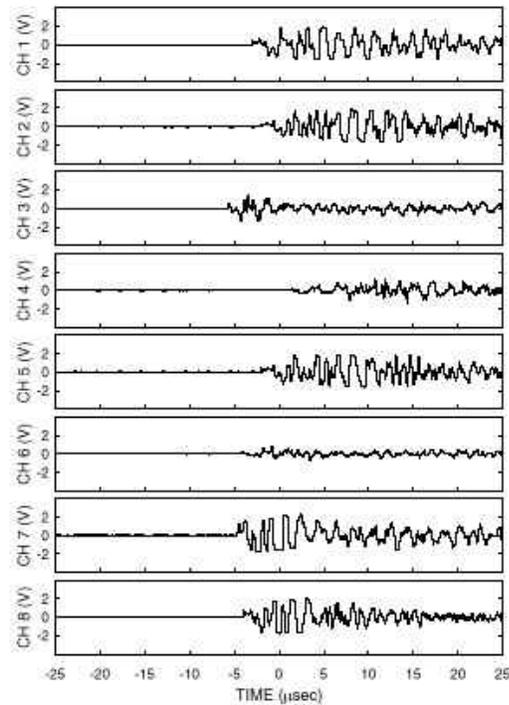
Figure 2.49: Transient recorder with multiple output acoustic emission signals (Sypeck 1996)

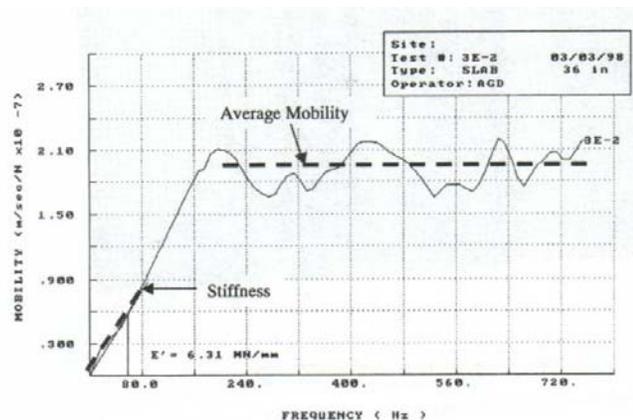
Figure 2.55: Typical mobility plot for sound concrete (Davis 2003)

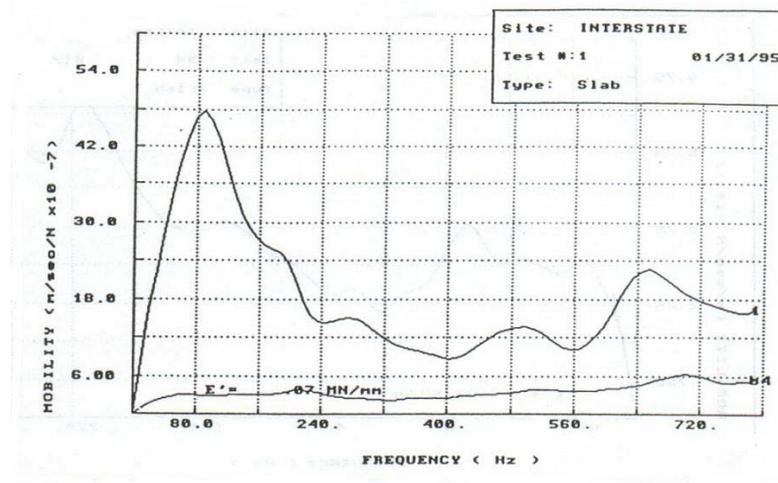
Figure 2.56: Mobility plots for sound and debonded concrete (Davis et al. 2001)

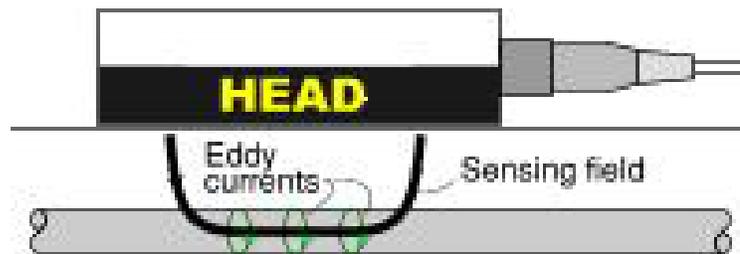
Figure 2.60. Typical configuration of covermeter testing apparatus

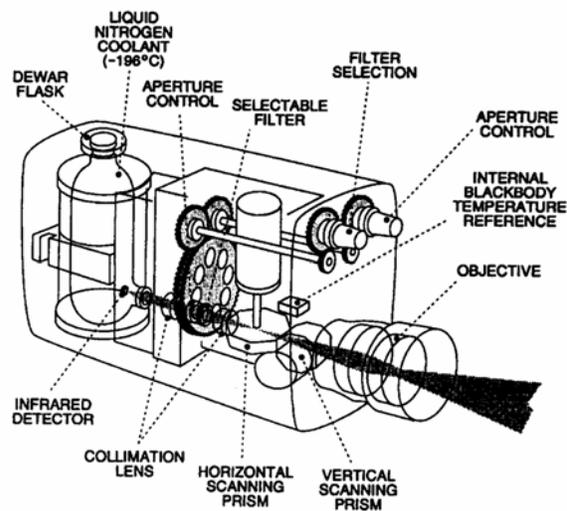
Figure 2.66: Schematic of a scanning radiometer IR camera (Maldague, 2001)

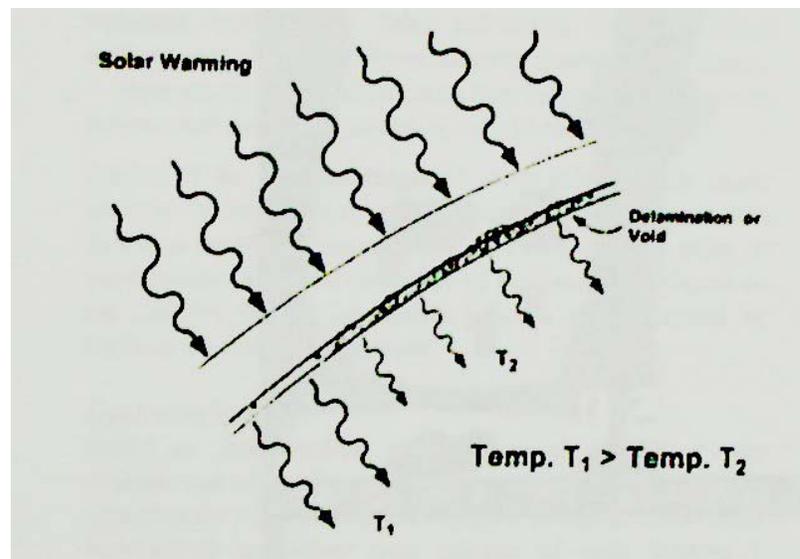
Figure 2.67 Schematic description of thermographic void detection process (Weil & Rowe 1998)

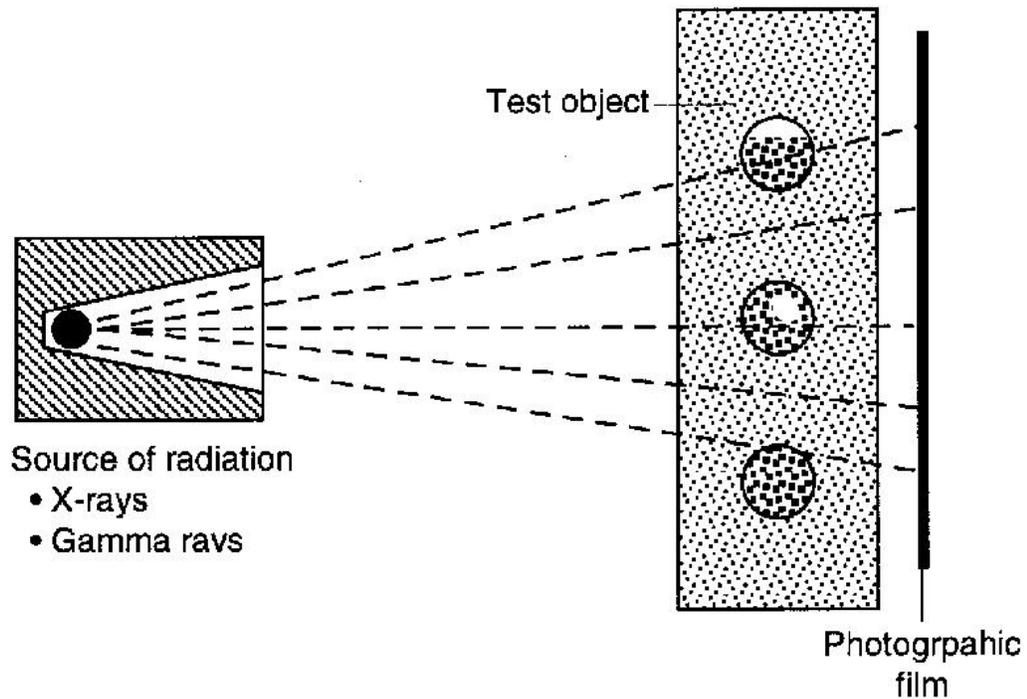
Figure 2.68: Radiography schematic (Lew et al. 1998)

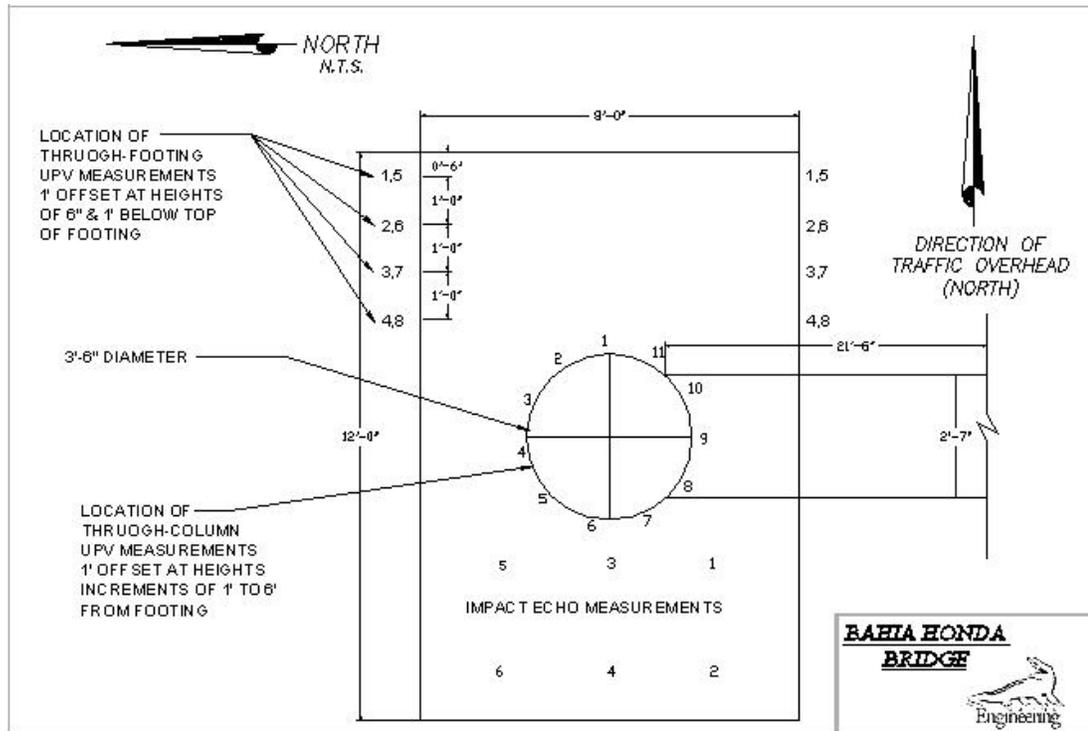
Figure 4.1: Plan view of Bahia Honda bridge pilecap and column 54

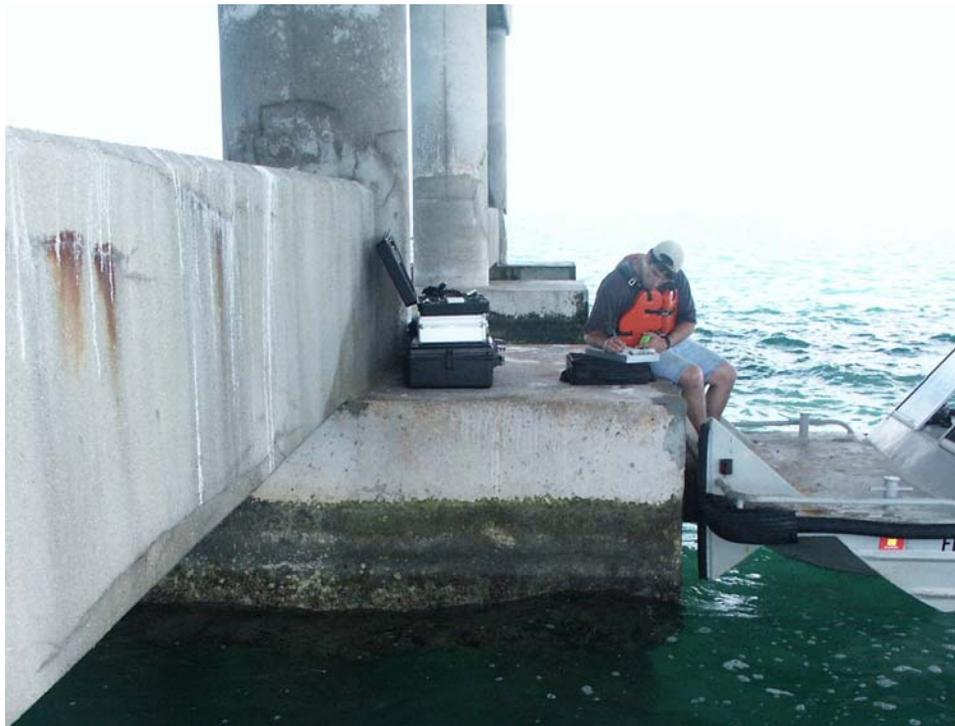
Figure 4.4: View of footing

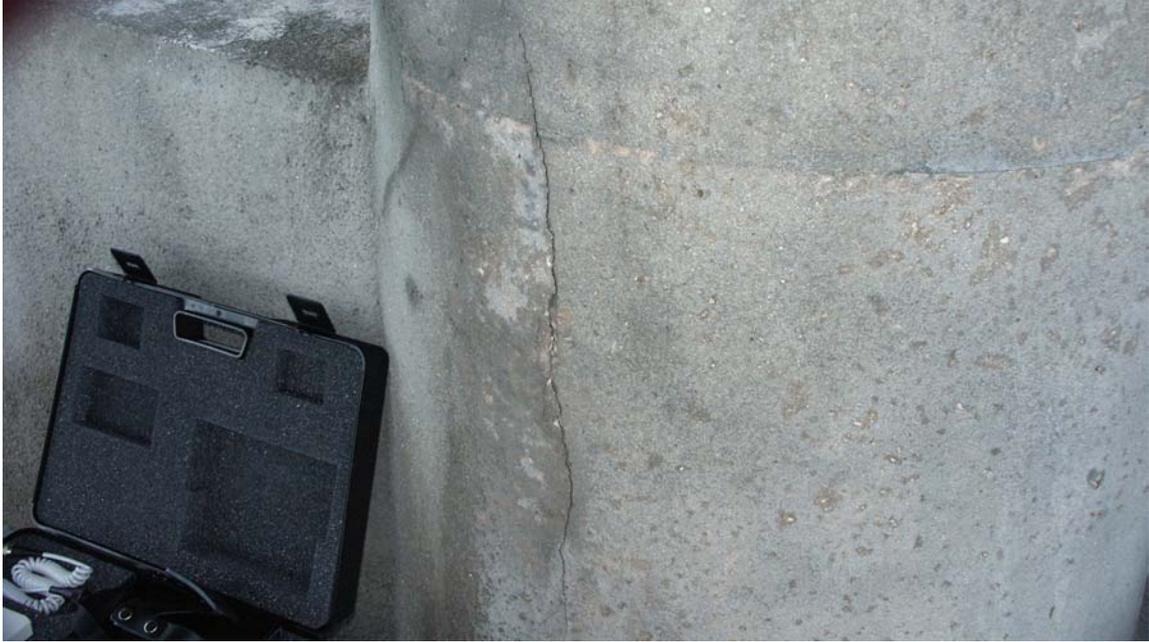
Figure 4.5: View of crack in column

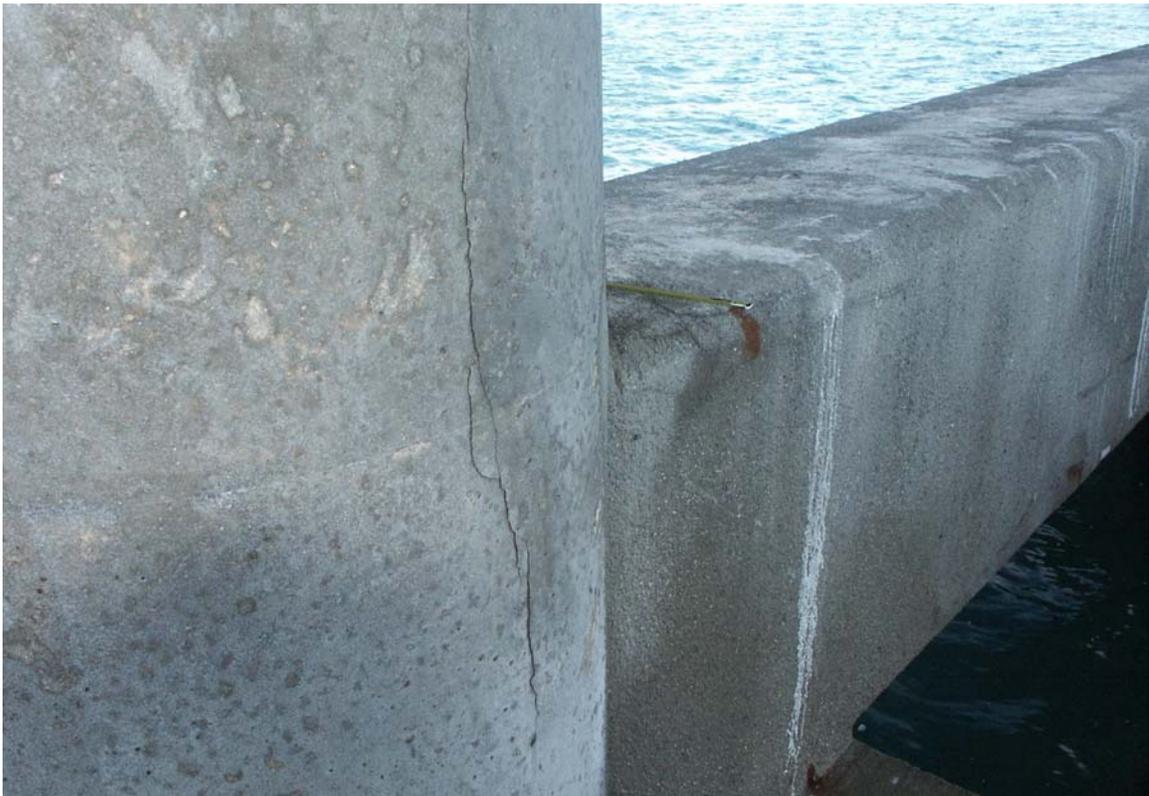
Figure 4.6: View of crack in column. Efflorescence of the gunite topping on the strut can be seen in the background

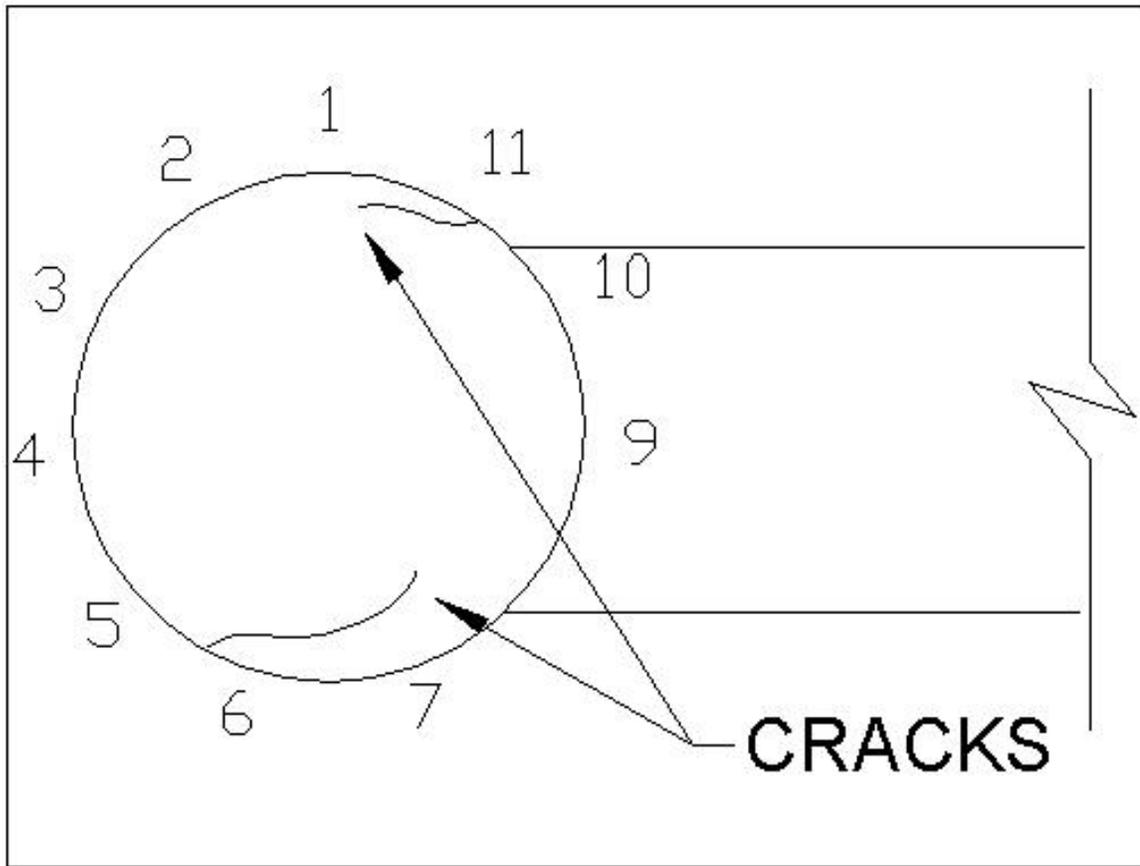
Figure 4.7: Plan view of crack orientation on column 54

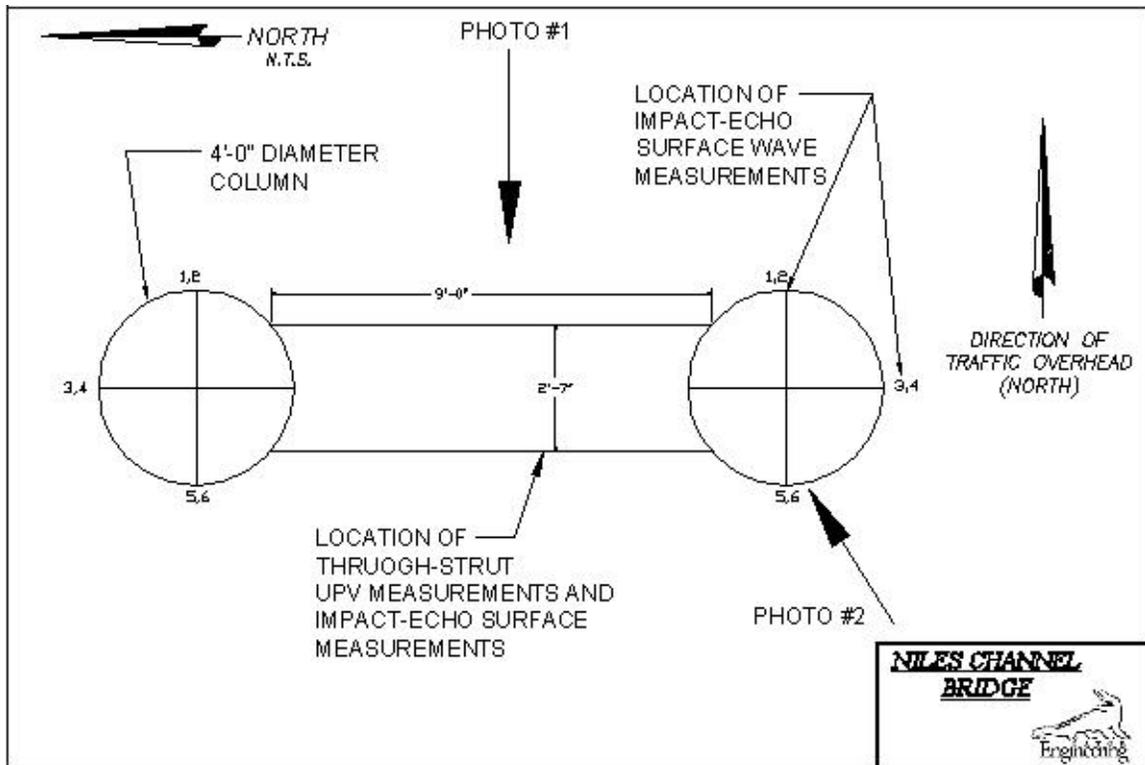
Figure 4.8: Plan view of Niles Channel Bridge column line 20

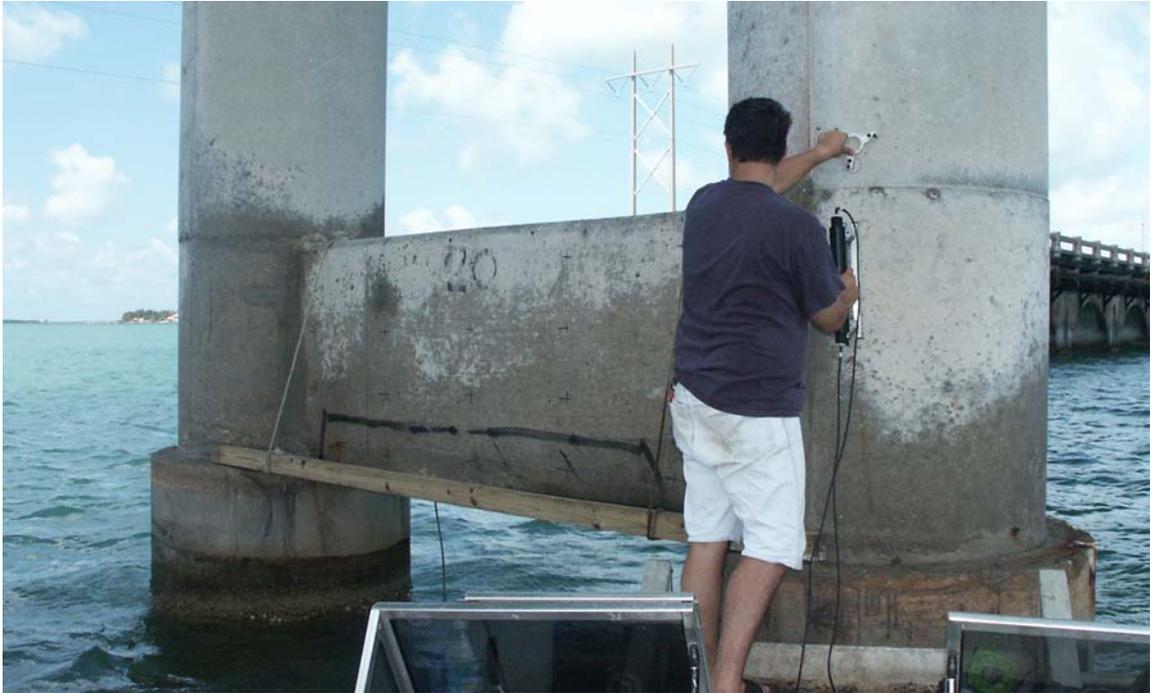
Figure 4.10: Impact-echo testing on bridge column

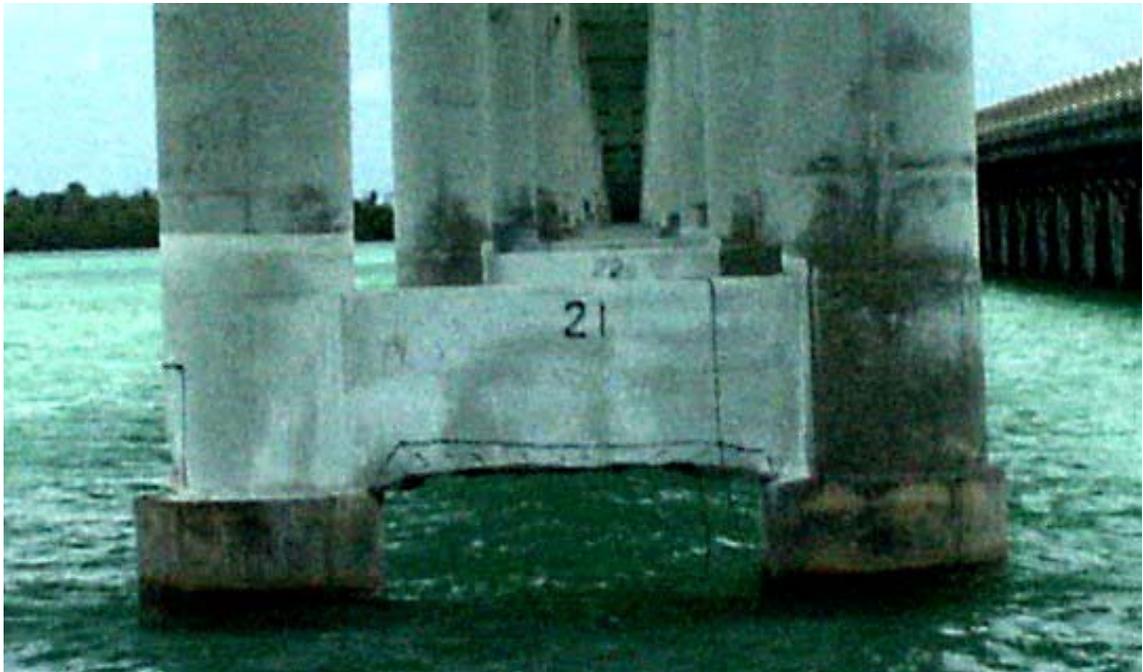
Figure 4.11: View of typical strut and column repair. Note spalls in strut underside

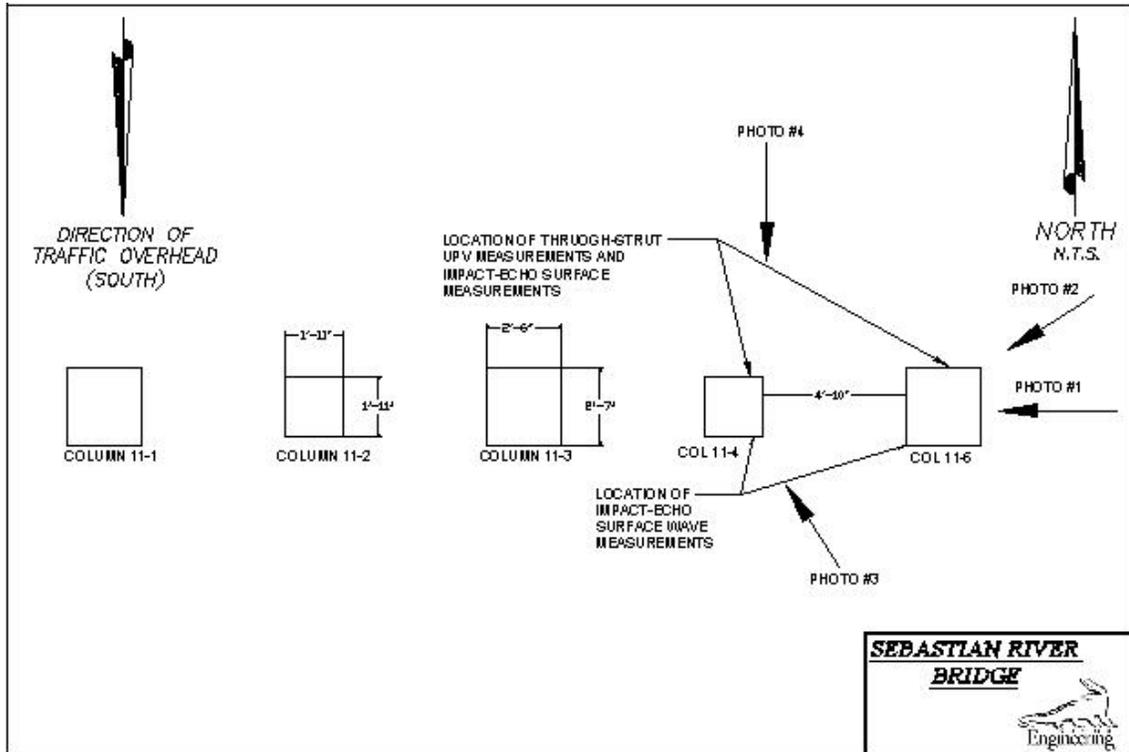
Figure 4.12: Plan view of Sebastian River Bridge column line 11
