ADVANCED NONDESTRUCTIVE MONITORING AND EVALUATION OF  
DAMAGE IN CONCRETE MATERIALS

A THESIS PRESENTED TO THE GRADUATE SCHOOL  
OF THE UNIVERSITY OF FLORIDA IN PARTIAL FULFILLMENT  
OF THE REQUIREMENTS FOR THE DEGREE OF  
MASTER OF ENGINEERING

UNIVERSITY OF FLORIDA

2003

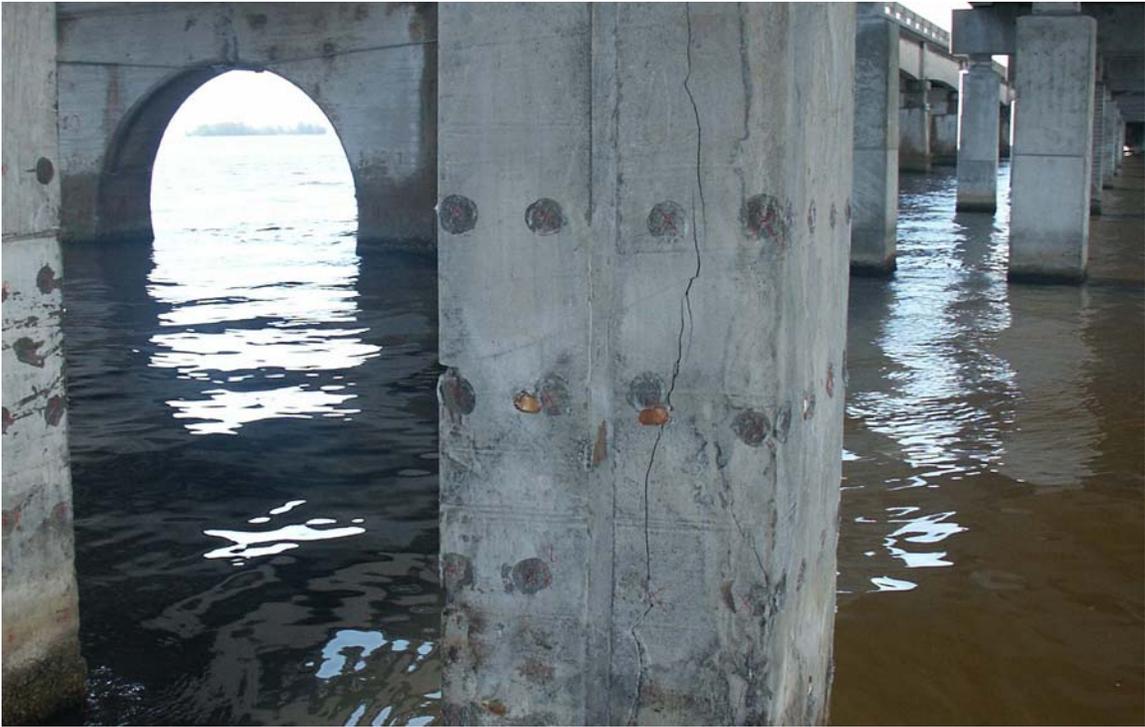
Figure 4.16: Cracked and delaminated repair in column 11-4

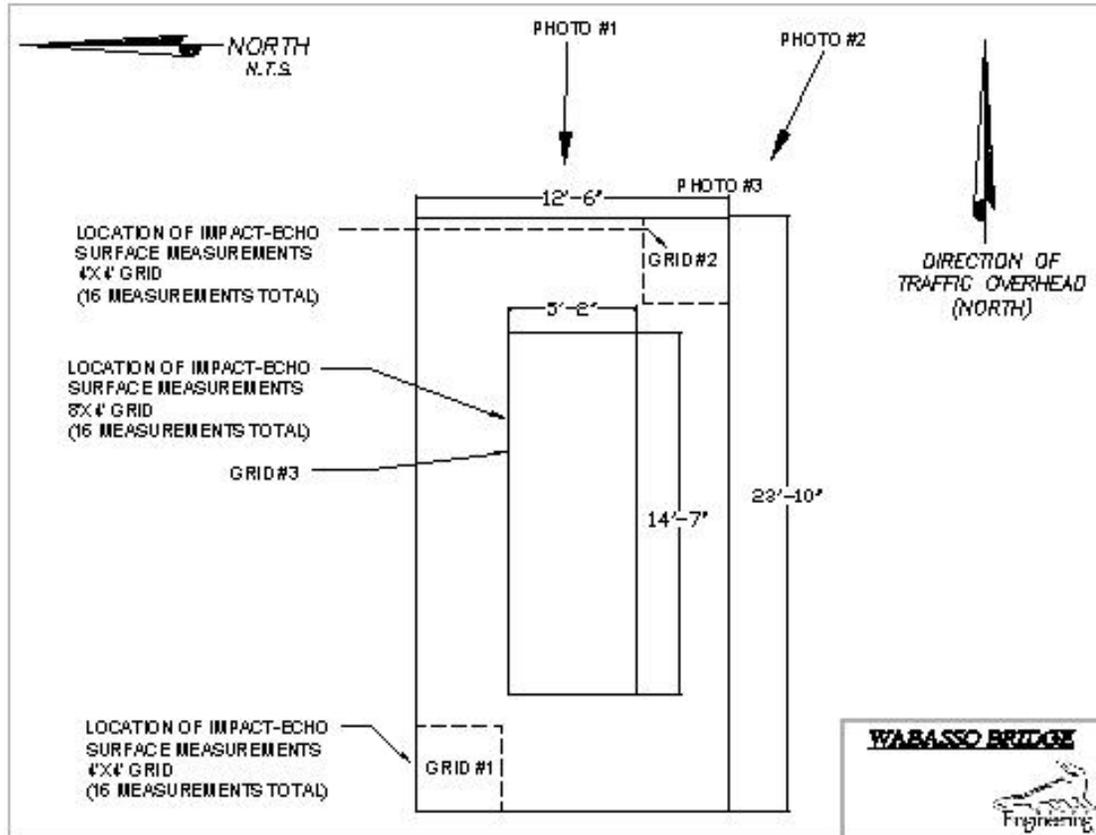
Figure 4.17: Plan view of Wabasso Bridge column

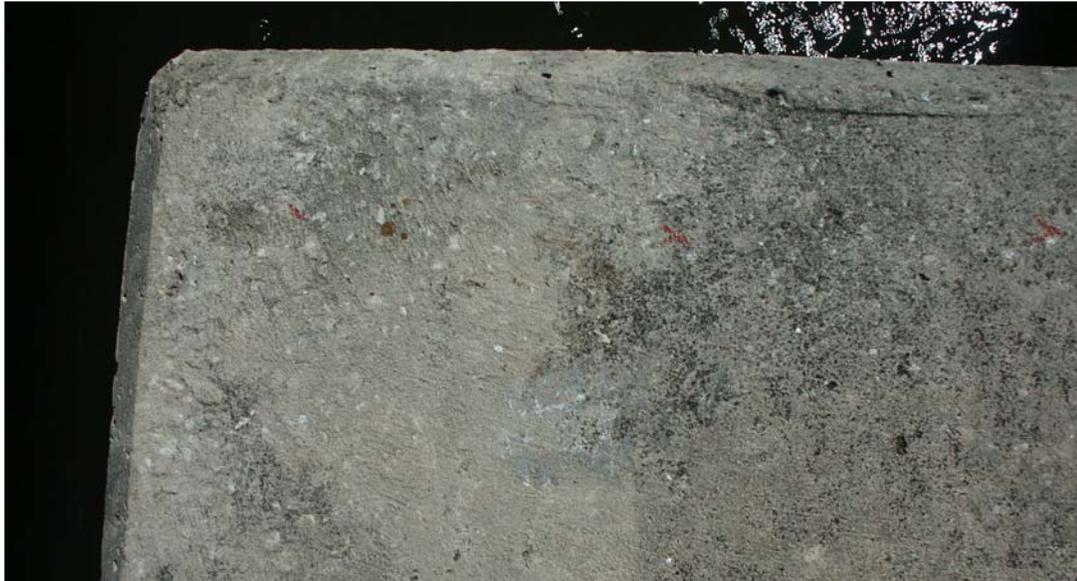
Figure 4.20: Close-up of exposed seashell aggregate on pile cap 5

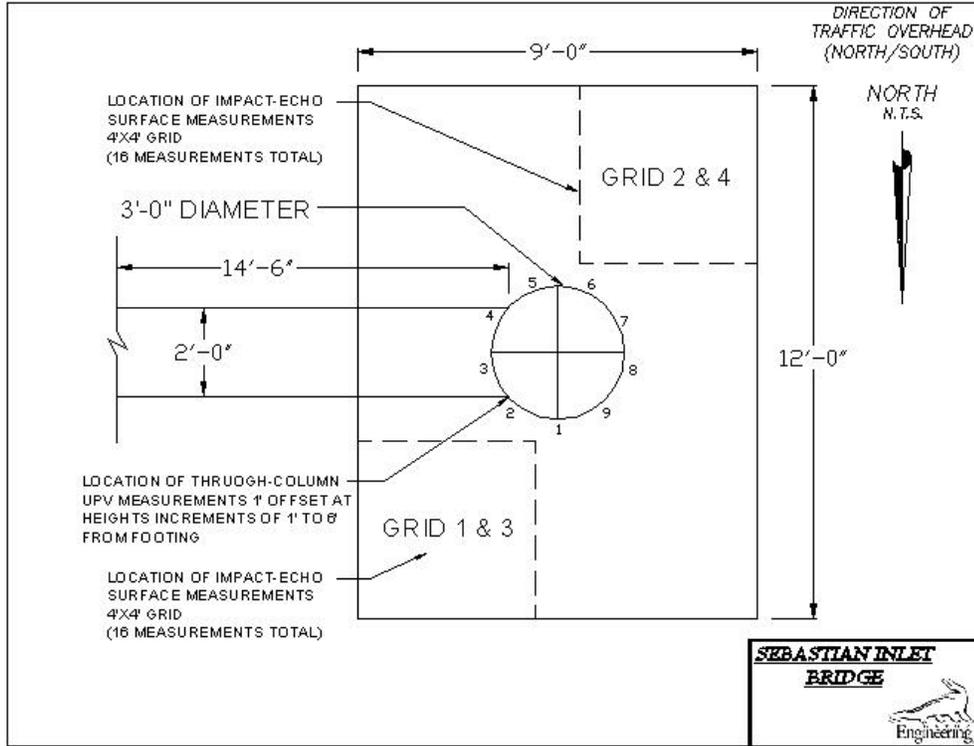
Figure 4.21: Plan view of column / pile cap of Sebastian Inlet Bridge

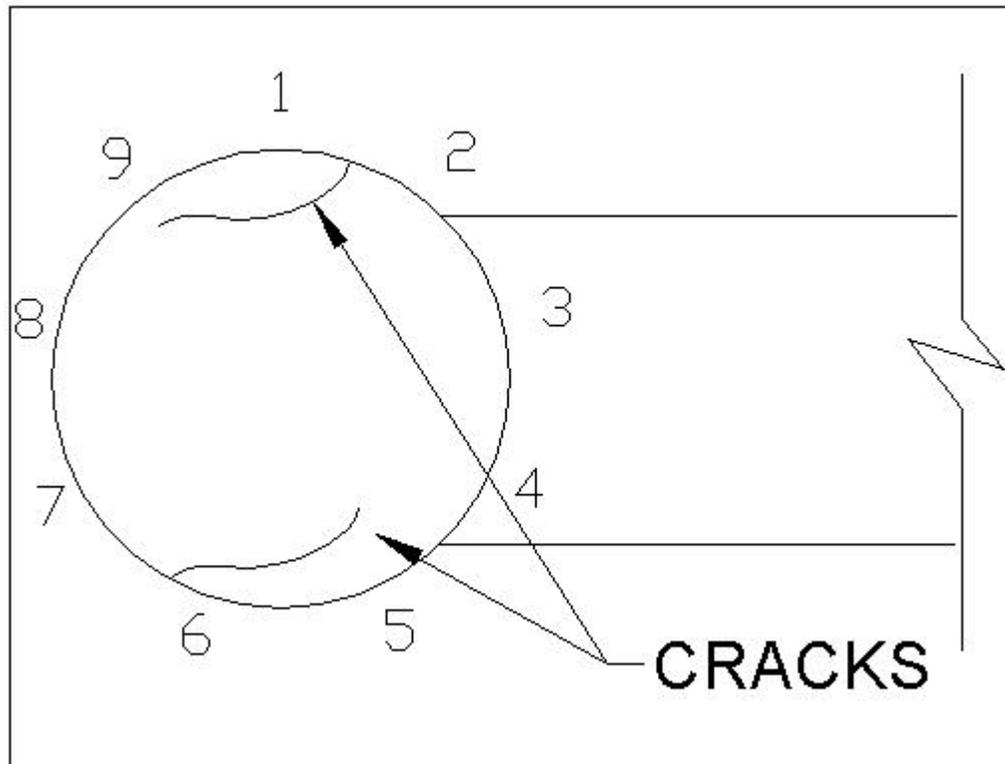
Figure 4.24: Plan view of crack orientation on column 12

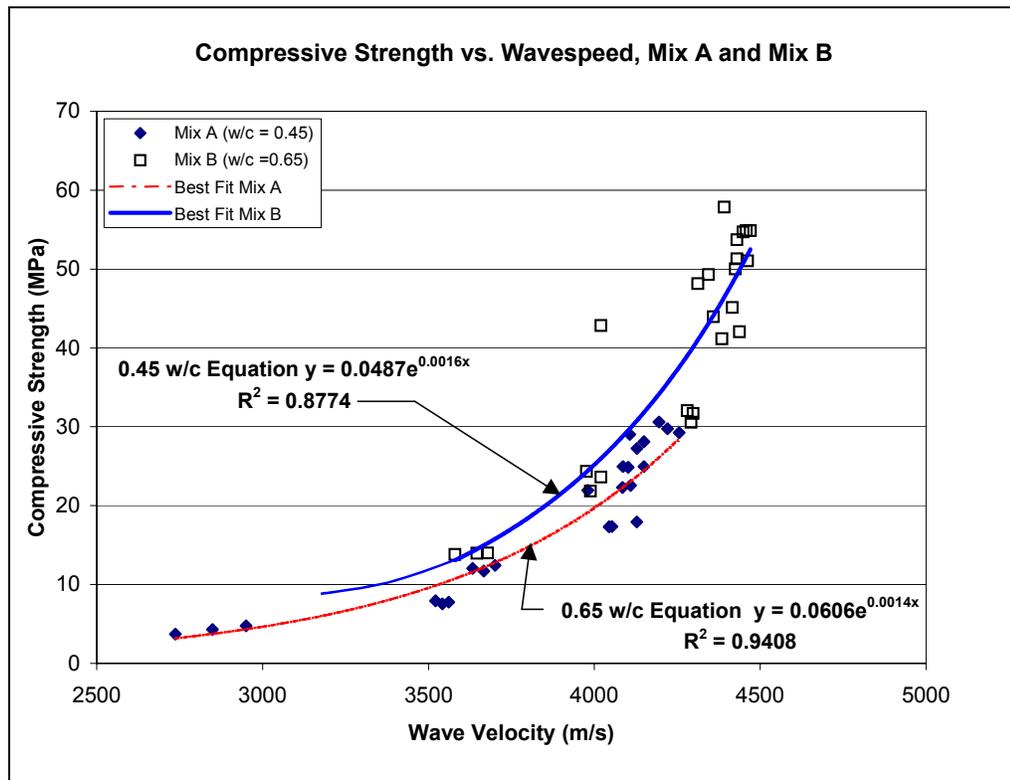
Figure 5.4: Compressive strength vs. wave velocity for Mixtures A and B

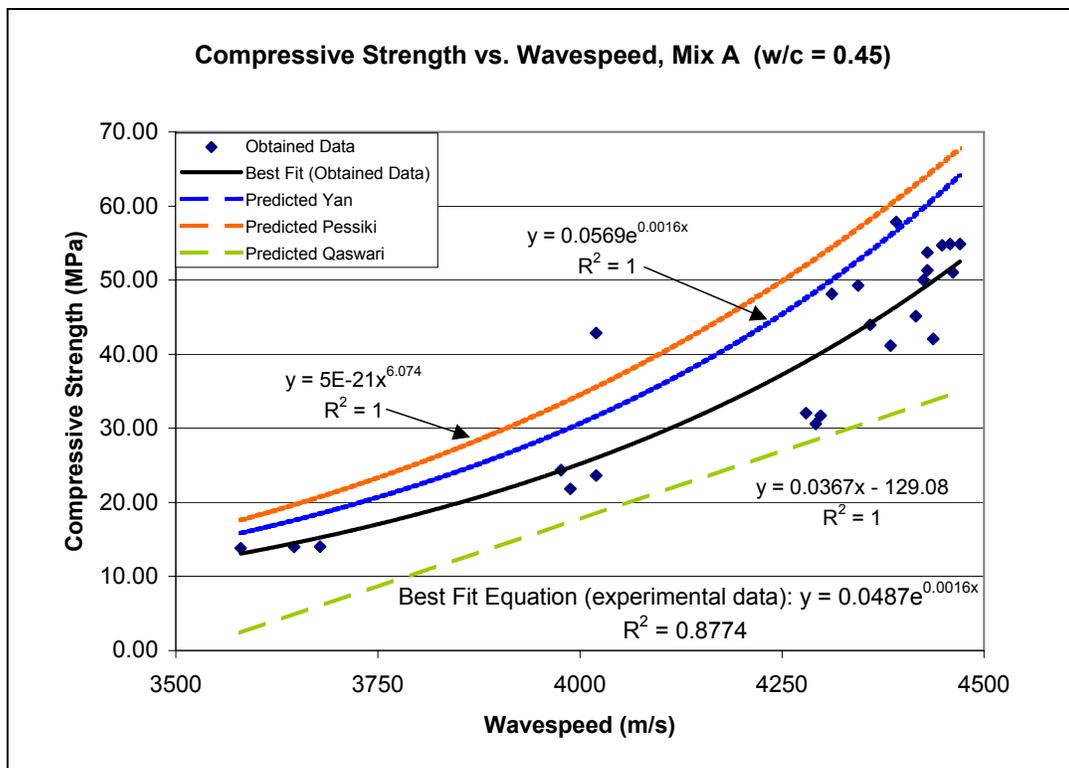
Figure 5.5: Results from compressive strength vs. wave velocity results for Mixture A  
The use of a power equation properly correlates the early strength verses

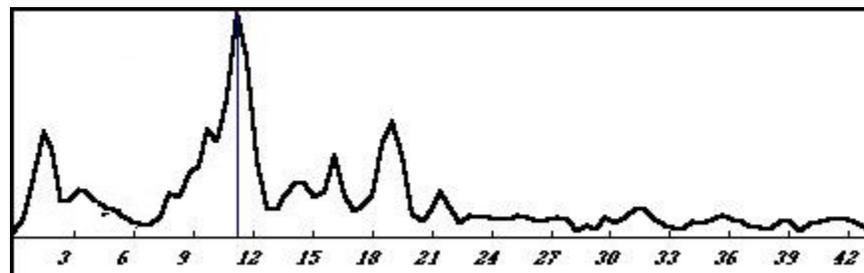
Figure 5.6: Frequency spectrum of typical impact echo data point.

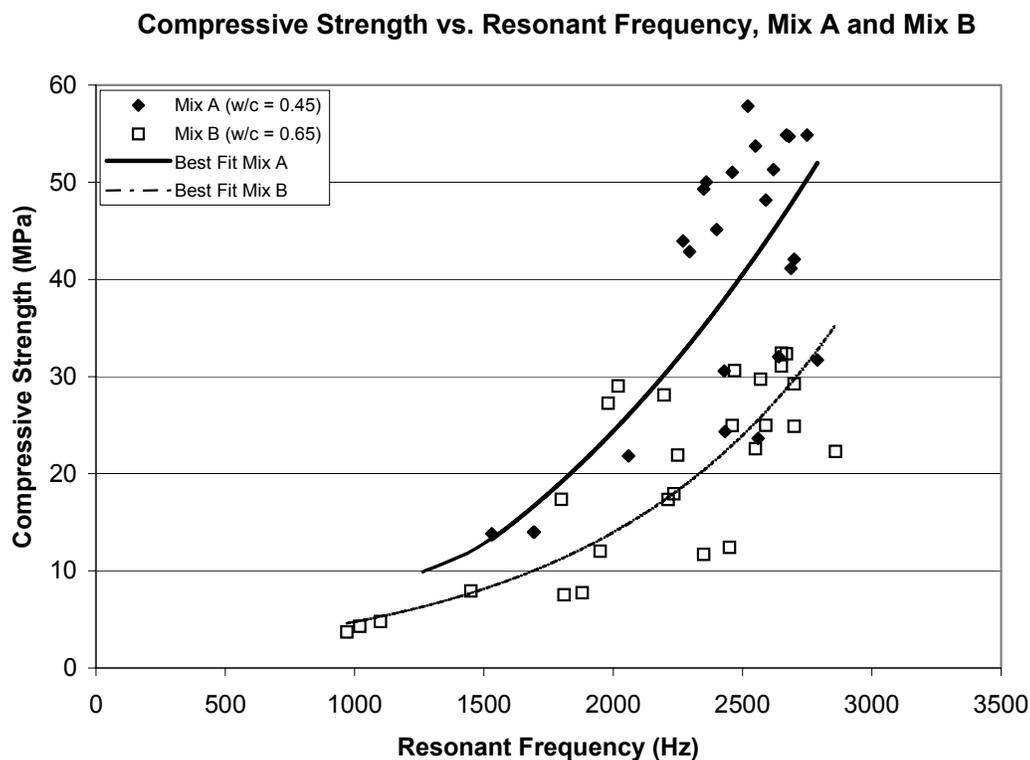
Figure 5.7: Compressive strength vs. resonant frequency for Mixtures A and B

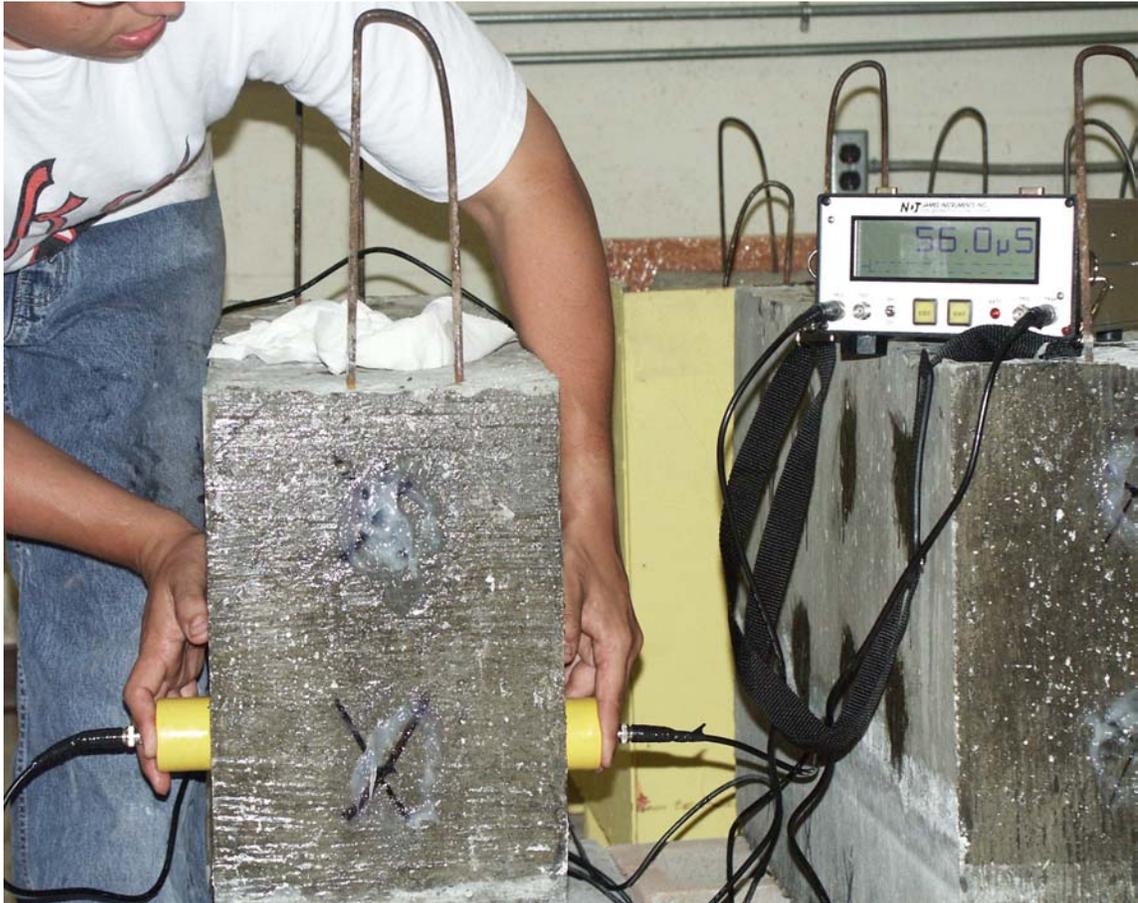
Figure 6.2: Ultrasonic pulse velocity testing on specimen

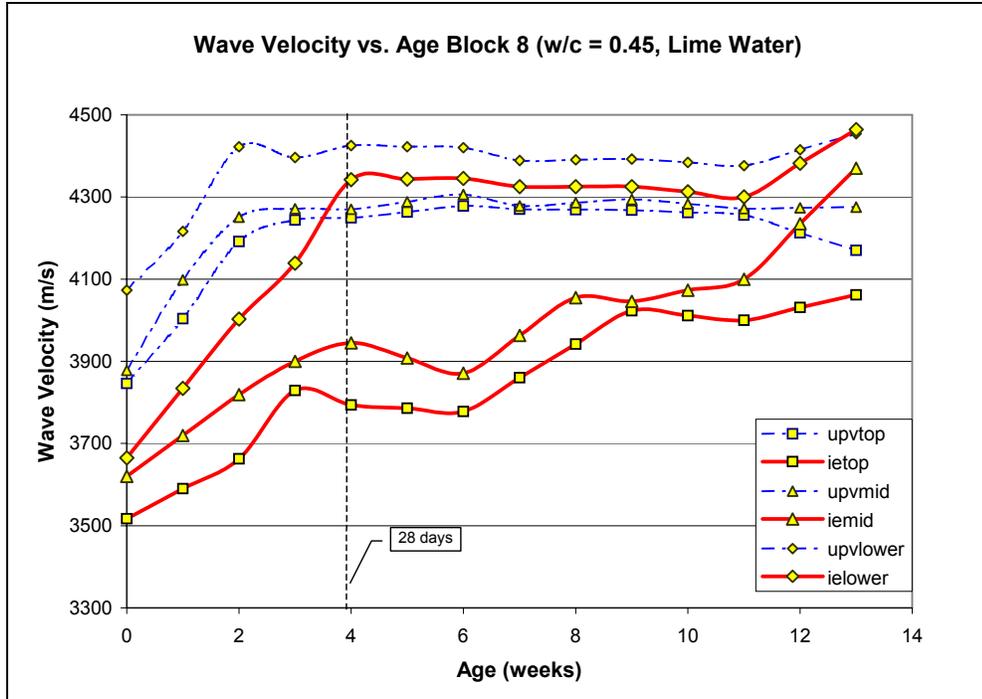
Figure 6.4: Wave velocity vs. age for a sample from Mixture A exposed to limewater.

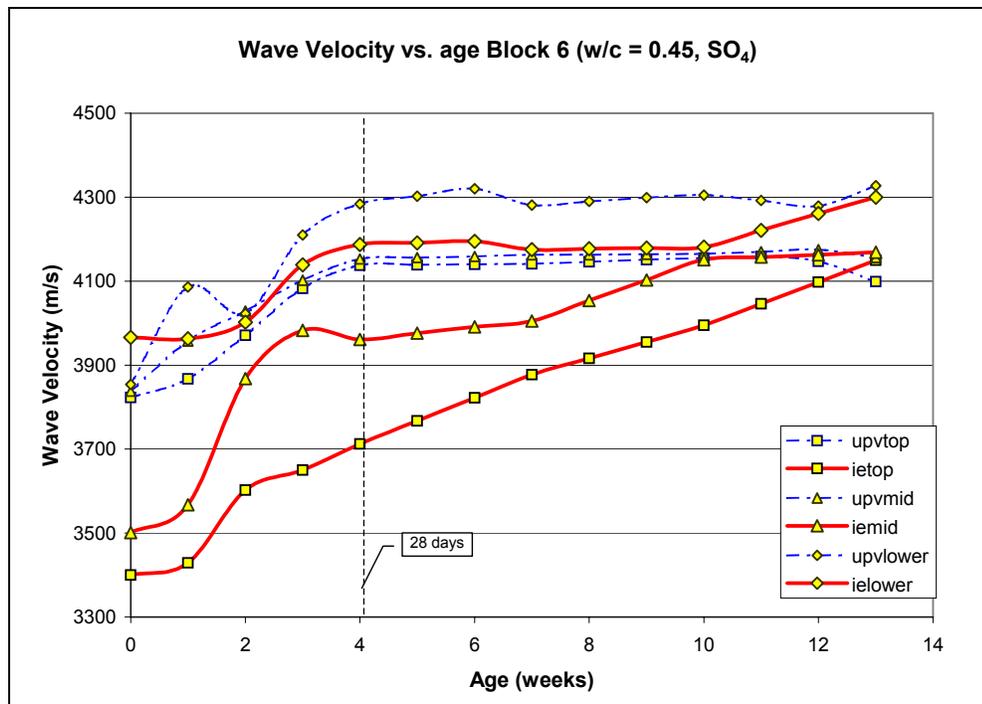
Figure 6.5: Wave velocity vs. age for a sample from Mixture A exposed to sulfate solution.

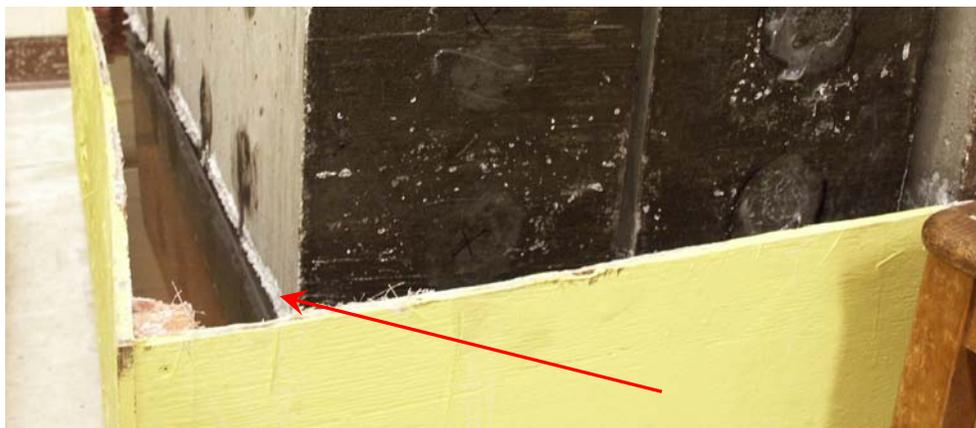
Figure 6.6: Close up view of a sample exposed to sulfate solution. The arrow denotes the area of precipitated salt crystals.

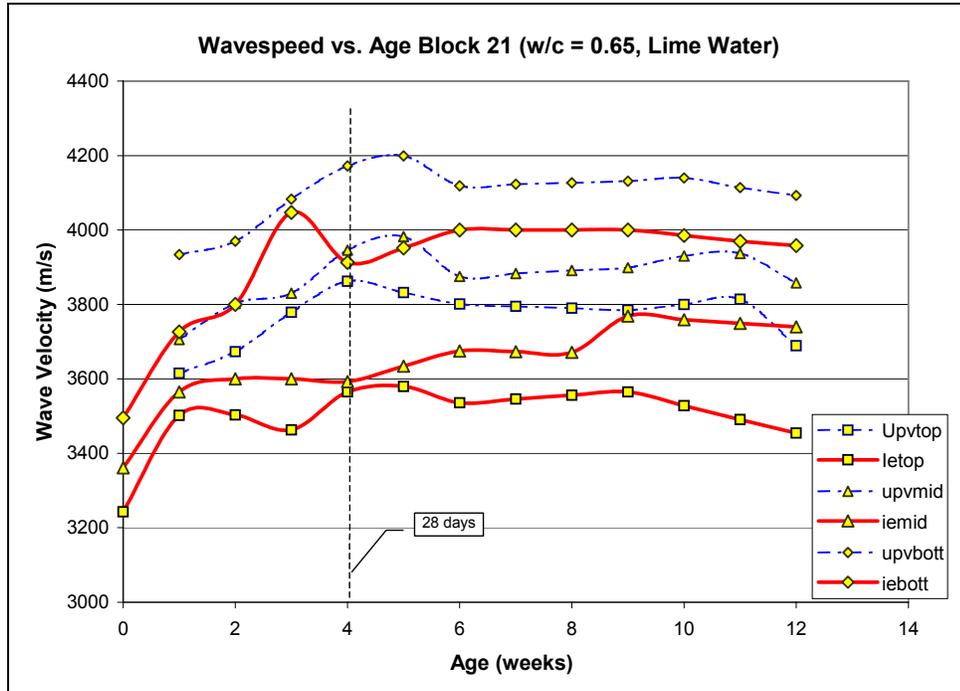
Figure 6.7: Wave velocity vs. age for a sample from Mixture B exposed to limewater

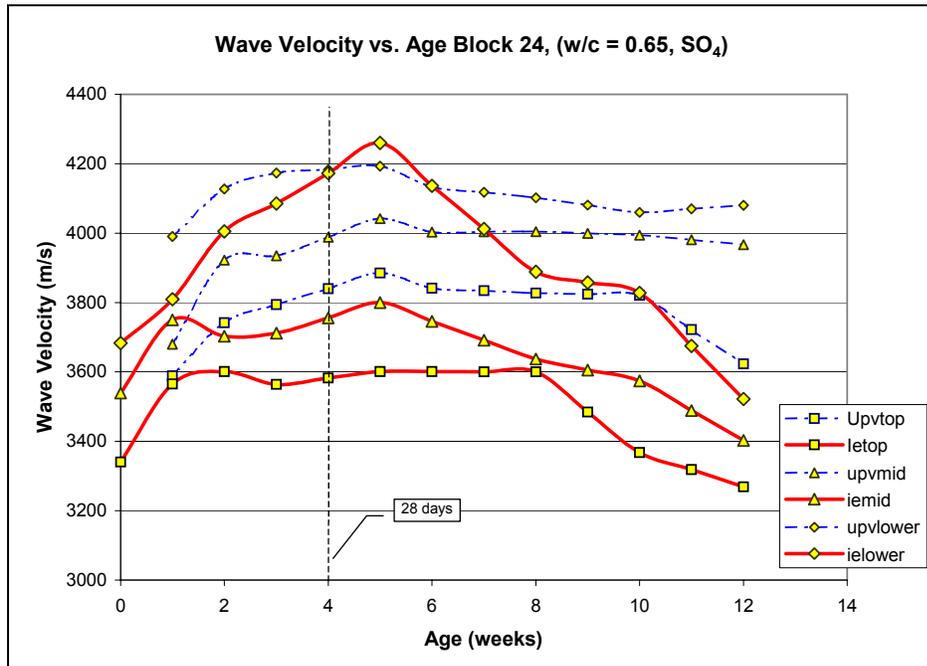
Figure 6.8: Wave velocity vs. age for a sample from Mixture B exposed to sulfate solution
