DATING HISTORIC HOUSES IN ALACHUA COUNTY, FLORIDA

A THESIS PRESENTED TO THE GRADUATE SCHOOL
OF THE UNIVERSITY OF FLORIDA IN PARTIAL FULFILLMENT
OF THE REQUIREMENTS FOR THE DEGREE OF
MASTER OF SCIENCE IN ARCHITECTURAL STUDIES

UNIVERSITY OF FLORIDA

2005

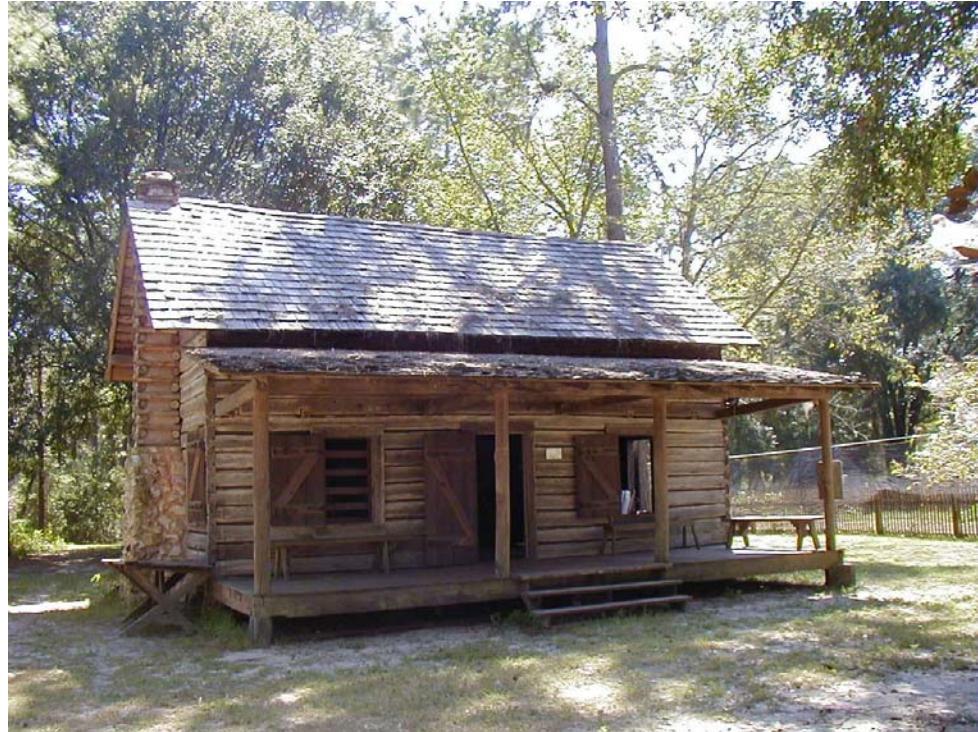
Figure 4-1: 1840s log cabin with later rear addition, Hogan's Cabin, Morningside Park, Gainesville, Florida.

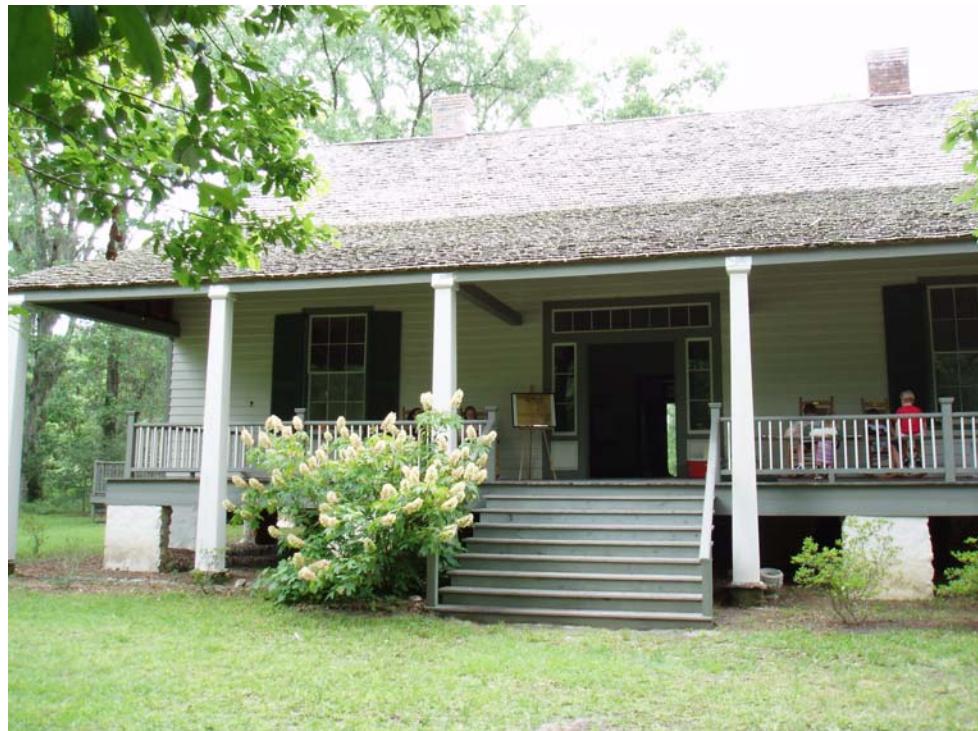
Figure 4-2: Symmetrically designed Haile Plantation house, Gainesville, Florida, 1854.

Examining the plan form and architectural style of a house provides a starting point for an in-depth investigation of the house by a researcher. A look at the form of the Haile Plantation house reveals a symmetric one-and one-half story Georgian center hall house with matching rear wings. Front and rear porches provided protected activity areas for the family. Raised foundations, large windows protected by roof overhangs, and interior doors linking every room created an efficient ventilation flow for optimum cooling conditions during the hottest days of the year. Further examination of the physical fabric of the house will yield more information concerning its construction and historical evolution.

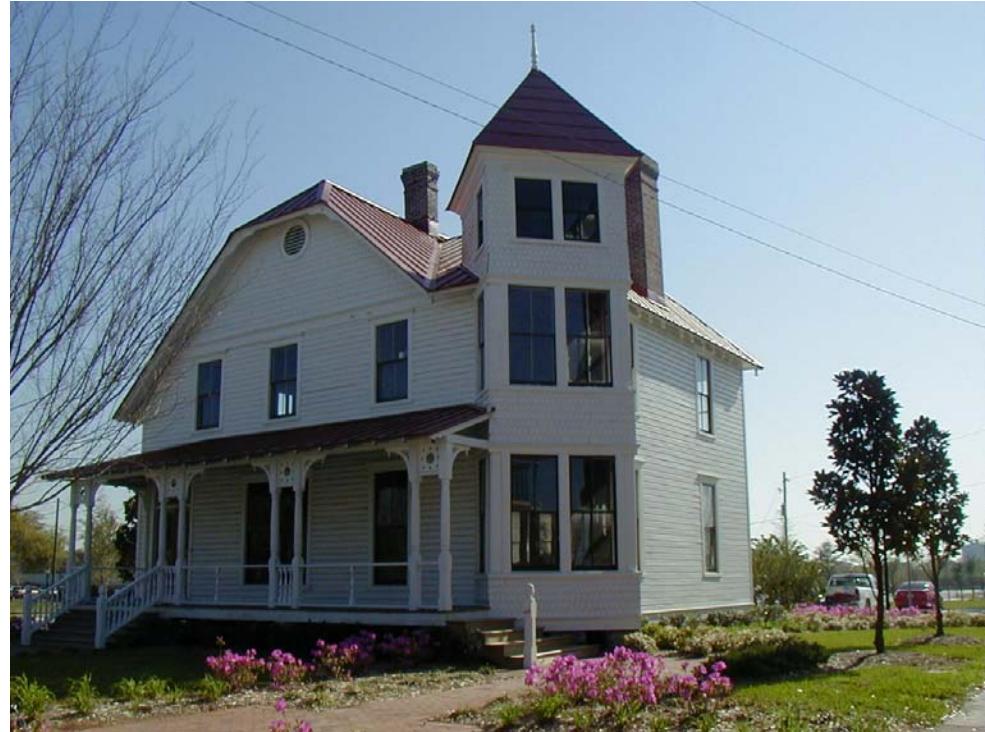
Figure 4-3: Merrill House, Jacksonville, Florida. The simple box house was later renovated as a Queen Anne with the addition of a tower and architectural detailing, which was tracked through a careful analysis of key building materials.

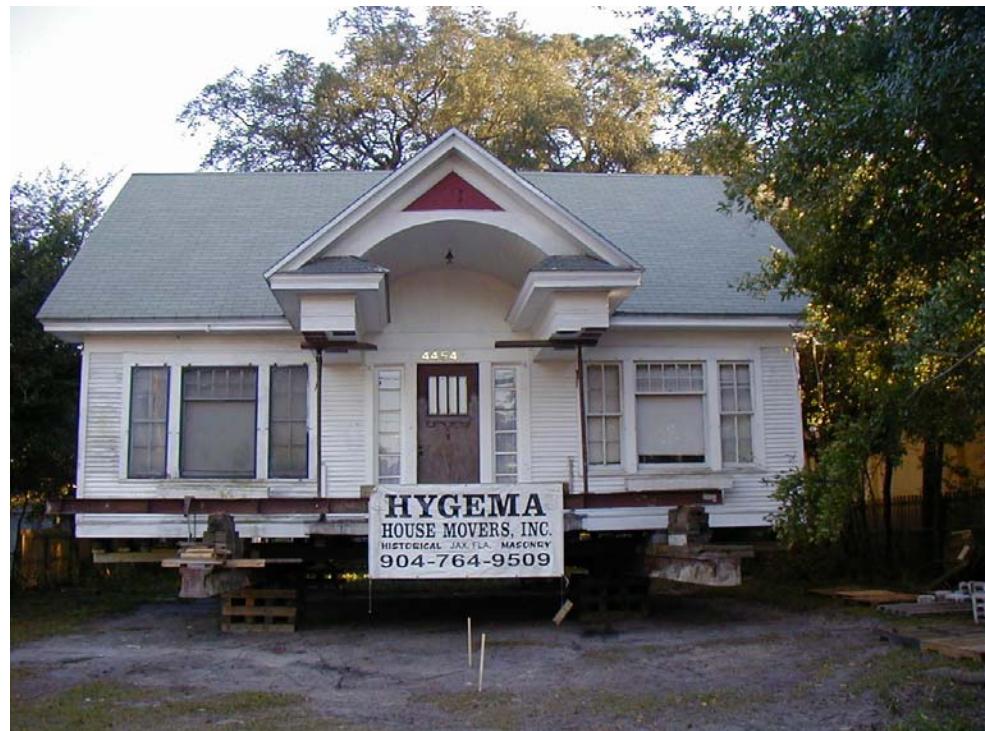
Figure 4-4: Sears catalog house, Jacksonville, Florida. Early twentieth century cottage with modern interpretive detailing of windows and porch.

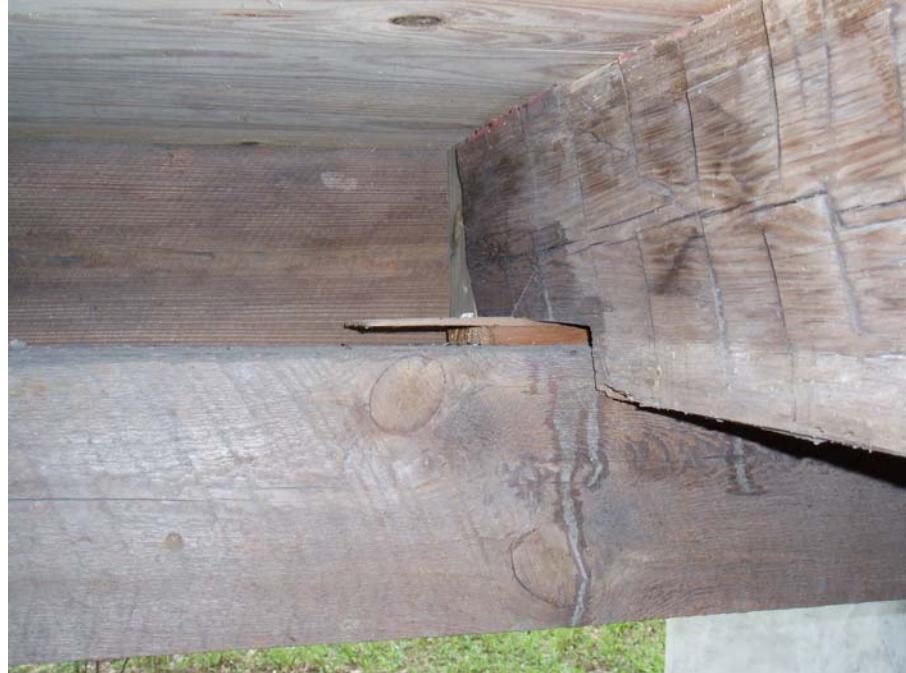
Figure 5-1: The timber on the right has the faceted markings from the axe which was used to shape it. The timber on which the first one rests has the curved markings that a circular saw would leave behind. Haile Plantation House, Gainesville, Florida.

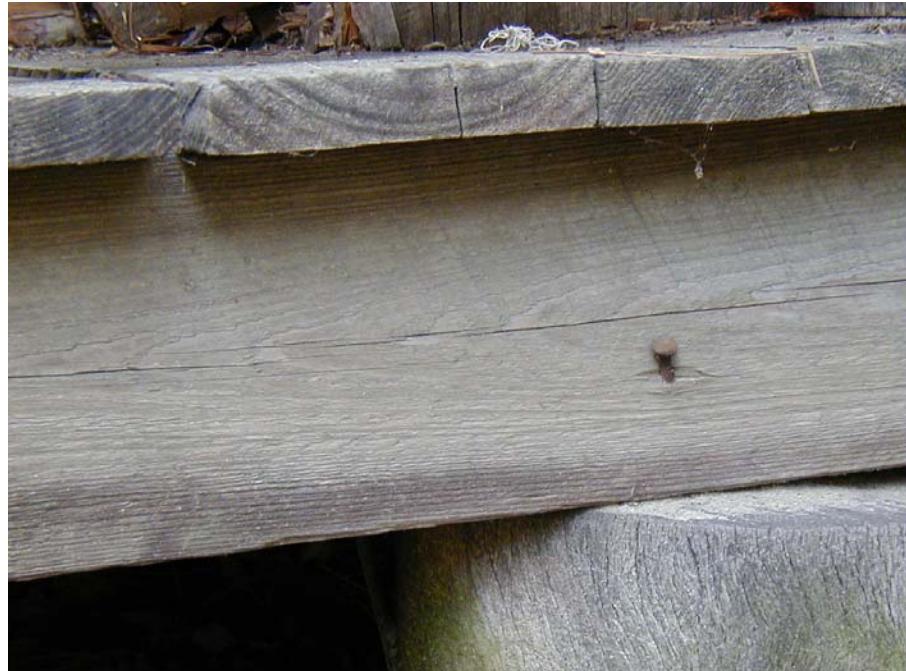
Figure 5-2: The angled saw marks on this timber are unevenly spaced, placing it in the category of a pit sawn timber rather than the evenly spaced marks from a reciprocating saw in a mill. Hogan's cabin, Morningside Park, Gainesville, Florida.

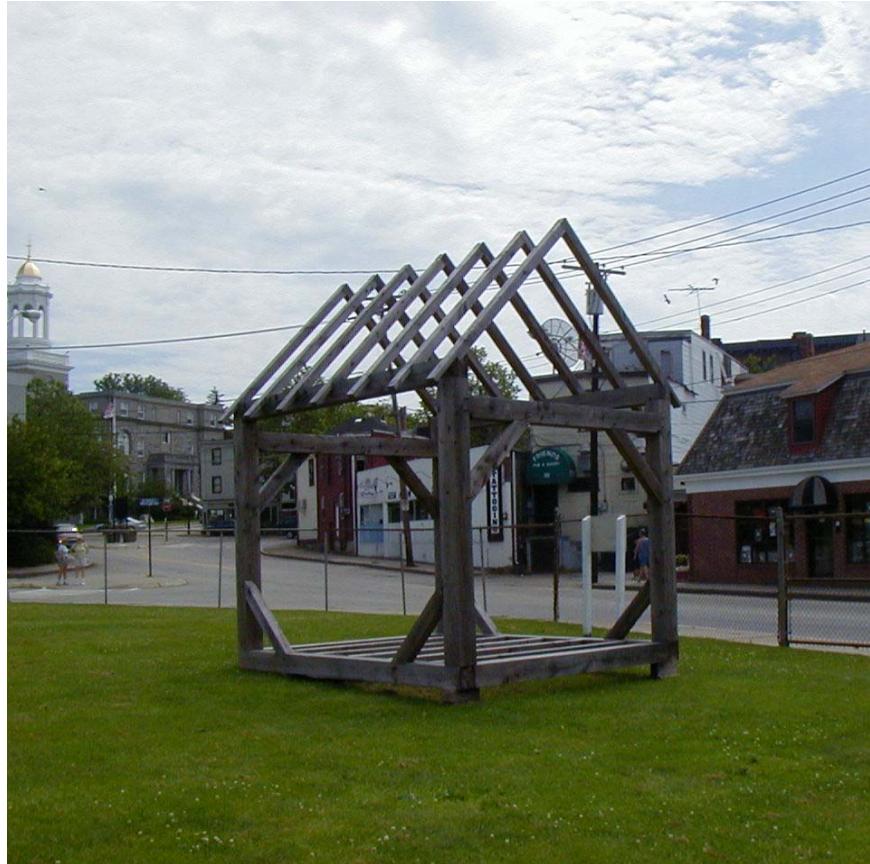
Figure 5-3: A small example of a heavy timber frame structure located in Newport, Rhode Island. Note the angle braces and the practice of staggering where multiple timbers intersect to avoid weakening a post at a critical point.

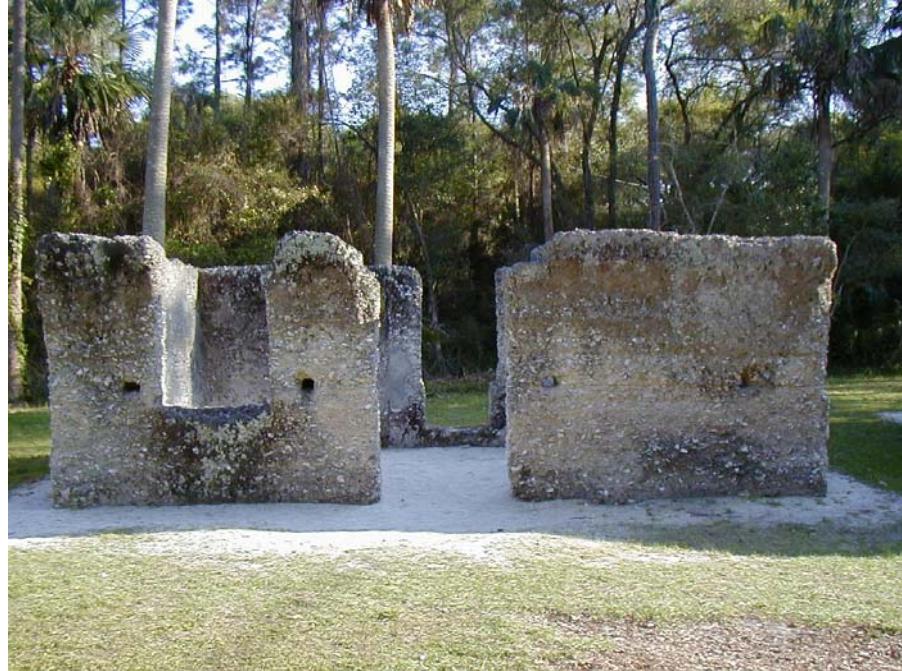
Figure 5-4: Kingsley Plantation slave cabin, Amelia Island, Florida. This unusual plantation from the early 1800s had a number of buildings including the slave cabins, barn and the house foundations constructed out of tabby.

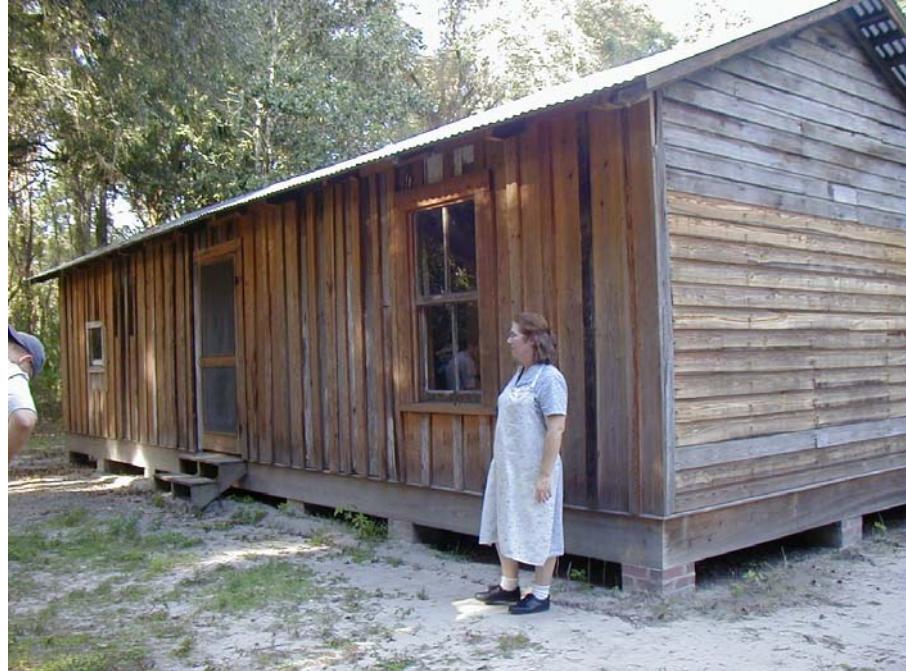
Figure 5-5: The tenant house moved to the Marjorie Kinnan Rawlings State Park has vertical board and batten siding on the rear elevation of the building and horizontal lap siding on the gable end.

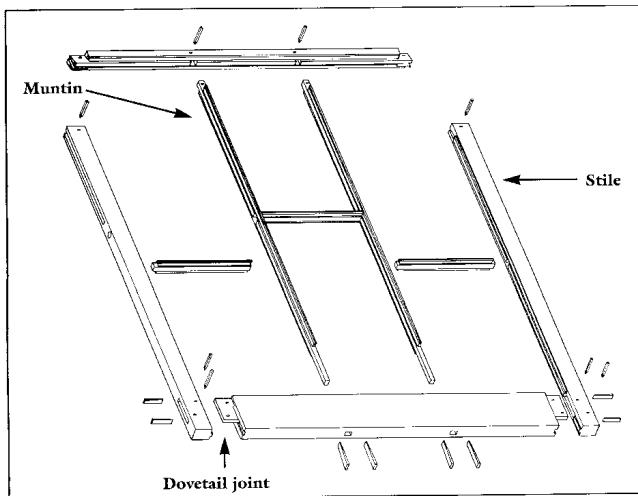
Early 19th-century, double-hung sash construction: meeting rails join stiles with a dovetail joint, and vertical muntins pass through the lower rail. (Michael J. Devonshire)

Figure 5-6: Window frame construction. (New York Landmark Conservancy 1992, 22)

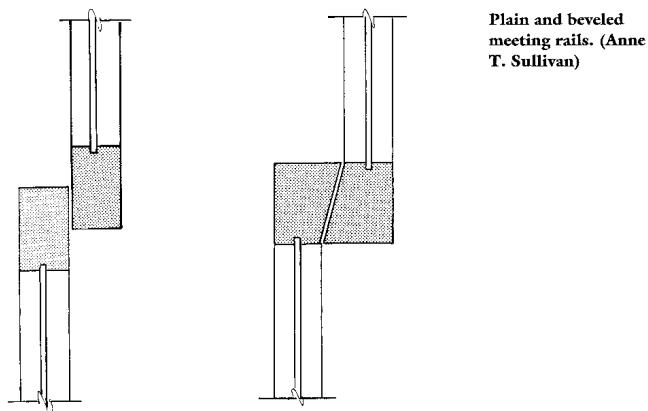
Figure 5-7: Detail of meeting rails of double hung sashes. (New York Landmark Conservancy 1992, 23)

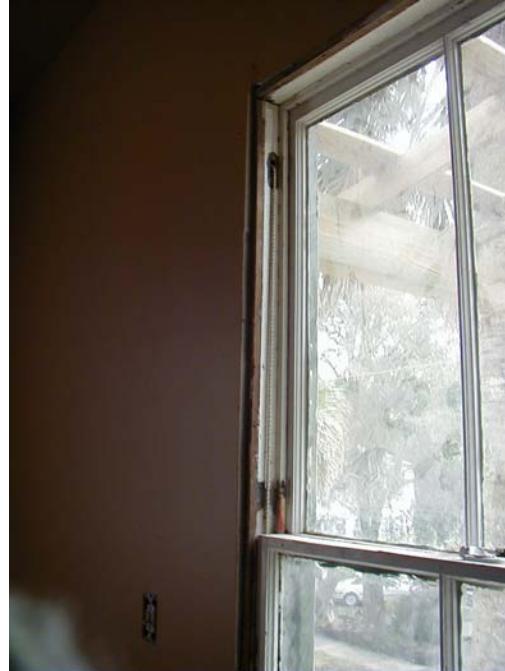
Figure 5-8: Pulley and rope connecting the sash to balancing sash weights hidden behind framing, Housing Authority Building, Gainesville, Florida.

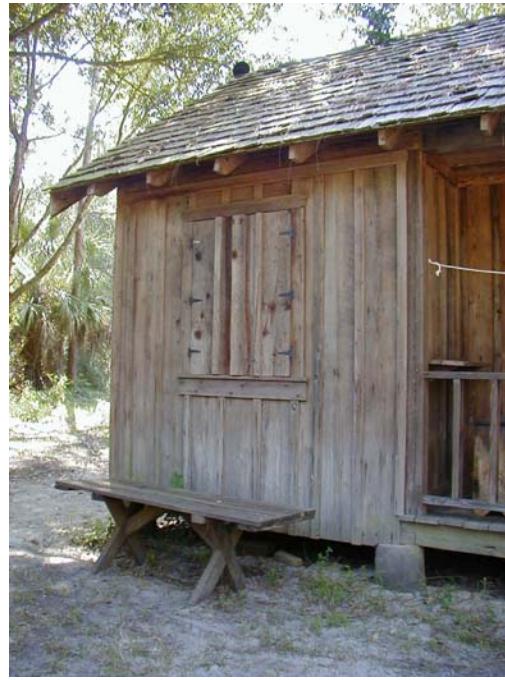
Figure 5-9 Kitchen window of addition to Hogan's cabin, Morningside Park, Gainesville, Florida. Simple shutters cover the opening when light and ventilation of the room are not necessary, but a splayed head for the window framing echoes Greek Revival architectural detailing practices transformed by vernacular ideas.

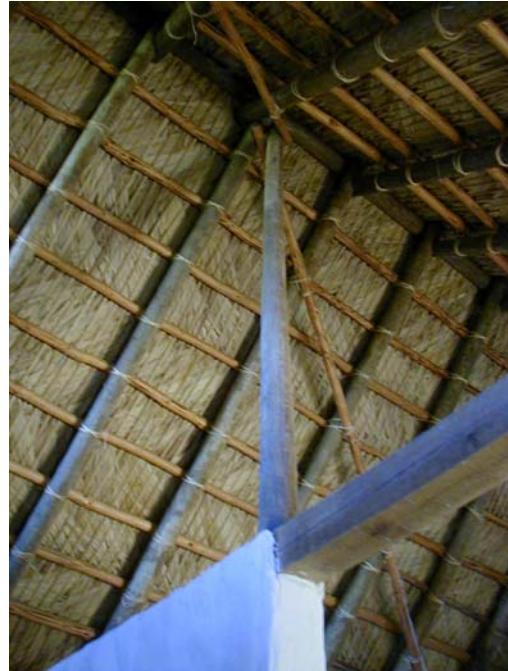
Figure 5-10: Palm thatching lashed to poles attached to roof frame of reconstructed house at Mission San Louis de Apalachee, Tallahassee, Florida.

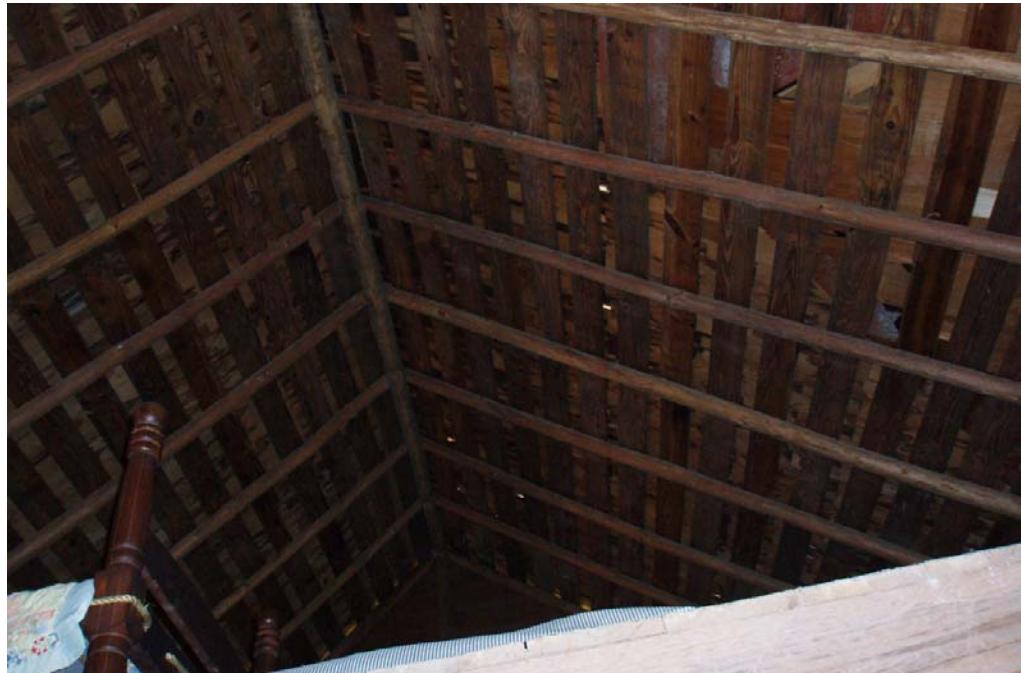
Figure 5-11: Wood shingles nailed to widely spaced boards covering the roof frame of Hogan's cabin, Morningside Park, Gainesville, Florida. Rain would cause the shingles to swell and fill the cracks in between so the roof did not leak.

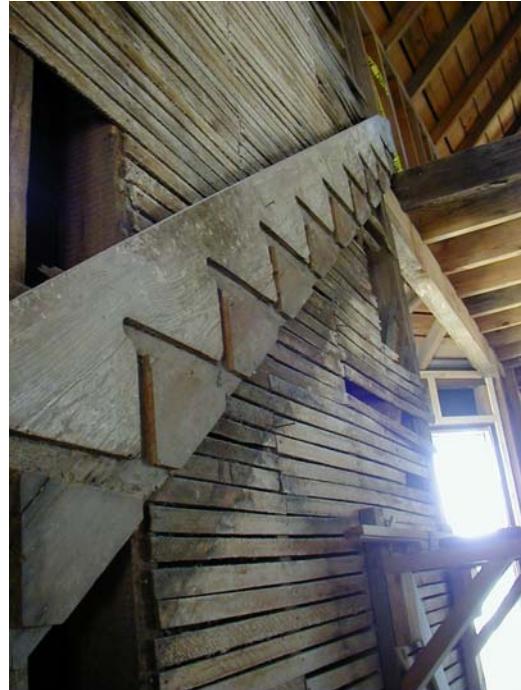
Figure 6-1: A surviving portion of the main staircase of the Merrill House in Jacksonville, Florida portrays the configuration of the steps as well as a shadow line on the wood lathe showing that the area underneath the stairs was open and the wall was plastered.

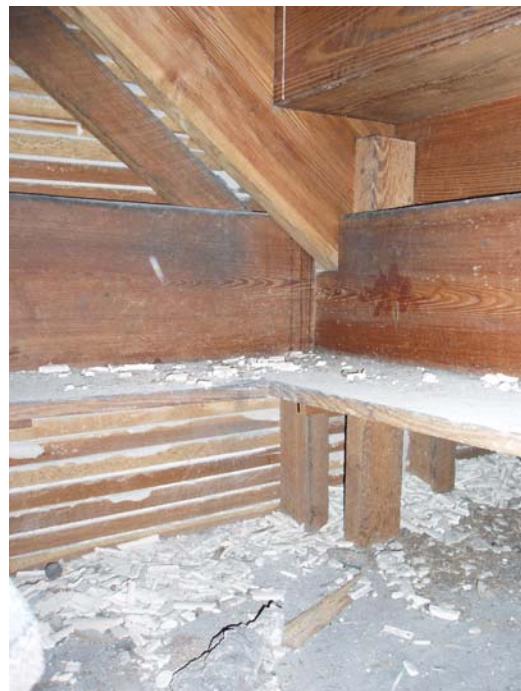
Figure 6-2: A small door leads to a space under the stairs of the Haile Plantation house reveals that the interior framing of the walls and stairs is of mill-sawn lumber and the plaster keys between the lathe are visible.

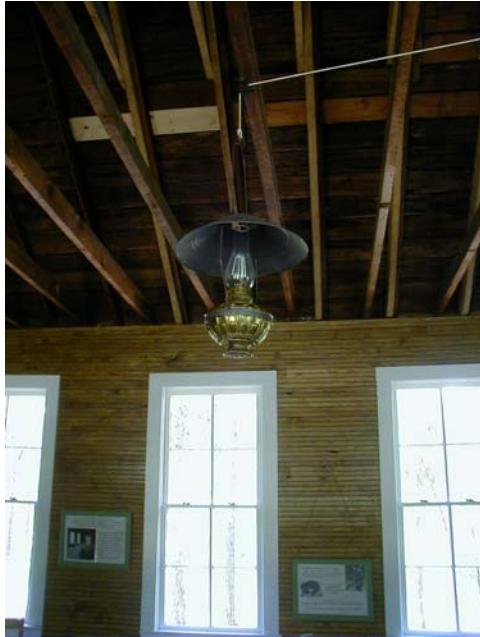
Figure 6-3

Figure 6-3: A portable lamp suspended on a rope and pulley in a schoolhouse located at Morningside Park, Gainesville, Florida.

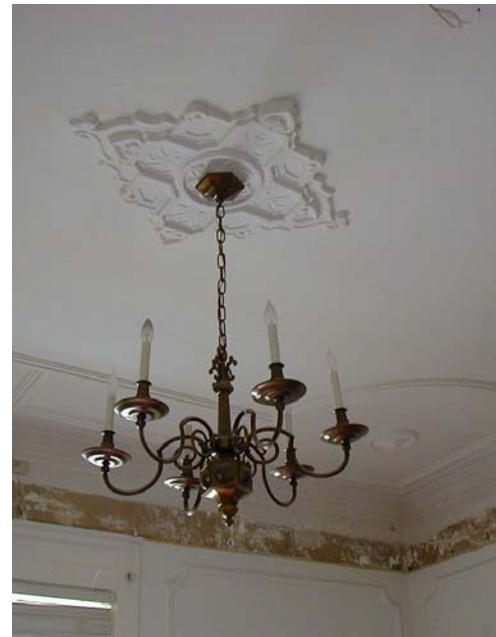
Figure 6-4

Figure 6-4: An electrified candle chandelier with plaster ceiling medallions and molding located in the Housing Authority Building, Gainesville, Florida.

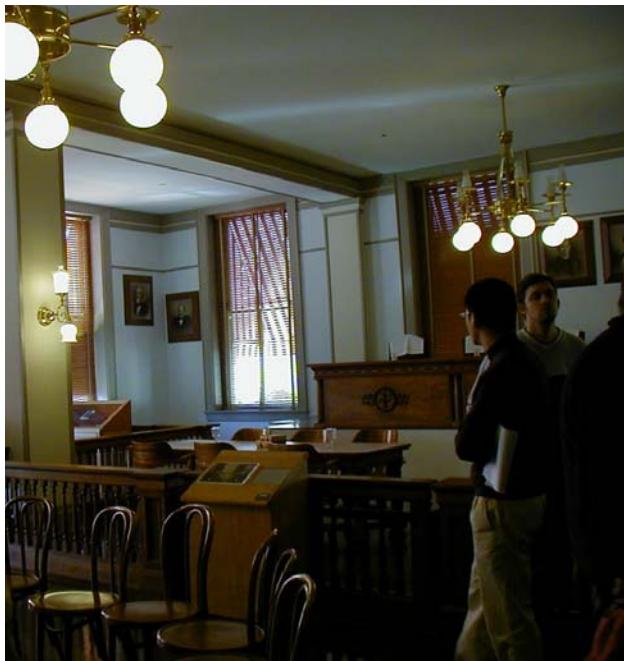
Figure 6-5

Figure 6-5: Gas/electric chandeliers and wall sconce in the State Capitol Building, Tallahassee, Florida.
