IMPACT ON CARPET TILE IN A HOSPITAL PATIENT UNIT CORRIDOR:
AN OBSERVATIONAL CASE STUDY

A THESIS PRESENTED TO THE GRADUATE SCHOOL
OF THE UNIVERSITY OF FLORIDA IN PARTIAL FULFILLMENT
OF THE REQUIREMENTS FOR THE DEGREE OF
MASTER OF INTERIOR DESIGN

UNIVERSITY OF FLORIDA

2006

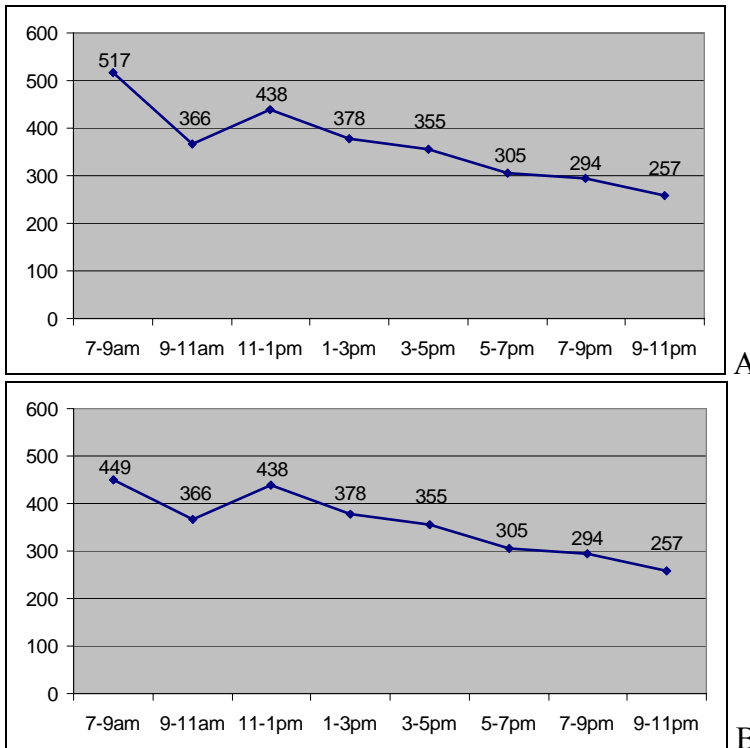
Figure 4.2: Average foot traffic timeline, by time block. Part A shows a regression line all time blocks observed; part B shows means taken without data from the time block during which an emergency code occurred

Figure 4.2 shows average foot traffic counts for each time block both with and without data from the time block during which an emergency code occurred. Both timelines show a slightly decreasing trend.

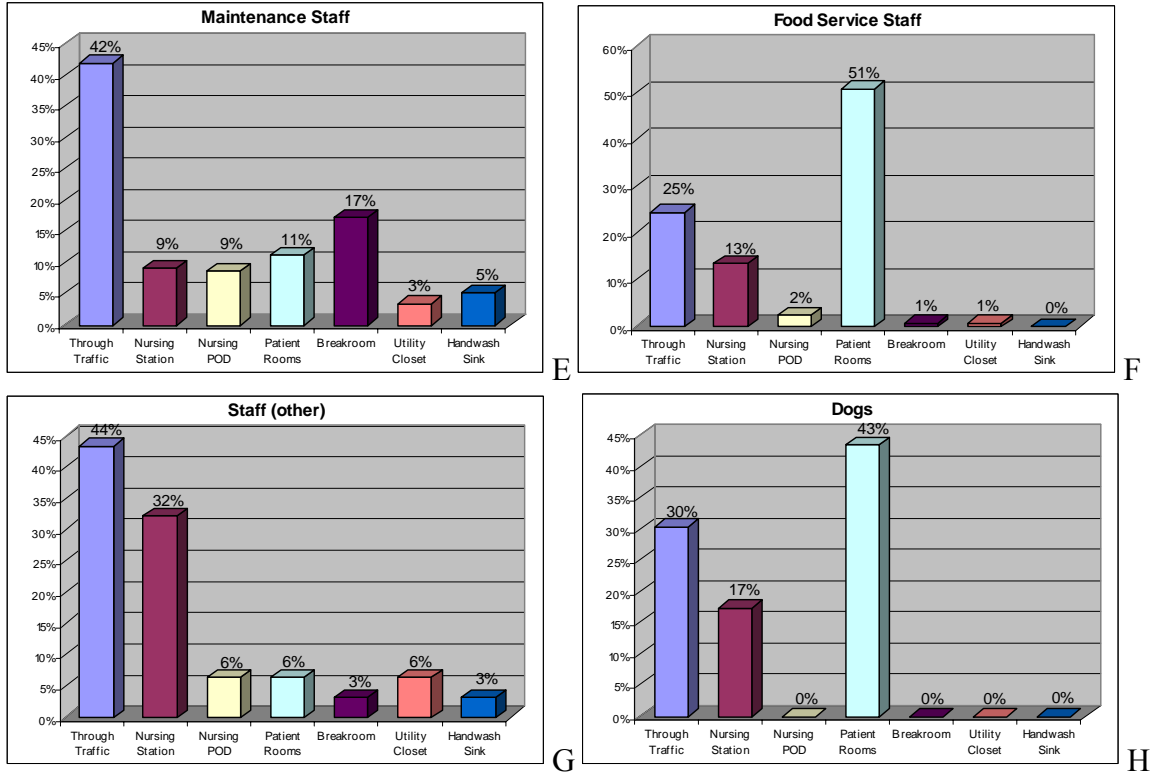
Figure 4.7: By user group category, locations on study corridor commonly receiving foot traffic, as percentages of total foot traffic observed. A) healthcare staff, B) visitors, C) patients, D) housekeeping staff, E) maintenance staff, F) food service staff, G) staff (other), and H) dogs

Figure 4.7 details destination/entry locations frequented by specific user group categories.

- One quarter of food service staff traffic was through-traffic, while over half traveled to and from patient rooms.
- Dogs visiting as part of the hospital's Animal-Assisted Therapy program traveled largely to and from patient rooms. Approximately one third of dog traffic was through-traffic. Dogs also visited the nursing station area, but none were observed traveling to or from any other location in the study corridor area.

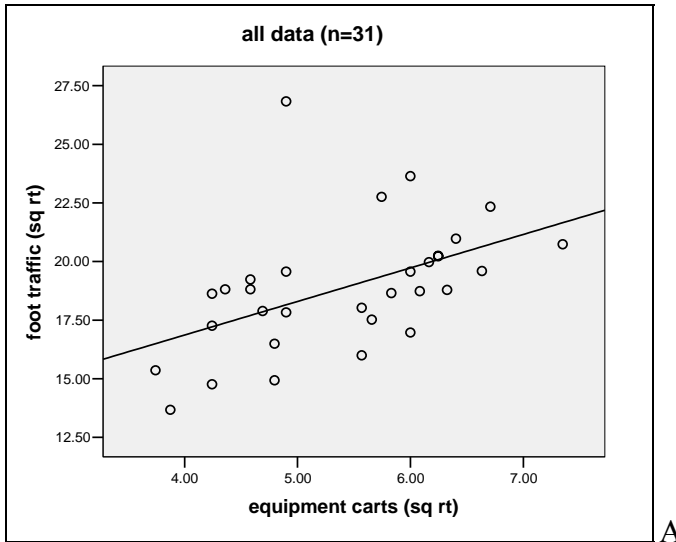
Figure 4.9: Correlation between foot traffic and equipment cart counts. Part A shows a regression line for all time blocks observed (n=31); part B shows a regression line for all time blocks except the time block during which an emergency code occurred (n=30)

However, testing did show a significant correlation between foot traffic counts and equipment cart counts, both with ($r=0.49$, $p<0.05$) and without ($r=0.65$, $p<0.05$) data from the time block during which the emergency code occurred. Figure 4.9 shows regression lines for the data including all time blocks ($n=31$) and for the data with the time block including the emergency code removed ($n=30$). A stronger correlation exists between between foot traffic and equipment cart counts when the time block during which the emergency code occurred is removed from the data set.

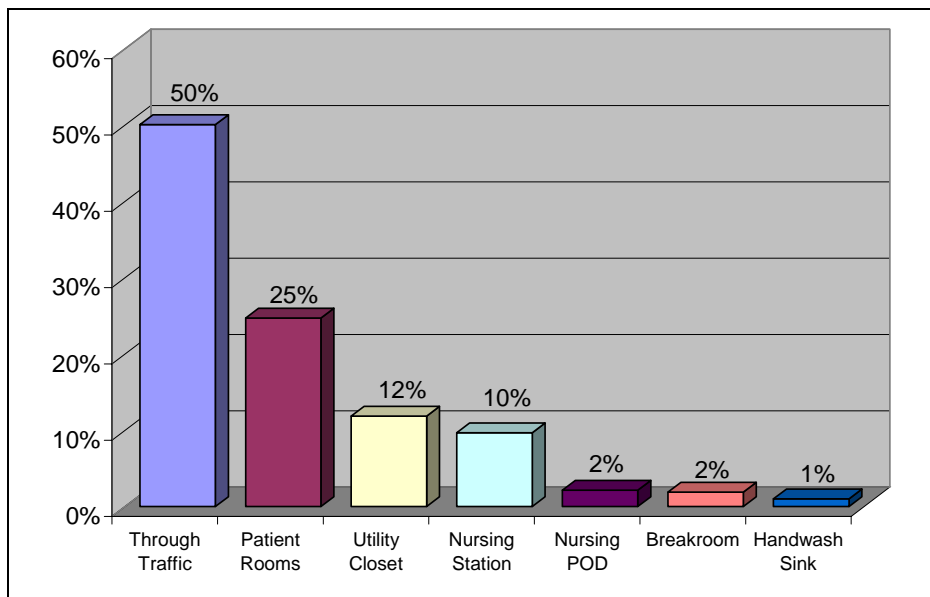
Figure 4.11: Locations on study corridor commonly receiving equipment cart traffic, as percentages of total equipment carts/items observed

- Approximately 1 out of every 4 equipment carts moving through the study corridor traveled to or from a patient room.
- 12% of all carts observed traveled from or to the utility closet.
- 10% of all carts observed visited the area in and around the nursing station.
- The nursing POD, breakroom, and handwashing sink each accounted for less than 2% of all equipment carts/items observed.

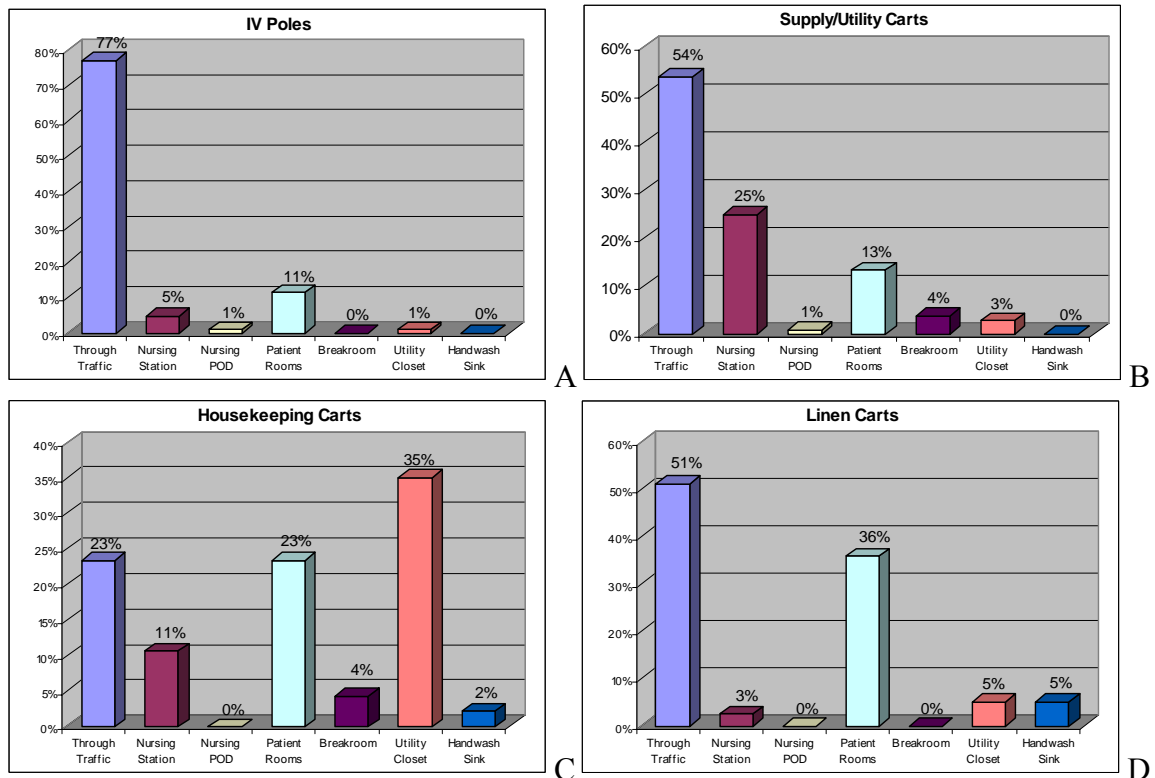
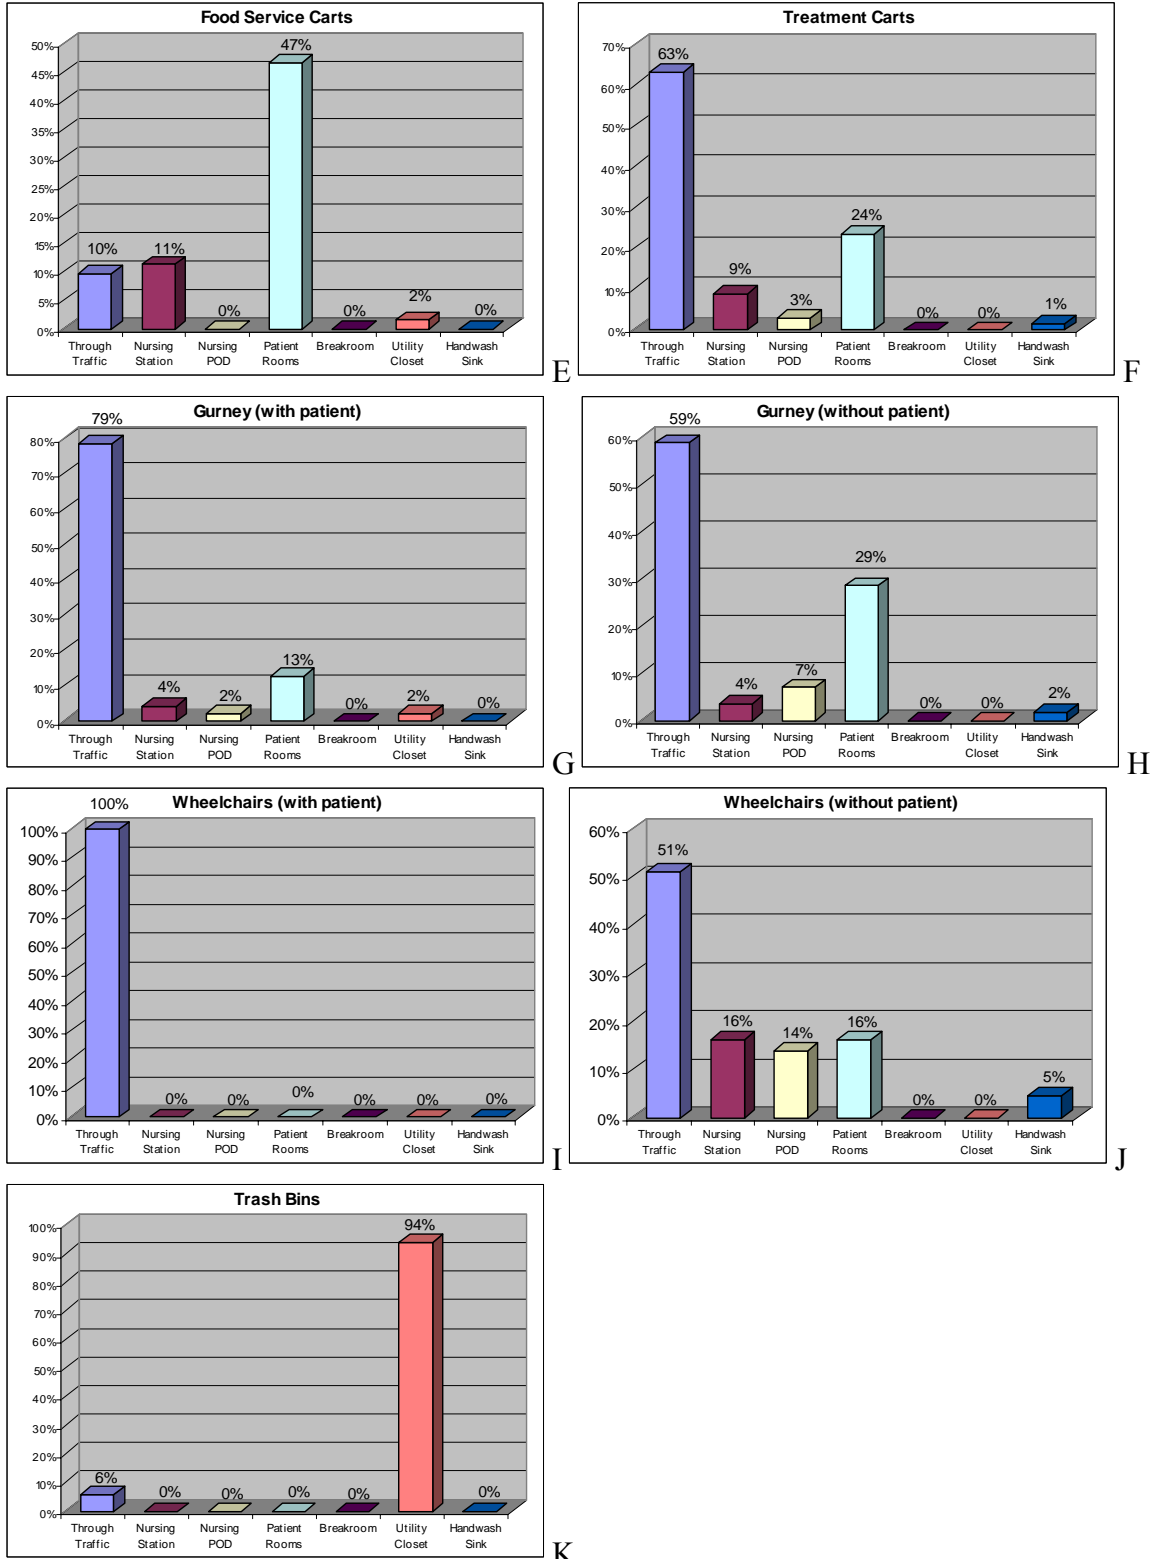
Figure 4.12 details the destination/entry points frequented by specific equipment carts/items.

- Half of the linen carts observed were through-traffic, and much of the remainder moved to or from patient rooms.
- Only 1 of every 10 food service carts was through-traffic, while half traveled to and from patient rooms.
- Close to two-thirds of all treatment carts observed were through-traffic, with patient rooms receiving most of the remainder of treatment cart activity.
- Gurneys, both with and without patients, showed similar trends with regard to destination/entry points.
- All observed wheelchairs with patients were through-traffic.
- Of wheelchairs without patients, only half were through-traffic. The nursing station, nursing POD, and patient room areas received the remaining traffic.
- Trash bins traveled almost exclusively to and from the utility closet. Just 6% passed through the corridor area as through-traffic.
