MODIFIED PWA 1483 NICKEL-BASED SUPERALLOY
FOR INDUSTRIAL GAS TURBINE APPLICATIONS

A DISSERTATION PRESENTED TO THE GRADUATE SCHOOL
OF THE UNIVERSITY OF FLORIDA IN PARTIAL FULFILLMENT
OF THE REQUIREMENTS FOR THE DEGREE OF
MASTER OF SCIENCE

UNIVERSITY OF FLORIDA

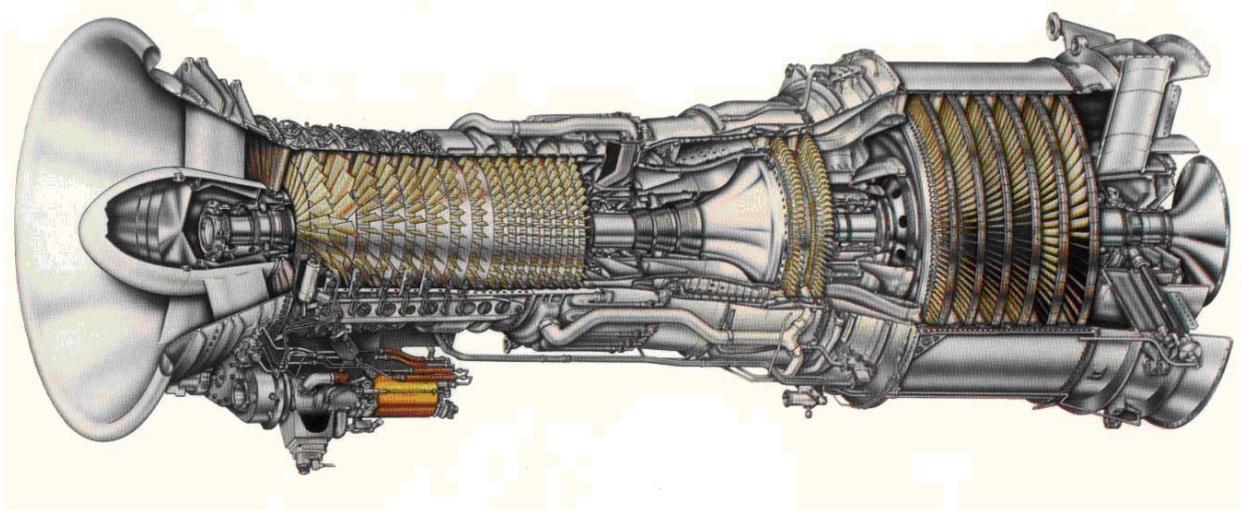
Figure 1-2. GE LM2500 Gas Turbine Engine; Cross-Sectional View [4].

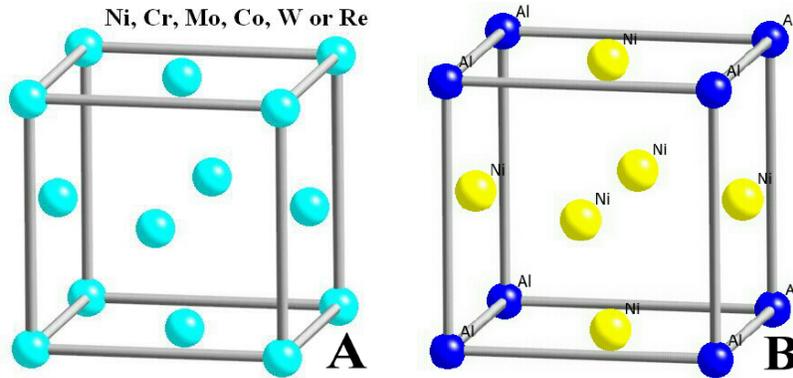
Figure 1-3. Crystal Structure of A) Gamma Phase (γ) B) Gamma Prime Phase (γ') [9].

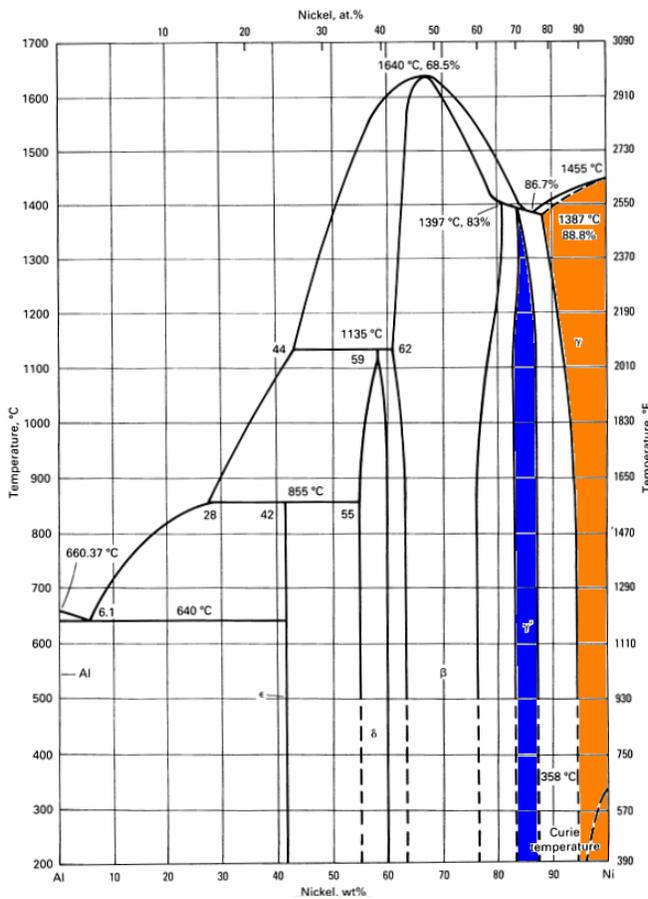
One very important fact should be noted here: these γ and γ' phases exist over a range of compositions. This might seem obvious for the γ phase, but the same is true for the γ' phase, shown in Figure 1-4 (*below*) in orange and blue (respectively):

Figure 1-4. Al-Ni Phase Diagram Showing Gamma Phase (orange) and Gamma Prime Phase (blue) [10].

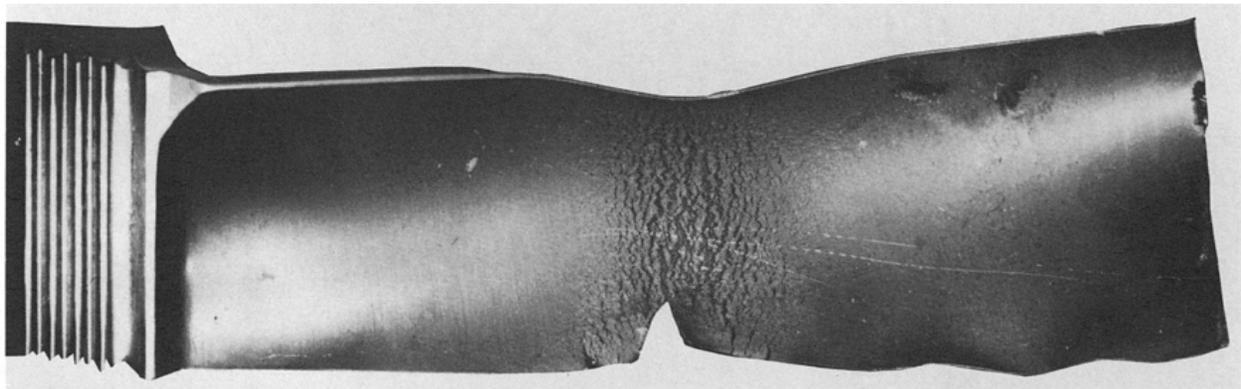
increasing the creep and thermal-mechanical fatigue (TMF) resistance of the blade. As illustrated in Figure 1-5 (*below*), creep progresses in a direction perpendicular to the stress axis. Finally, the process of growing single crystal blades was developed. This process – as the name would suggest – produces a single grain, which can be oriented in a manner to minimize the effects of creep. These single crystal alloys represent the best the industry currently has to offer where strength is concerned. For that reason, the applications which are most demanding in terms of temperature and stress usually employ single crystal alloys, and as the demands within the IGT increase, these alloys will be of more and more interest.

Figure 1-5. Creep Damage in Turbine Blade [19].

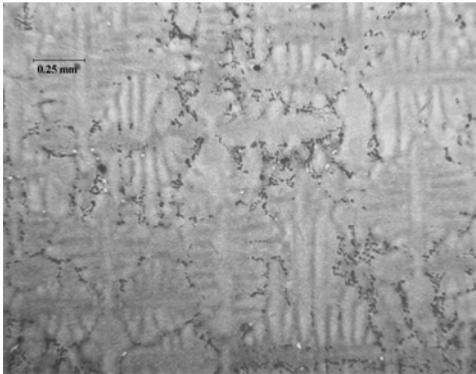
Figure 2-1. Microstructure of As-Received Baseline PWA 1483.

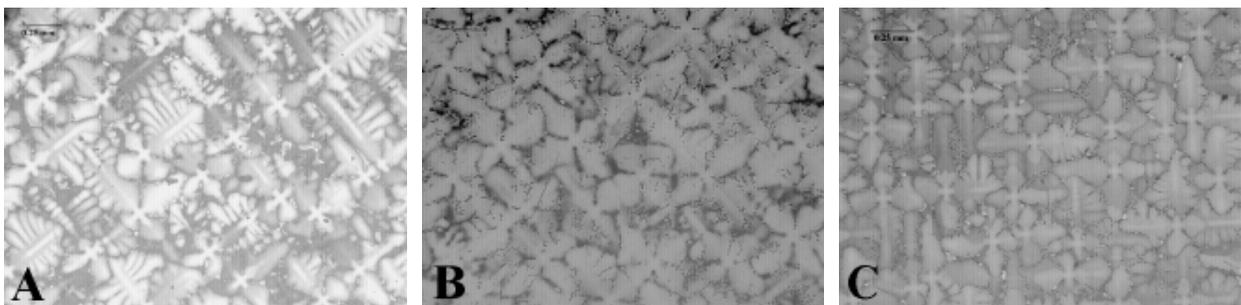
PWA 1483 was chosen because of its relatively good castability and its excellent resistance to environmental degradation. Because of its low refractory composition, solution heat treatments usually are significantly shorter than those of second- and third-generation superalloys. When the decision was made to add these elements in an effort to strengthen the alloy, it was understood that this would also likely increase the solution heat treatment time, and thus, a new heat treatment schedule would have to be developed. The segregation in the as-received (heat-treated) Baseline sample can be seen in Figure 2-1 (*below*) and in the as-cast Modification samples in Figures 2-2 (A-C) (*below; all images from L.J. Grant*):

Figure 2-2. Microstructure of As-Cast A) Mod I sample B) Mod II sample C) Mod III sample.

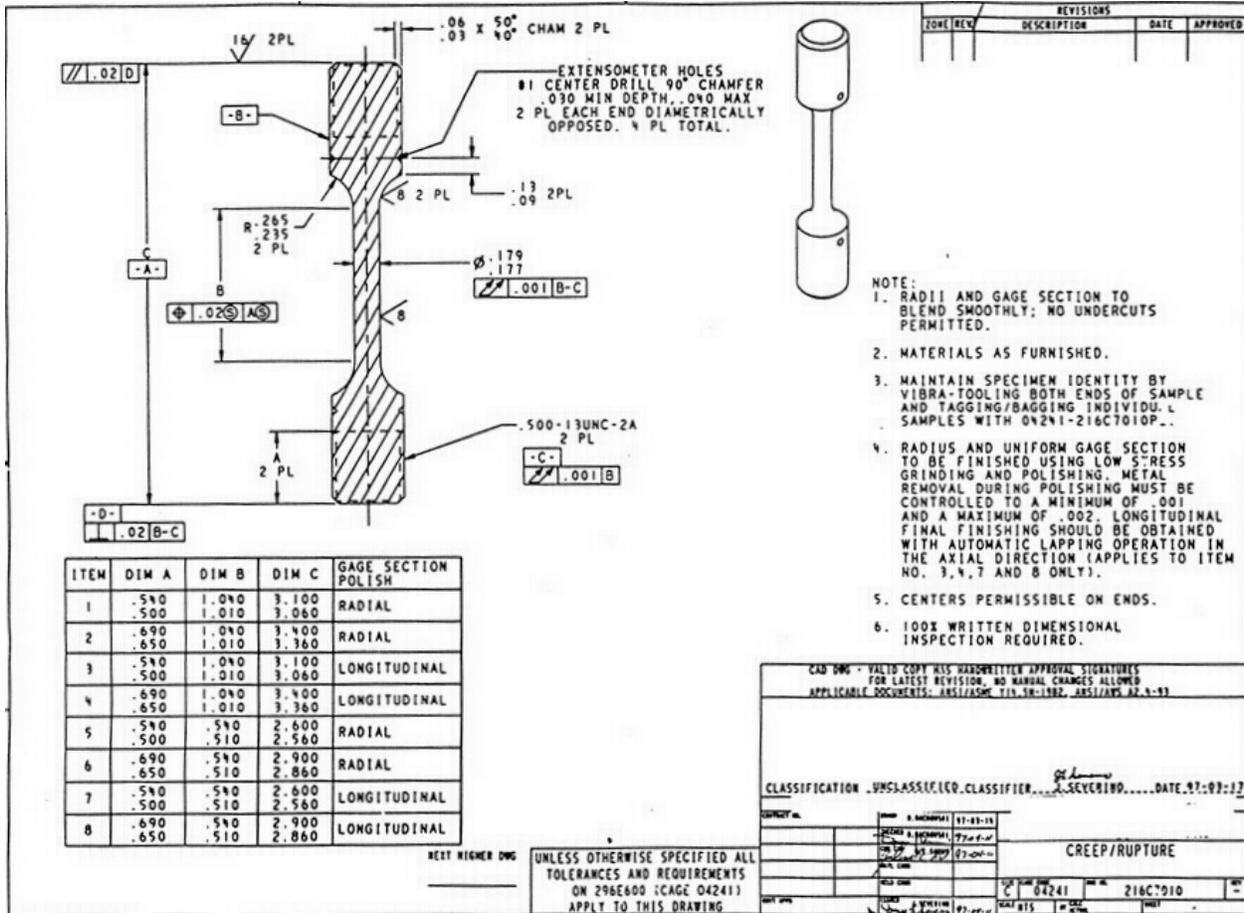
the sample via mounting screws. These holes are shown in the 3D rendition of the sample in Figure 2-3 (below):

Figure 2-3. Tensile/Creep Sample Design. All dimensions shown are in inches.

Another 8 samples were machined from the Baseline sample bars, with the only deviation from the design in Figure 2-3 being shoulder diameter, which was 0.9525 cm (0.375 in) rather than the 1.27 cm (0.500 in) called for. Of the 34 samples, 28 were used for testing – 23 successfully. Two tests proved to be unsuccessful due to erroneous data collected by the extensometer and its associated software. Most likely, this was caused by the extensometer frame slipping on the sample as a test was in progress. Two others were unsuccessful because the data was lost. One test was unsuccessful as a result of damage to the sample threads caused

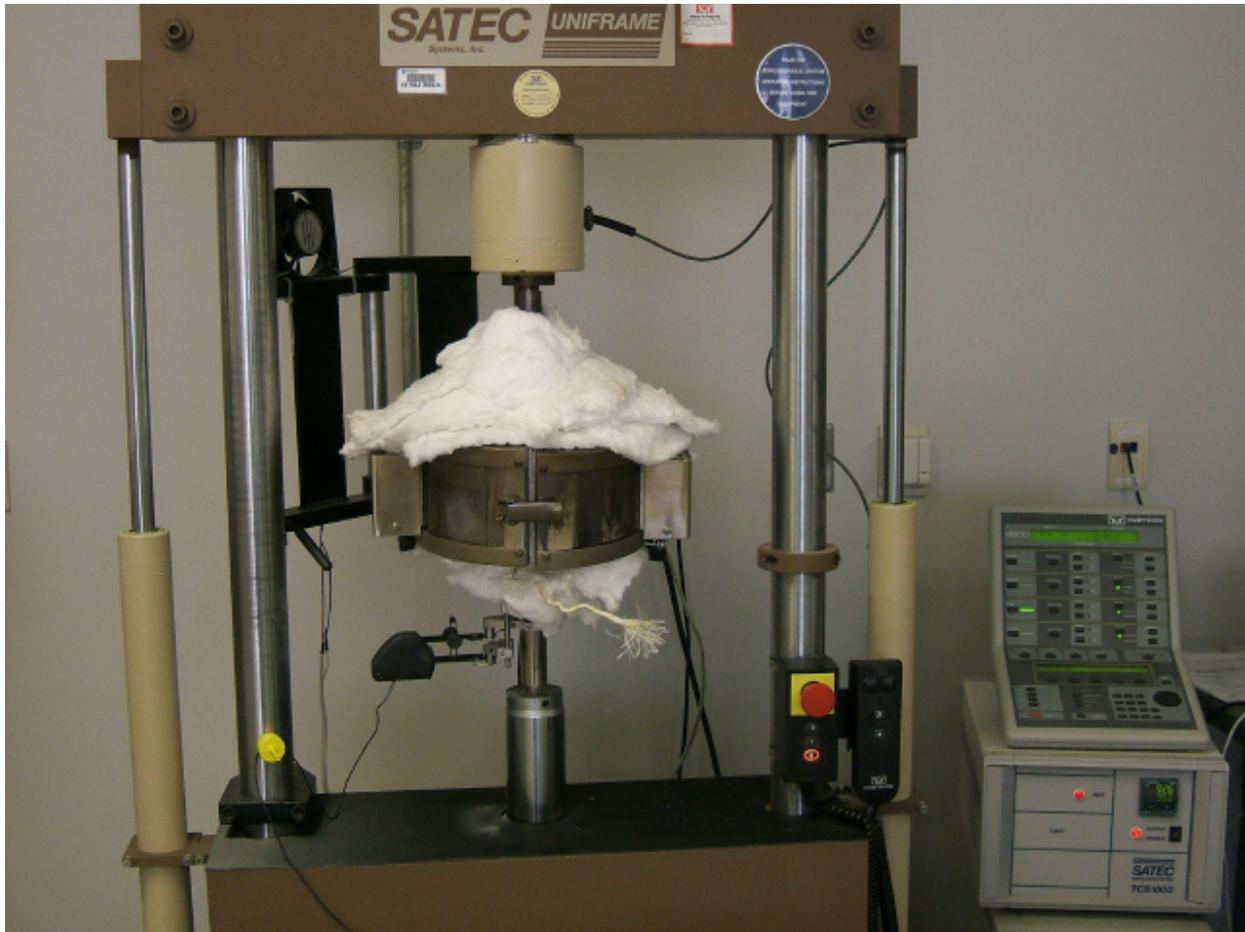
Tensile testing was performed using an Instron Model TC 25 servo-hydraulic frame in the High Temperature Alloys Laboratory at the University of Florida, shown in Figure 2-4 (*below*):

Figure 2-4. Instron test frame with clam-shell shut and insulated for tensile test.

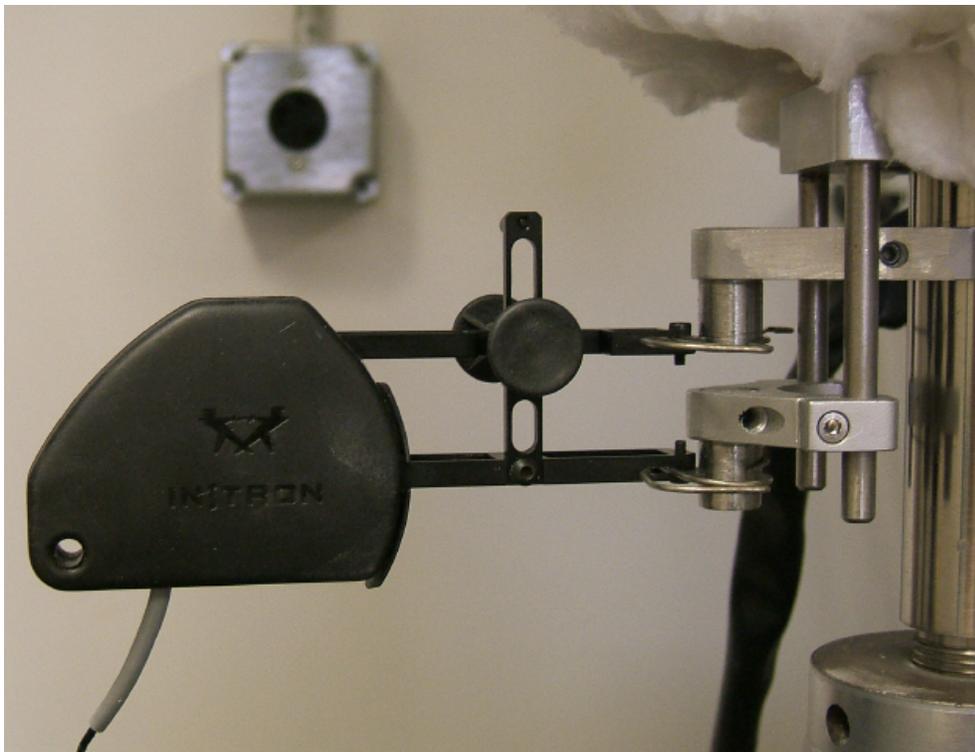
The sample was fixed into the extensometer frame by means of two pairs of 6.4 mm (0.25 in) diameter knife-edge inserts. The extensometer frame and inserts were fabricated from Haynes 214 alloy. An Instron model 2630-100 static extensometer – shown in Figure 2-5 (*below*) – with a 25.4 mm (1.0 in) gauge length and 25.4 mm (1.0 in) of travel was used for measuring strain, and attached to the sample by means of two 6.4 mm (0.25 in) stainless steel clips (also shown in Figure 2-5). Once the sample was fixed into the extensometer frame and loaded into the testing frame with the thermocouples attached, the test was commenced.

Figure 2-5. Instron Model 2630-100 Static Extensometer with Stainless Steel Clips.

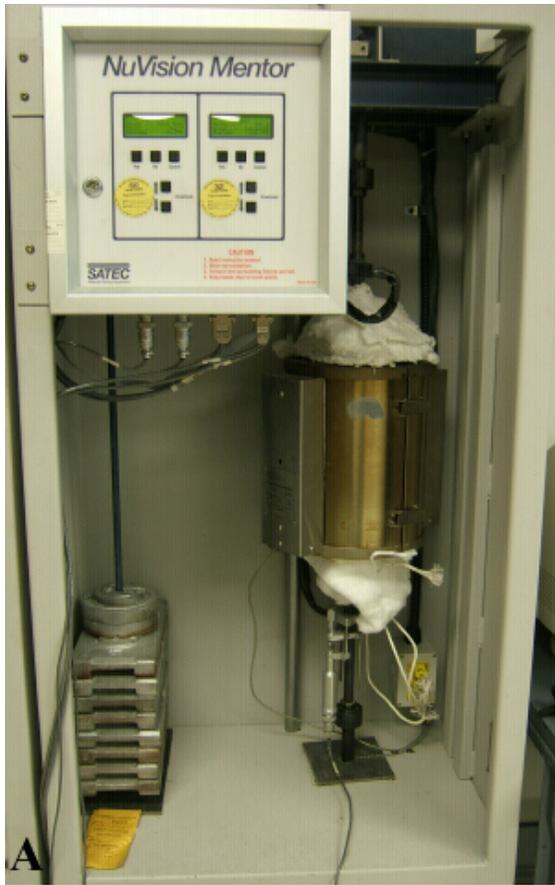
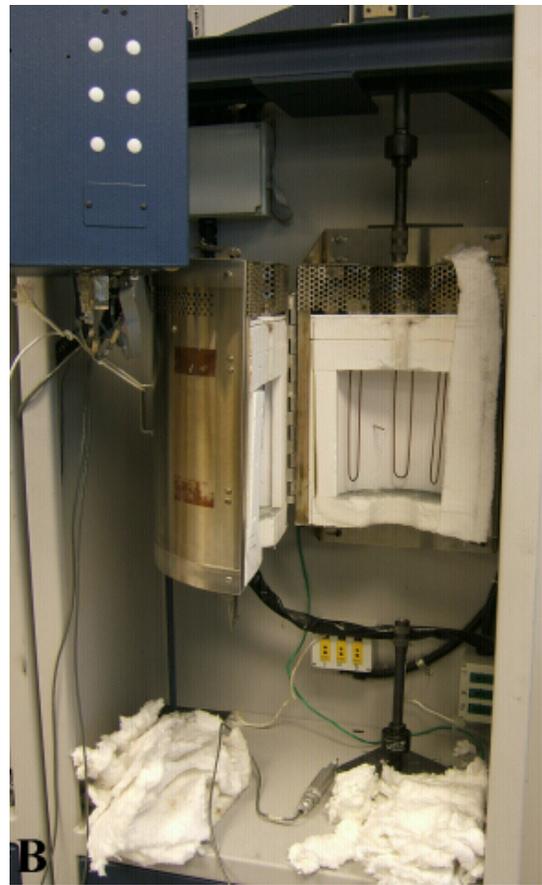
Creep testing was performed using Satec Model M3 creep frames shown in Figure 2-6 (*following page*). A total of four frames are located in the High Temperature Alloys Laboratory at the University of Florida, and three of the four were used for the testing. Two frames – like the one shown in Figure 2-6 (a) – are fitted with Satec Model SF-16 2230 Power Positioning Furnaces. These furnaces have three different hot zones (top, middle and bottom) of independently-controlled Kanthal heating elements. This allows more precise control of heat input, providing a more even heating of the entire gauge section of the sample being tested. The other two frames – like the one shown in Figure 2-6 (b) – are fitted with Satec Model KSF 2-8-18 Power Positioning Furnaces. These furnaces have a single hot zone, and utilize MoSi₂ heating elements which are capable of testing temperatures up to 1500°C (2732°F).

Figure 2-6. Instron M3 Creep Frames with A) SF-16 2230 Power Positioning Furnace B) KSF 2-8-18 Power Positioning Furnace..

Use of this equation indicated that at a desired time to failure of 144 hours, the required stress would be 831.5 MPa (120.6 Ksi) at 750°C. The Mentor software automatically converted the stress to load, using the dimensions of each sample, which were input manually prior to the test, and all four creep frames utilize a lever-arm with a 16:1 ratio between applied load on the sample and actual weights required on the machine. The arm and weights are visible in Figure 2-6 (a-b).

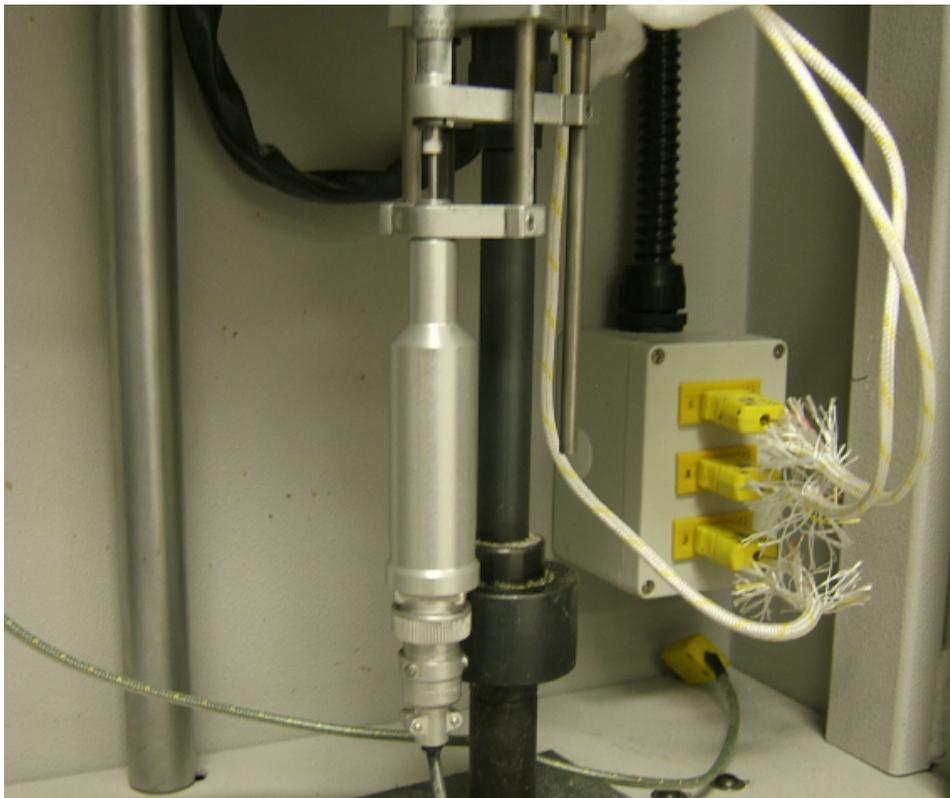
- Their length, which is due to the size of the furnace on each type of frame. The larger-sized creep furnaces require longer extensometer frame arms than those required by the smaller clam-shell furnace on the tensile unit.
- The manner in which the sample is mounted in the extensometer frame. For the creep tests, the samples were held in place by using screws which engaged the holes machined into the shoulders of the samples (as discussed and shown previously in Figure 2-3), whereas knife-edges were used for the frames in the tensile tests.
- The type of strain-measurement device used. The clip-type design used for tensile testing was shown previously in Figure 2-5, and the threaded-type design used for creep testing is shown in Figure 2-7 (*below*):

Figure 2-7. Satec Model 9234 LVDT Used in Creep Testing.

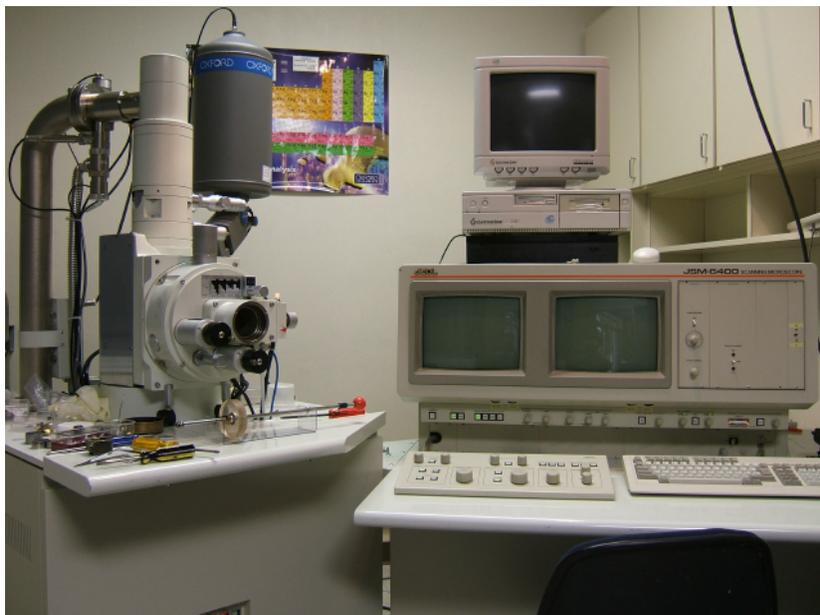
Each sample was then placed into a JEOL JSM 6400 Scanning Electron Microscope (SEM) – shown in Figure 2-8 (*below*) – for analysis.

Figure 2-8. JEOL JSM 6400 SEM.

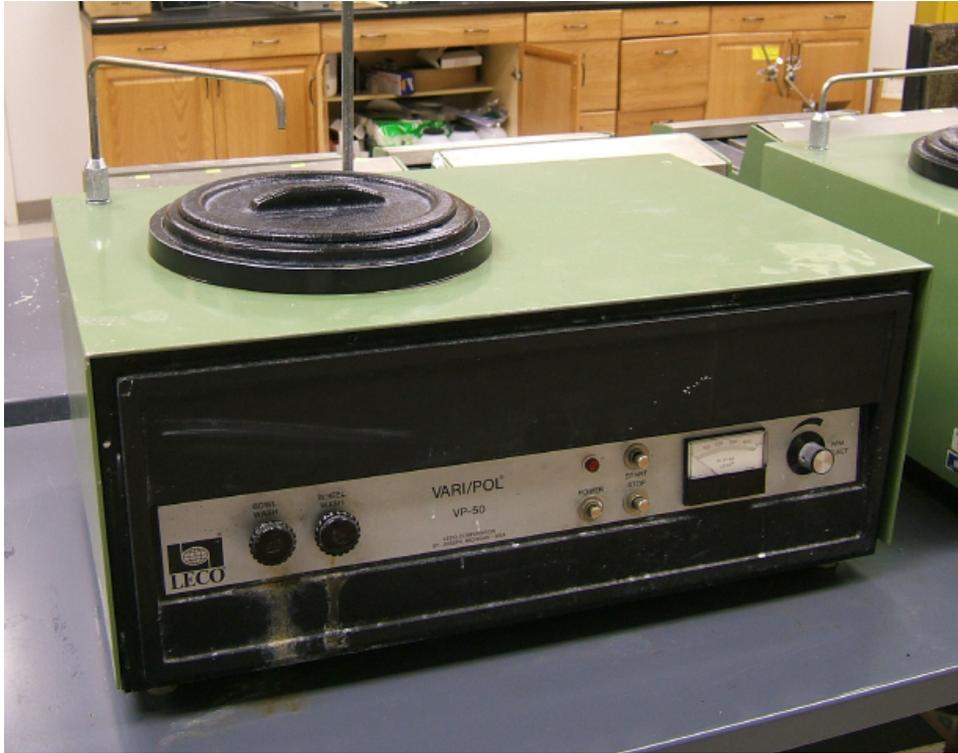
Each of these was then polished by hand using a LECO VARI/POL Model VP-50 polishing wheel – shown in Figure 2-9 (*below*) – at 200RPM.

Figure 2-9. LECO VARI/POL VP-50 Polishing Machine.

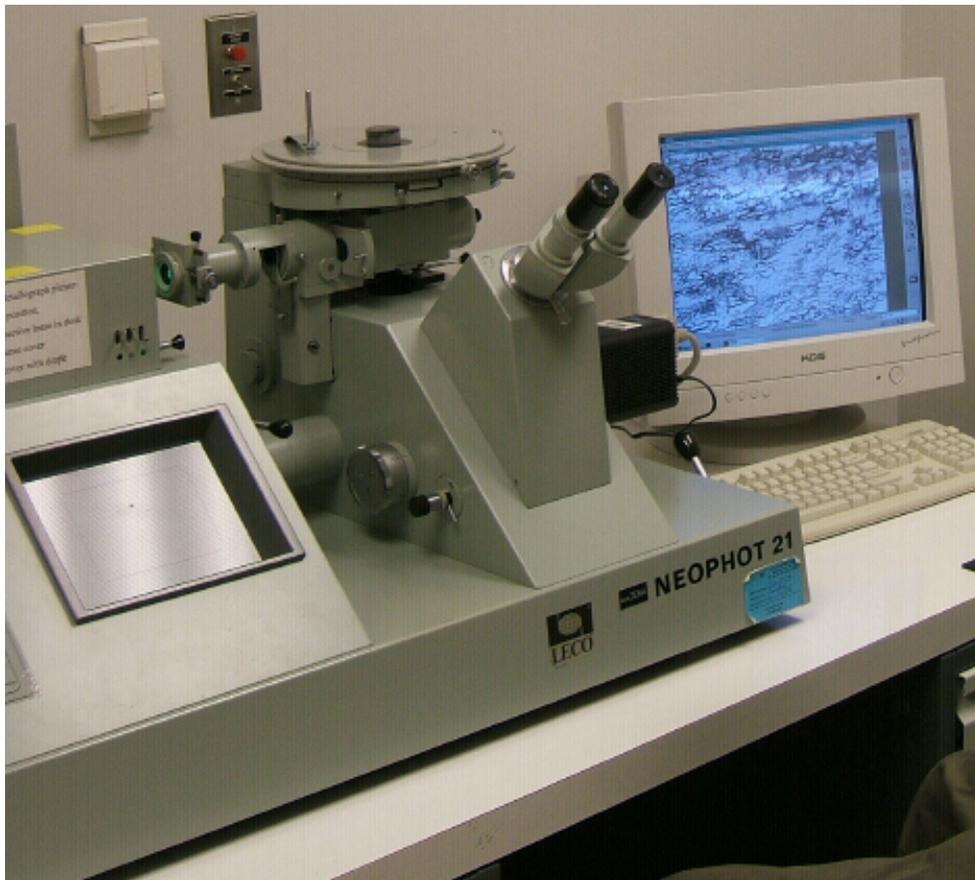
These polished samples were then evaluated using a LECO Neophot Model 21 optical microscope – shown in Figure 2-10 (*below*) – with SPOT advanced software from Diagnostic Instruments, Inc. on an attached standard desktop computer. A series of 4 images were taken at 50x and then merged into one larger image using the Microsoft Paint program. This was done to show the general character of the microstructure in the vicinity of the fracture surface.

Figure 2-10. LECO Neophot 21 Optical Microscope.

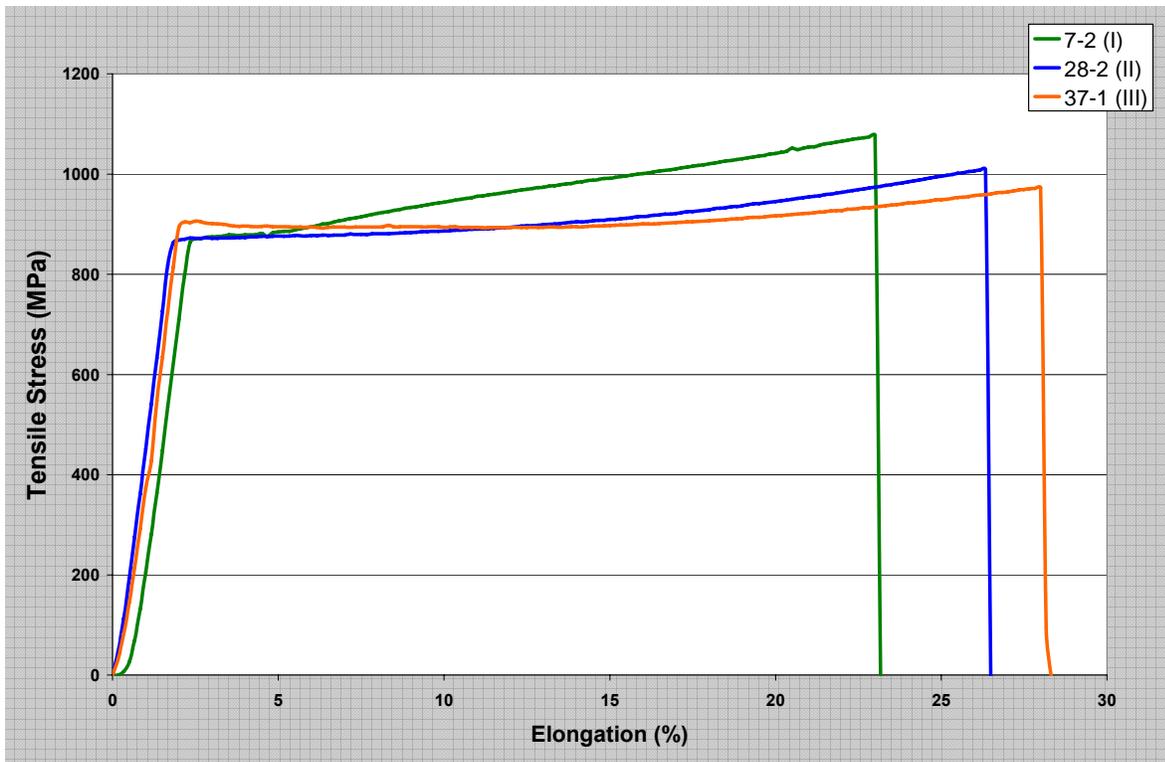
Figure 3-1. Room Temperature Tensile Testing Results.

In all three alloys, a fairly sharp yield is indicated. Additionally, the YS for all three alloy modifications were similar. It should be noted that there is a slight change in slope toward the bottom of the tensile curve for all tests except those at 950°C. This is a result of a small amount of slack in the initial setup and was therefore ignored when considering the 0.2% offset. Modification II and III alloys undergo less work hardening and are more ductile than the Modification I alloy. The slight drop in strength with increasing strain seen on the Modification II and III alloys indicate the occurrence of a slight amount of necking in the sample, which is consistent with what is observed on the samples themselves. The amount of work hardening of these alloys was approximately 206 MPa (30Ksi), 138 MPa (20Ksi) and 69 MPa (10Ksi) for Modifications I, II and III (respectively).

The data from Table 3-1 was obtained from graphs of the raw data from the tests, which was imported into an Excel spreadsheet and graphed. These graphs are shown in Figures 3-1 through 3-4 (*below and subsequent pages*):

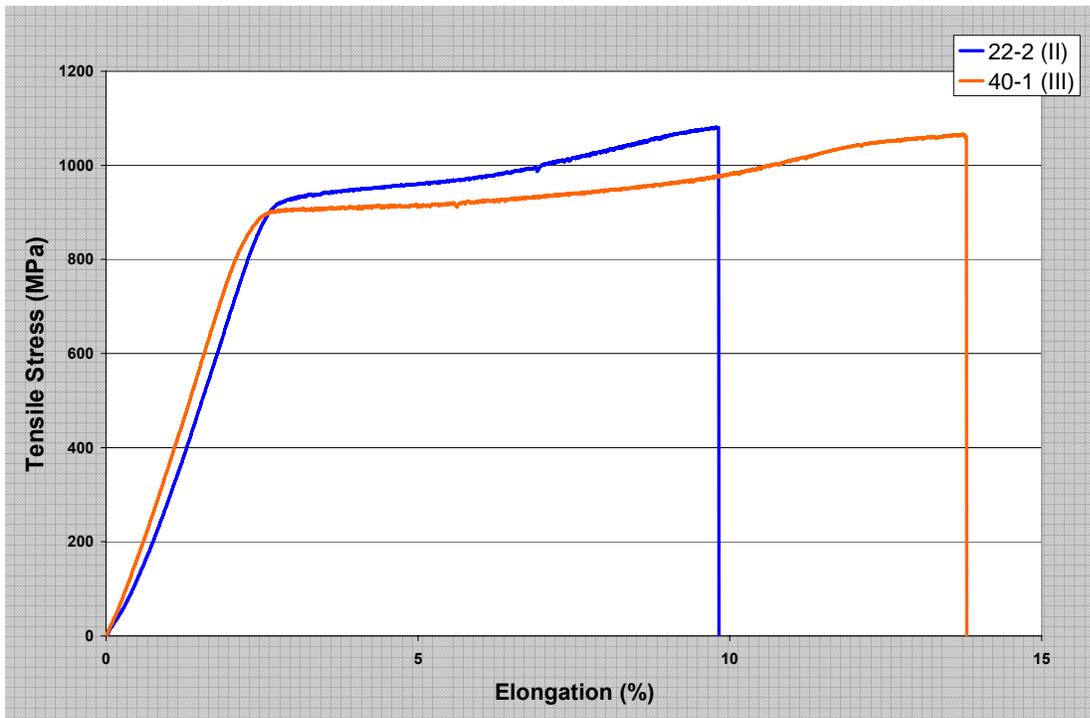
Figure 3-2. 750°C Tensile Testing Results.

Similar to the results of the tests at room temperature, the 750°C tests indicate only a slight amount of work hardening in the two alloys – approximately 145 MPa (21Ksi) and 165 MPa (24Ksi) for Modifications II and III (respectively). And, like the previous tests, Modification II and III have similar values of YS and UTS. The Modification III alloy exhibited a greater amount of elongation than did the Modification II alloy. The yield points appear to be slightly less sharp than those for the previous test, but this is actually a result of the difference in x-axis scale rather than an actual change in behavior.

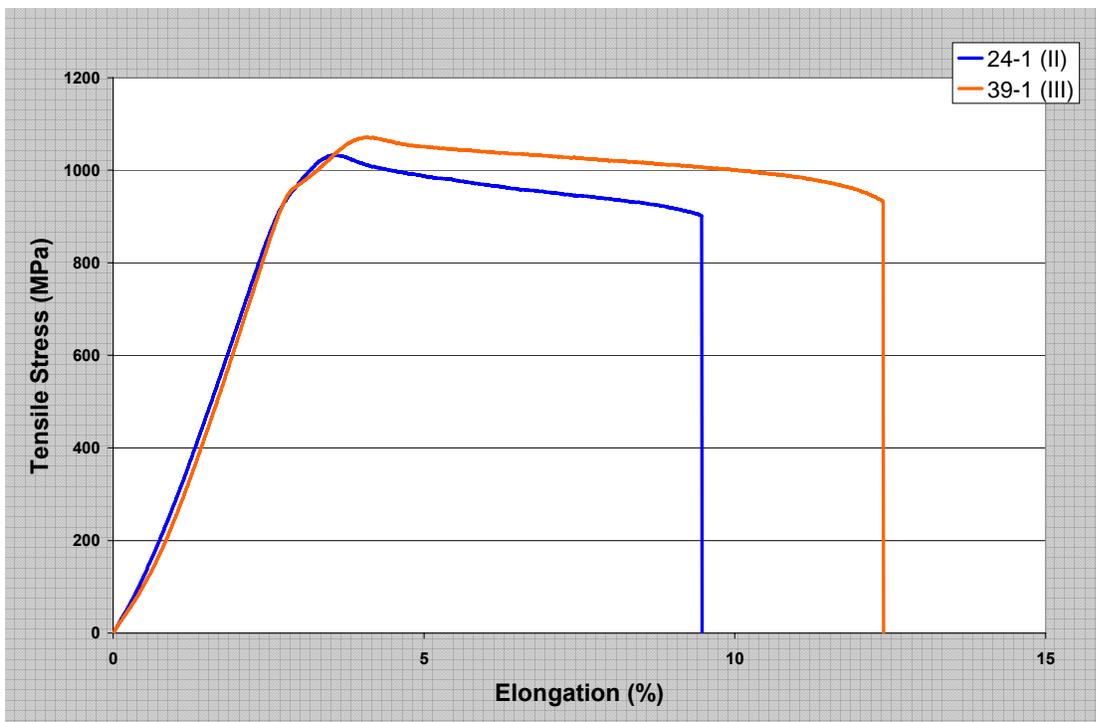
Figure 3-3. 850°C Tensile Testing Results.

strength – indicating some necking has occurred, which is consistent with what was observed on the samples. As with previous tests, the YS of both alloys is similar, but in this case, the YS of the Modification III alloy is higher, contrary to previous results. However, consistent with previous results, the Modification III alloy displays a greater amount of ductility than the Modification II alloy.

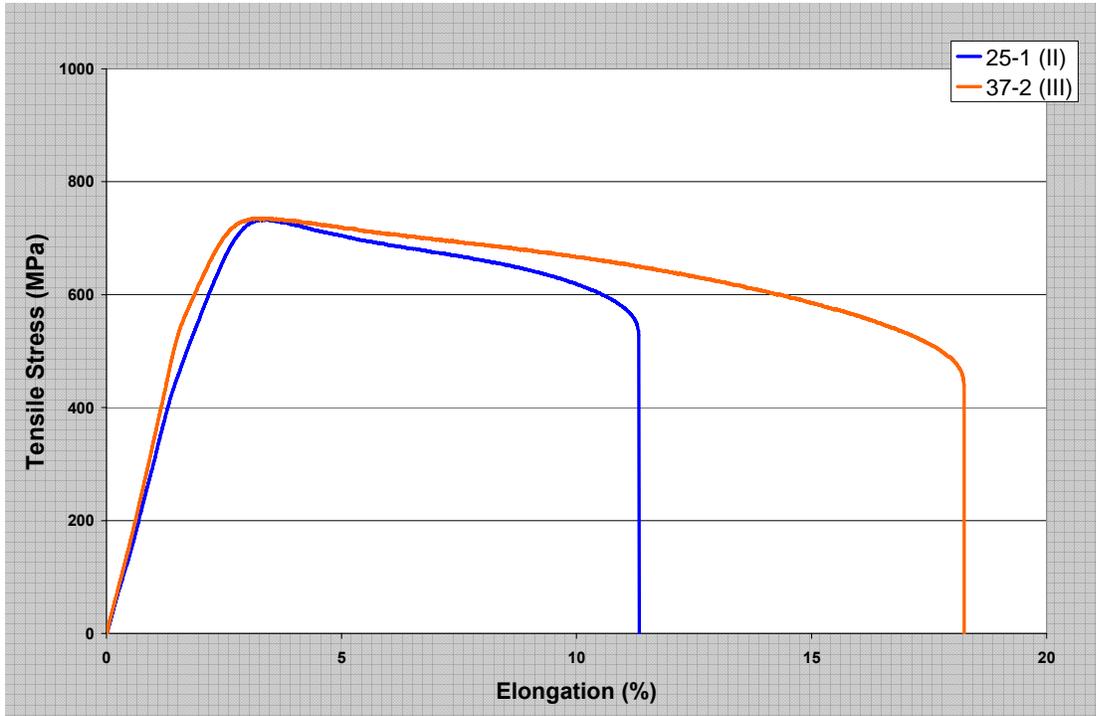
Figure 3-4. 950°C Tensile Testing Results.

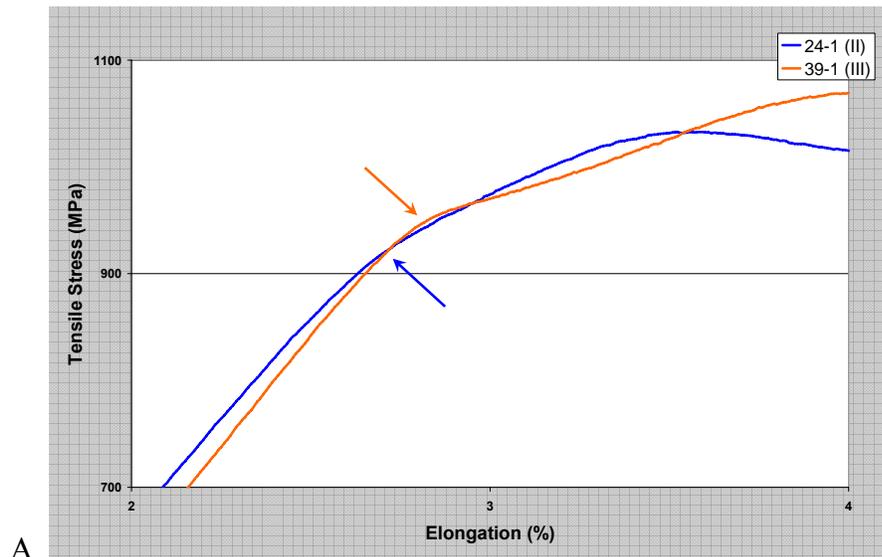
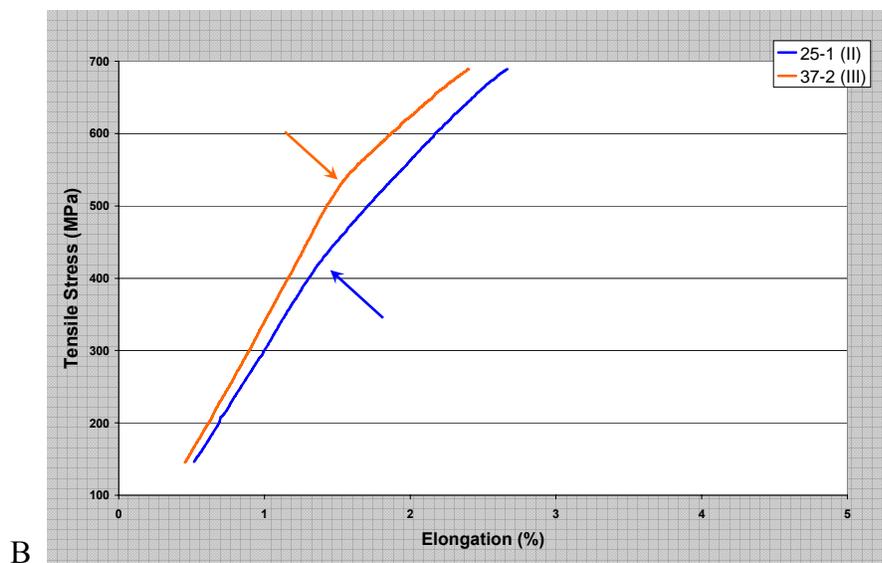
Closer examination of these curves indicates an bending point along the elastic portion of the curves, which can be seen more clearly in Figure 3-5 (A-B) (*following page*). Existence of such a bending point suggests that there is some change in deformation mechanism, which is why the YS values were based upon this point, rather than the upper point on each curve. It is highly unlikely that this behavior was due to slippage of the extensometer, because the other tests did not exhibit such behavior, and the behavior was consistent within each set of conditions.

Figure 3-5. Magnified Portions of Tensile Testing Curves at A) 850°C and B) 950°C. Bending points identified by arrows.

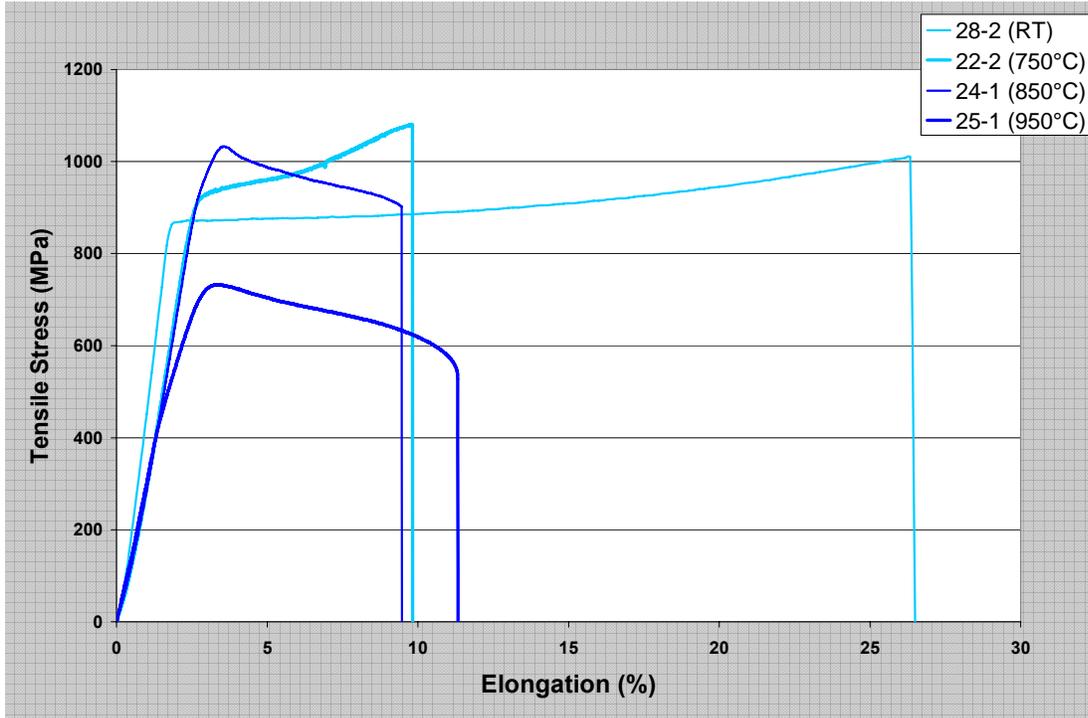
Figures 3-6 and 3-7 (below) illustrate the changing behavior of each alloy with temperature:

Figure 3-6. Modification II Tensile Testing Results.

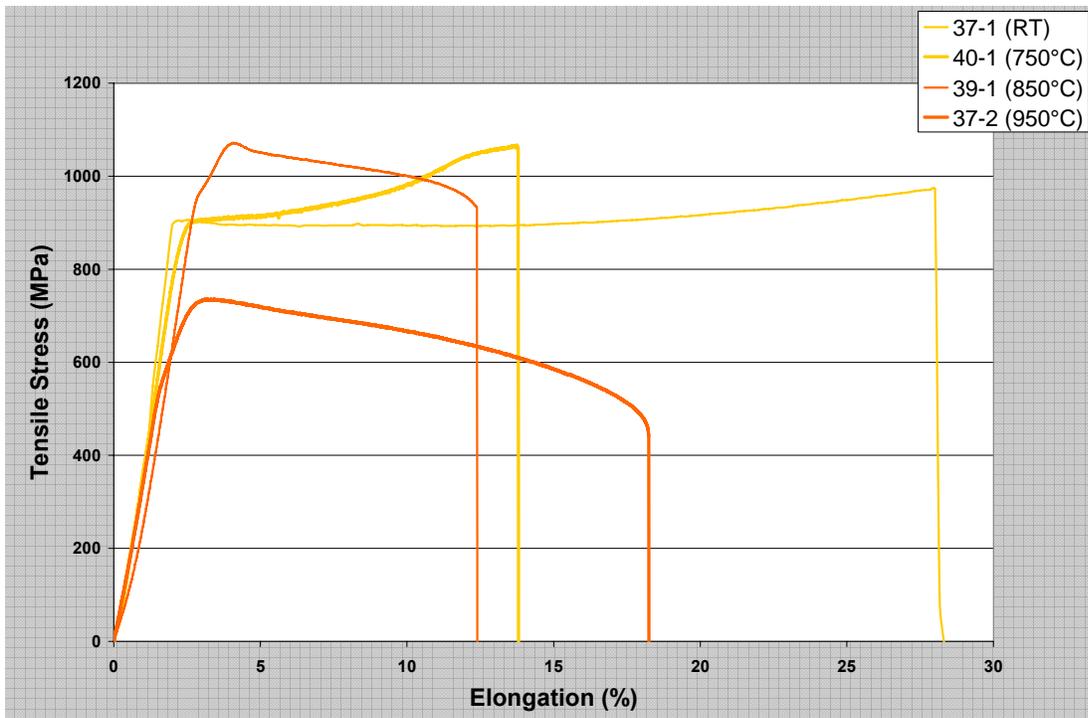
Figure 3-7. Modification III Tensile Testing Results.

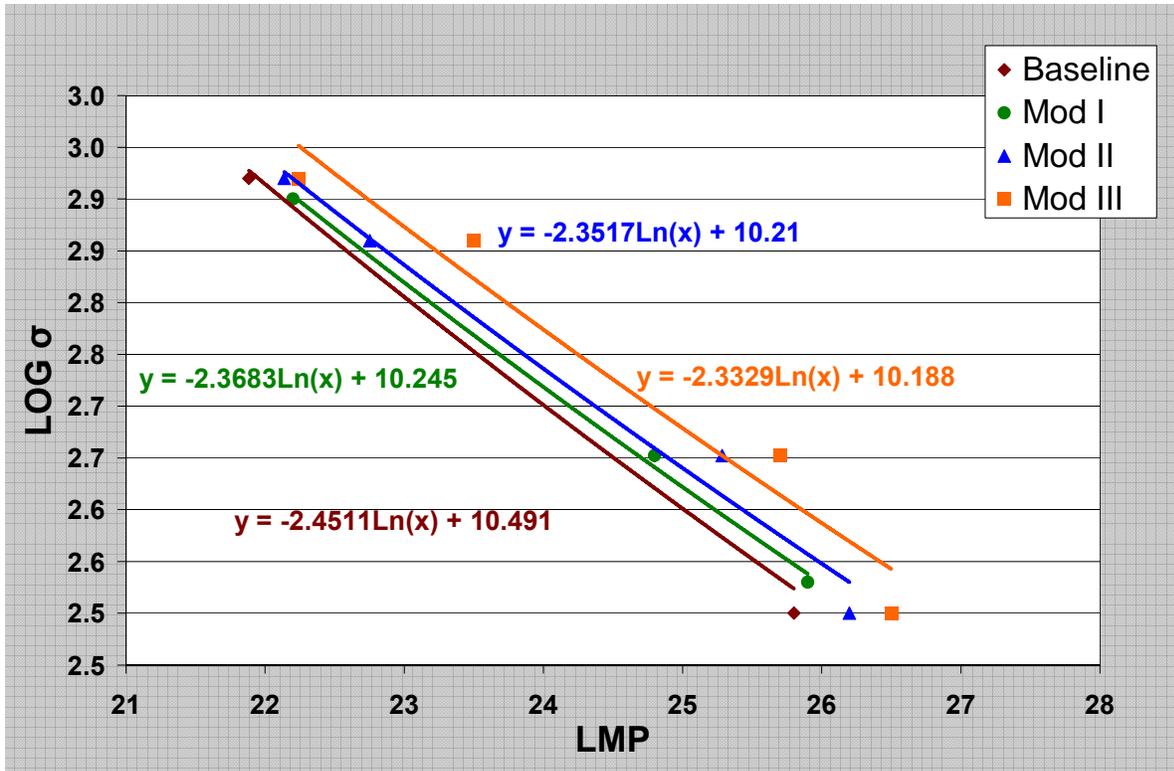
The final Larson-Miller plot is shown in Figure 3-8 (*following page*), with the derived equations for each trendline displayed for comparison.

Figure 3-8. Larson-Miller Plot.

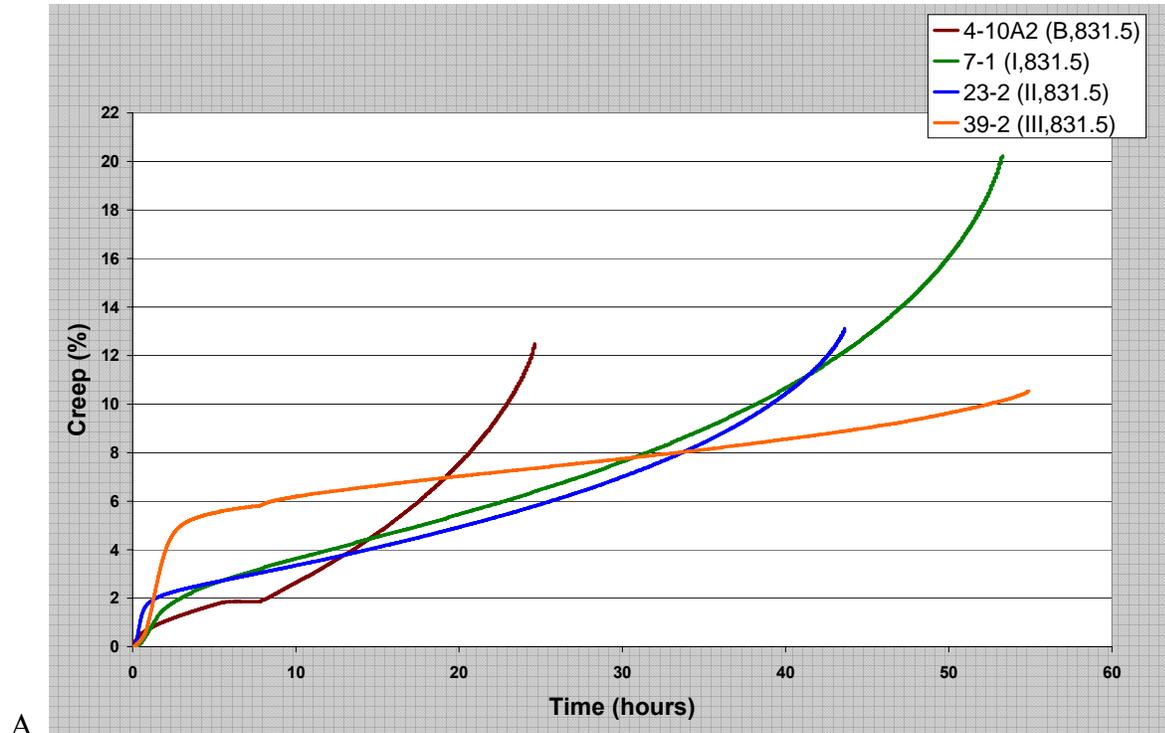
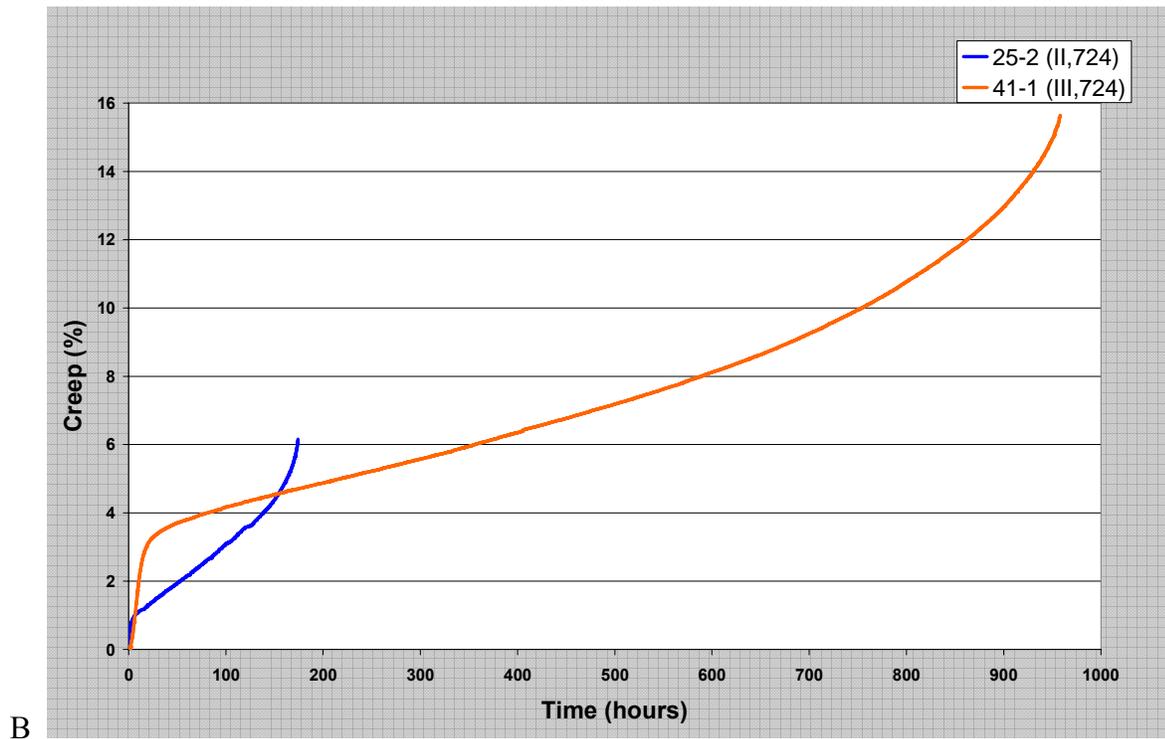
The results of the first set of 750°C creep tests can be seen in Figures 3-9 and 3-10 (*following page*). The testing at 831.5 MPa indicates that all three modifications undergo some degree of pronounced primary creep, followed by a long period of secondary and tertiary creep. These regions are characterized by: a rapid rise in elongation initially (primary); a region of low, nearly-linear creep rate (secondary); and a region of exponentially increasing elongation to failure (tertiary). The transition between the regions of secondary and tertiary creep is not clearly evident, indicating that there may be significant overlap of the mechanisms typically dominate each region.

Figure 3-9. 750°C Creep Testing Results for A) 831.5 MPa B) 724 MPa.

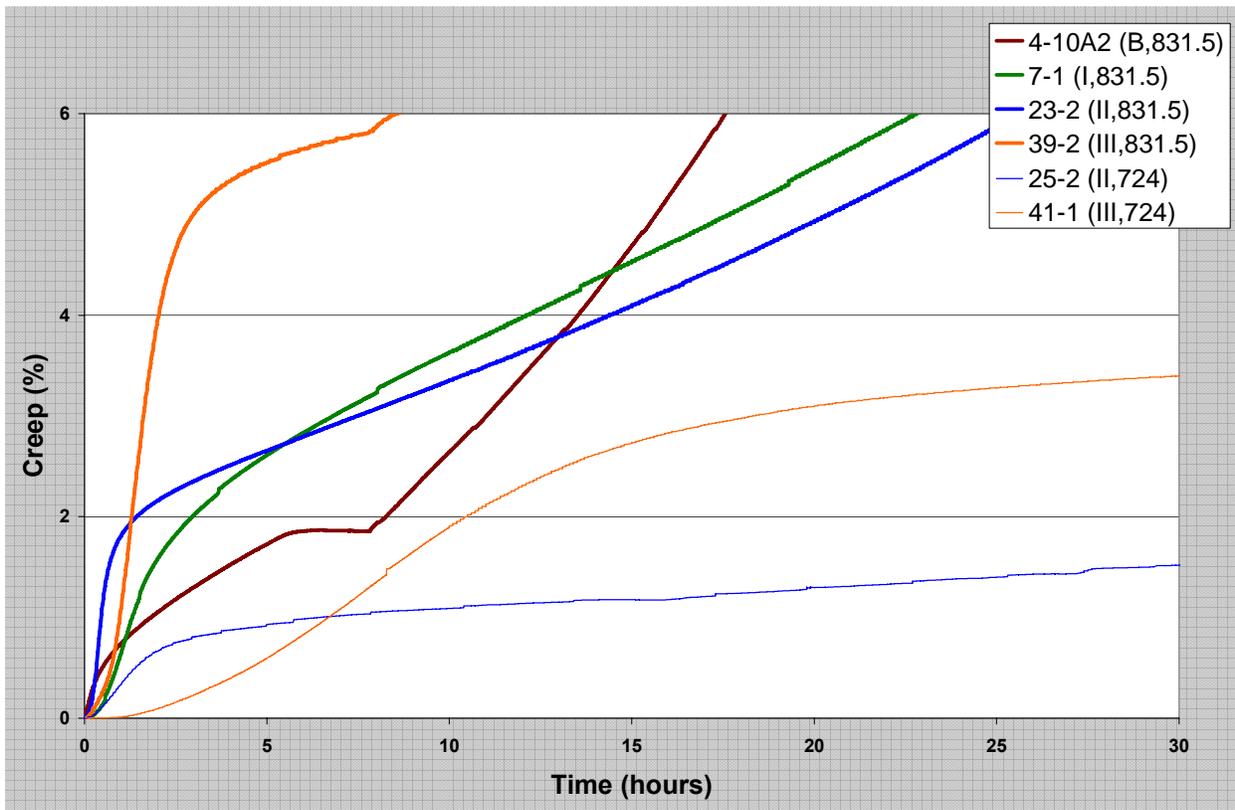
The curves for the 724 MPa tests are shown in Figure 3-10 as well, but obviously no comparison may be made between the Baseline and the Modification II and III alloys at that stress level. These are provided in the graph to show the difference in the primary creep behavior exhibited by the same alloy at a lower stress condition.

Figure 3-10. Magnified Portion of Creep Testing Curves at 750°C.
