MODIFIED PWA 1483 NICKEL-BASED SUPERALLOY
FOR INDUSTRIAL GAS TURBINE APPLICATIONS

A DISSERTATION PRESENTED TO THE GRADUATE SCHOOL
OF THE UNIVERSITY OF FLORIDA IN PARTIAL FULFILLMENT
OF THE REQUIREMENTS FOR THE DEGREE OF
MASTER OF SCIENCE

UNIVERSITY OF FLORIDA

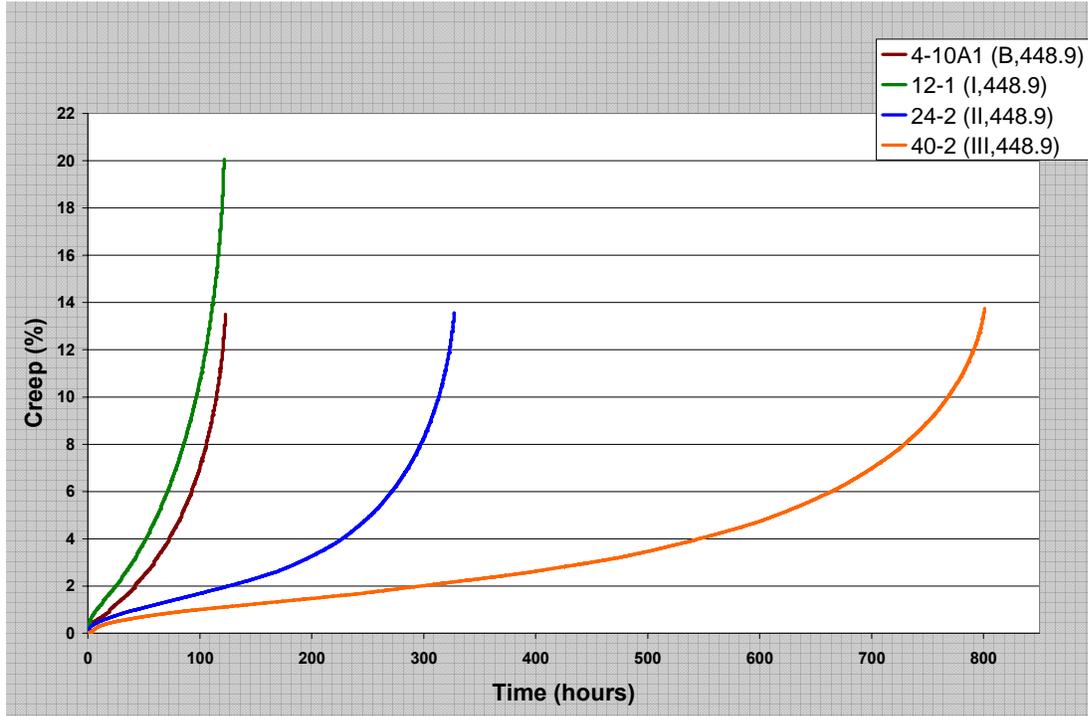
The results of the 850°C creep tests can be seen in Figure 3-11 (*below*):

Figure 3-11. 850°C Creep Testing Results.

The results for these conditions indicate that Modifications II and III exhibit improved lifetimes from that of the Baseline alloy, whereas Modification I exhibits decreased creep resistance compared to the Baseline. The improvement of the Modification II and III alloys shows significant promise, in that it represents between a 3x and 8x increase. In addition, it appears that where the Baseline alloy exhibited a slightly longer delay in primary creep than did any of the three modified alloys at 750°C/831.5 MPa, in this case, the Modification II and III alloys now have a longer delay, as can be seen in Figure 3-12 (*following page*). Again, the difference in the delay of primary creep is insignificant on the scale of the lifetime of the alloys, but the data seems to indicate that there is at least some improvement. Again, there is no clear transition point between the secondary and tertiary regions of creep, indicating significant mechanism overlap as before.

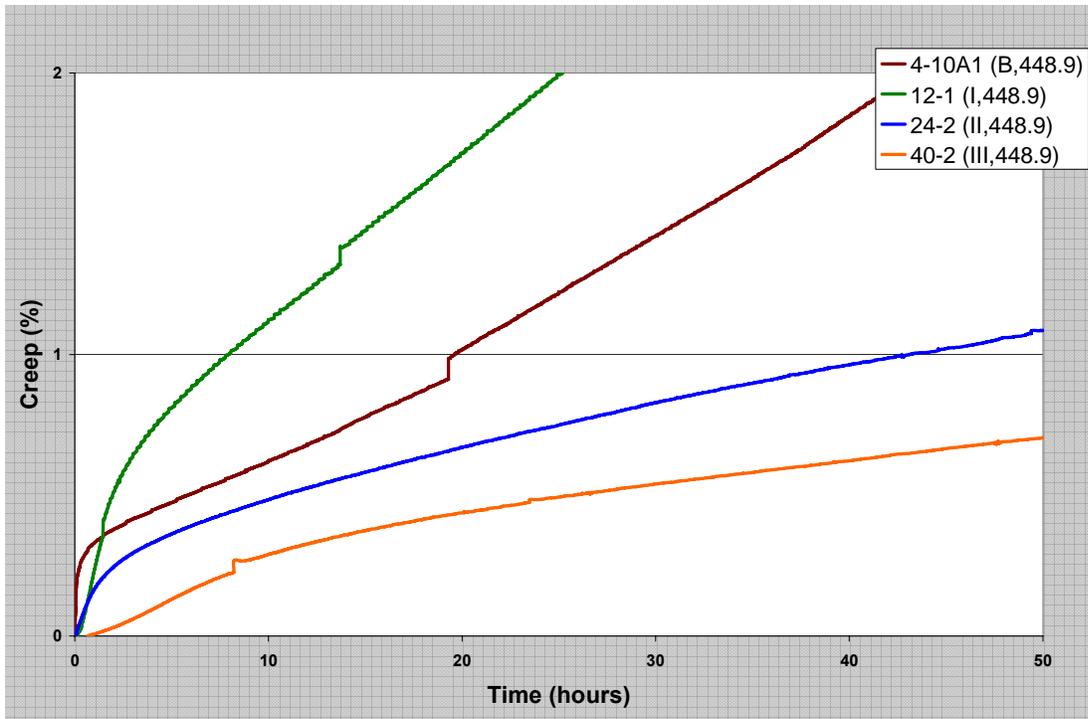
Figure 3-12. Magnified Portion of Creep Testing Curves at 850°C.

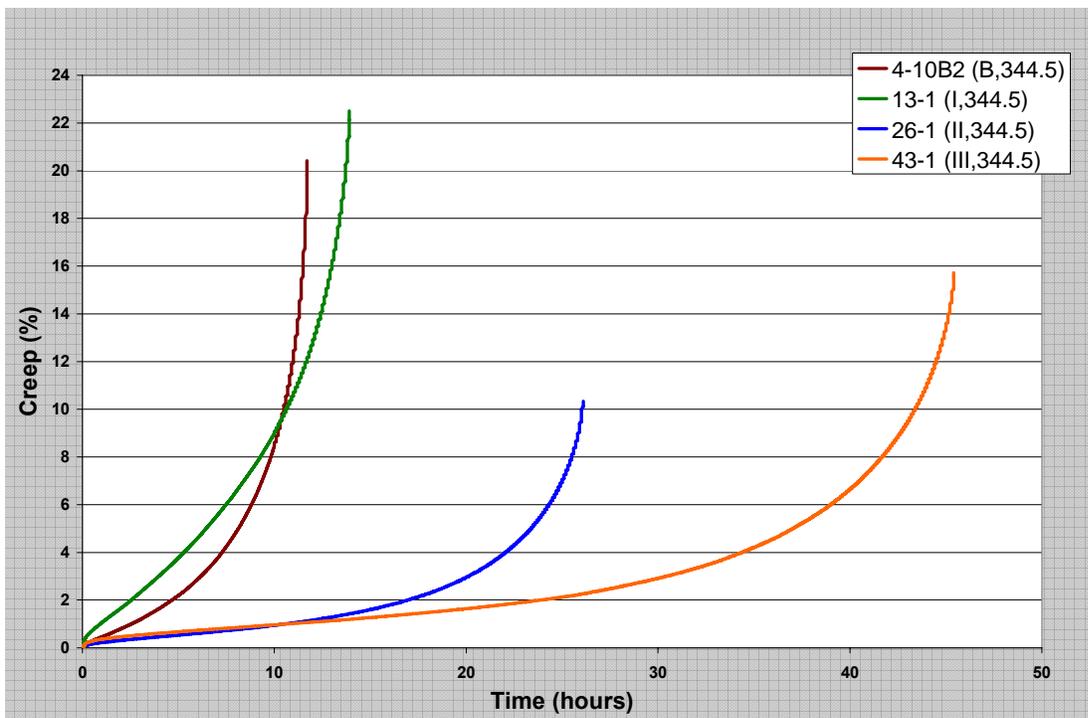
The results of the 950°C creep tests can be seen in Figure 3-13 (*below*):

Figure 3-13. 950°C Creep Testing Results.

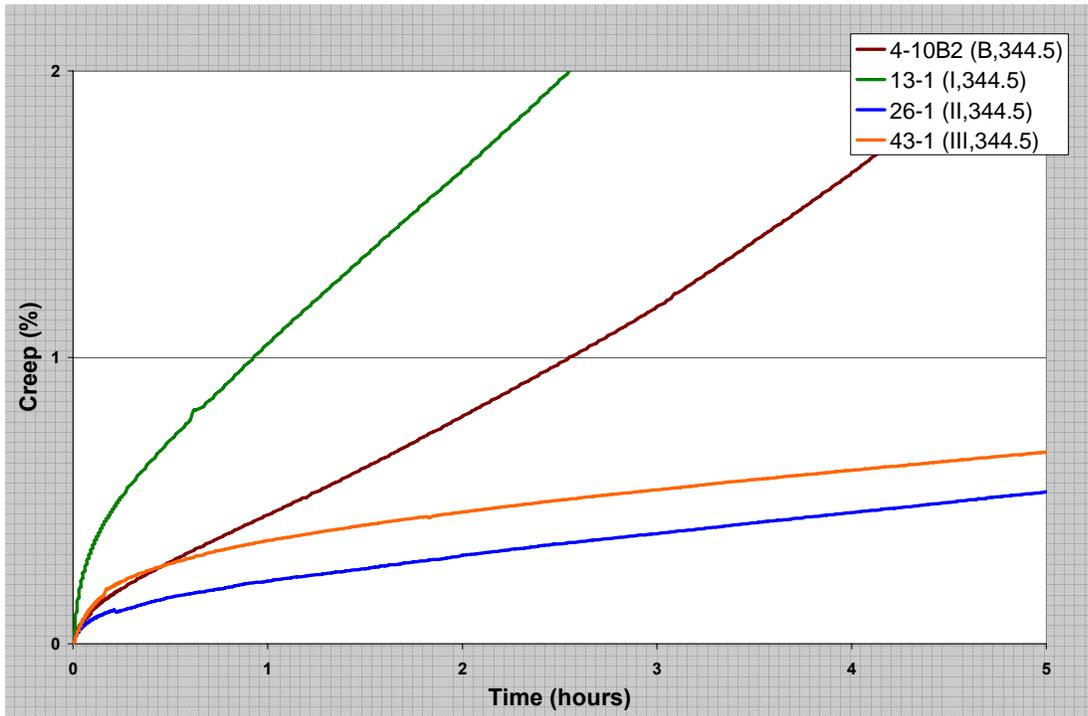
The comparison of primary creep behavior can be seen in Figure 3-14 (*below*). The values for all three alloys are now essentially identical. In the case of the Modification I alloy, and somewhat for the Baseline alloy, it is actually of more concern that the alloys seem to go directly from primary to tertiary creep under these conditions.

Figure 3-14. Magnified Portion of Creep Testing Curves at 950°C.

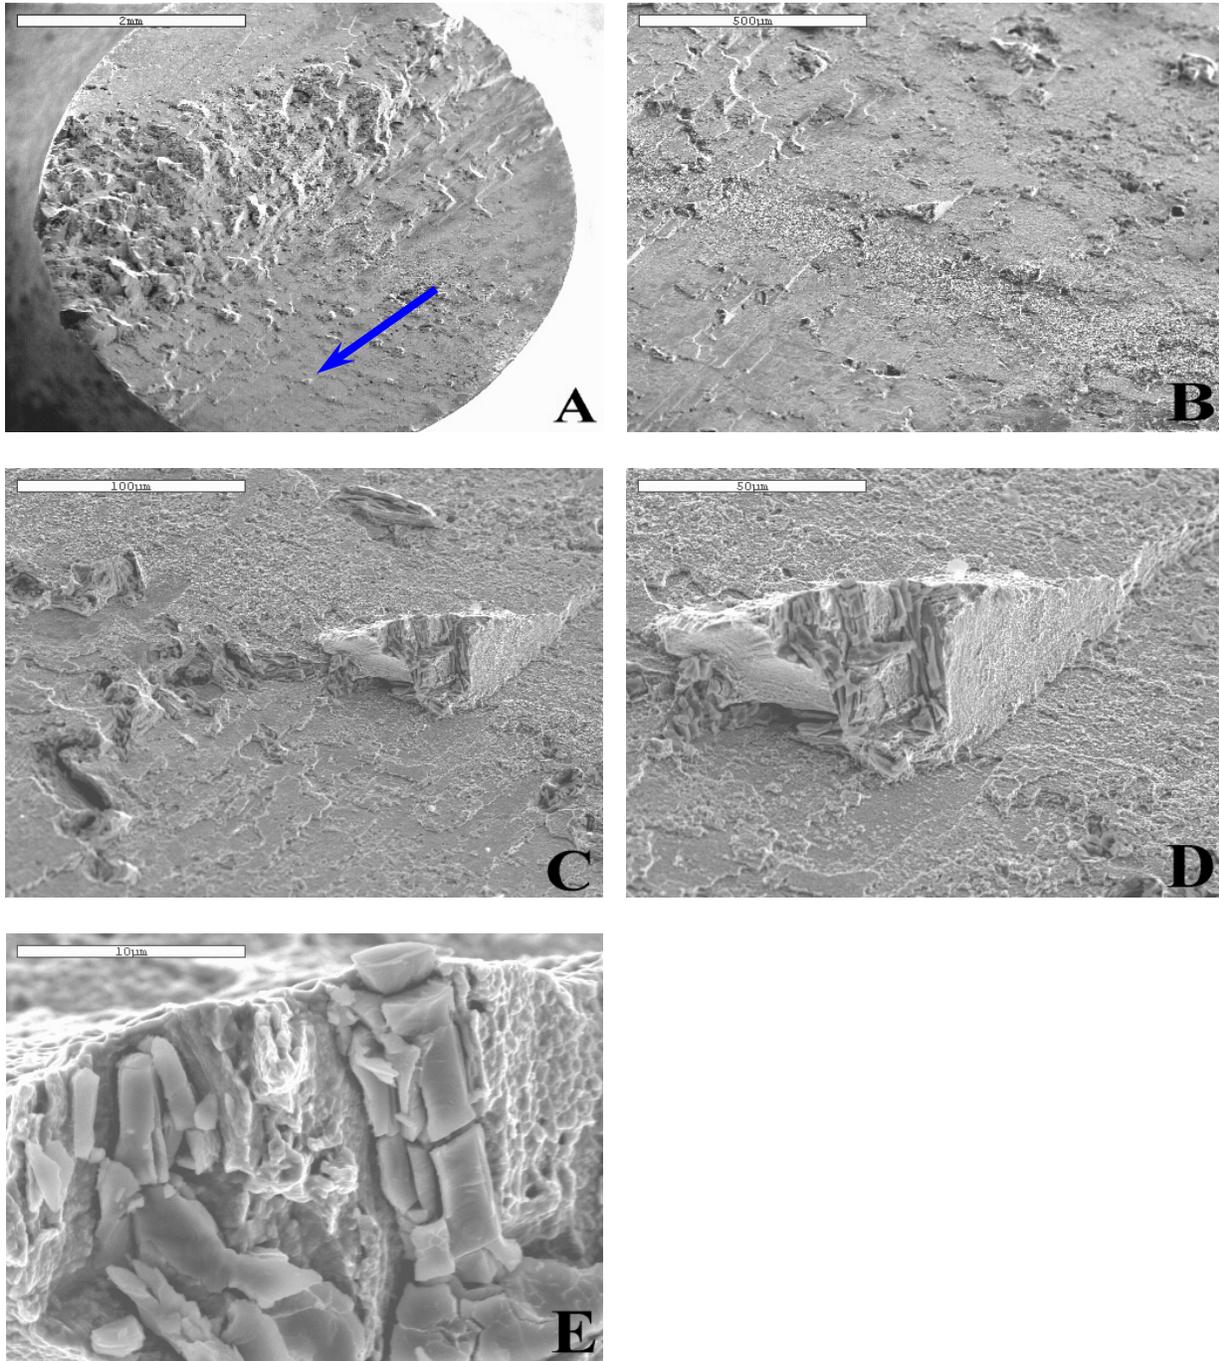
An example series of the tensile sample fracture surfaces can be seen in Figure 3-15 (A-E) (*below*). An arrow is provided on the 25x image to show the location of the other micrographs.

Figure 3-15. Fracture Surface of Tensile Sample (40-1; *Modification III*) at A) 25x B) 100x C) 500x D) 1000x E) 5000x.

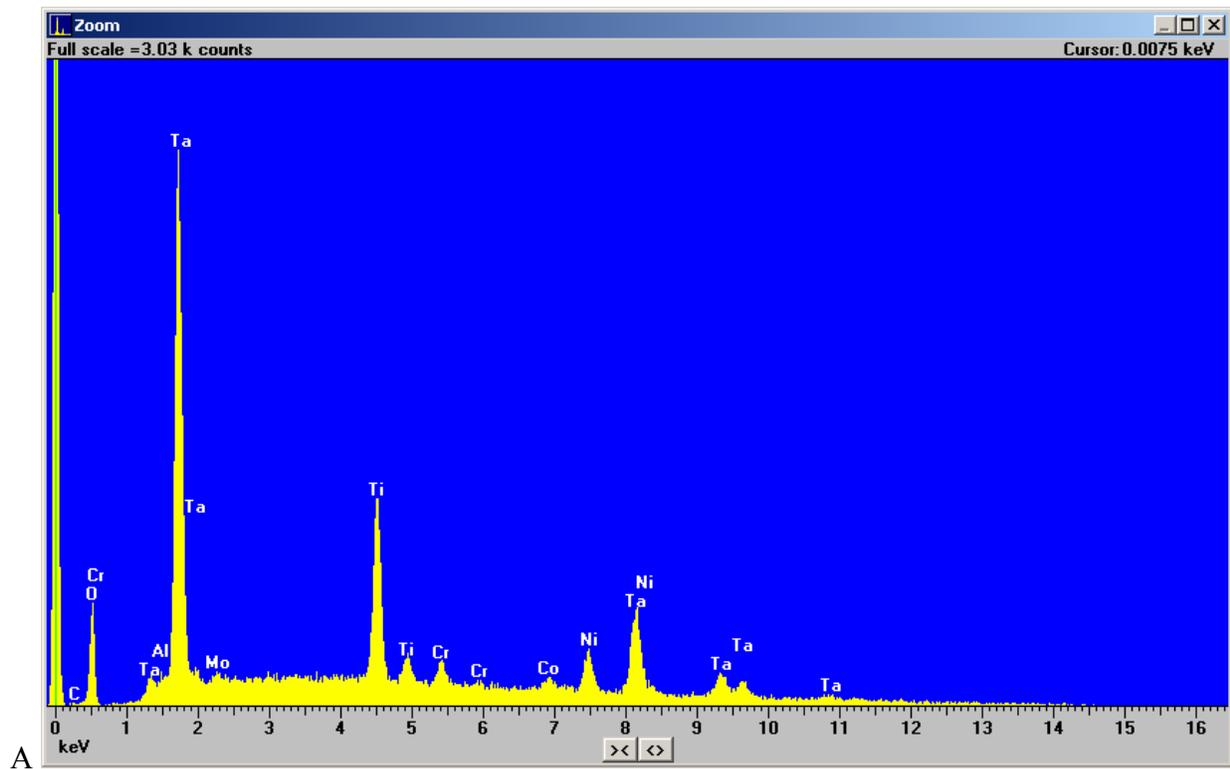
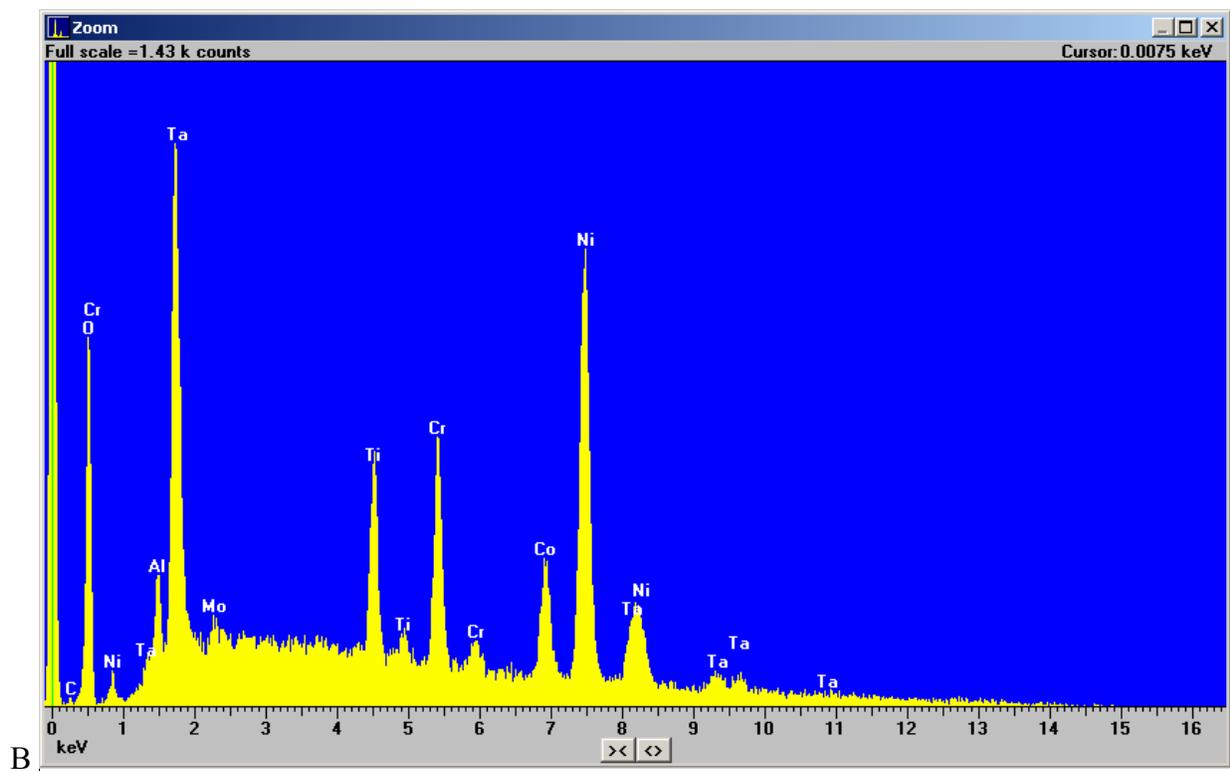
**The Carbide scan was taken as a spot sample on the carbide itself. The Surrounding Area scan was taken for the entire area shown in Figure 3-15 (E). Values are shown to exhibit that there was a difference between the compositions of each area.

Figure 3-16. EDS Spectra of Sample 40-1 features: A) Carbide B) Surrounding Area.

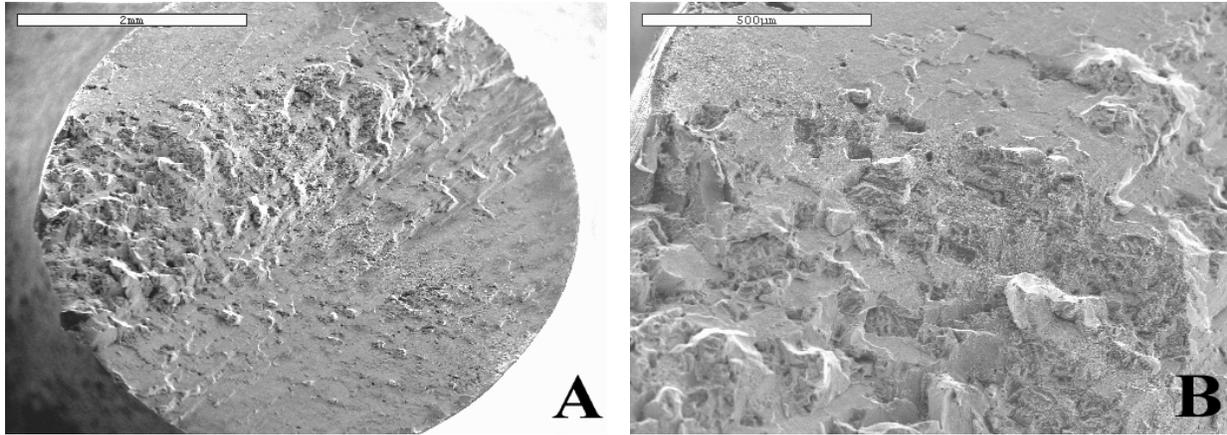
The tensile samples exhibited mixed-character deformation at all temperatures. This was dominated by quasi-cleavage and cleavage-like fracture on the order of 90%. Evidence of ductility in all samples was present, but remained approximately 10% of the fracture surface in all cases. At low magnifications (25x, 100x) the surface sometimes appeared to be the result of a ductile-type failure, as seen in Figure 3-17 (A-B) (*below*):

Figure 3-17. Fracture Surface of Tensile Sample (40-1; *Modification III*) at A) 25x B) 100x.

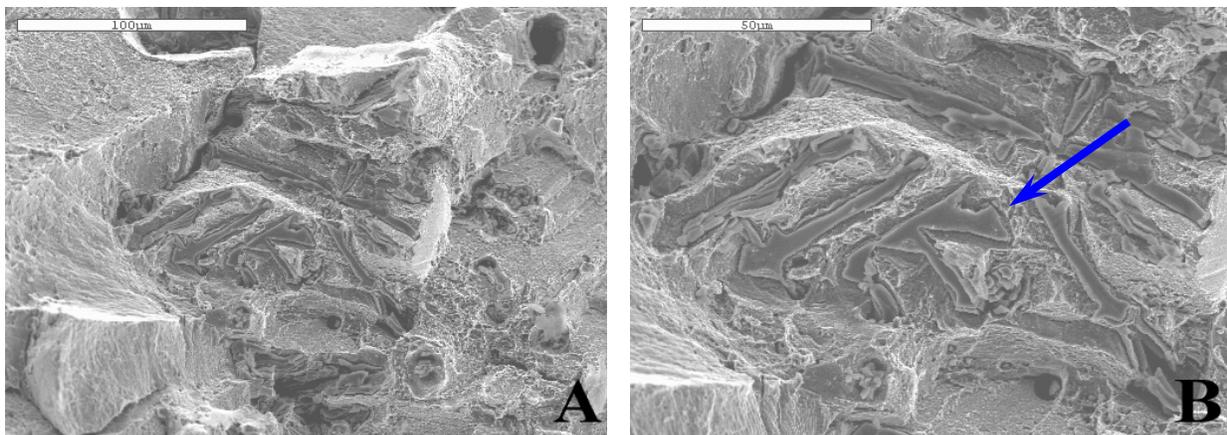
Figure 3-18. Fracture Surface of Tensile Sample (40-1; *Modification III*) at A) 500x B) 1000x.

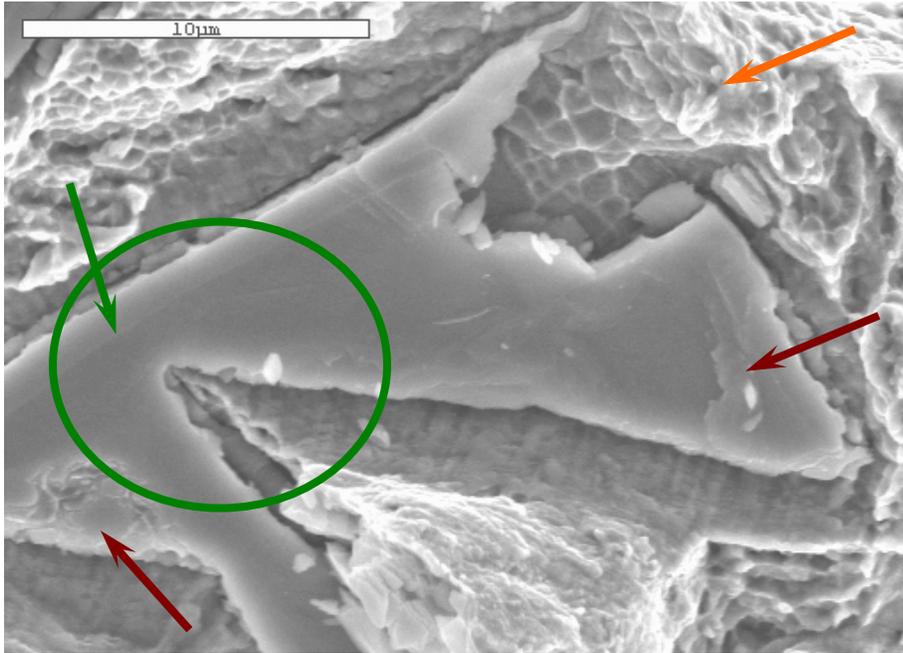
Figure 3-19. Fracture Surface of Tensile Sample (*40-1; Modification III*) at 5000x.

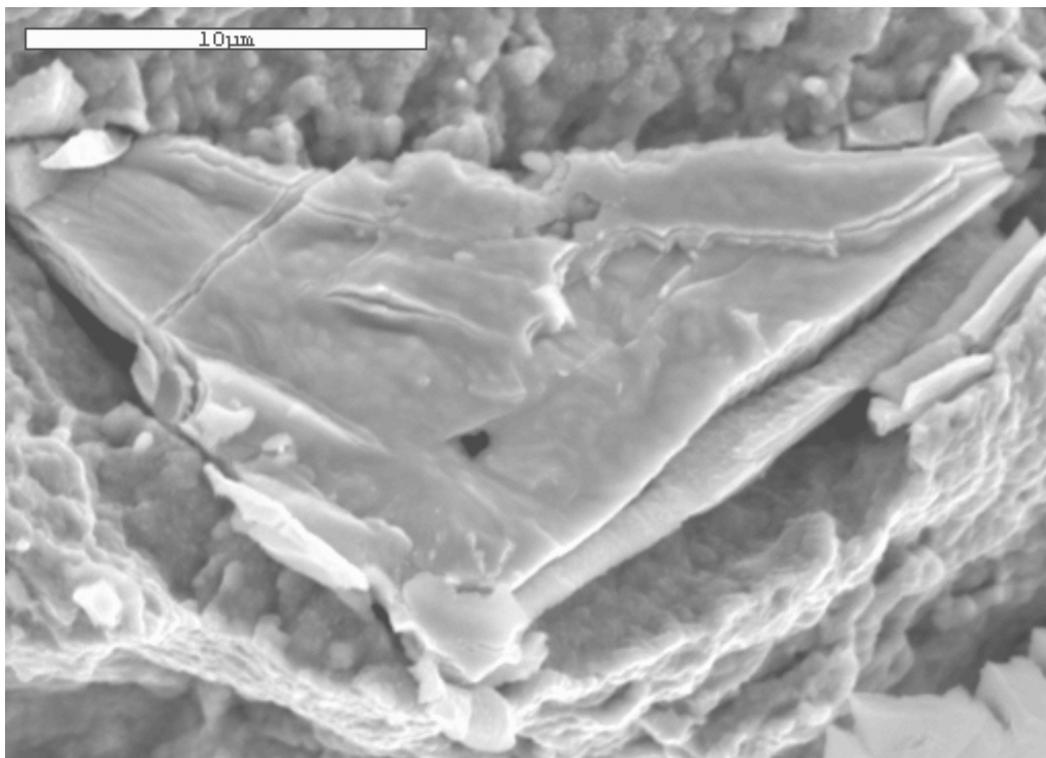
Figure 3-20. Fracture Surface of Tensile Sample (24-1; *Modification II*) at 5000x.

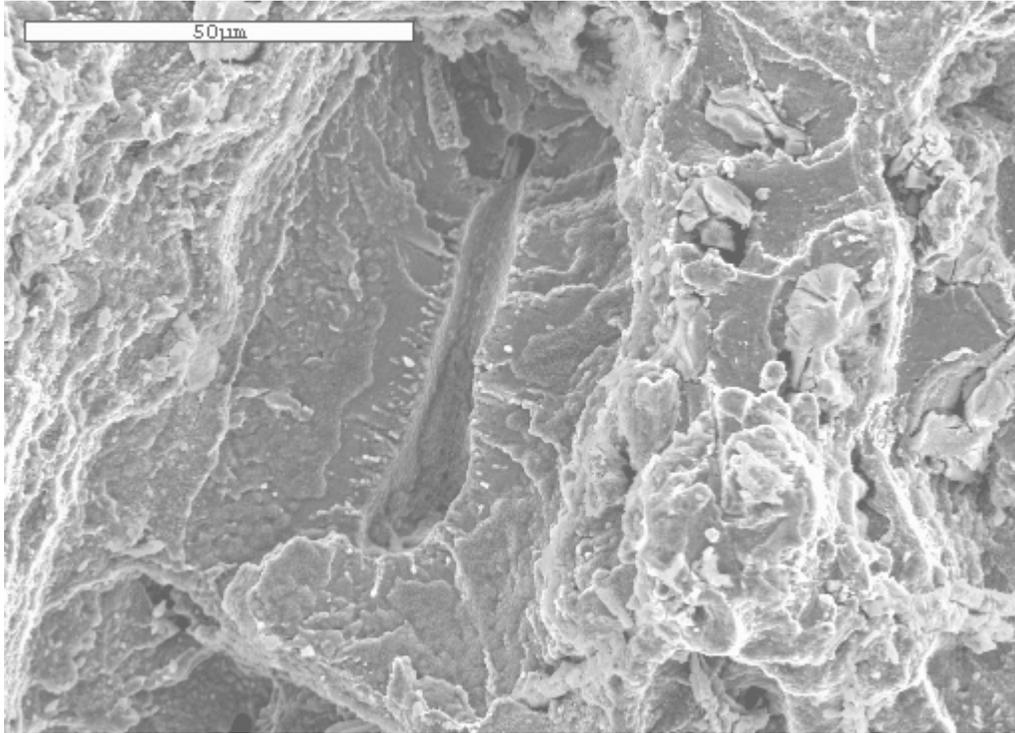
Figure 3-21. Fracture Surface of Creep Sample (*41-1; Modification III*) at 1000x.

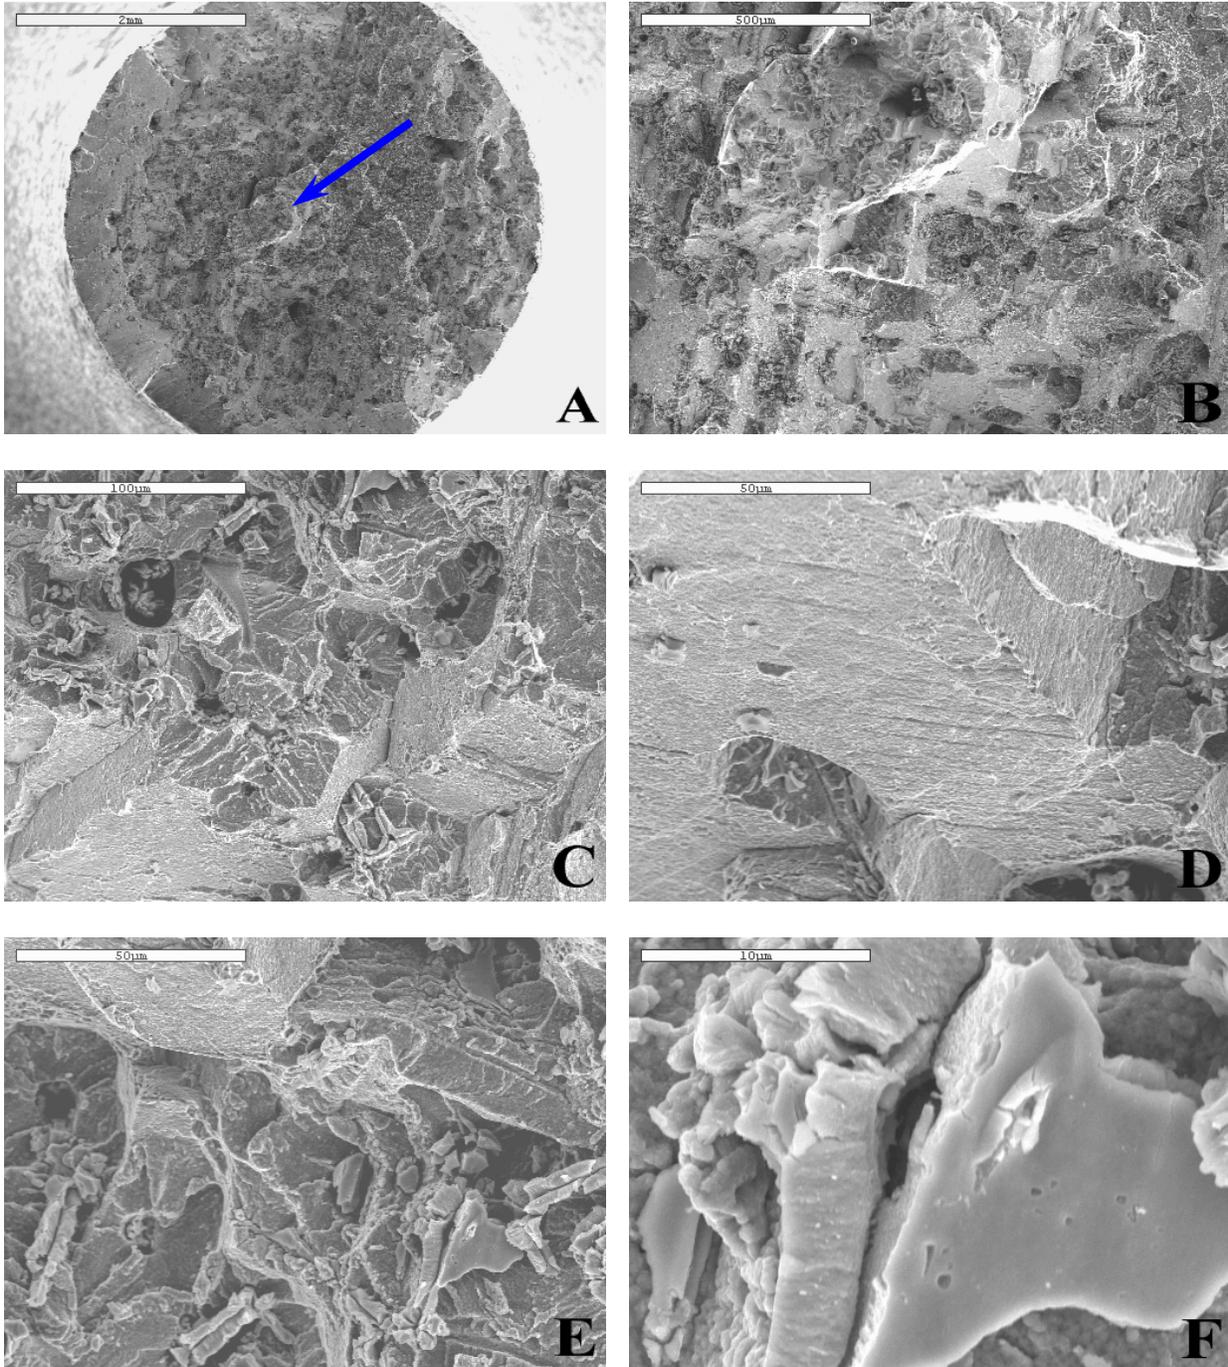
Figure 3-22. Fracture Surface of Creep Sample (39-2; *Modification III*) at A) 25x B) 100x C) 500x D) 1000x E) 1000x F) 5000x.

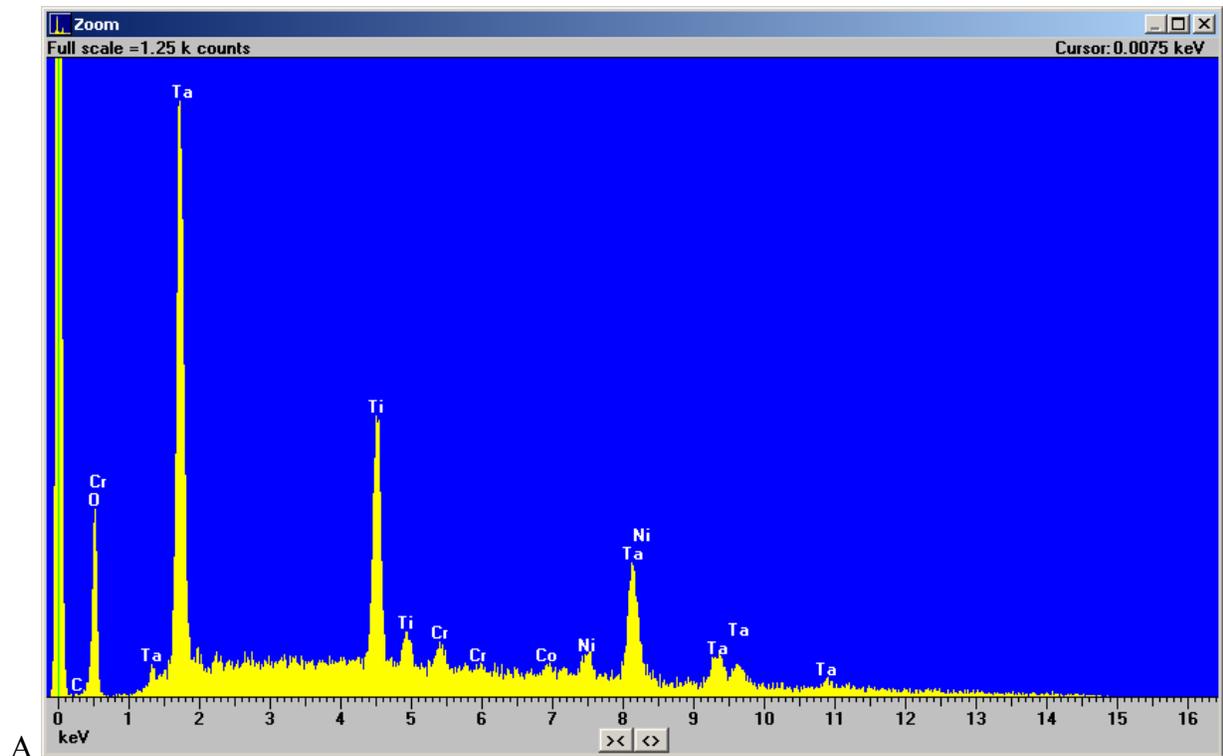
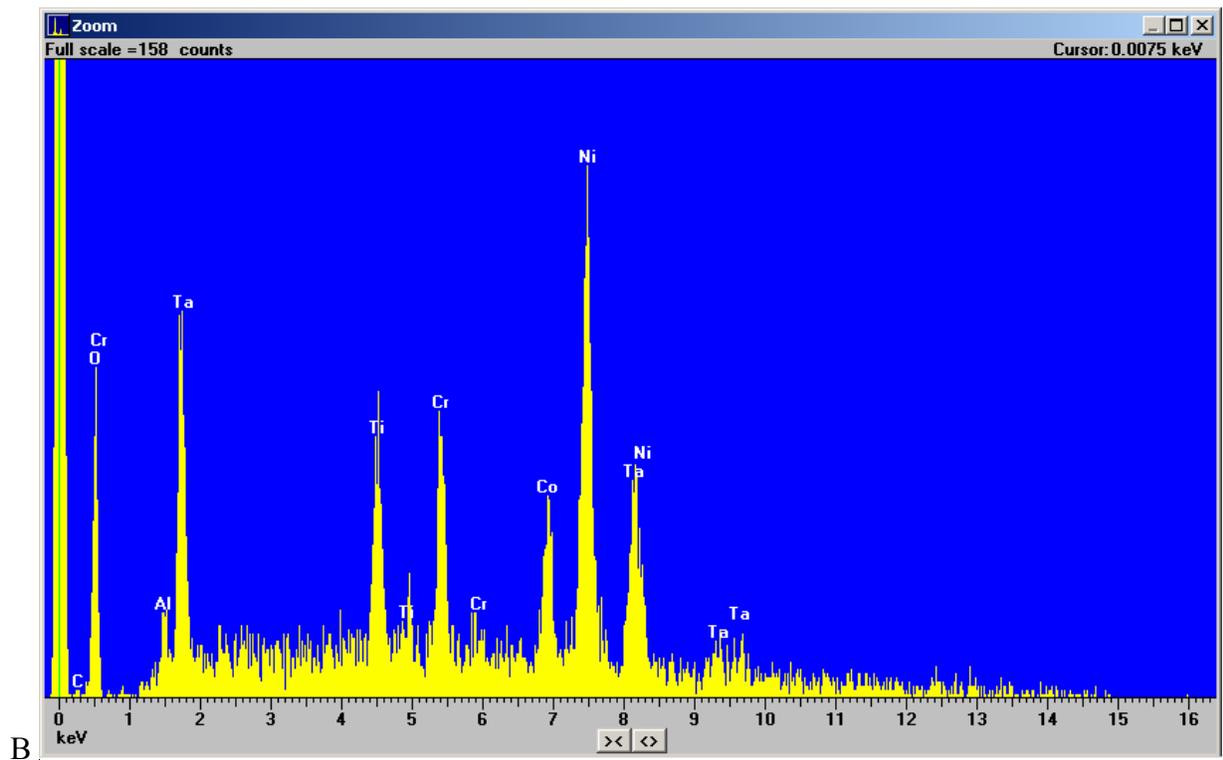
Figure 3-23. EDS Spectra of Sample 39-2 features: A) Carbide B) Surrounding Area.

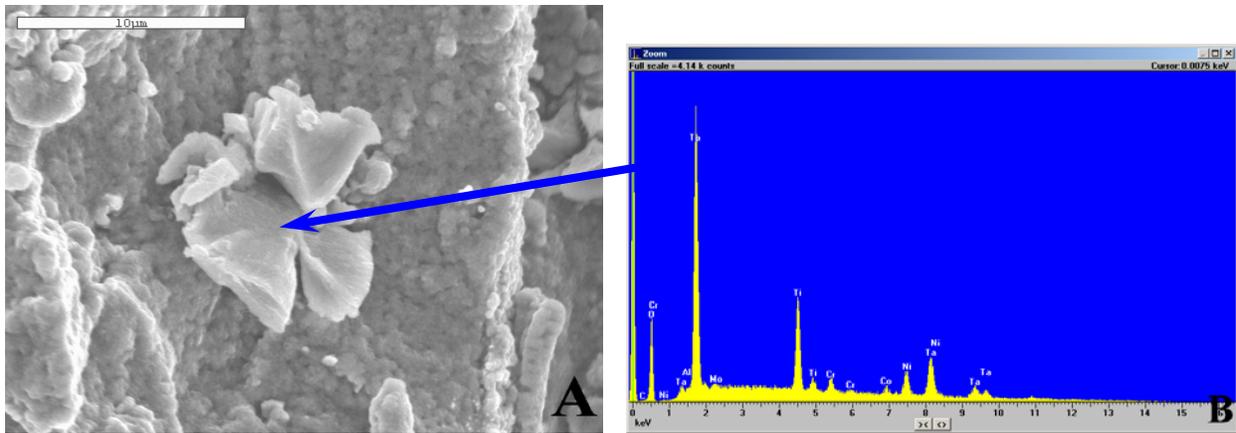
Figure 3-24. Carbide A) Morphology B) EDS Spectrum on Fracture Surface of Creep Sample (40-1; Modification III) at 5000x.

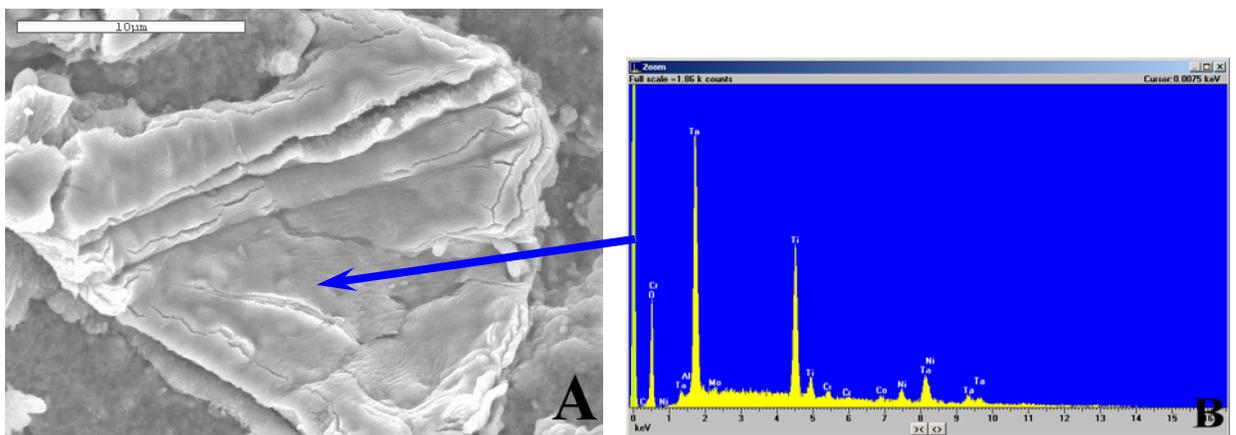
Figure 3-25. Carbide A) Morphology B) EDS Spectrum on Fracture Surface of Creep Sample (13-1; Modification I) at 5000x.

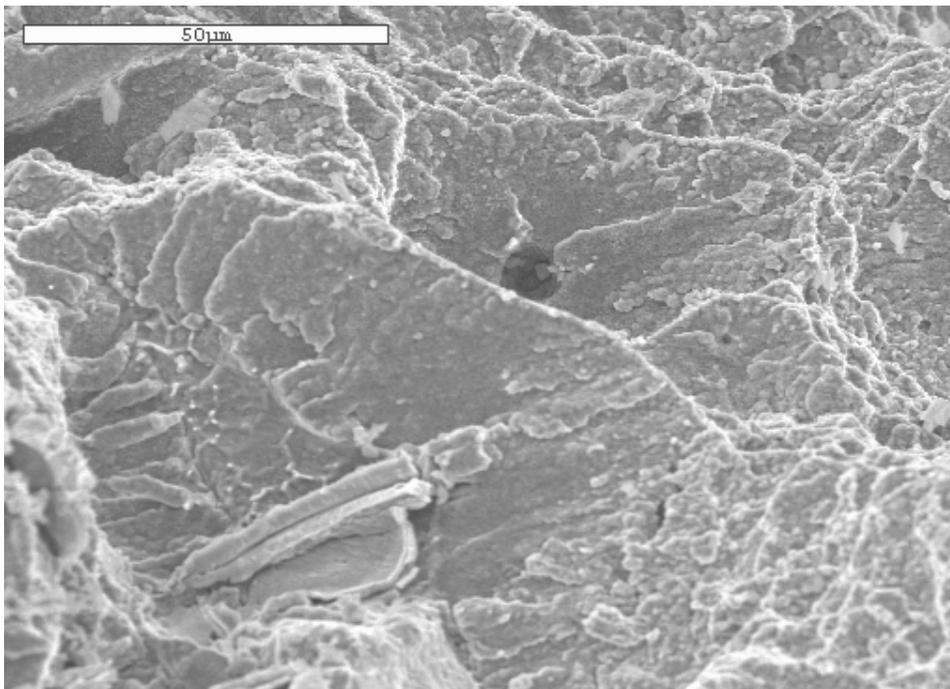
Figure 3-26. Fracture Surface of Creep Sample (40-2; *Modification III*) at 1000x.

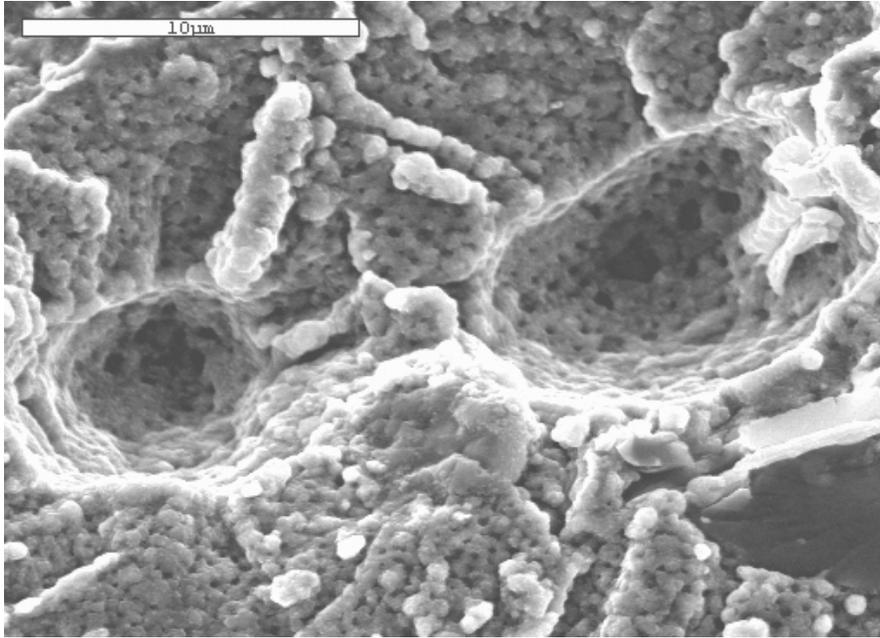
Figure 3-27. Casting Pores on Fracture Surface of Creep Sample (7-1; *Modification I*) at 5000x.

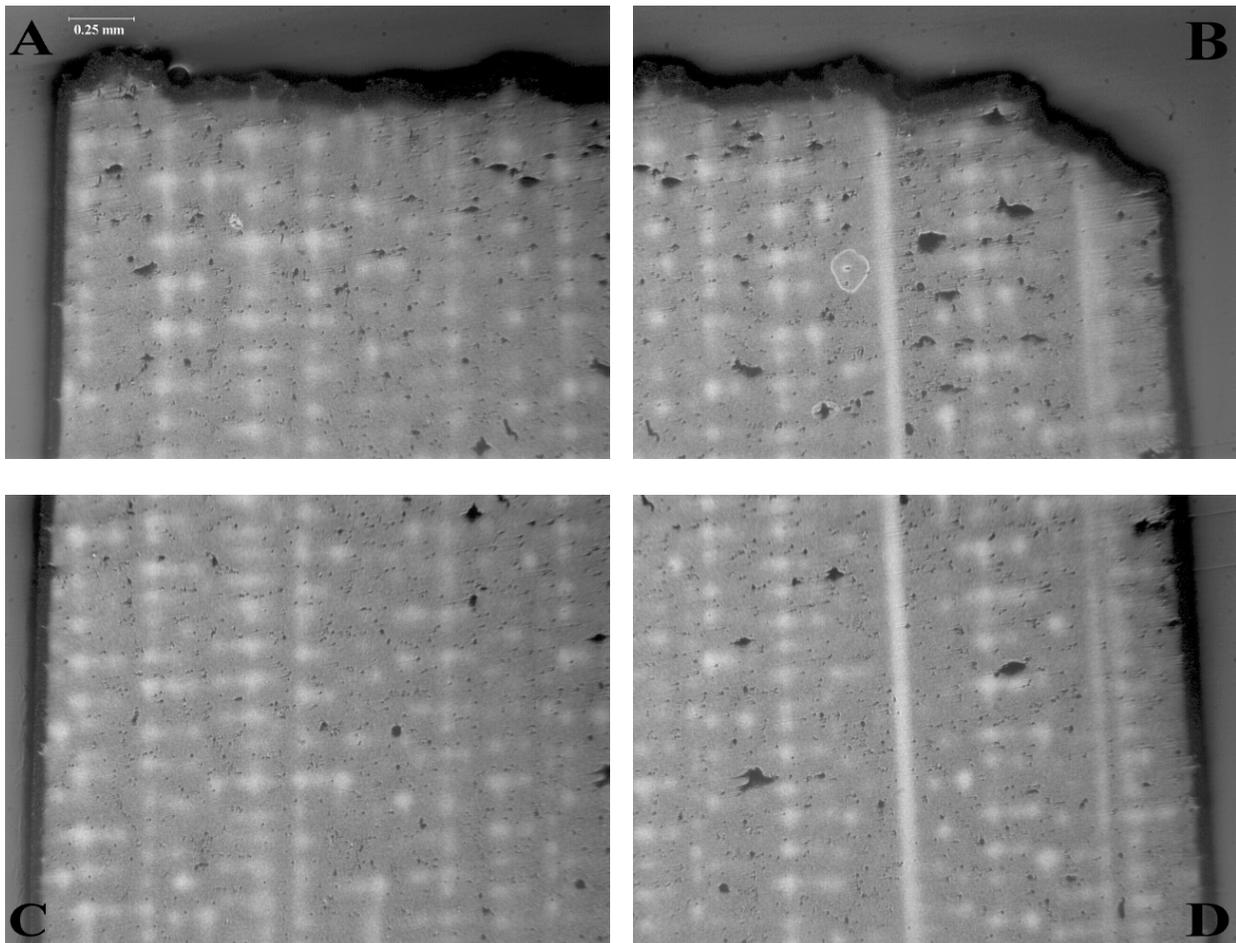
Figure 3-28. Cross-Section of Creep Sample (7-1; *Modification I*) A) Upper Left B) Upper Right C) Lower Left D) Lower Right.

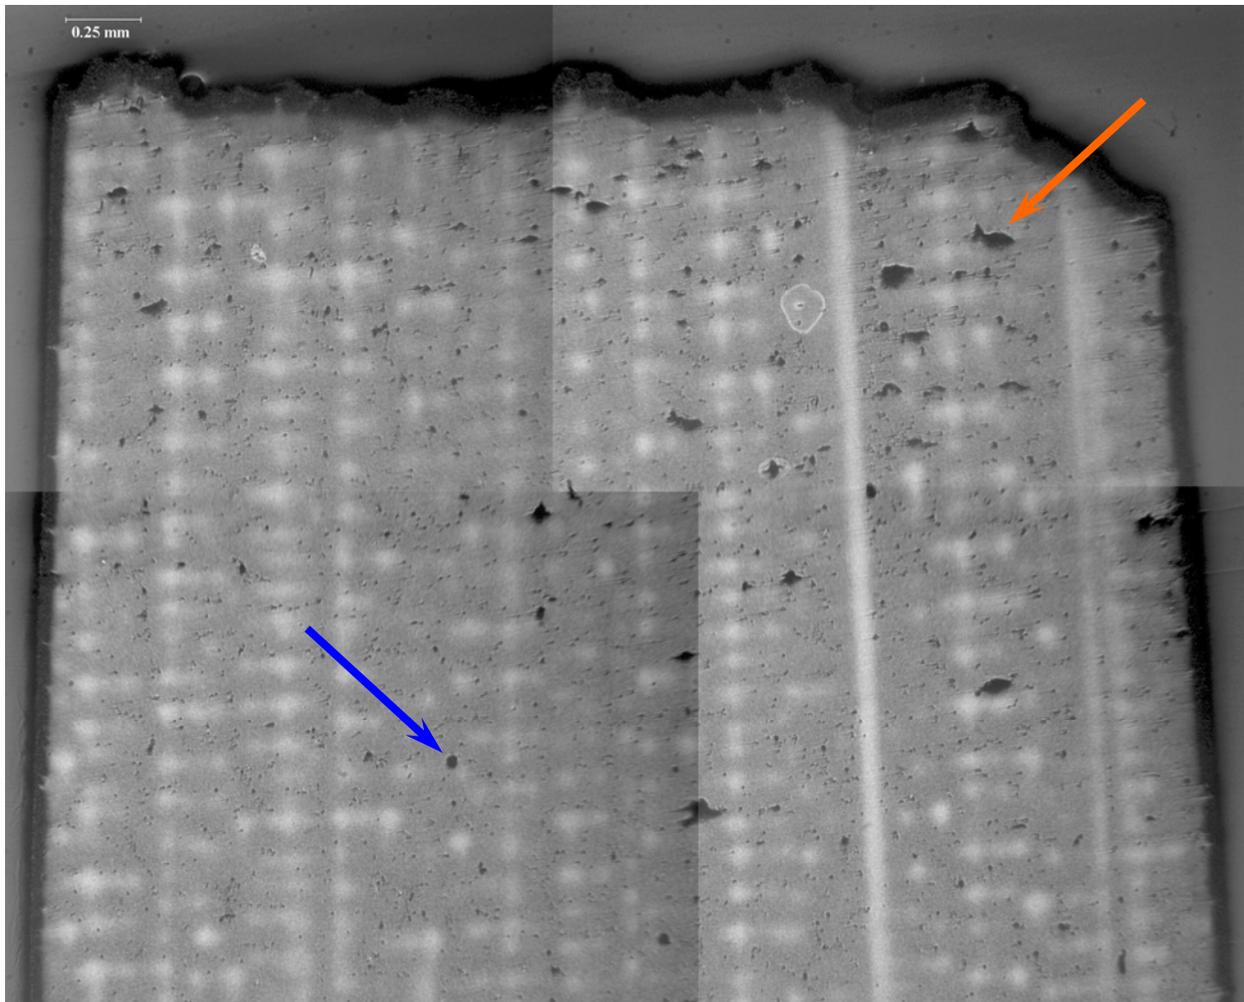
Figure 3-29. Composite Cross-Section of Creep Sample (7-1; Modification I).

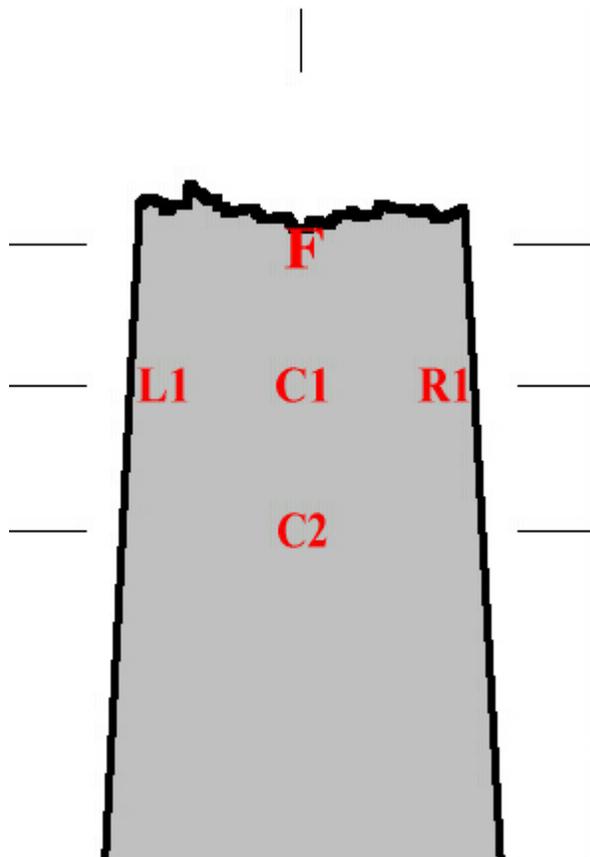
Figure 3-30. Imaging Points for SEM Analysis of Cross-Section Samples.

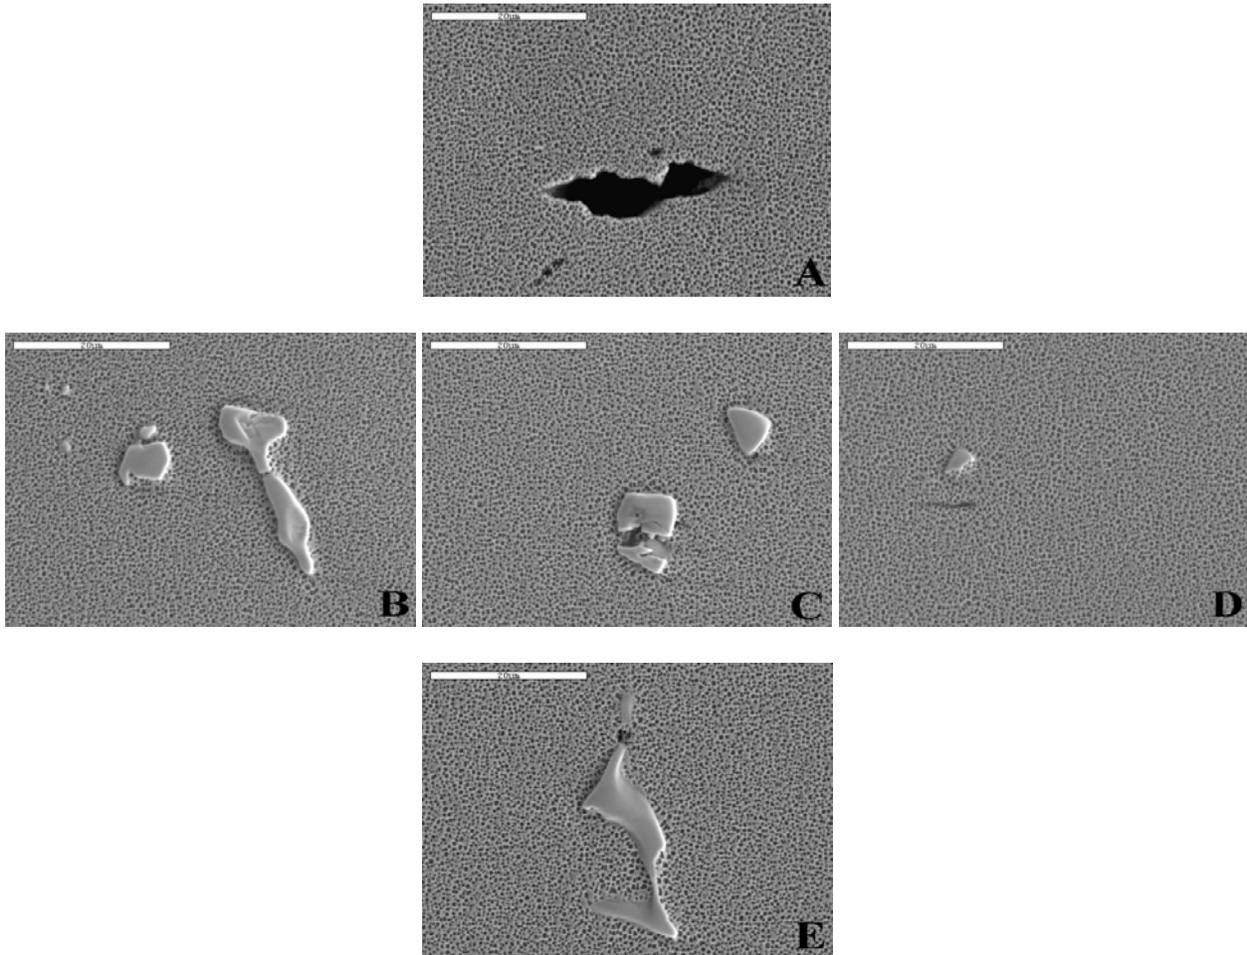
Figure 3-31. Imaging Points for Cross-Section of Creep Sample (7-1; *Modification I*) A) **F** B) **L1** C) **C1** D) **R1** E) **C2**.

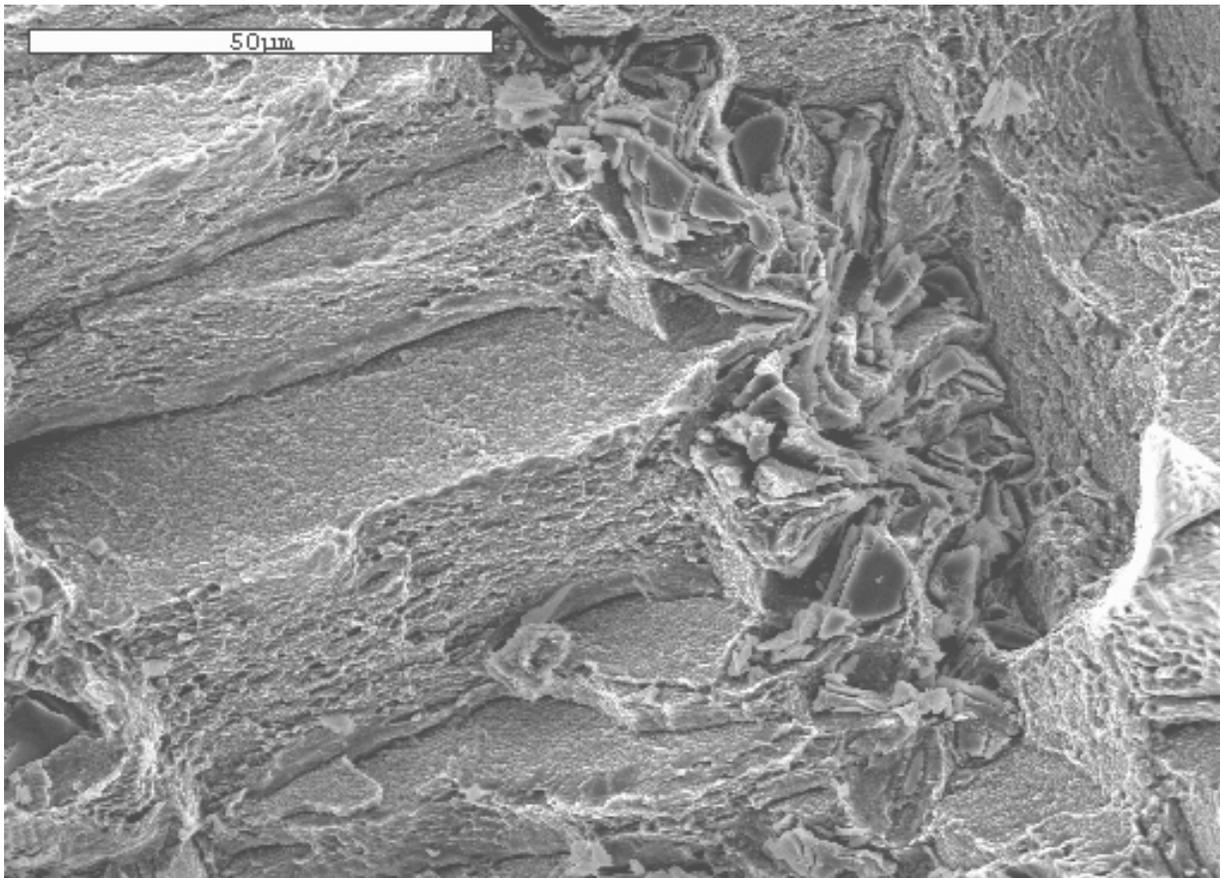
Figure 4-1. Fracture Surface of Creep Sample (7-1; *Modification II*) at 1000x.
