MODIFIED PWA 1483 NICKEL-BASED SUPERALLOY
FOR INDUSTRIAL GAS TURBINE APPLICATIONS

A DISSERTATION PRESENTED TO THE GRADUATE SCHOOL
OF THE UNIVERSITY OF FLORIDA IN PARTIAL FULFILLMENT
OF THE REQUIREMENTS FOR THE DEGREE OF
MASTER OF SCIENCE

UNIVERSITY OF FLORIDA

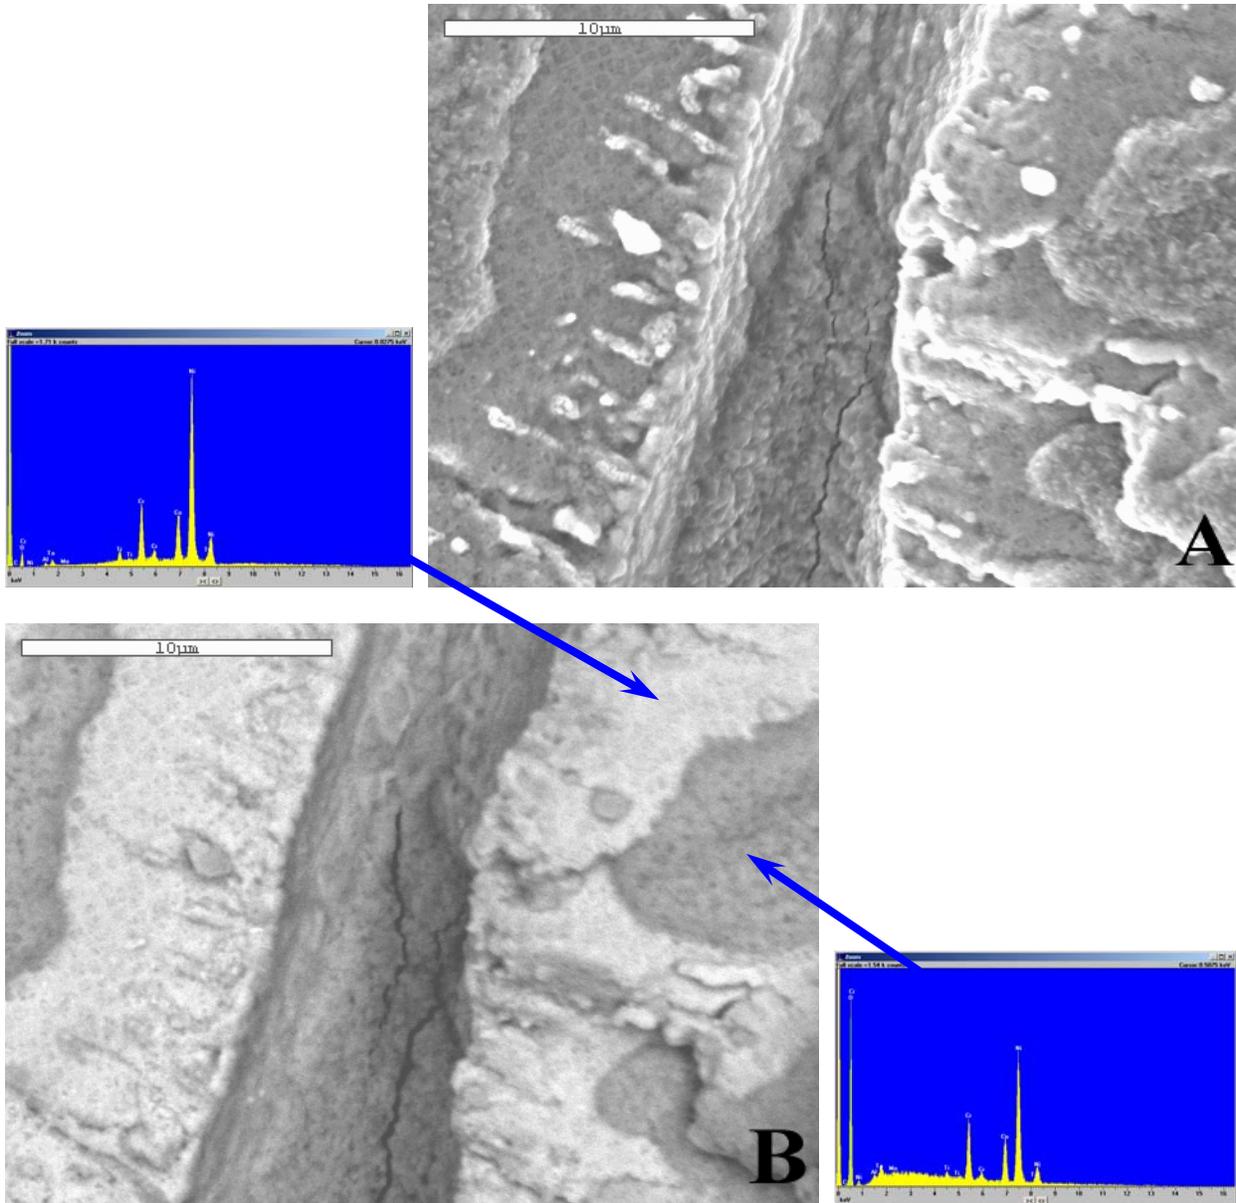
Figure 4-2. A) SE B) BSE Image of Carbide Cavity on Fracture Surface of Creep Sample (41-1; *Modification III*) at 5000x.

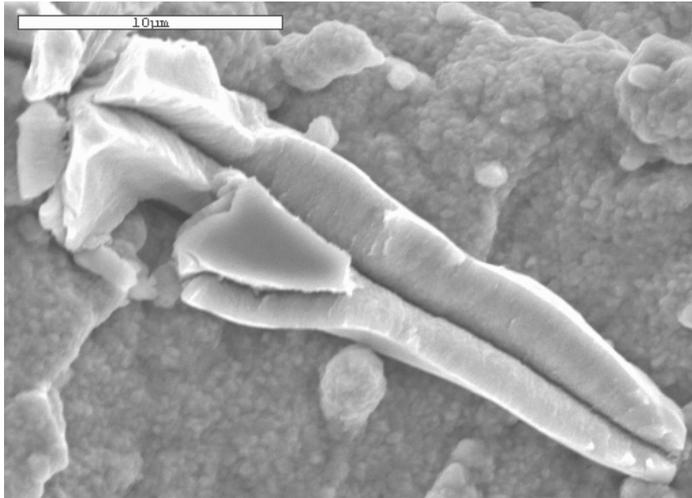
Figure 4-3. *Stringer Carbide on Surface of Creep Sample (12-1; Modification II) at 5000x.*

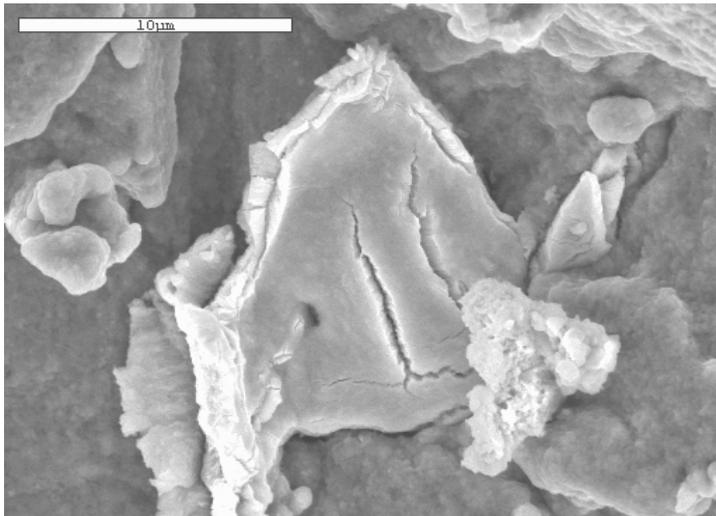
Figure 4-4. *Script Carbide on Surface of Creep Sample (43-1; Modification III) at 5000x.*

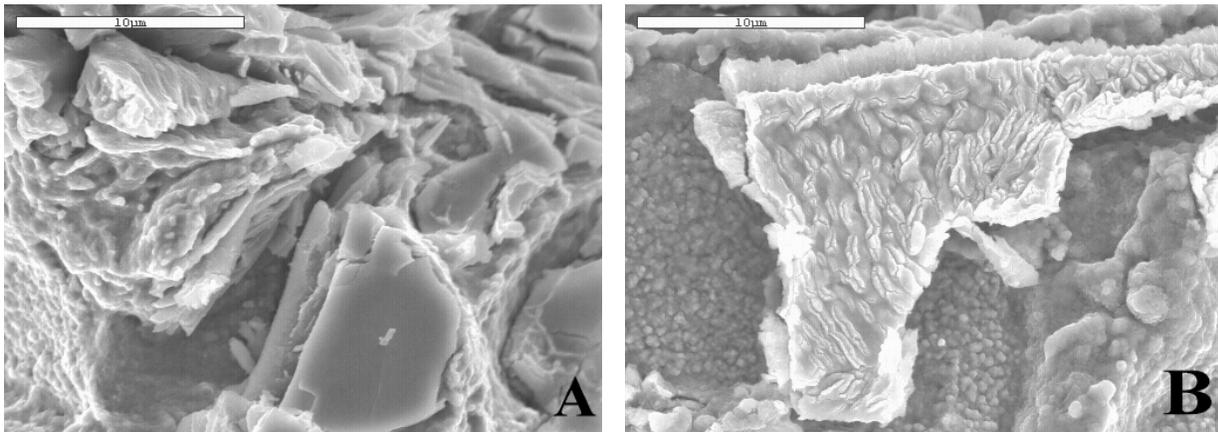
Figure 4-5. Carbide Surface Morphology for A) 750°C Creep Test (7-1; *Modification I*) B) 950°C Creep Test (26-1; *Modification II*).

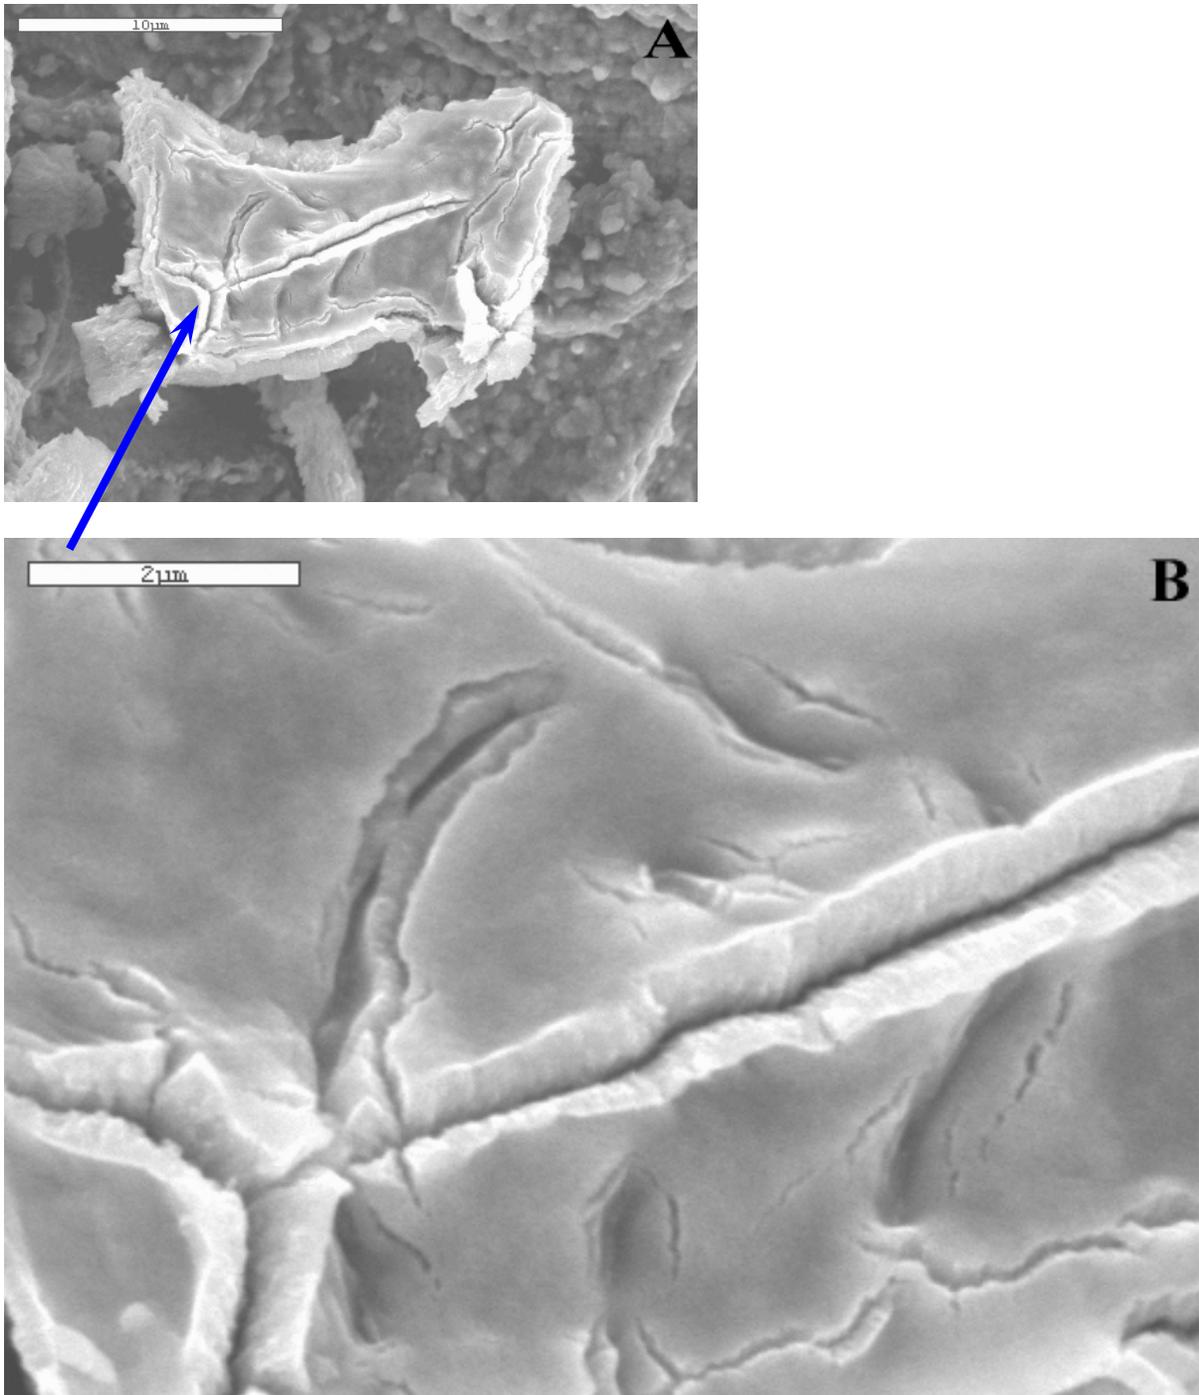
Figure 4-6. Carbide Face Crack Morphology (*43-1; Modification III*) at A) 5000x B) 15000x.

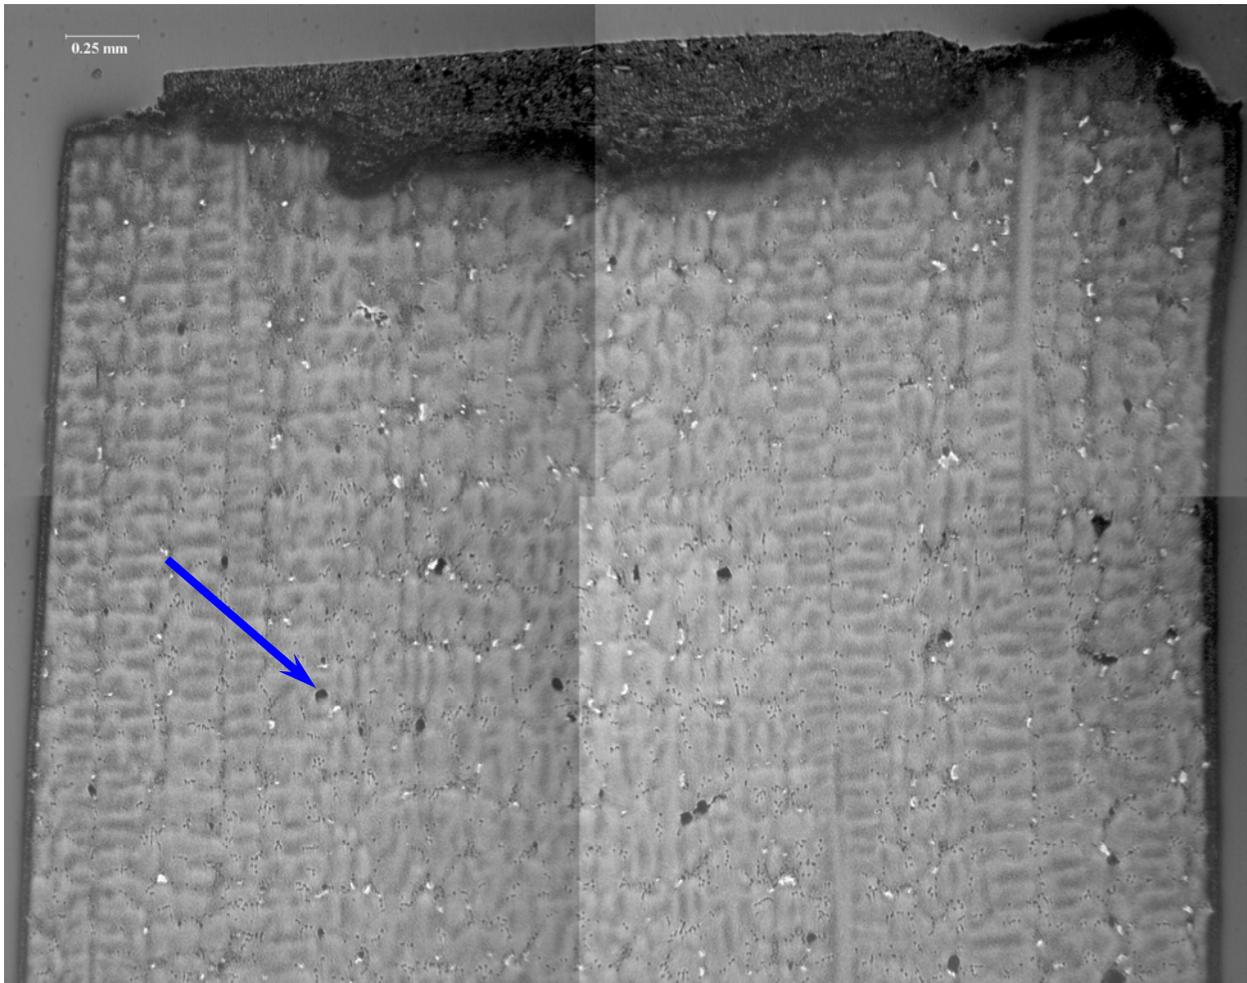
Figure 4-7. Composite Cross-Section of Creep Sample (*4-10A2; Baseline*).

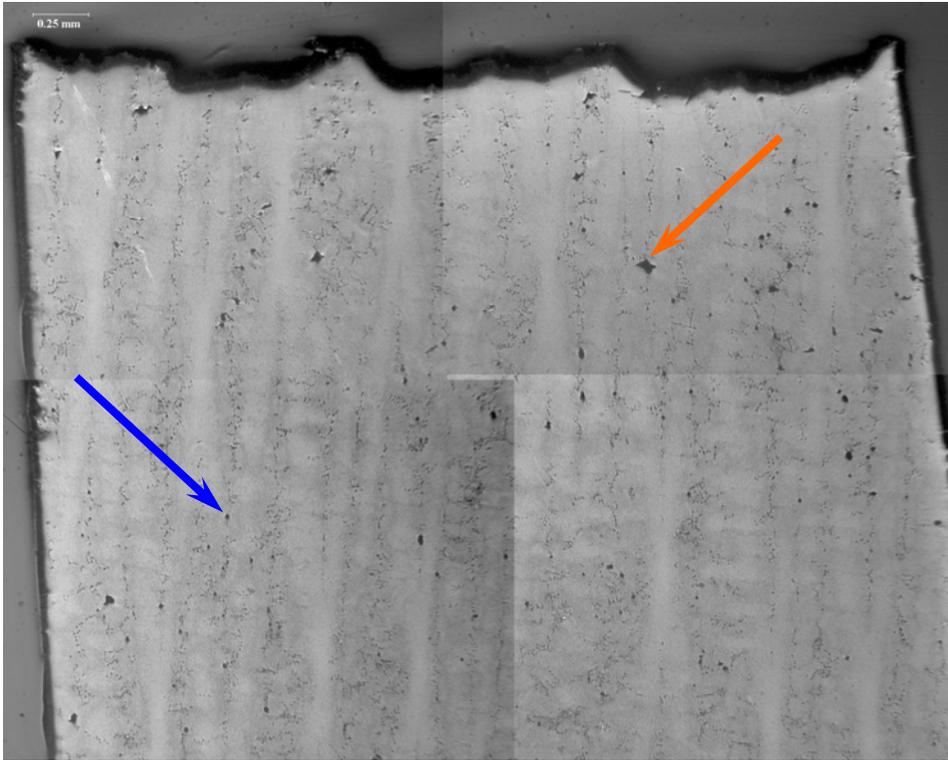
Figure 4-8. Composite Cross-Section of Creep Sample (23-2; *Modification II*).

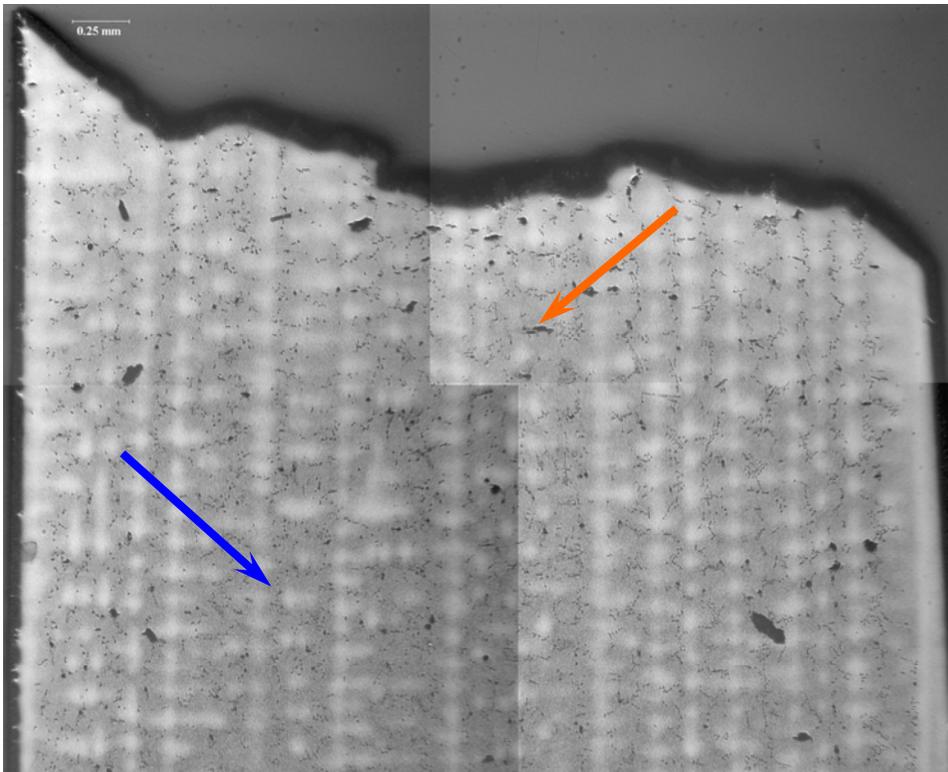
Figure 4-9. Composite Cross-Section of Creep Sample (39-2; *Modification III*).

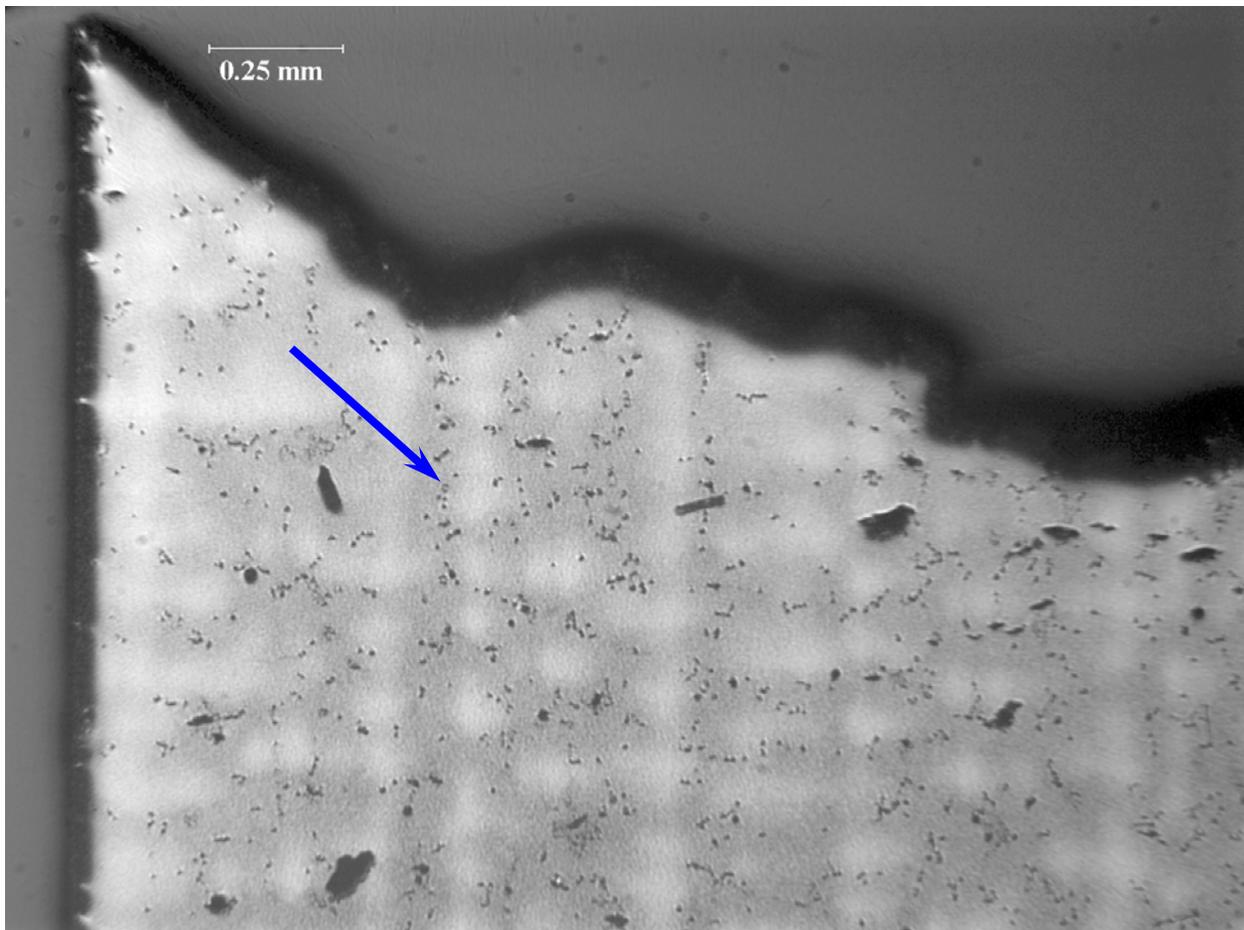
Figure 4-10. Cross-Section of Creep Sample (39-2; *Modification III*) – Upper Left Portion.

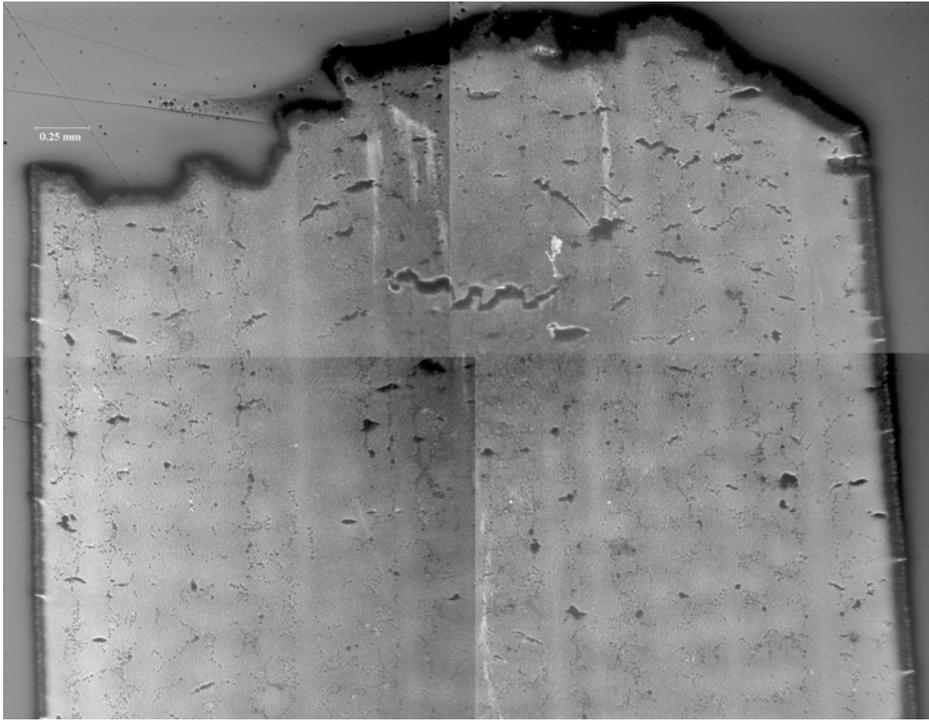
Figure 4-11. Composite Cross-Section of Creep Sample (*24-2; Modification II*).

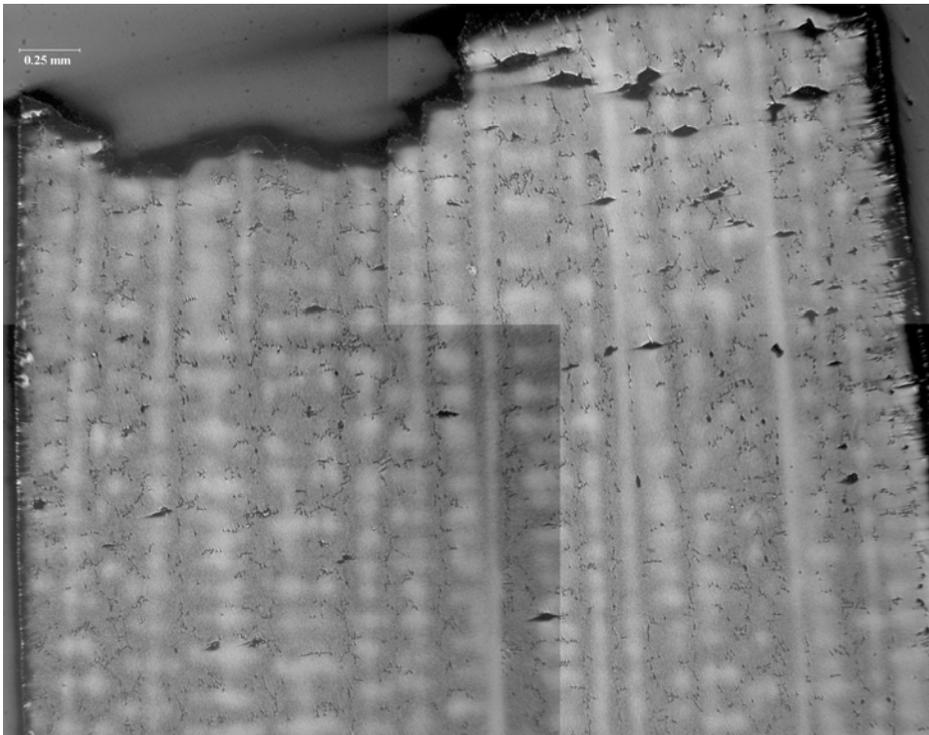
Figure 4-12. Composite Cross-Section of Creep Sample (*13-1; Modification I*).

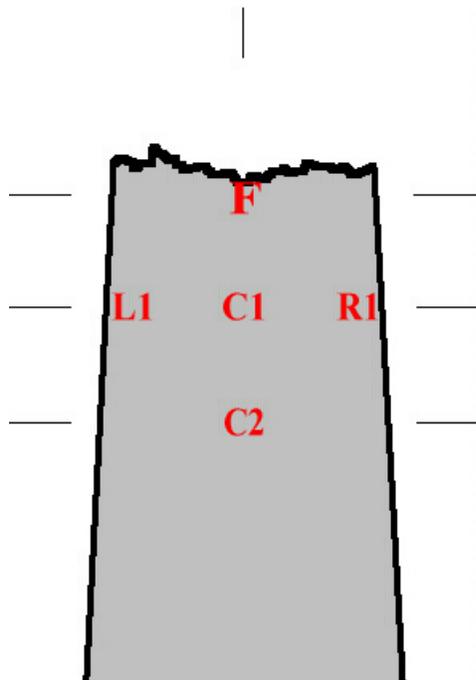
Figure 4-13. Imaging Points for SEM Analysis of Cross-Section Samples.

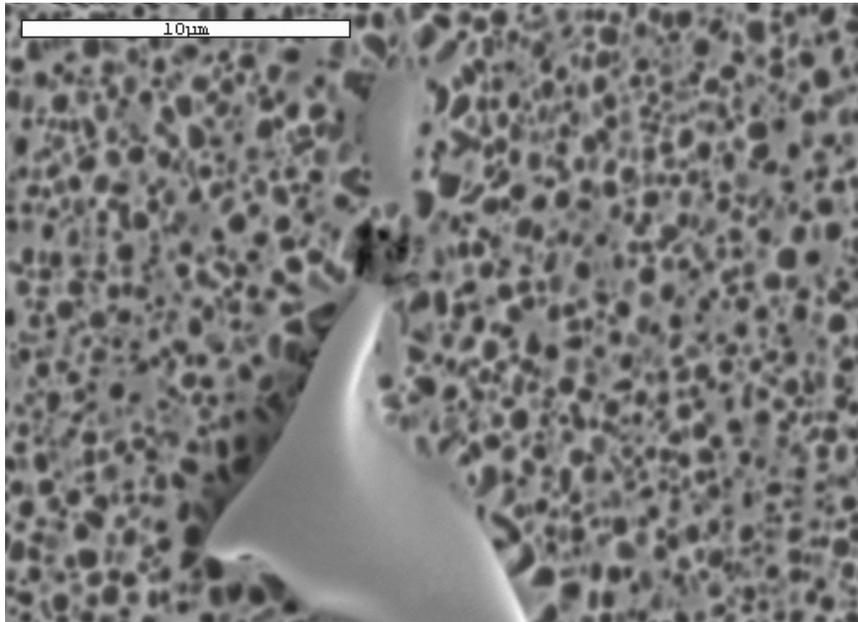
Figure 4-14. **C2** Image Point of Creep Sample Cross Section (7-1; *Modification I*) at 5000x.

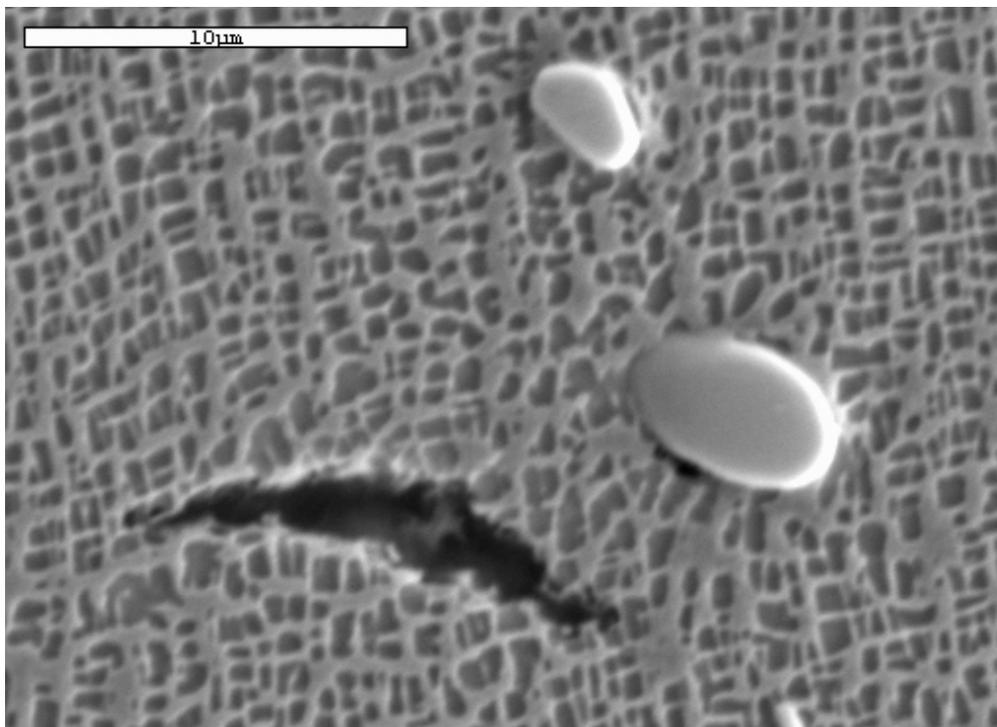
Figure 4-16. Crack Propagation around Irregularity in Brick-Wall γ/γ' Structure on Creep Sample Cross Section (23-2; *Modification II*) at 5000x.

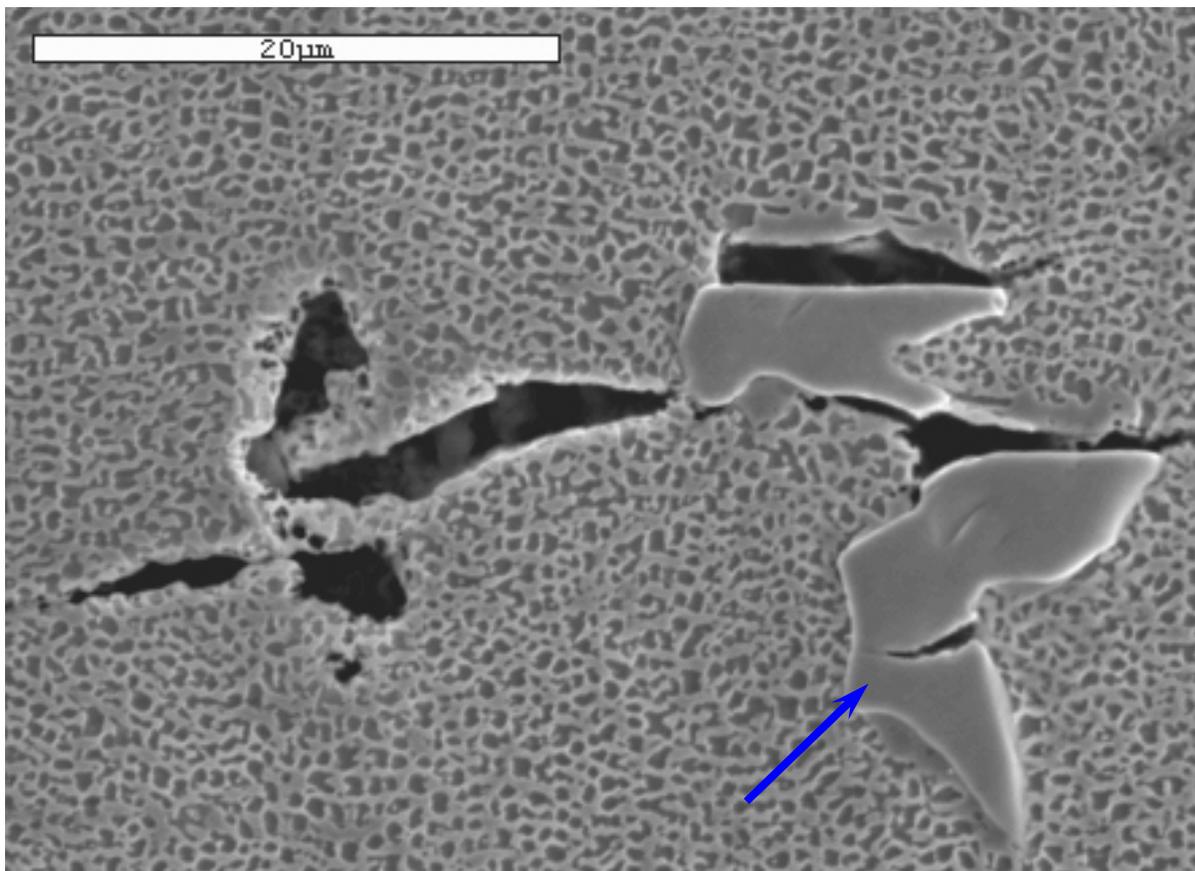
Figure 4-17. Crack Propagation on Creep Sample Cross Section (*43-1; Modification III*) at 2500x.

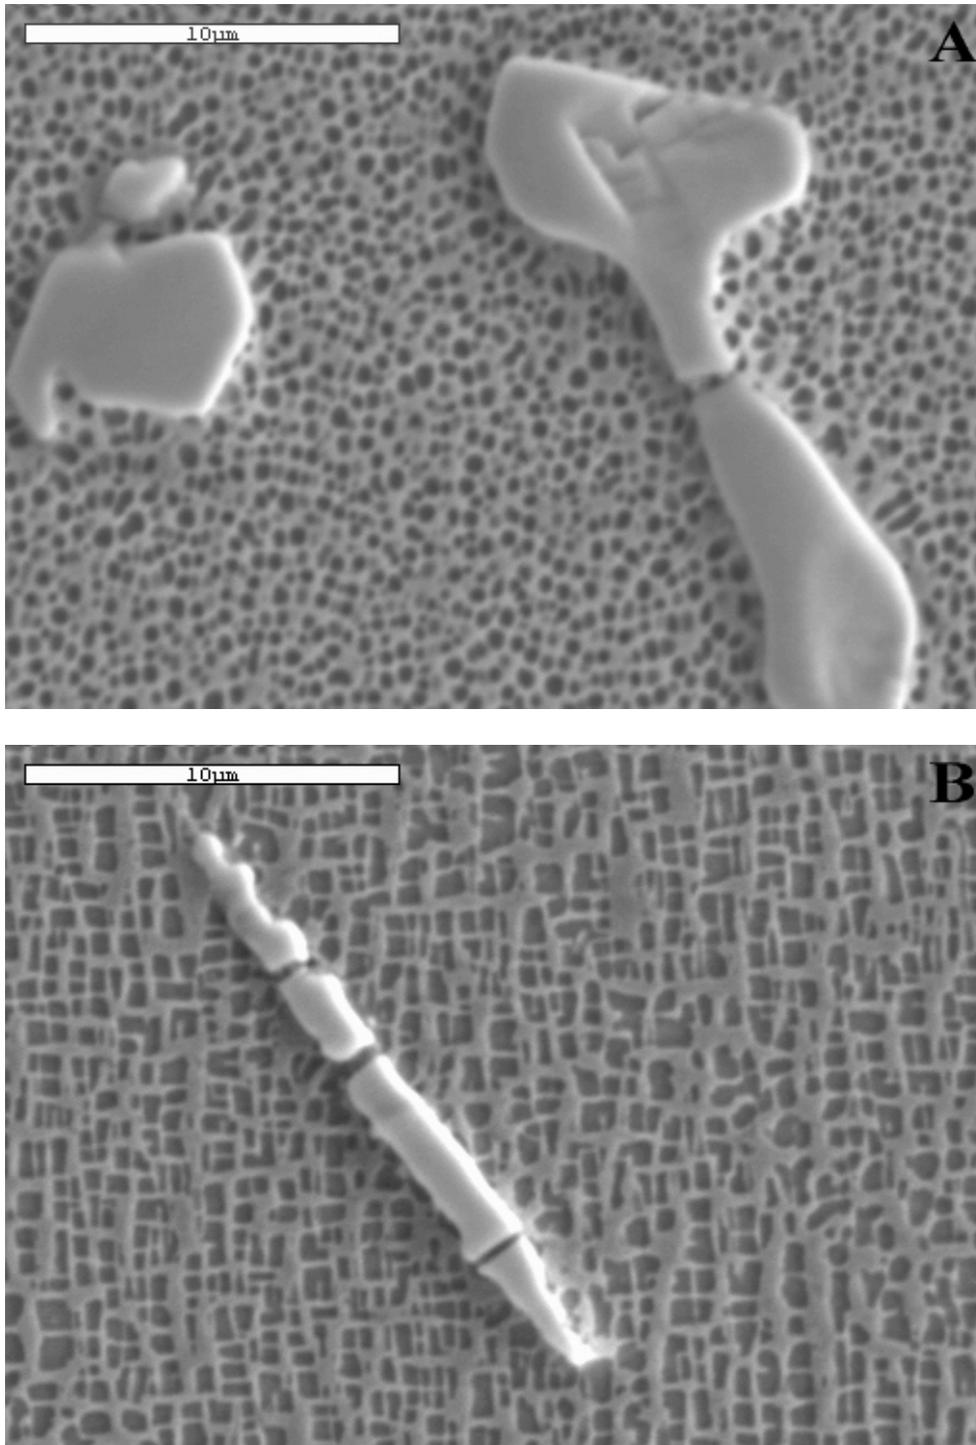
Figure 4-18. Cracks in Carbide Particles on Creep Sample Cross-Sections A) (7-1; *Modification I*) B) (25-2; *Modification II*).

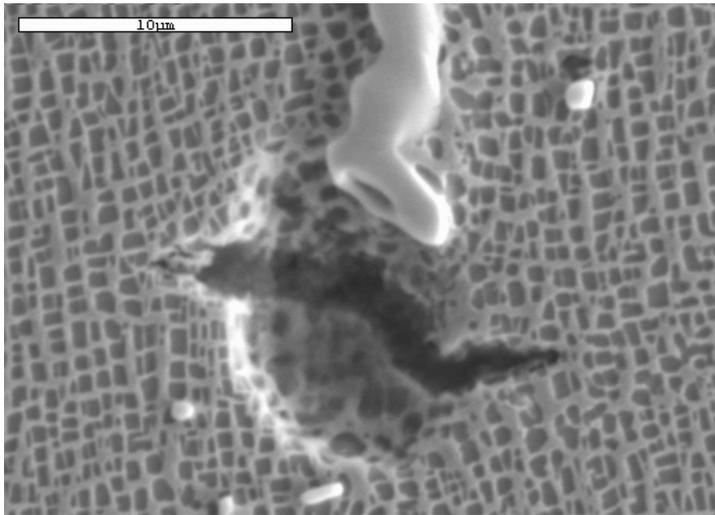
Figure 4-19. Cracks in Casting Pore on Creep Sample Cross Section (23-2; *Modification II*) at 5000x.

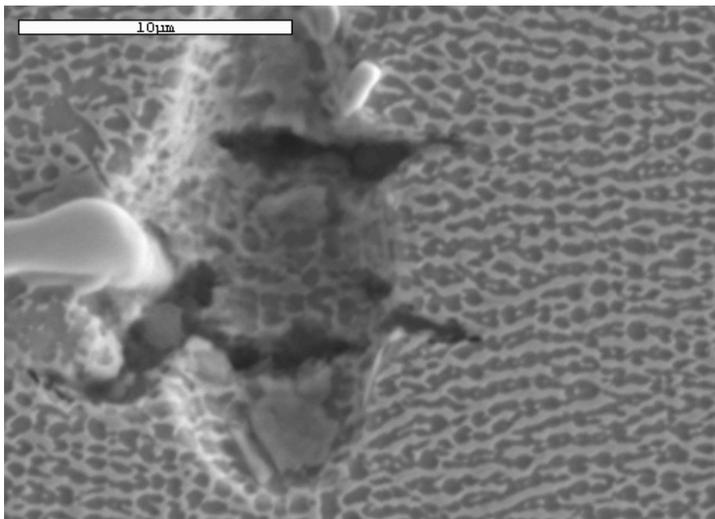
Figure 4-20. Cracks in Casting Pore on Creep Sample Cross Section (26-1; *Modification II*) at 5000x.

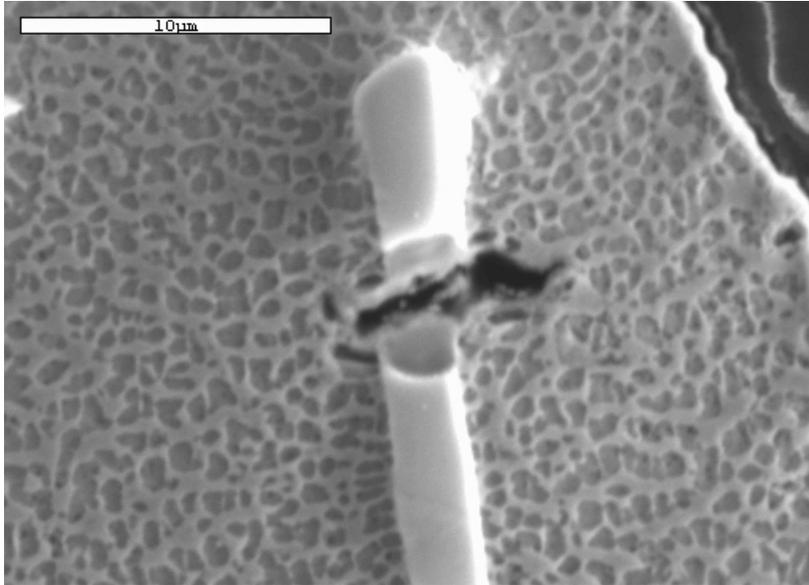
Figure 4-21. Partially Rafted Structure at **F** Image Point of Creep Sample Cross Section (4-10B2; *Baseline*) at 5000x.

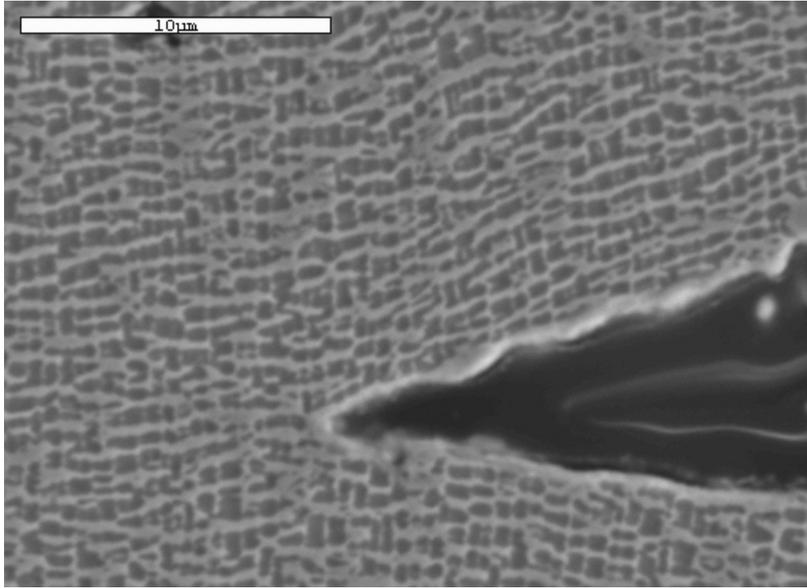
Figure 4-23. Partially Rafted Structure at **F** Image Point of Creep Sample Cross Section (24-2; *Modification II*) at 5000x.

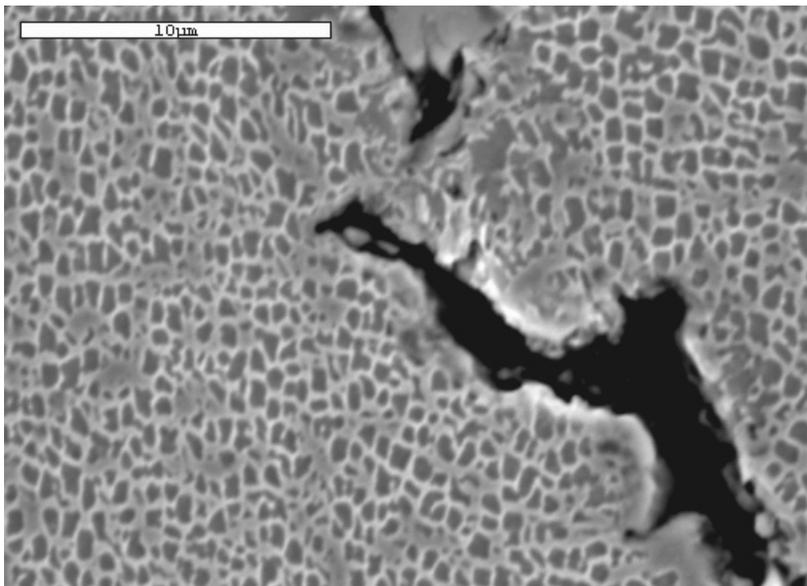
Figure 4-24. Structure at **F** Image Point of Creep Sample Cross Section (40-2; *Modification III*) at 5000x.
