COMPARISON OF WIND-DRIVEN RAIN TEST METHODS FOR RESIDENTIAL
FENESTRATION

A THESIS PRESENTED TO THE GRADUATE SCHOOL
OF CIVIL ENGINEERING AT THE UNIVERSITY OF FLORIDA IN PARTIAL
FULFILLMENT OF THE REQUIREMENTS FOR THE DEGREE OF
MASTER OF ENGINEERING

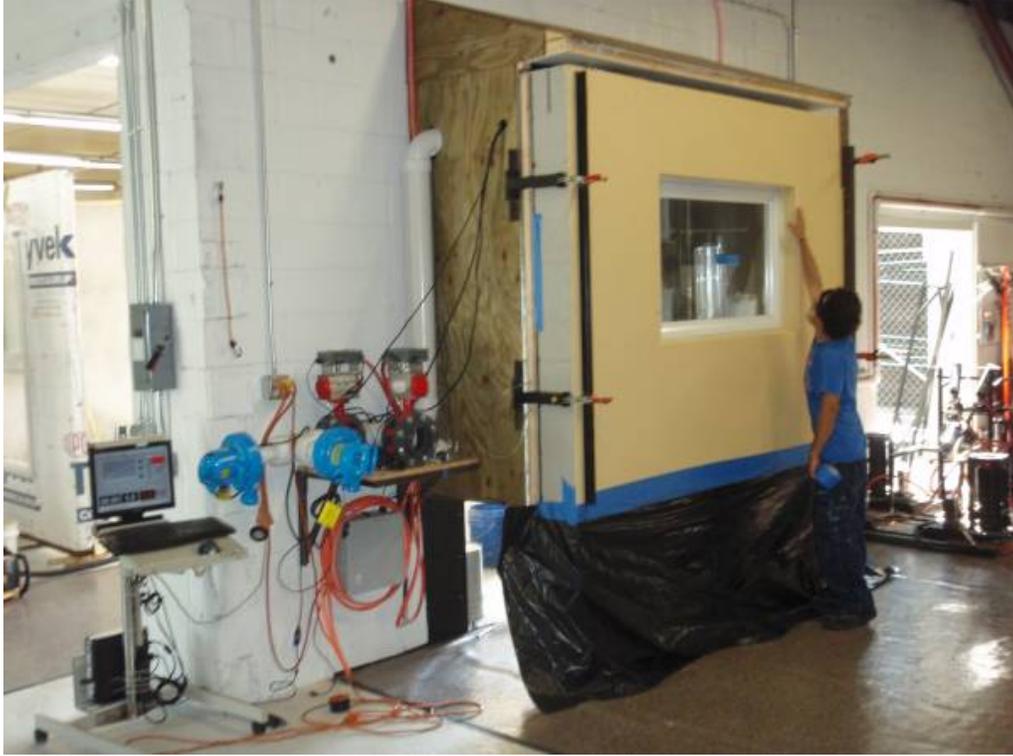
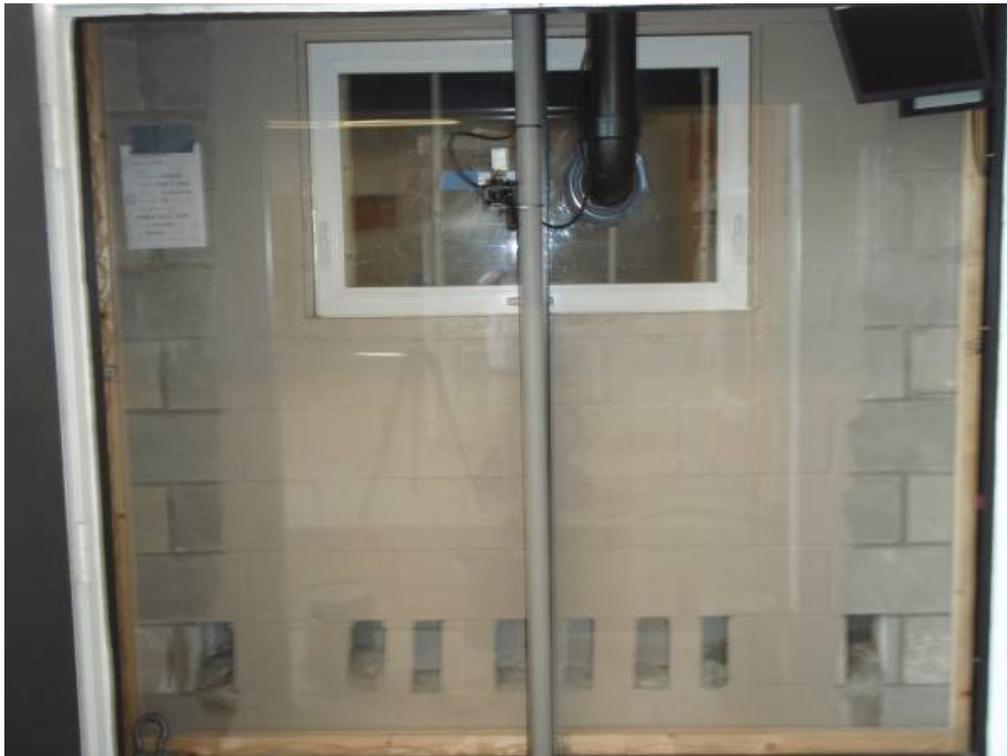
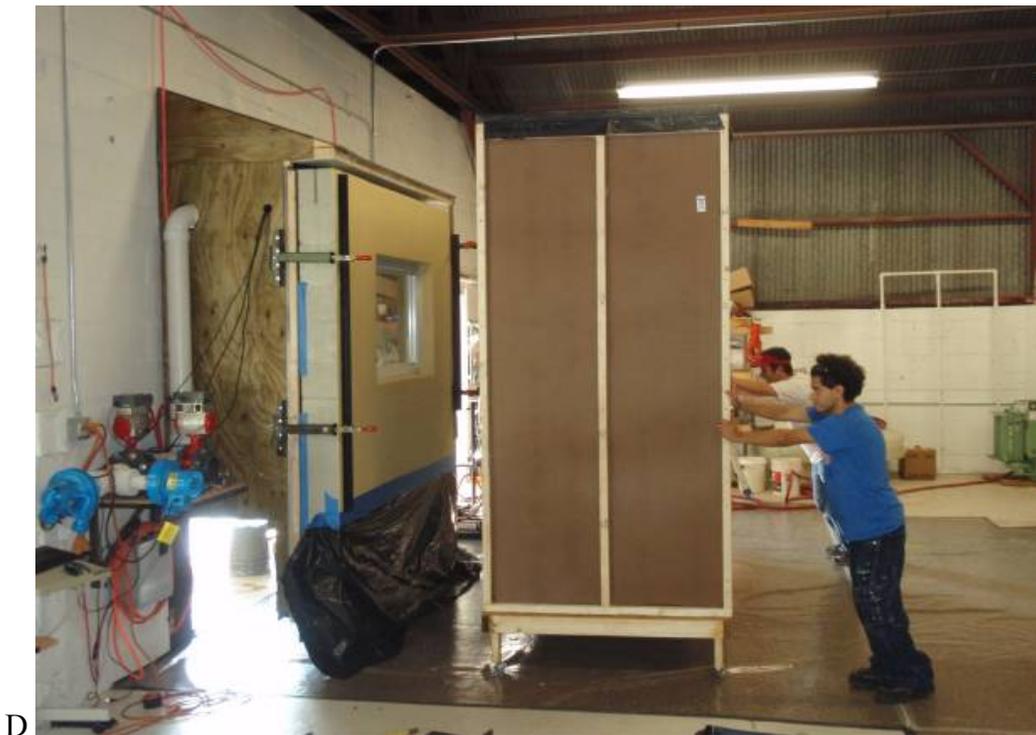
Figure 4-1. Negative Pressure Chamber: A) Wall attached to the pressure chamber. Suction is applied to the interior. B) Interior view of the wall specimen looking through 25.4 mm (1.0 in) acrylic. C) Rain Chamber containing the spray rack. D) Spray Rack is mounted to the wall exterior and sealed to collect water.

UF constructed a negative air pressure chamber, which consists of a 26.4 mm (1 in) thick acrylic sheet mounted on a steel frame measuring 2.4 m x 2.4 m x 0.3 m (8.0 ft x 8.0 ft x 1.0 ft). It was designed to have a large unobstructed viewing area with minimal steel reinforcement while maintaining a maximum deflection of 1.6 mm (1/16 in) during the peak design pressures of 2873.0 Pa (60.0 psf) (see figure 4-1). HP-33 series Cadillac centrifugal blowers operating in parallel provide the required pressure and airflow (function of leakage). The blowers are capable of producing a pressure differential of about 2394.0 Pa (50.0 psf) at approximately 4.3-5.6 m³/min (150.0 – 196.0 CFM), which exceeds 50% of the highest pressure rating of any specimens in this study. Pressure was modulated by two 106.0 mm (4.0 in) Bray Series 20

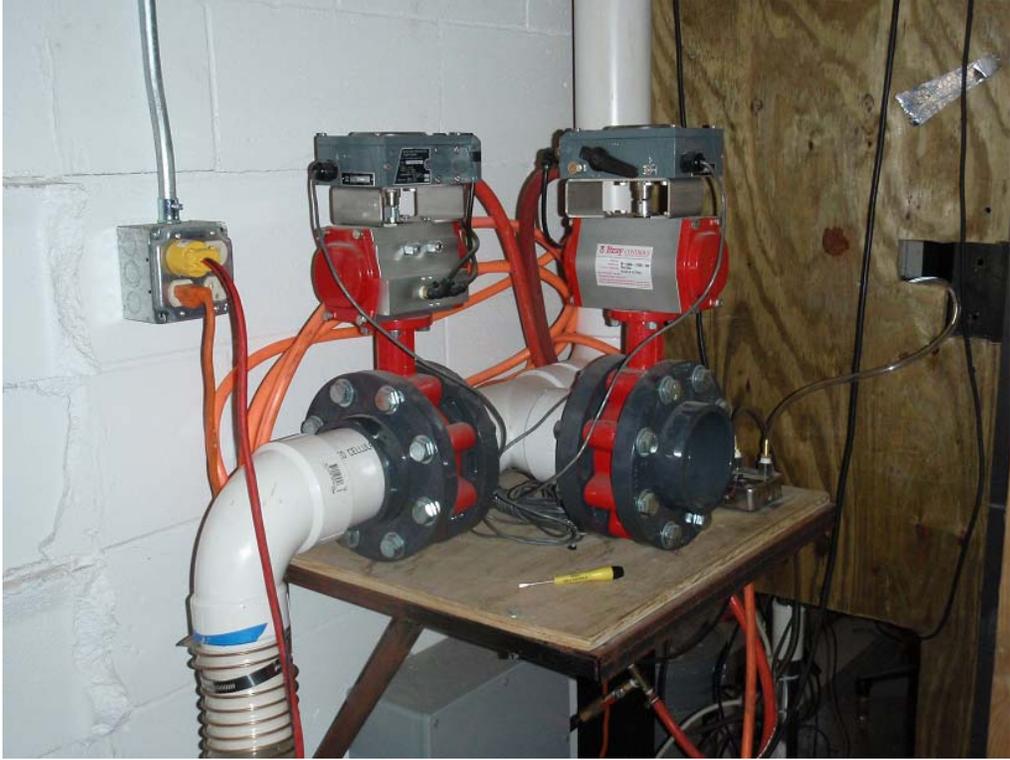
Figure 4-2. Electro-Pneumatic Valves

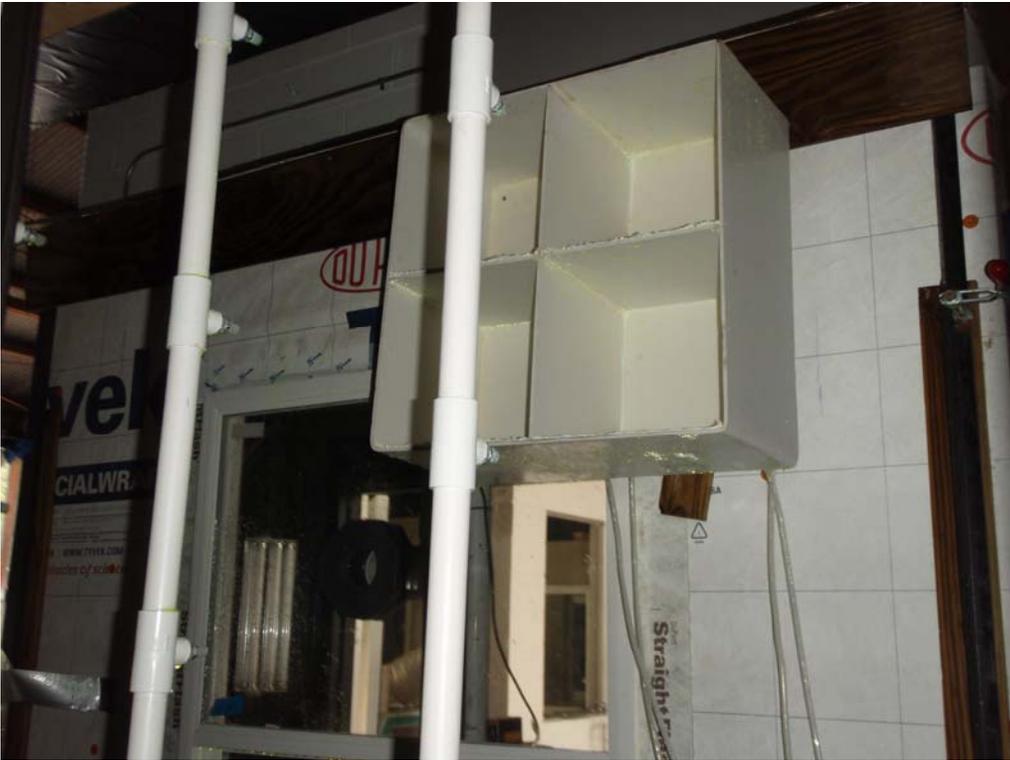
Figure 4-3. Calibration Catch Box

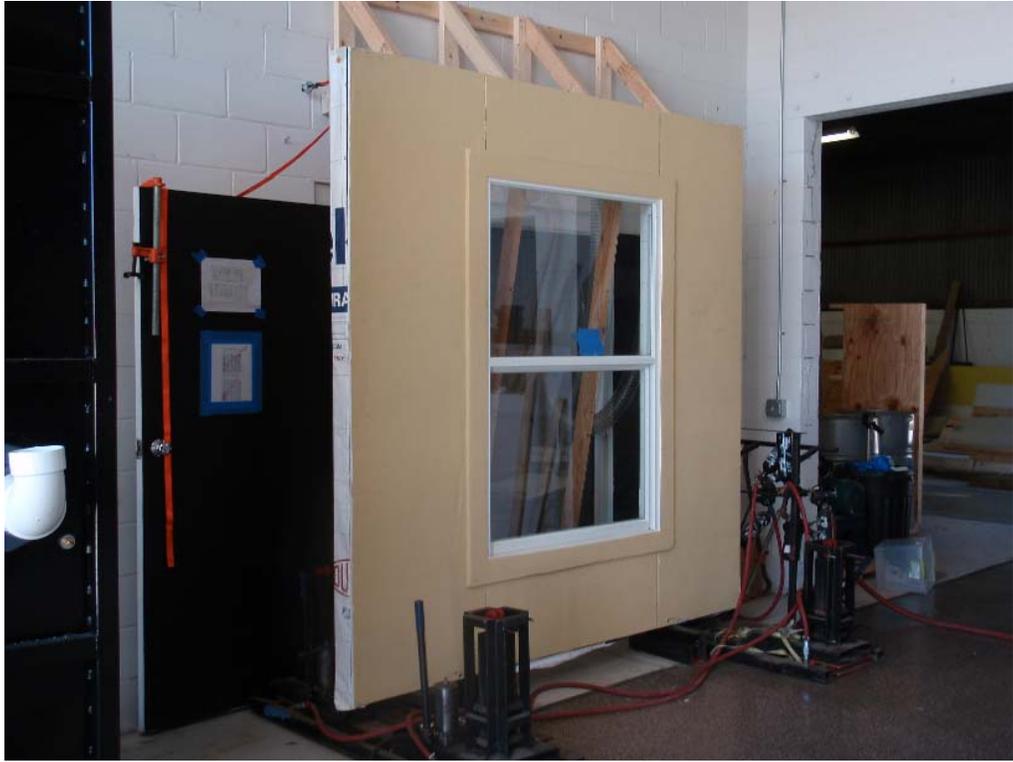
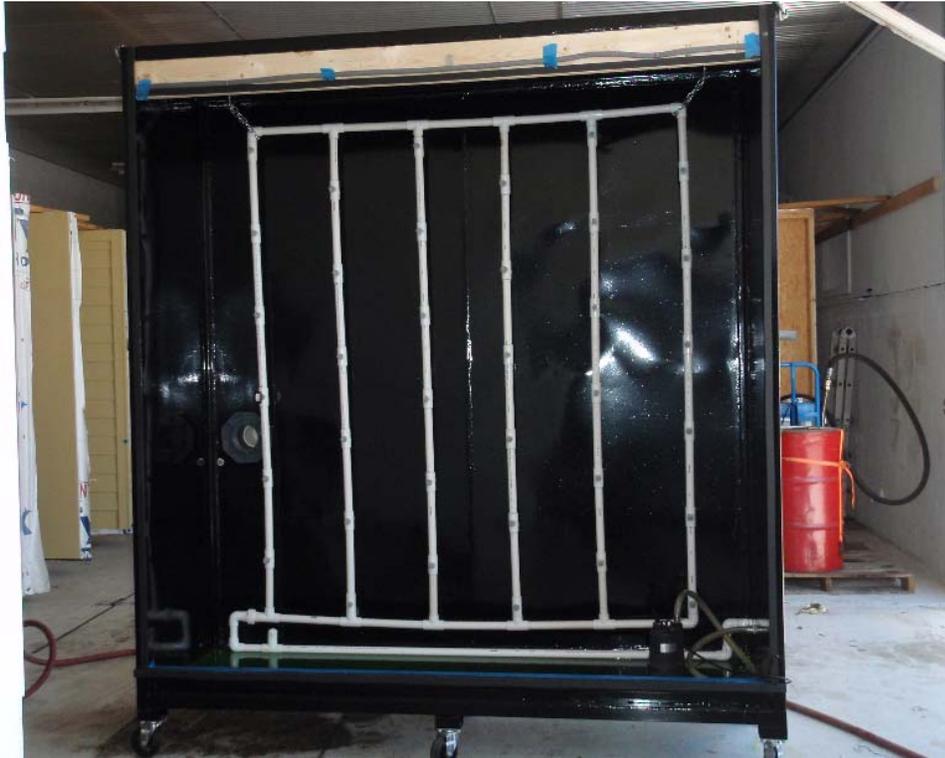
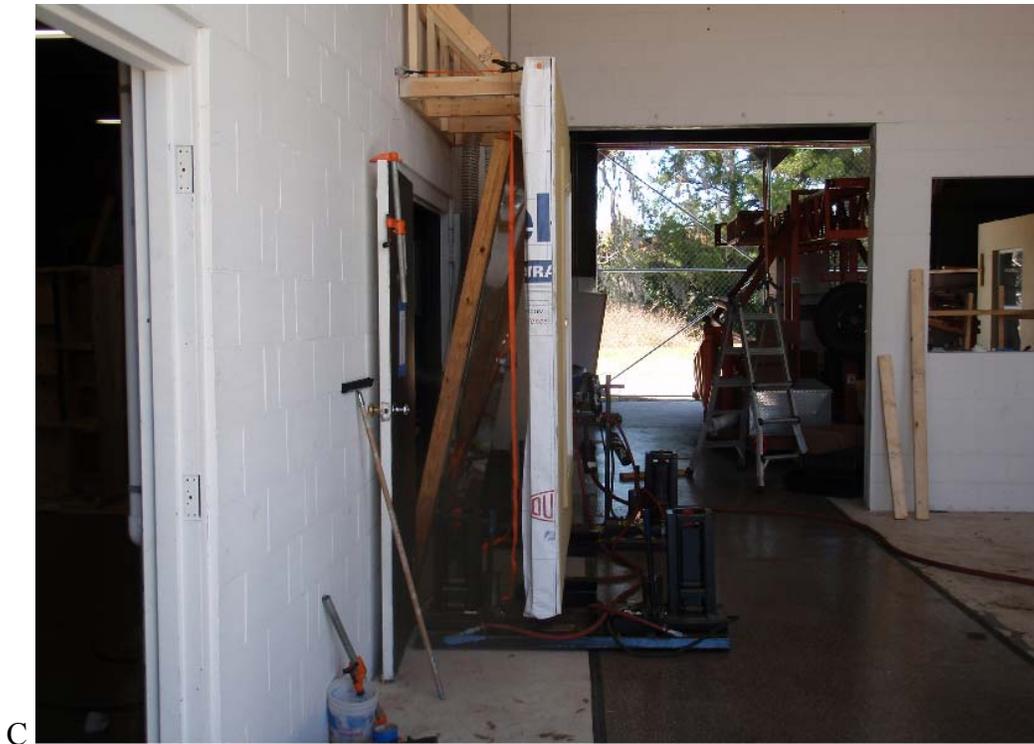
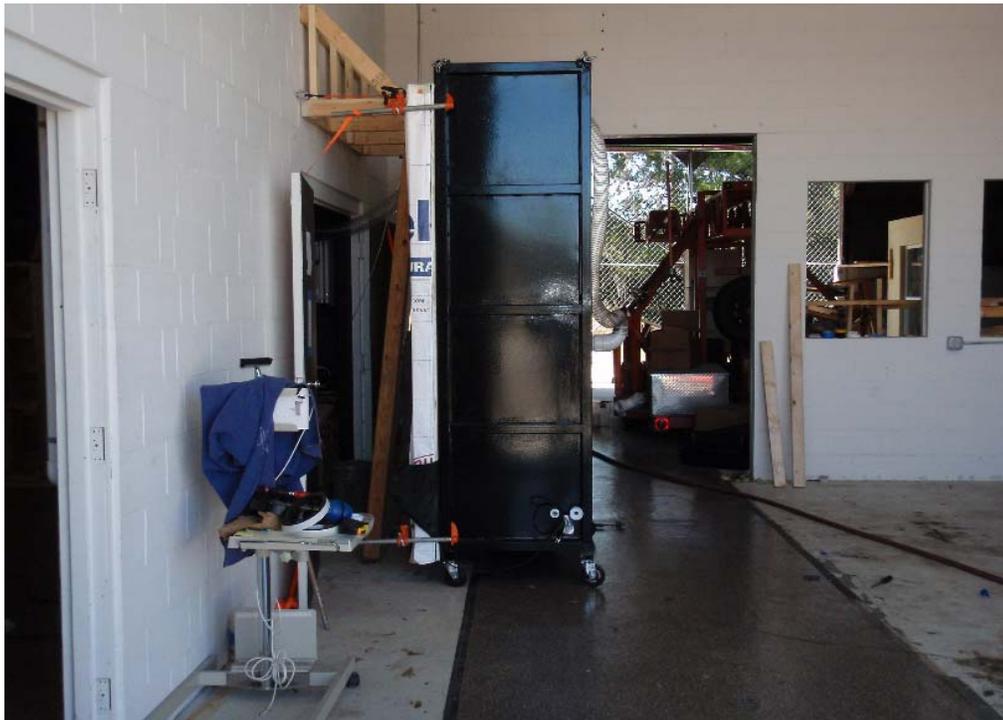
Figure 4-4. Posivie Pressure Chamber: A.) Wall on permanent stands attached to the fixed truss. B.) Rain Chamber containing the spray rack calibrated to produce prescribed (8.0 – 17.6 in/hr) wetting. C.) Side view of mounted wall D.) Attached chamber.

positive pressure chamber capable of achieving 3830.0+ Pa (80.0+ psf) was constructed. To minimize flexing of the frame, 14 gauge galvanized sheet steel lined the inside of a frame consisting of 51.0 mm x 51.0 mm x 3.0 mm (2.0 in x 2 in x 1/8 in) HSS steel tubing spaced at a maximum of 711.0 mm (28.0 in). The spray rack used in the suction chamber was relocated to this chamber. A Spencer single stage centrifugal blower capable of a pressure of 3984.0 Pa (83.2 psf) and an airflow rate of 11.3 m³/min (400 CFM) created the loads. The pressure was modulated through the same electromechanical valves used in the suction chamber.

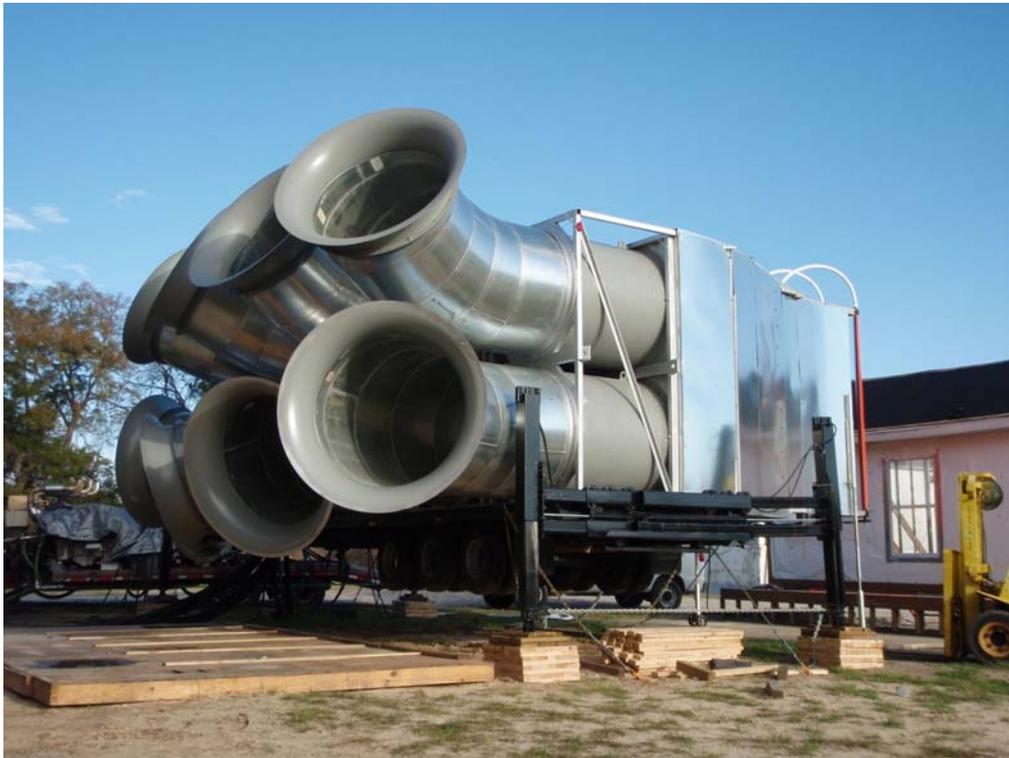
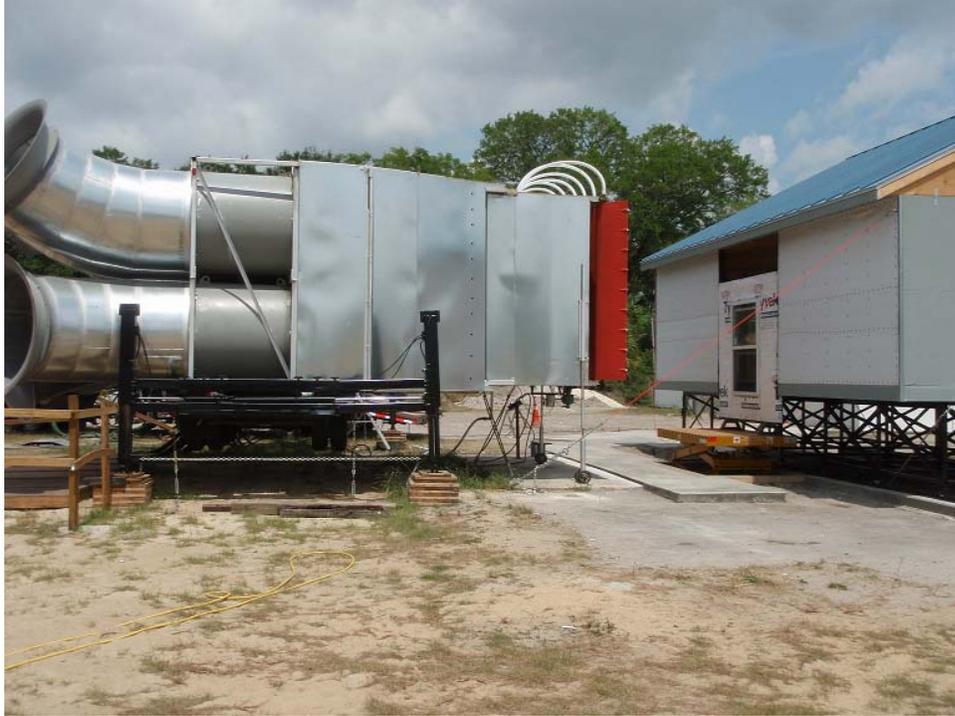
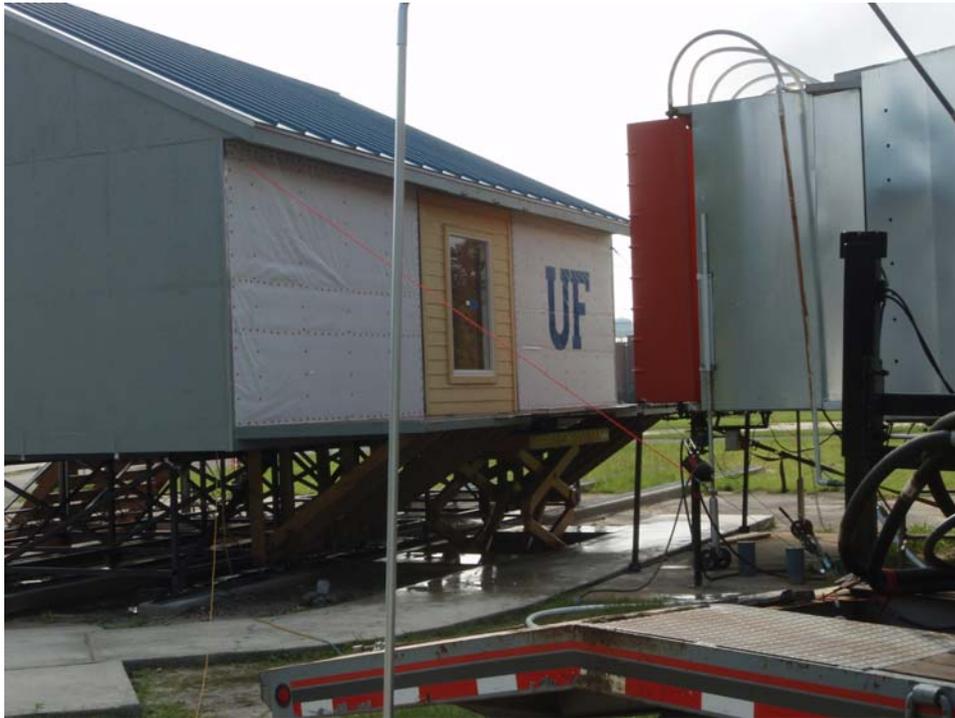
Figure 4-8. Hurricane Simulator: A) Tuned inlets that connect to industrial vaneaxial fans. B) Side view of simulator. The inlets and contraction can be removed for travel. C) Hurricane Simulator, residential model and specimen being prewetted.

To test each of the specimens with the Hurricane Simulator, a 4.6 m x 9.8 m x 4.9 m (15.0 ft x 32.0 ft x 16.0 ft) model residential structure was constructed. The house mockup was designed in accordance to the Wood Frame Construction Manual (WFCM-2001) to withstand wind loads prescribed in ASCE 7 for 67+m/s (150+mph), ensuring its durability. The roof system was to be a standing seam metal roof system, to avoid repair after every test, and the roof trusses were designed and manufactured by a truss company to withstand the same loads. To place the specimens in the correct location of the impinging air flow, the mockup had to be elevated 1.7 m (5.5 ft) on a steel structure built up of 50.8 mm x 50.8 mm x 3.18 mm (2.0 in x 2.0 in x 1/8 in) square tubing. Raising the specimens into place was accomplished by employing a 27.0 KN (6,000lb) rated hydraulic lift installed under the mockup (figure 4-9). Once raised the specimens were connected to the roof assembly with a removable pin connection (figure 4-10).

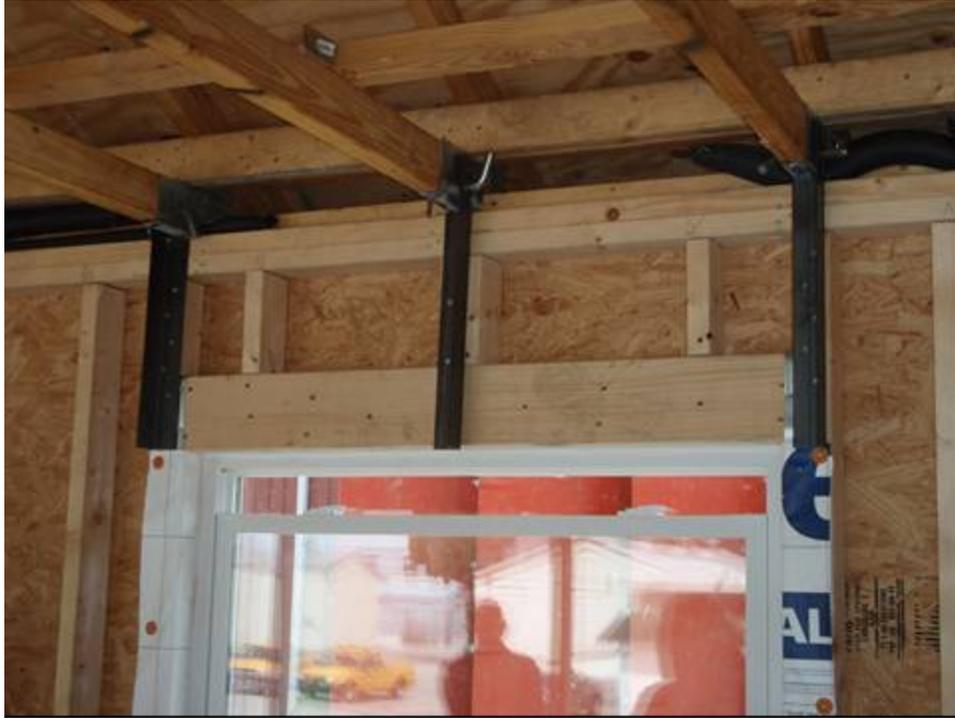
Figure 4-10. Roof to Wall Connection

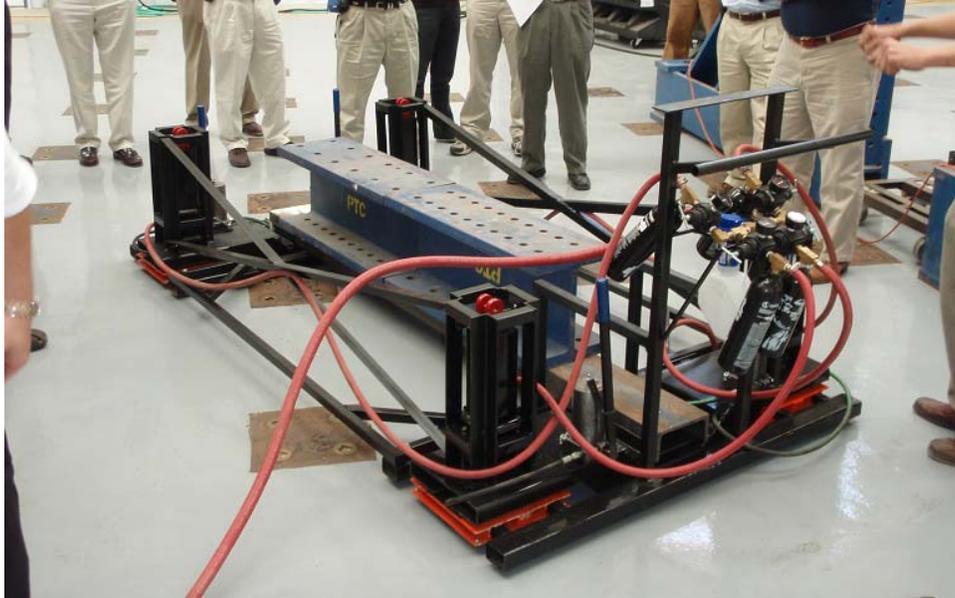
Figure 4-11. Air Caster Cart

Transportation of the specimens was also of concern because 25 of the specimens received an application of stucco or decorative cementitious coating. Cracking of the specimens during transportation would negate the validity of test results. Consequently a custom designed air caster cart was fabricated to transport specimens from testing station to testing station as well as into the storage facility. The air caster cart is a steel frame that can be assembled and disassembled around specimens (see figure 4-11). It rests on four air casters rated for 17.8 KN (4,000 lbs) each, the heaviest of the specimens being approximately 17.8 kN (4,000 lbs). Once loaded, the air casters are pressurized and the specimens are floated on a cushion of air 3.2 mm (1/8 in) thick. In case of accidental depressurization, the cart along with the specimen would slowly drop as the casters deflate. These measures insured the utmost care.

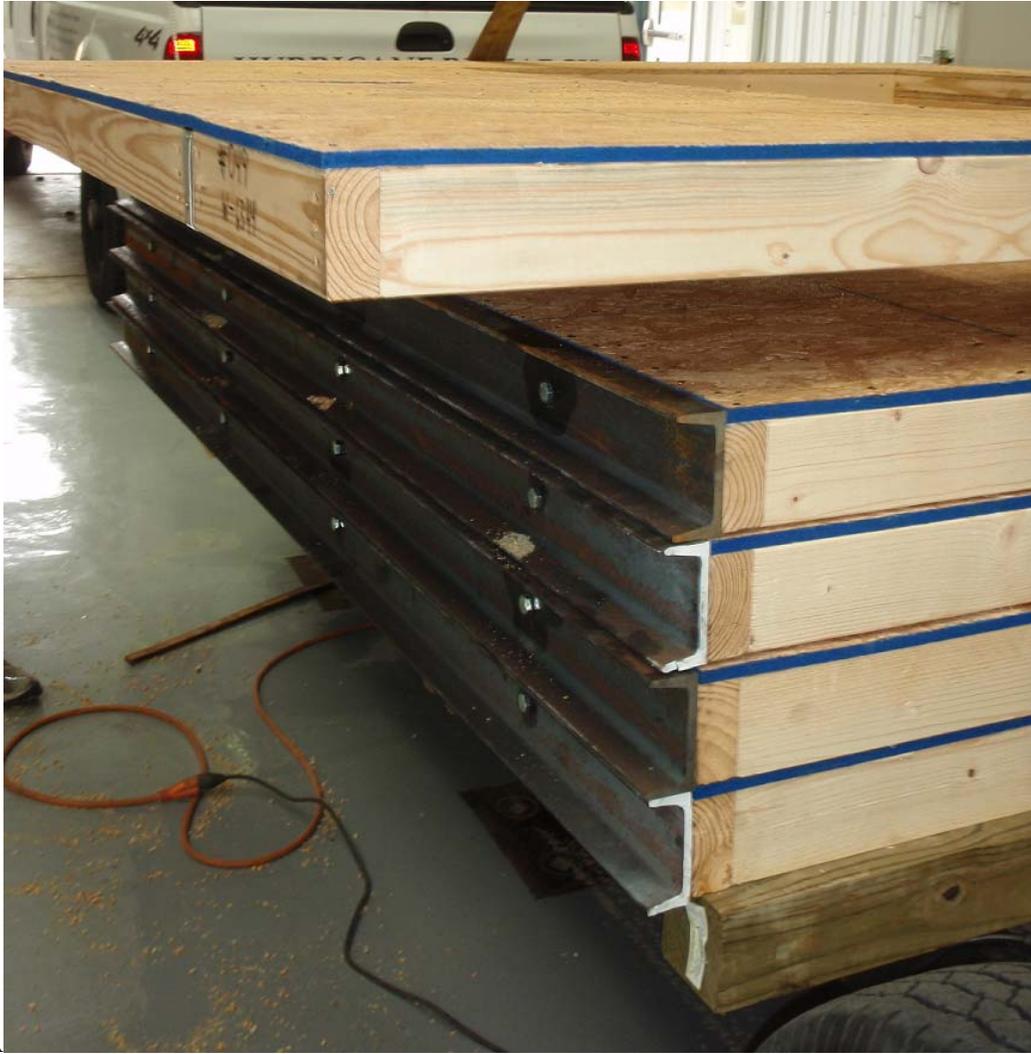
Figure 5-1. Bolted Channels to Wood Frame Walls

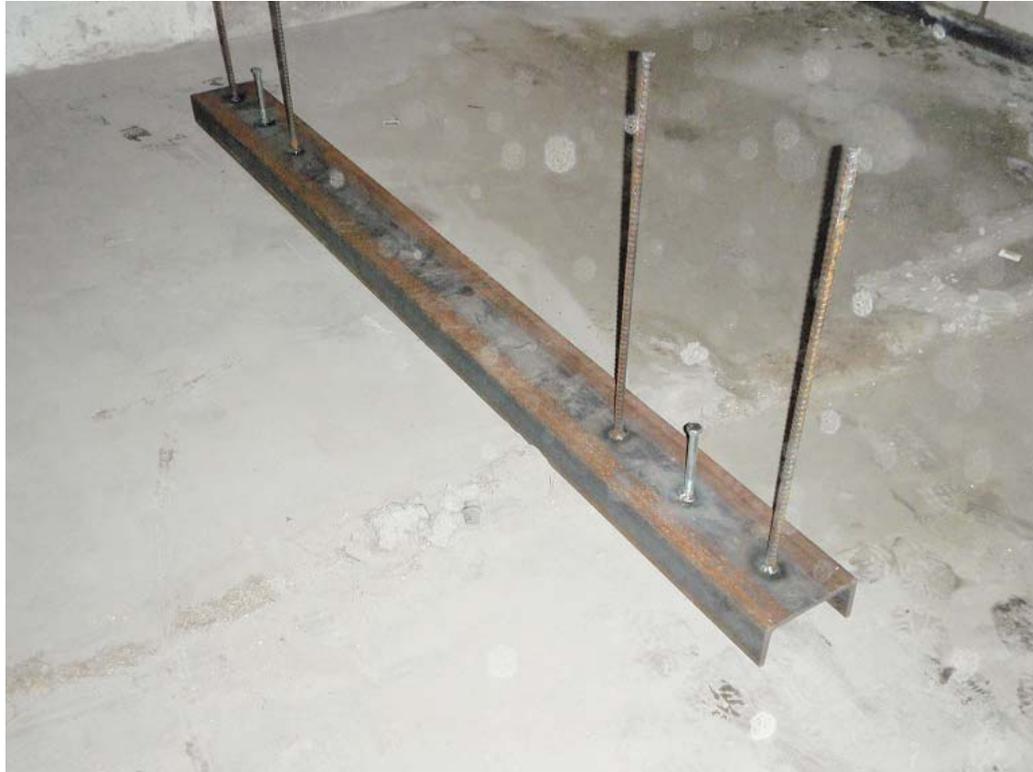
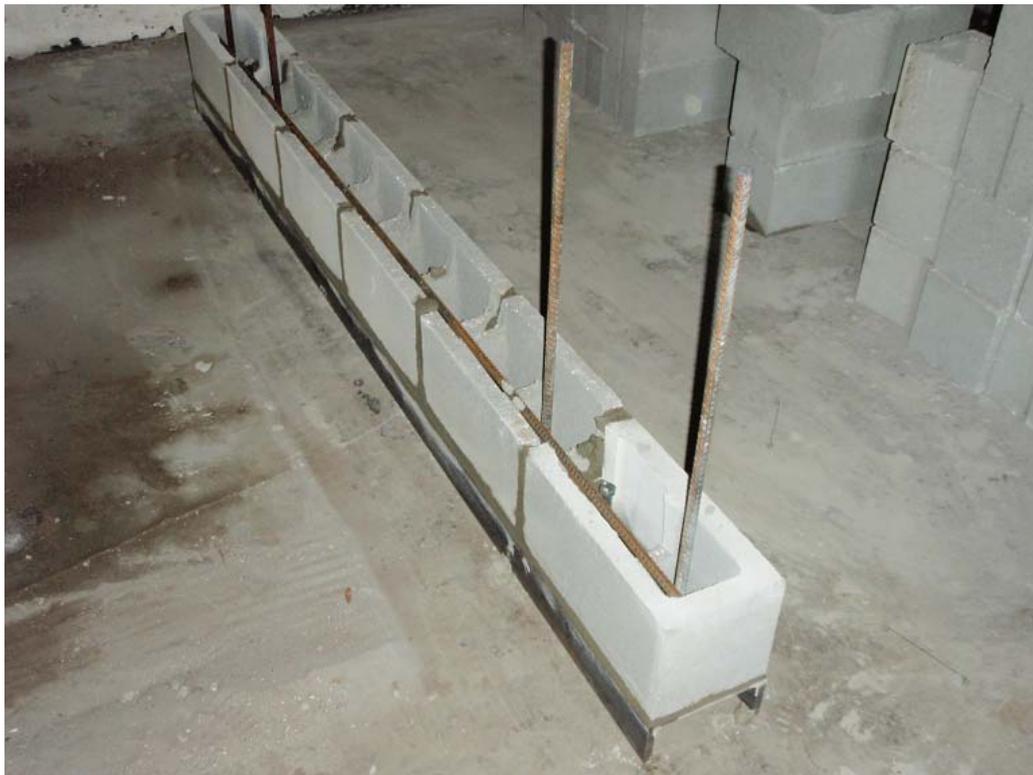
Figure 5-3. CMU Wall Specimen Stabilization Channel

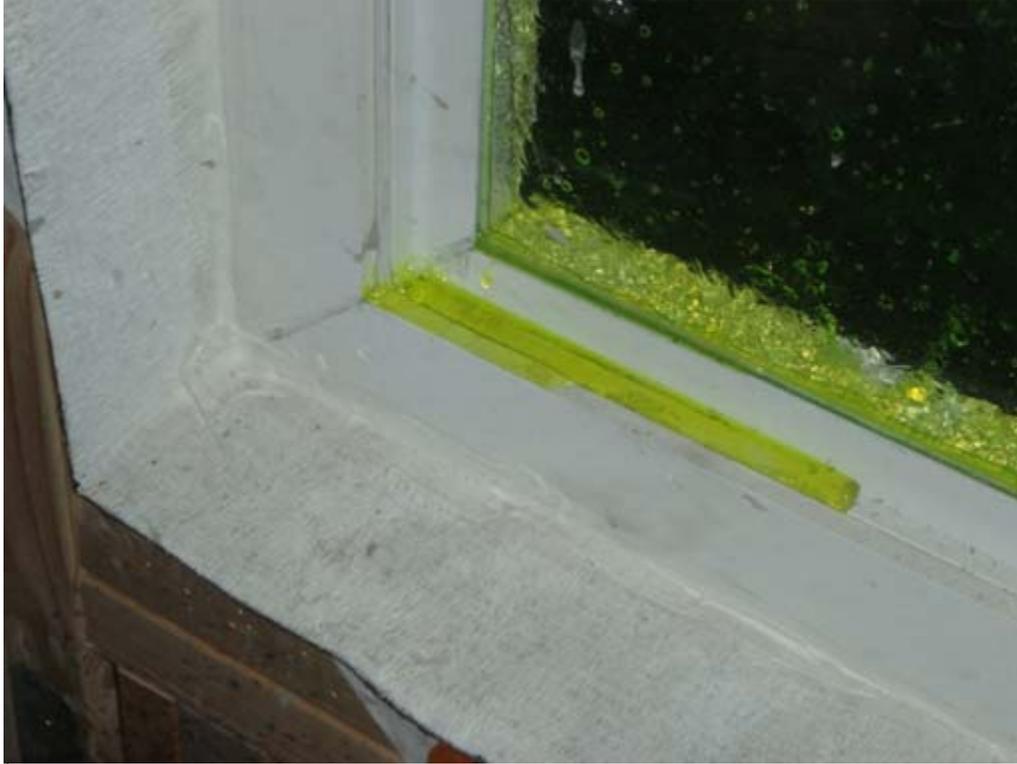
Figure 6-3. Water Infiltrated at the End of Static Pressure Test (bottom left corner of specimen 006/ Casement window)

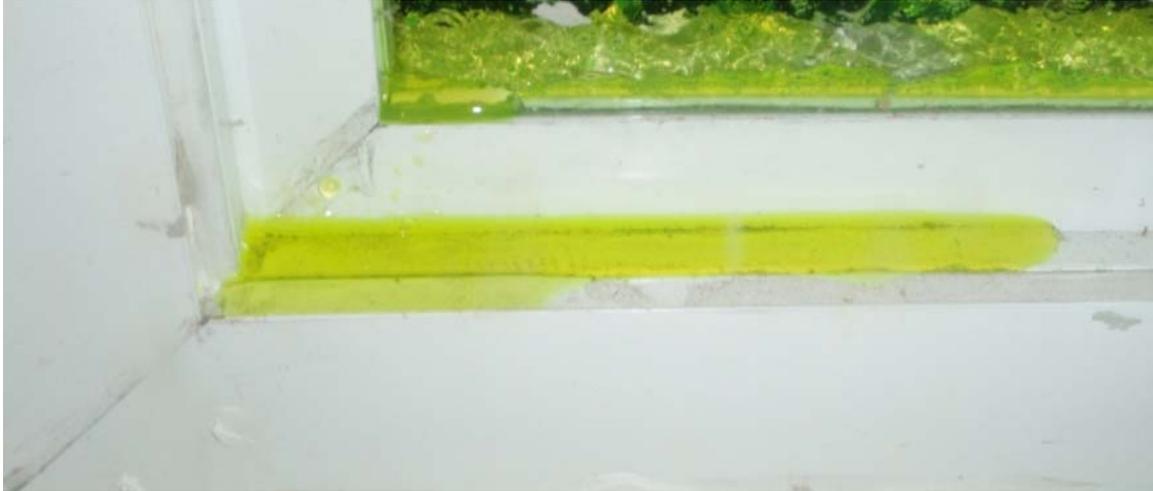
Figure 6-5. Typical Infiltration for Casement Windows (Bottom left corner above sill)

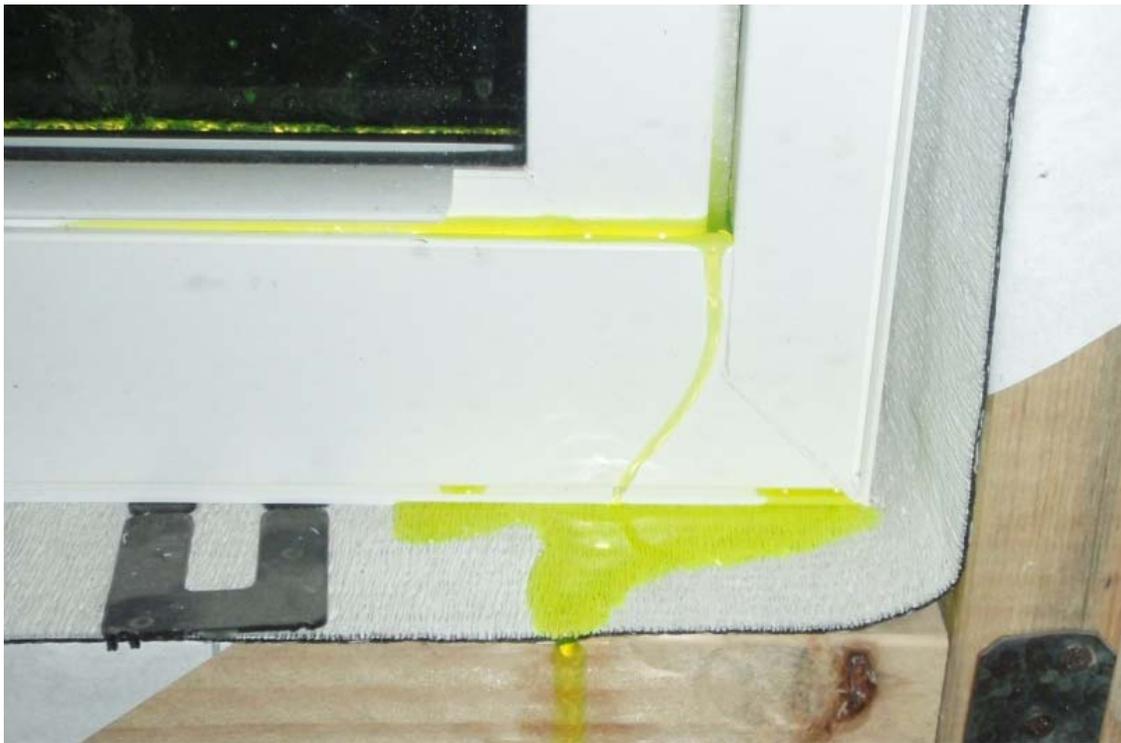
Figure 6-6. Typical Infiltration for Single Hung Windows (Bottom right corner above sill)

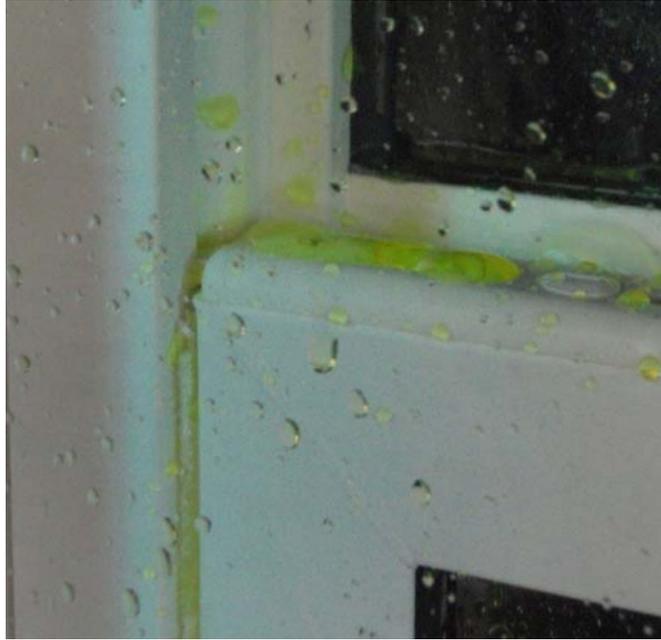
Figure 6-7. Typical Infiltration for Single Hung Windows (Left side of meeting rail)

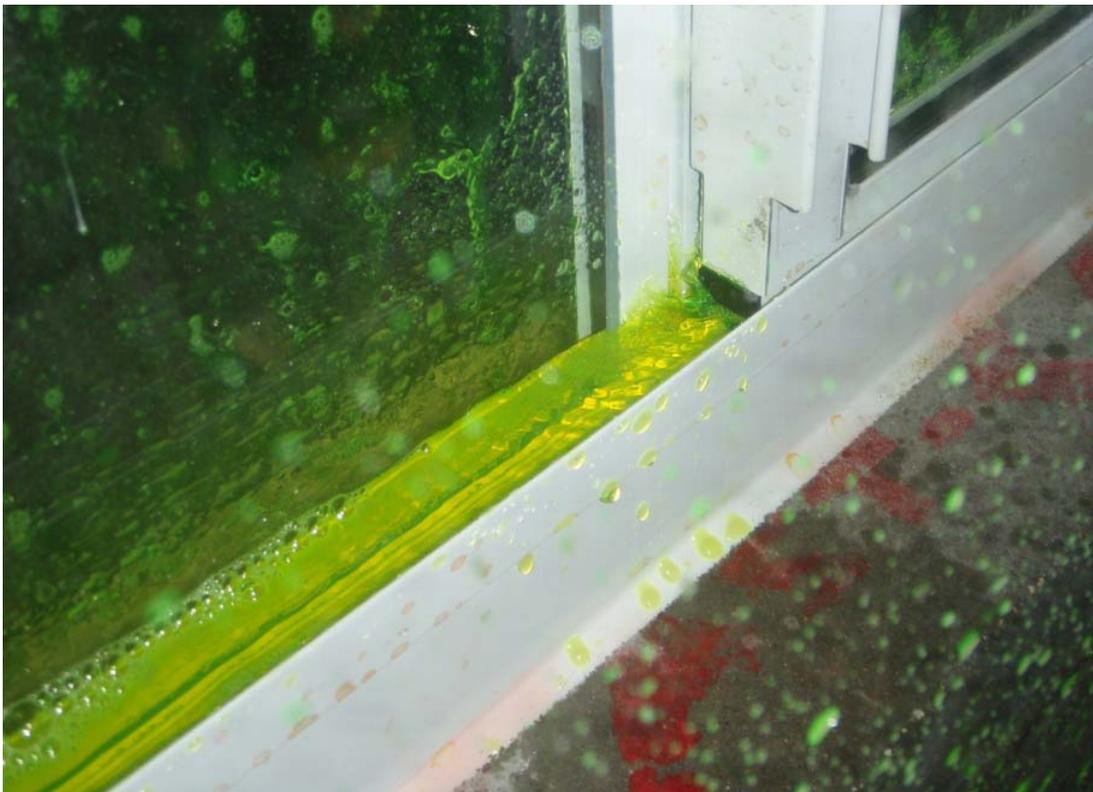
Figure 6-8. Typical Infiltration for Horizontal Sliding Windows

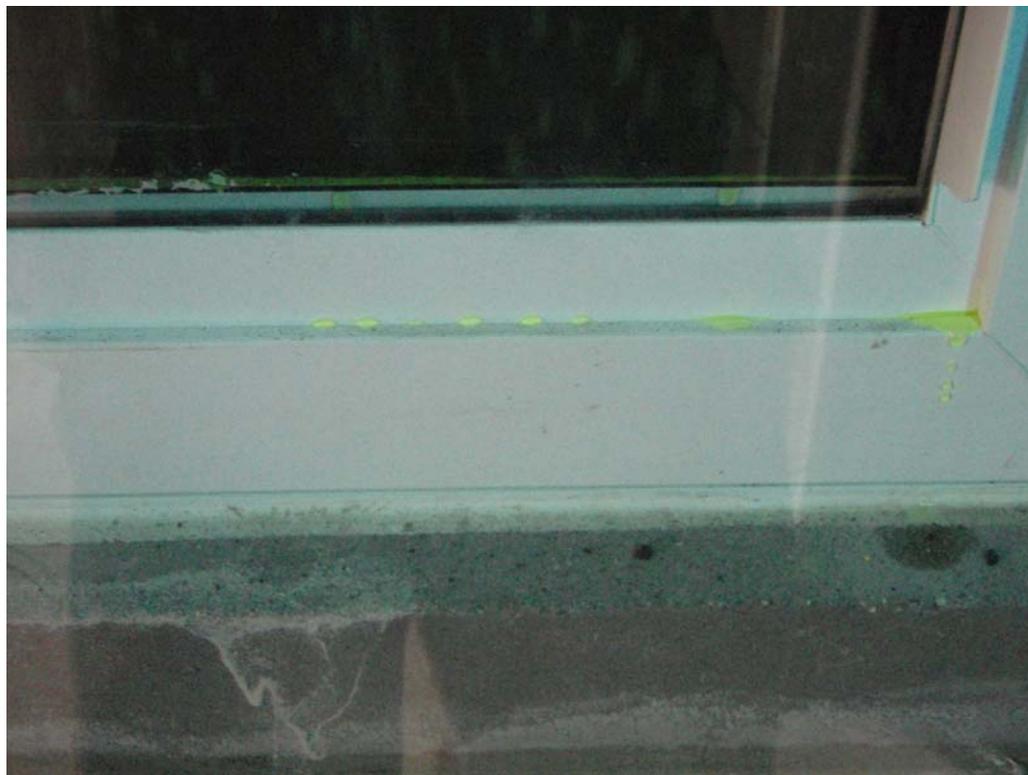
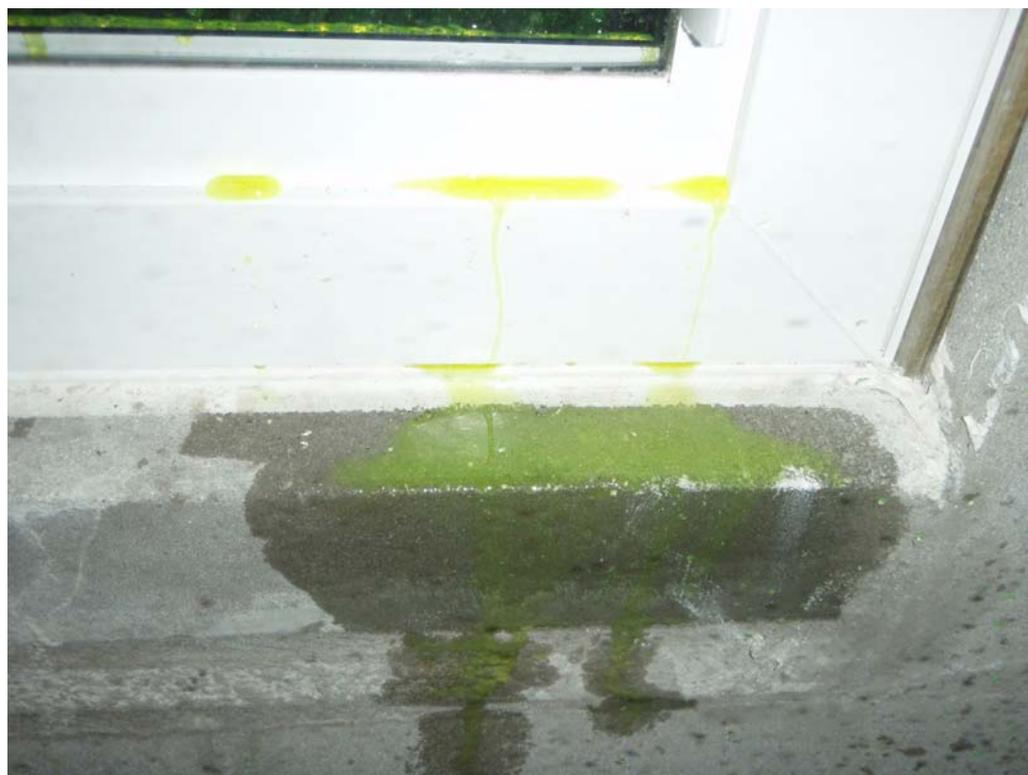
Figure 7-1. Infiltration Paths Through the Right Side of the Operable Sill of Specimen #032. A) End of the cyclic test B) End of the static test.
