VISIBILITY-RELATED FATALITIES IN THE CONSTRUCTION INDUSTRY

A THESIS PRESENTED TO THE GRADUATE SCHOOL  
OF THE UNIVERSITY OF FLORIDA IN PARTIAL FULFILLMENT  
OF THE REQUIREMENTS FOR THE DEGREE OF  
MASTER OF SCIENCE IN BUILDING CONSTRUCTION

UNIVERSITY OF FLORIDA

2010

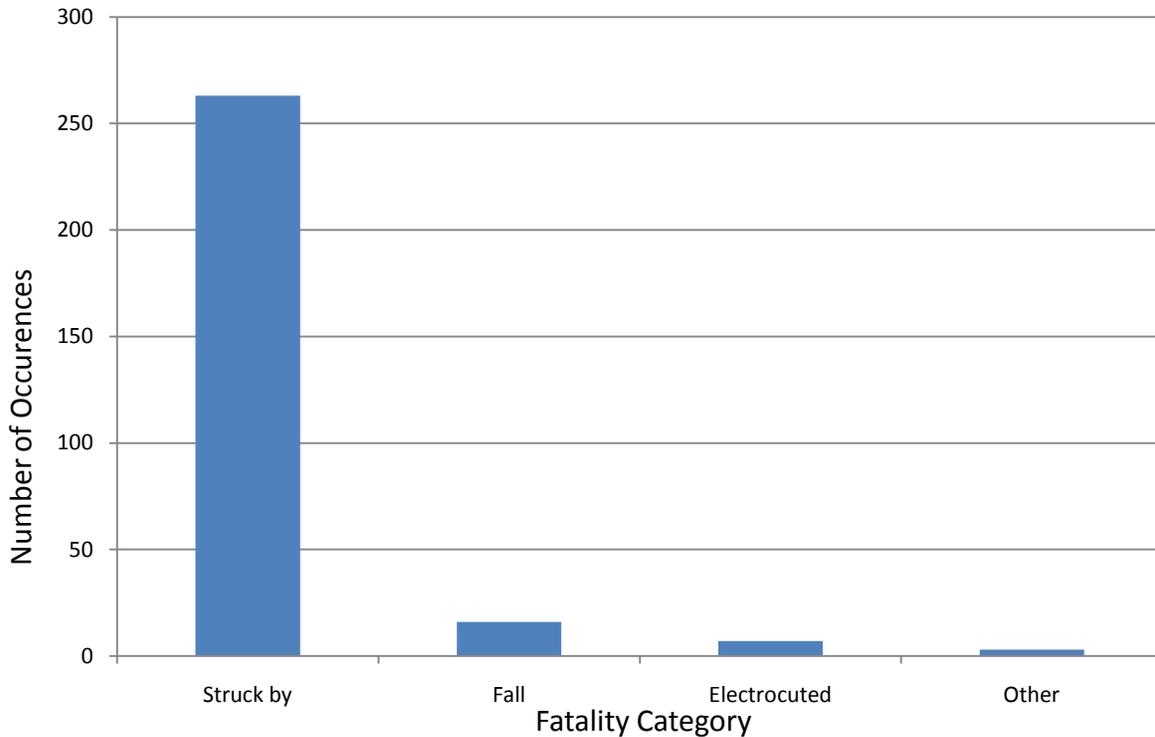
Figure 4-1. Classification of Fatalities (289 cases)

Visibility-related fatalities are categorized in Figure 4-1 into four types. These four types are listed as “struck by”, “falls”, “electrocutions”, and “other”. Figure 4-1 shows how frequently each of these four types of visibility-related fatalities occurred.

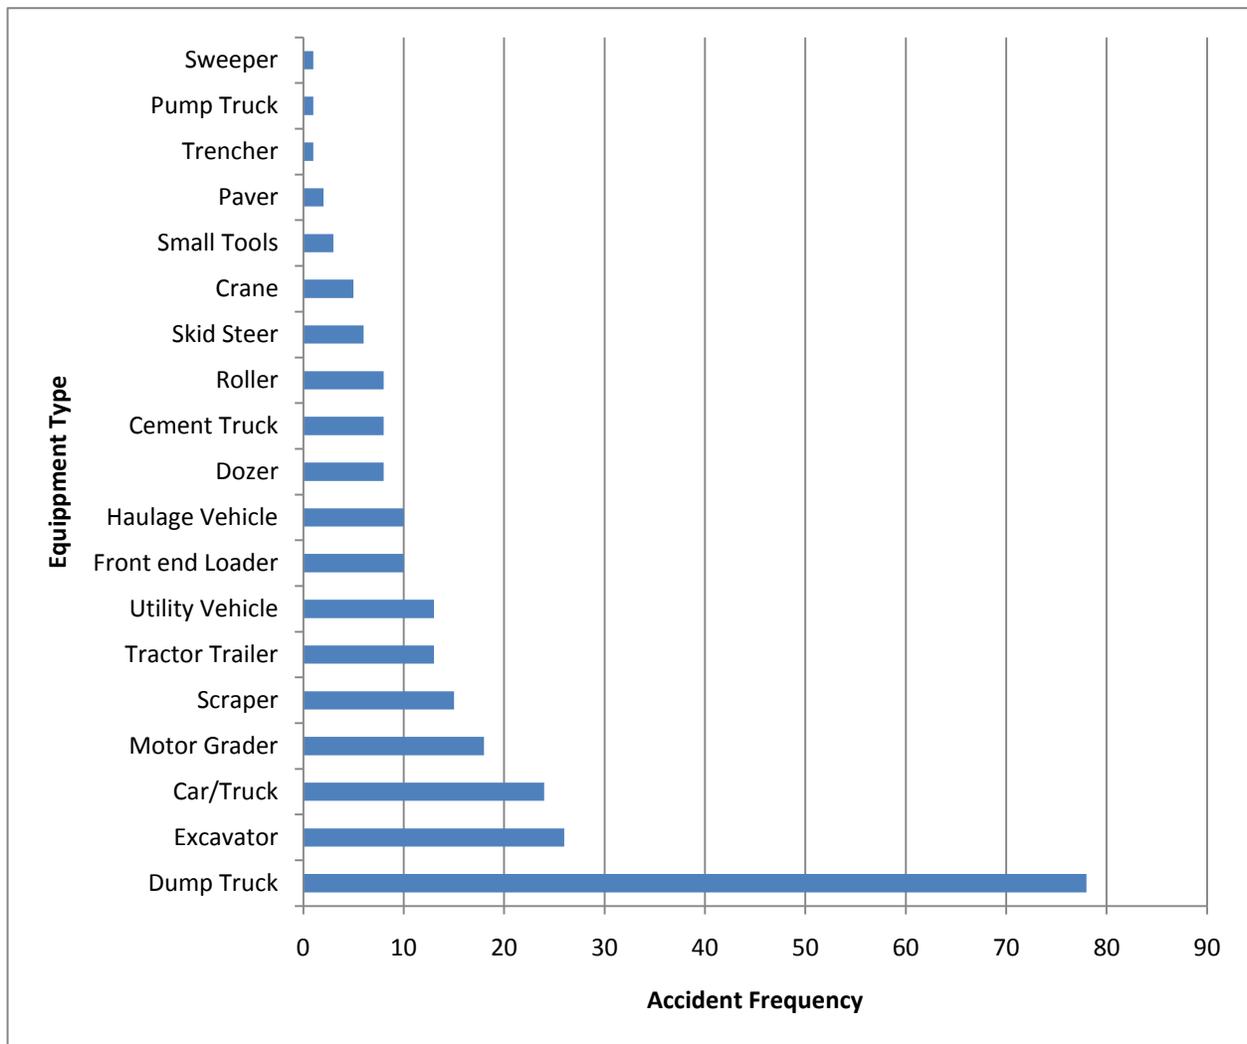
Figure 4-2. Fatalities grouped by equipment type.

Figure 4-2 identifies each equipment type involved in visibility-related fatalities, and shows how many times each equipment was implicated. Dump trucks were the most frequently occurring equipment and this can be attributed to their large blind spots as well as the time they spend reversing. The next most frequently occurring equipment accidents were caused by excavators, passenger vehicles and motor graders, respectively.

The “struck by” cases were evaluated in terms of the type of equipment involved in the accidents. It was found that dump trucks had the highest frequency of involvement in vision-related fatalities. Dump trucks are hauling vehicles that are relatively high off the ground and are positioned on large rubber tires. The dump truck contains a transportation bed that is enclosed on all sides to prevent material from falling out. This bed creates a large “blind spot” for the operator who must rely on rear view mirrors that provide a limited range of view. Objects that are located towards the

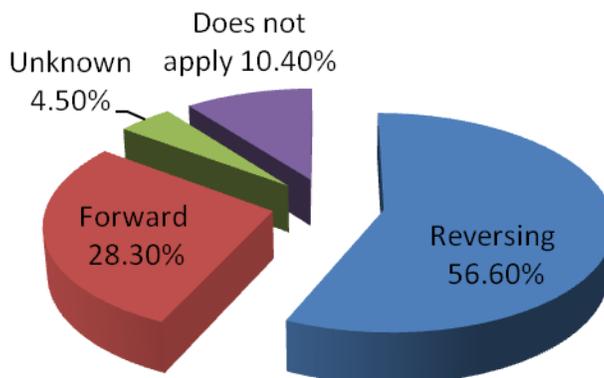
Figure 4-3. Travel Direction. (289 cases)

the details. The “does not apply” percentage refers to cases where the equipment was stationary when the visibility-related fatality occurred such as an excavator crushing a worker while trenching.

The construction equipment and vehicles that were involved in visibility-related fatalities were examined in terms of the direction of vehicle travel. The research showed that 162 were in the act of reversing, which is twice the amount of vehicles traveling forward. This statistic dramatizes the hazards associated with equipment when it travels in reverse.

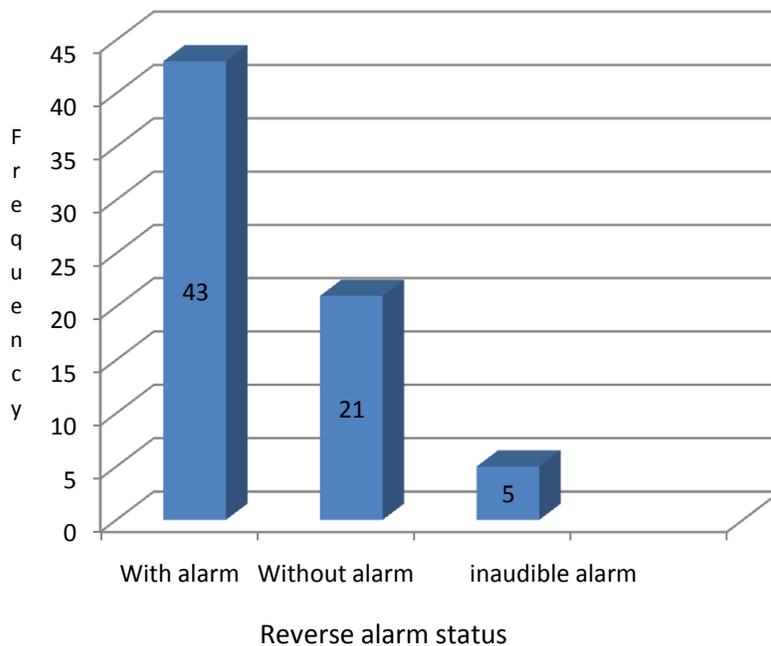
Figure 4-4. Reverse Alarms. (69 cases)

It is common for equipment to have blind spots located in the rear. The back-up alarm is a safety measure intended to warn anyone in the vicinity that equipment is engaged in reverse and that relocating to a safe position may be required. Figure 4-4 shows the amount of reversing vehicles that were equipped, not equipped, or did not have a reverse alarm. Many cases were found where equipment was operated in reverse in close proximity to others but that the equipment was not equipped with reverse alarms (21 occasions). It was specifically noted that 42 of the 162 vehicles traveling in reverse were equipped with a backup alarm, while 5 instances reported the presence of a reverse alarm that was inaudible because of job site noise. It was also found that when two backup alarms issue a warning at the same time that employee judgment can be impaired which renders the alarm ineffective.

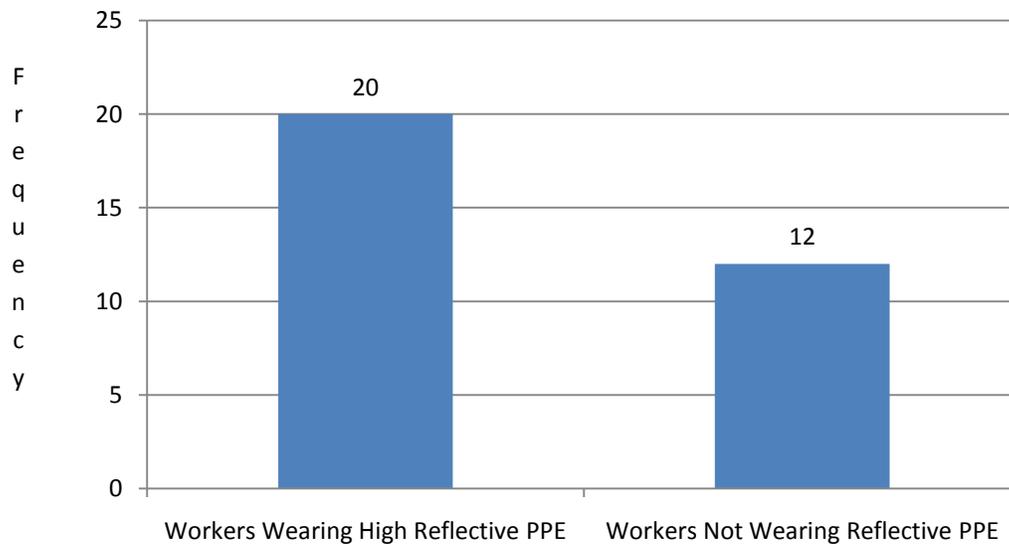
Figure 4-5. Reflective Vests (32 cases)

Reflective vests are fluorescent and brightly colored. They reflect light in areas of low illumination and they also make employees more visible in day time lighting conditions. Of the 32 reported cases involving visibility-related fatalities 20 of specifically noted that the employees were wearing reflective vests. Twelve cases reported that the deceased employees were not wearing reflective vests. Since most of the reports did not disclose whether or not the employees were wearing reflective vests, it was not possible to make an accurate assessment of the effect that wearing such equipment has on accident prevention. Figure 4-5 shows the amount of visibility-related fatality reports that stated whether a worker was wearing a reflective vest or not at the time of the fatality.

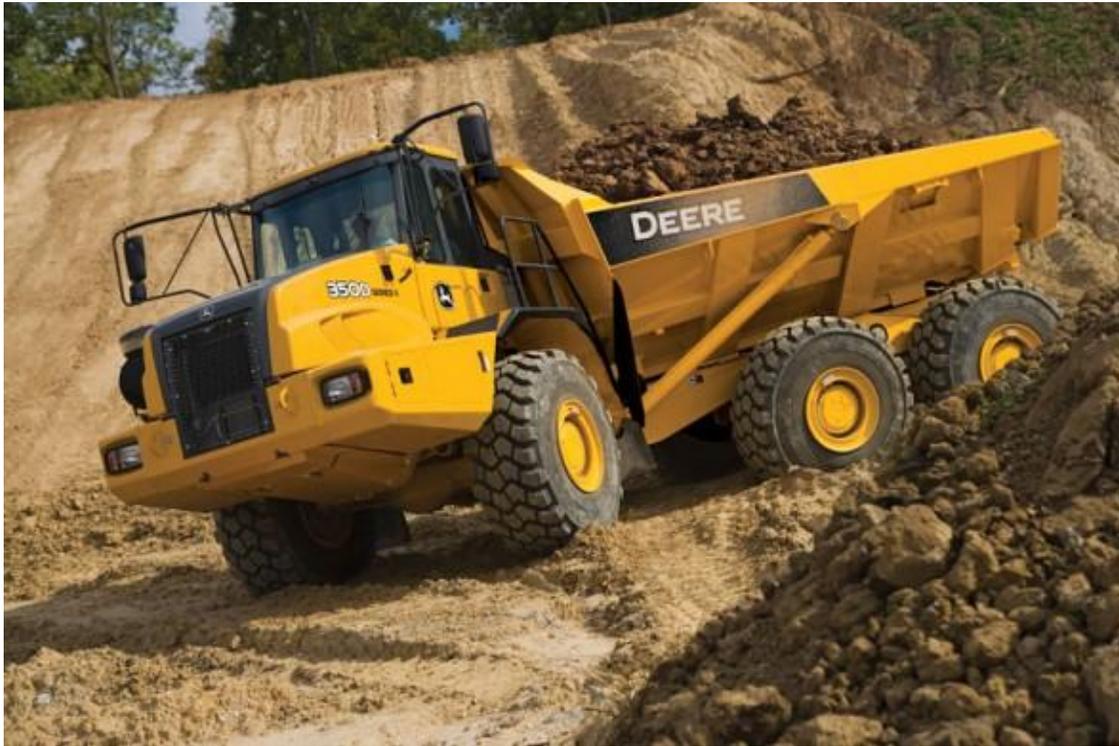
Figure 4.6. (Source: [www.archithings.com/search/john+deere\\_400d+ar](http://www.archithings.com/search/john+deere_400d+ar) 12/09).

Dump trucks had the greatest involvement in visibility-related fatalities. Figure 4-6 shows a picture of a dump truck similar to those commonly used in the construction industry. Dump trucks were involved in 31% of the struck by cases that resulted from visibility-related conditions. These statistics show that dump trucks are the particularly hazardous and this is especially the case when traveling in reverse. Ninety percent of these fatalities involved dump trucks traveling in reverse and this can probably be attributed to their large blind spot area (truck beds) as well as the frequency that they travel in reverse. Figure 4-7 shows the amount of visibility-related fatalities that occurred while dump trucks were reversing compared to when

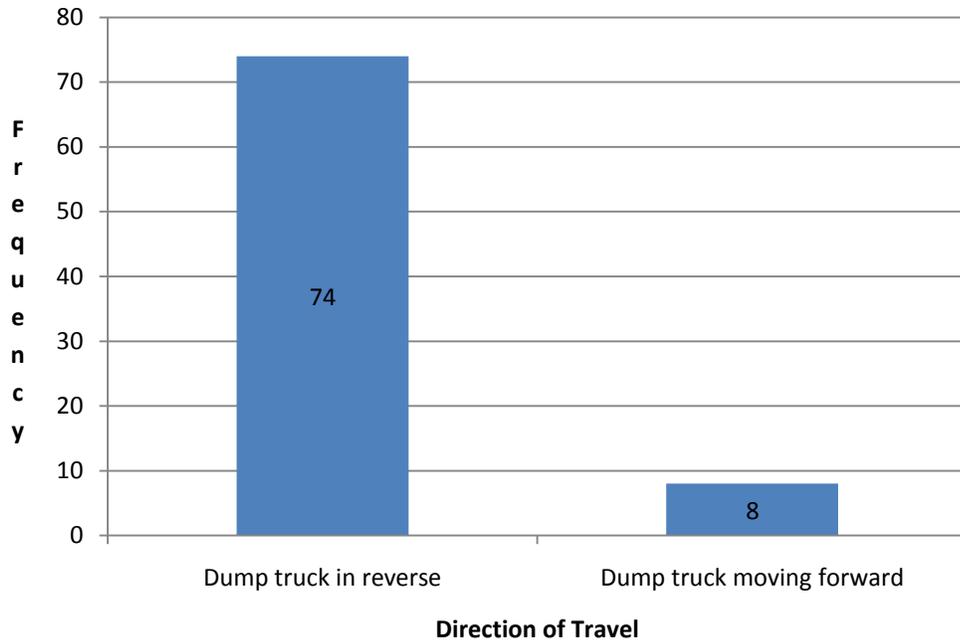
Figure 4-7. Dump truck travel direction (82 cases)

they were traveling forward travelling forward. There were 74 cases in which the dump truck was traveling in reverse at the time of the struck-by accident. There were 8 cases in which the dump truck was traveling forward at the time of the struck-by accident.

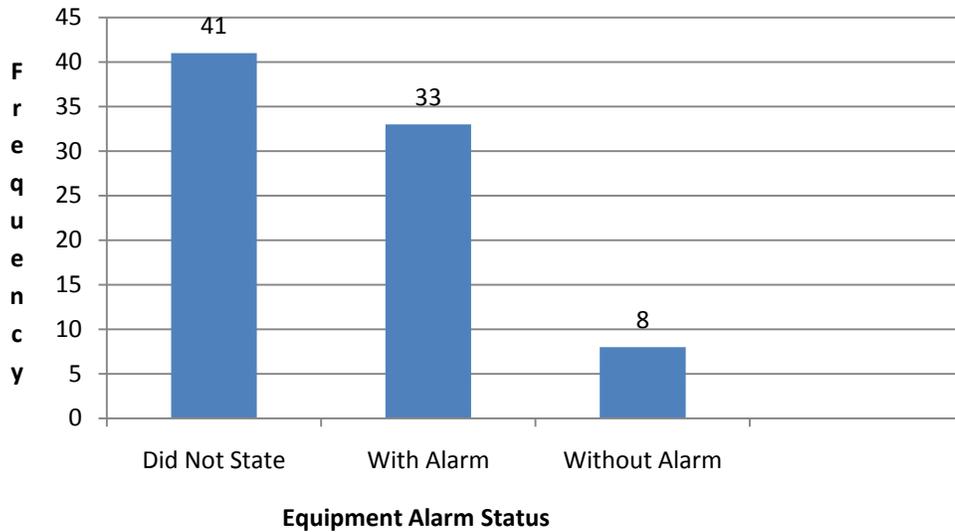
Figure 4-8. Dump trucks and reverse alarms (82 cases)

Figure 4-8 shows the number of dump trucks that were equipped with a backup alarm compared to the number of dump trucks that were not equipped with a backup alarm or did not state if there was a backup alarm at the time of the accident. There were 41 cases that did not state whether the vehicle had a backup alarm at the time of the accident. There were 33 cases in which the vehicle did have a backup alarm and 8 cases in which the vehicle did not have a backup alarm.

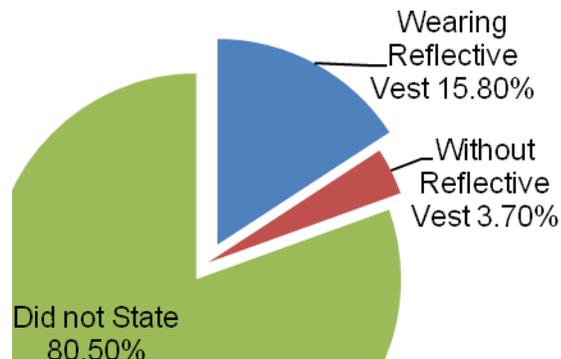
Figure 4-9. Dump trucks and reflective vest use (82 cases)

This finding showed that in 18% of the fatality cases caused by dump trucks, the workers were wearing reflective vests. This number of reflective vests worn might actually be larger, but the research was unable to determine this due to the infrequency of which the use of reflective vests were reported in the OSHA fatality database. Reflective vests increase the visibility of employees working in proximity to equipment and it can be deduced that the likelihood of preventing an accident would increase if everyone wore reflective vests at all times. Figure 4-9 shows the percentage of workers that were killed by dump trucks in relation to whether the worker was wearing a reflective vest or not. The majority of the cases studied did not state whether the worker was wearing a reflective vest at the time of the accident. Nearly 16% of the cases studied indicated that the worker was wearing a reflective vest at the time of the accident, while 3.7% indicated that the worker did not have a reflective vest on at the time of the accident.

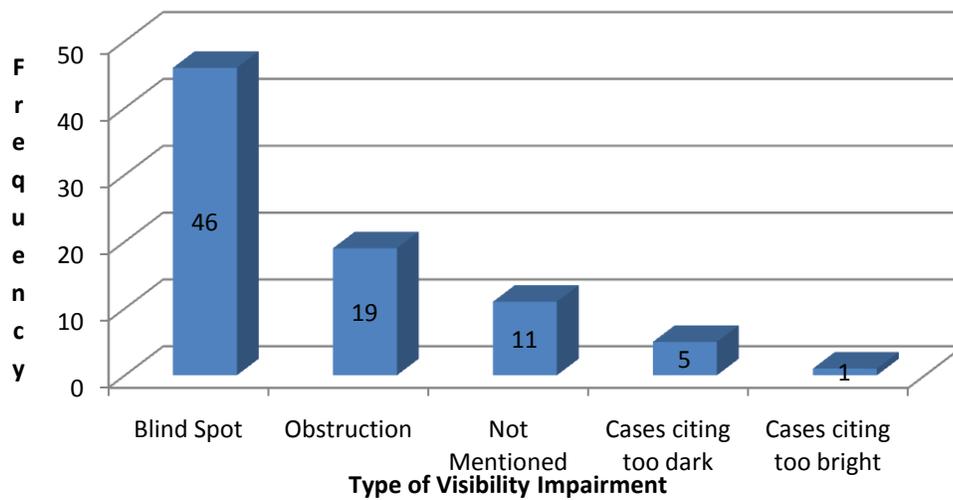
Figure 4-10. Vision factors attributed to dump truck fatalities (82 cases)

reported. There were 11 cases where the type of visibility obstruction was not mentioned, five cases where the lighting was too bright and one case where the lighting was too bright.

In each case examined in this study, one of the major goals of the research was to discover the root causes associated with visibility-related fatalities. The main contributing factors were grouped into four categories. The first of these categories were “too much lighting” as in the case of glare or a sudden change from a poorly illuminated area to one of overwhelming illumination. This type of situation would cause accidents when employees lost their visual reference of surrounding objects.

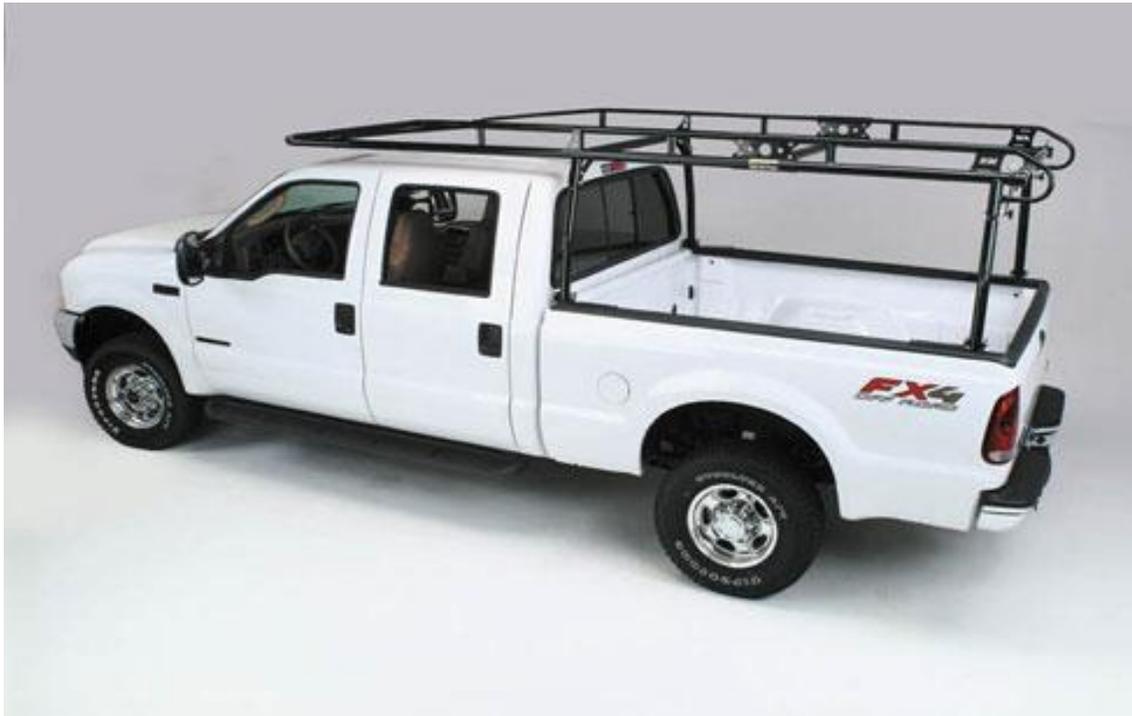
Figure 4-11. Passenger Vehicles (Source: [www.steadfastlinings.net/white\\_truck\\_rack.jpg](http://www.steadfastlinings.net/white_truck_rack.jpg) 12/09).

Passenger vehicles such as cars and trucks are often involved in visibility fatalities. Figure 4-11 shows a common version of a passenger truck that is used in the construction industry. The majority of visibility fatalities involve a vehicle traveling in the forward direction. Research has shown that highway construction is often effected by these types of vehicle accidents whether it is due to the improper arrangement of warning devices and signals about oncoming traffic or poor illumination of work areas.

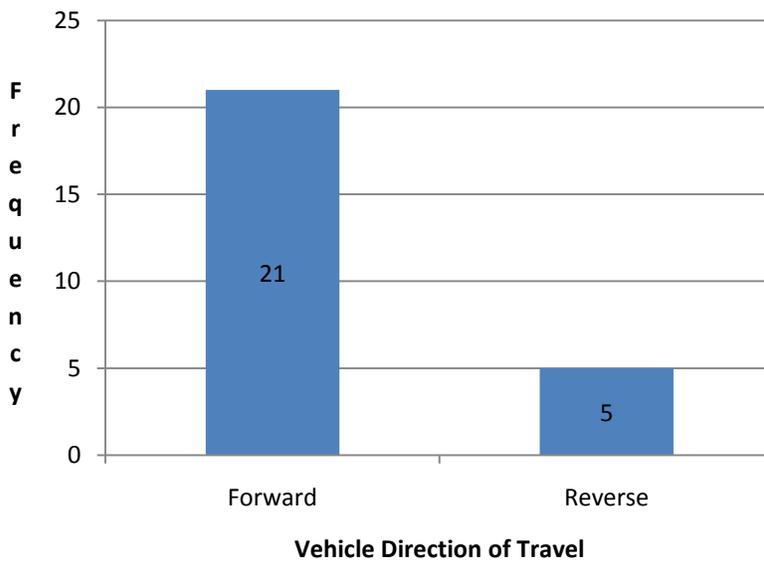
Figure 4-12. Vehicle travel direction (26 cases)

Figure 4-12 notes the number of fatalities that involved passenger vehicles traveling in forward and in reverse. Passenger vehicles traveling in the forward direction were involved 21 fatalities. It was found that vehicles traveling in reverse were only involved in five fatalities.

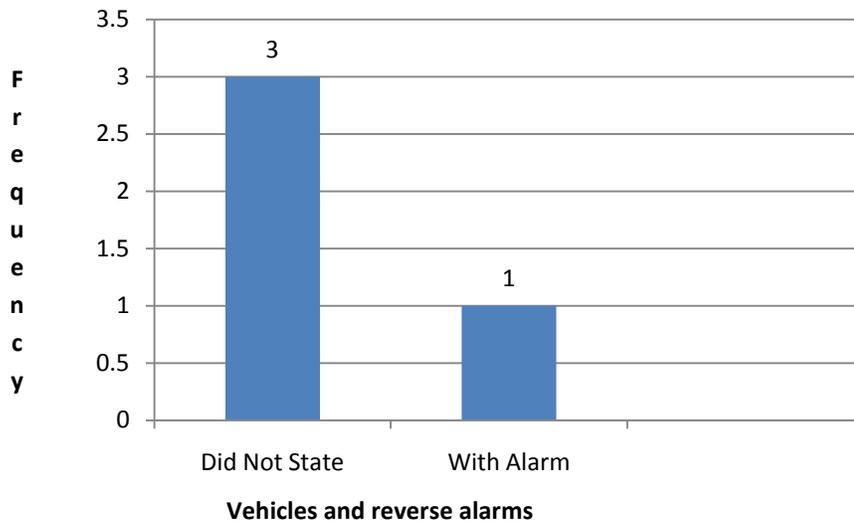
Figure 4-13. Vehicles equipped with reverse alarms (4 cases)

In the cases involving passenger vehicles, one case involved a vehicle that had an alarm, and three cases did not provide this information. All cases failed to report whether the decedent in the accident was wearing a safety vest or not. Figure 4-13 shows the amount of reversing passenger vehicles with alarms and the amount that were not mentioned.

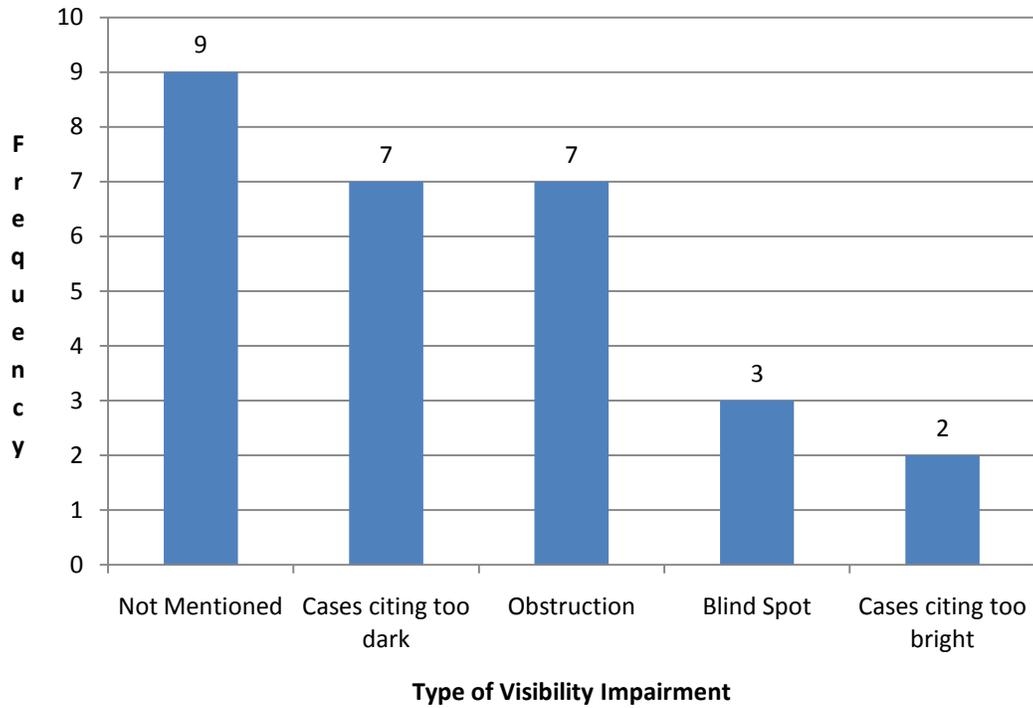
Figure 4-14. Vision factors attributed to vehicles fatalities (28 cases)

Figure 4-14 shows the number of visibility-related fatalities caused by passenger vehicles and the stated cause of the accident. In cases where the accident cause was cited, poor visibility caused by low lighting levels and obstructions were the most common causes cited. There were seven cases in which low lighting levels were cited as the cause of the accident. There were seven cases in which obstructions were cited as the cause of the visibility-related fatality. Blind spots were the next most common cause of visibility-related fatalities with three total cases. There were two reported fatalities where the lighting being too bright was cited as the cause of the accident.

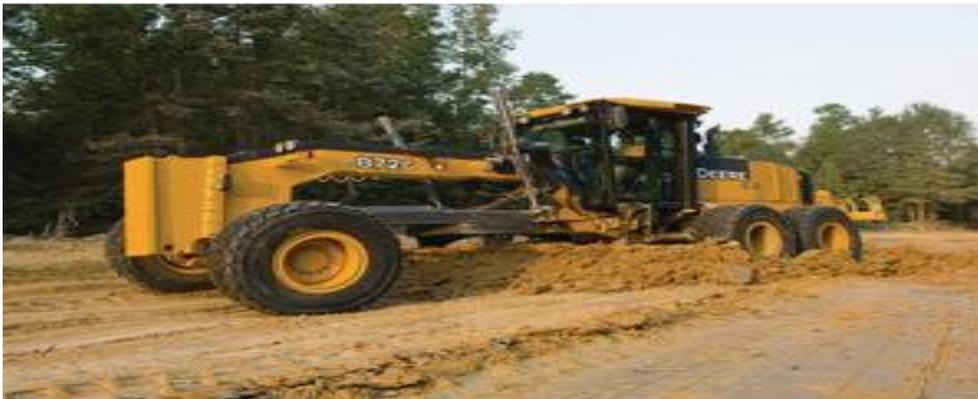
Figure 4-15. Motor Grader (Source: [www.equipment.forconstructionpros.com/product/620](http://www.equipment.forconstructionpros.com/product/620) 12/09).

Figure 4-15 shows a typical motor grader commonly used for the construction of roads and highways as well as various other site work activities. Motor graders represent the second most frequent equipment involved in visibility-related fatalities.

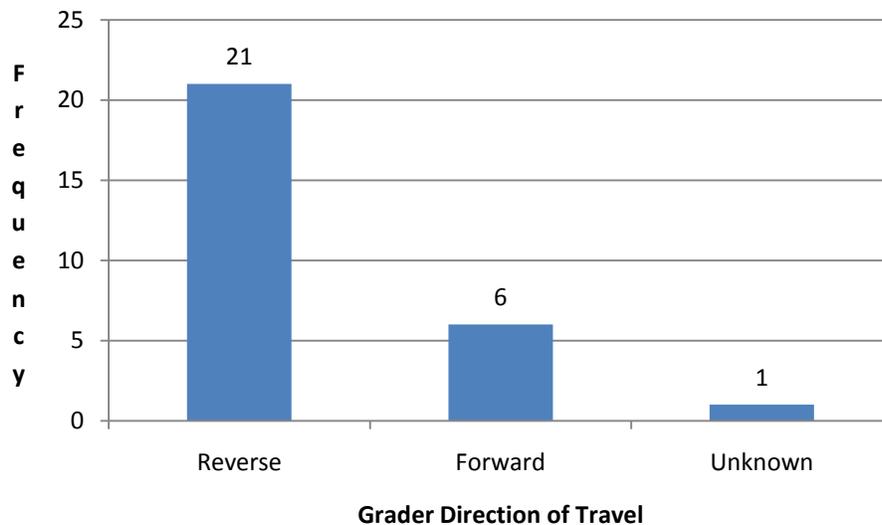
Figure 4-16. Grader direction of travel (18 cases)

Figure 4-16 shows the direction of travel of motor graders involved in visibility-related fatalities. There were 21 cases in which the grader was traveling in reverse at the time of a reported accident. There were six cases where the grader was traveling forward and one case where the direction of travel was unknown.

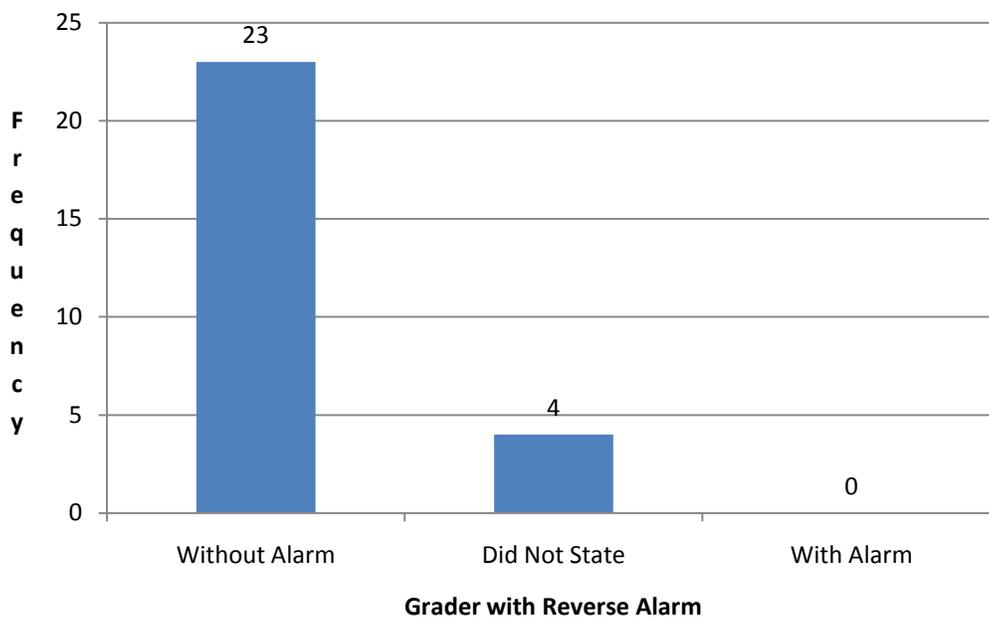
Figure 4-17. Graders equipped with reverse alarm (18 cases)

Figure 4-17 shows the number of graders involved in visibility-related fatalities and whether or not they were equipped with a backup alarm. There were 23 fatality cases reported where the grater was not equipped with a backup alarm. There were four cases that did not state if the grader was equipped with an alarm. There were no cases found of a visibility-related fatality where the motor grader was equipped with a backup alarm.

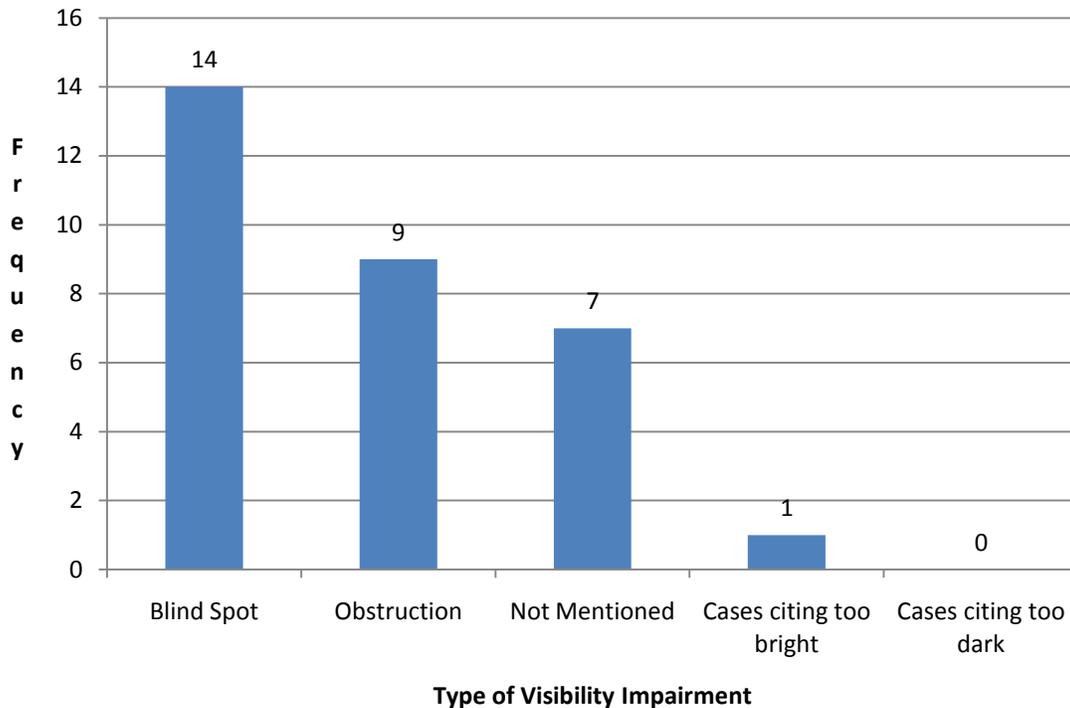
Figure 4-18. Vision factors attributing to grader fatalities (18 cases)

Figure 4-18 shows the number of visibility-related fatalities caused by motor graders and the stated cause of the accident. Blind spots were the most commonly cited reason for the visibility-related fatality with a total of 14 cases citing this as the cause. There were nine cases in which obstructions were cited as the cause of the accident. There were seven cases in which the cause of the visibility-related fatality was not cited. There was one reported fatality where the lighting being too bright was cited as the

cause of the accident. There were no cases in which the ambient lighting being too dark was cited as the cause of the visibility-related accident.

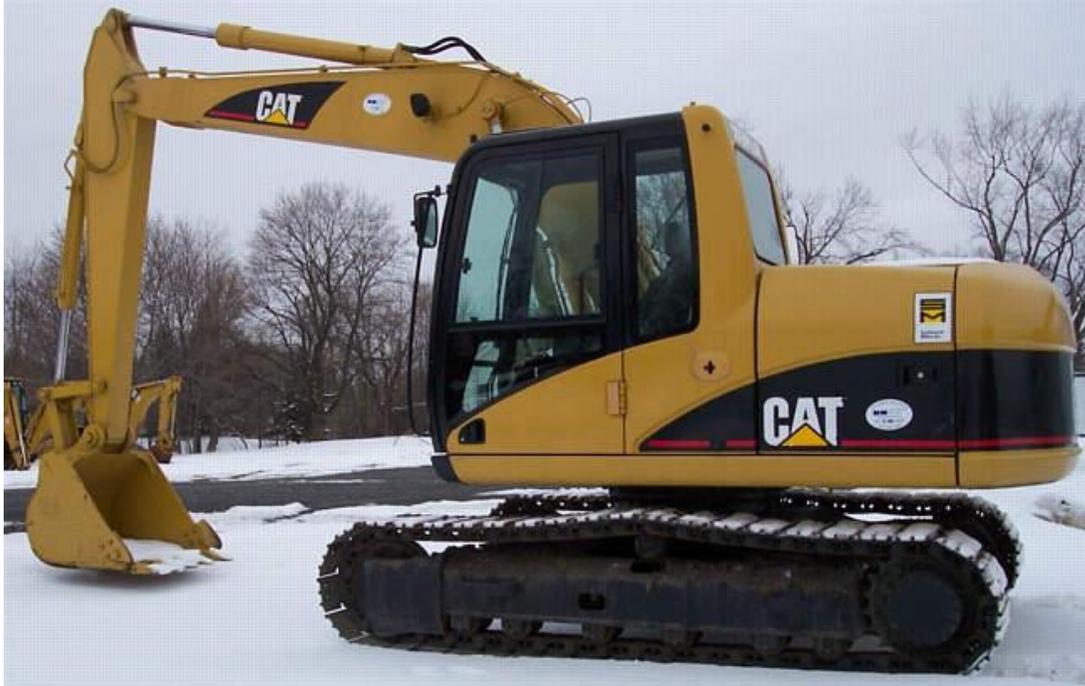
Figure 4-19. Excavator (Source: [www.xcavator.com/used\\_excavator.htm](http://www.xcavator.com/used_excavator.htm) 12/2009)

Figure 4-19 shows a typical version of an excavator that is commonly used in the construction industry. Excavators like these are commonly used to perform various aspects of site work and can be employed on a wide variety of projects ranging from residential to commercial and from industrial to civil. They have many functions and may be used for tasks that range from digging to hoisting materials.

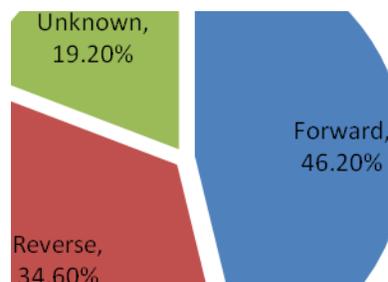
Figure 4-20. Excavator direction of travel (26 cases)

With regard to direction of travel at the time of accident, this research shows that most of the incidents involving excavators occurred when the equipment was traveling in the forward direction. Figure 4-20 shows the direction of travel of the excavator involved in a visibility-related fatality at the time of the accident. In 19.2% of cases, sufficient information to determine travel direction was not available.

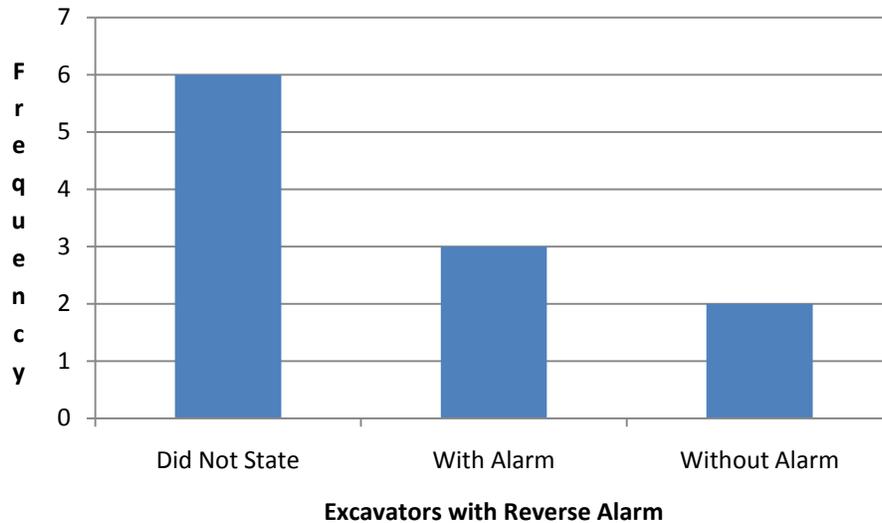
Figure 4-21. Excavators and reverse alarms (11 cases)

Figure 4-21 above shows the status of the excavators reverse alarm at the time of a visibility-related accident. Six cases did not state whether the vehicle was equipped with a reverse alarm at the time of the accident. Three cases indicated that the excavator was equipped with a reverse alarm and two cases indicated that the excavator was not equipped with a reverse alarm.

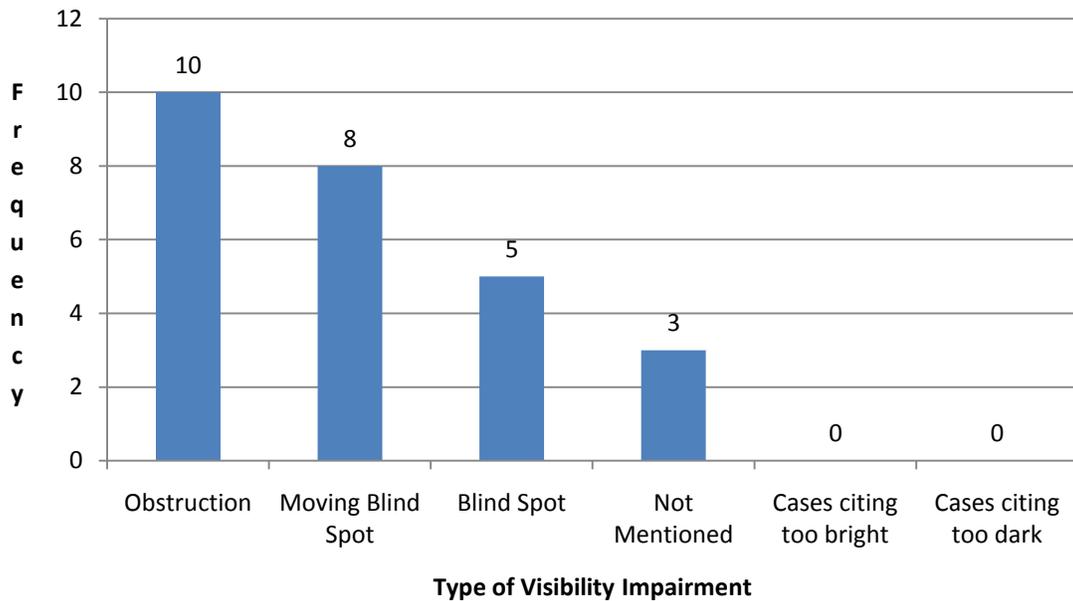
Figure 4-22. Factors attributed to excavator fatalities (26 cases)

Figure 4-22 below shows the number of vision-related excavator fatalities and the factors attributed to those fatalities. Obstructions were the most frequent cause associated with excavator visibility-related fatalities with 10 cases citing obstructions as the cause. Moving blind spots were the second most cause with 8 cases stating them as the cause. These two leading causes can be attributed to both the nature of excavation work as well as the unavoidable creation of moving blind spots due to the equipment configuration and operation.

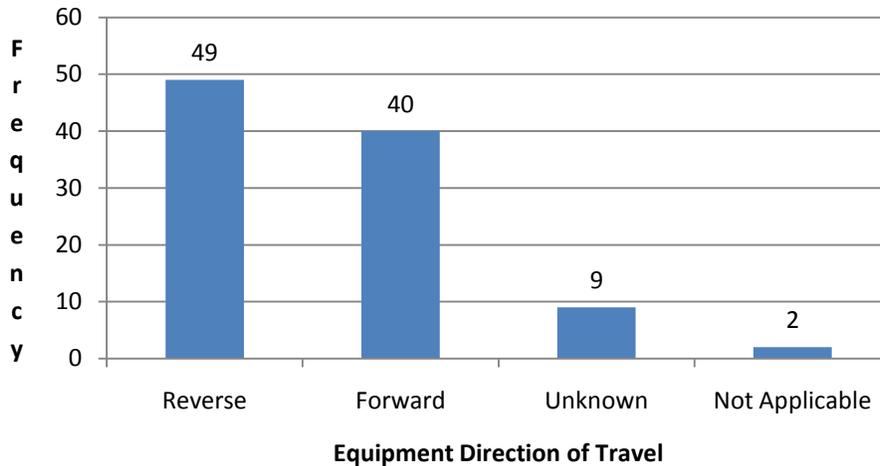
Figure 4-23. Direction of travel (100 cases)

The four equipment types that most frequently were involved in visibility-related fatalities were reported individually. All remaining vehicle and equipment types have been analyzed individually but reported as a single unit. Figure 4-23 below shows the total number of visibility-related fatalities for all remaining equipment types compared to the direction of travel at the time of the accident. There were 49 total cases in which the vehicle was traveling in the reverse direction and 40 total cases where the vehicle was traveling in the forward direction. There were nine reported cases in which the vehicle direction of travel was unknown and two reported cases where the vehicle direction of travel was not applicable.

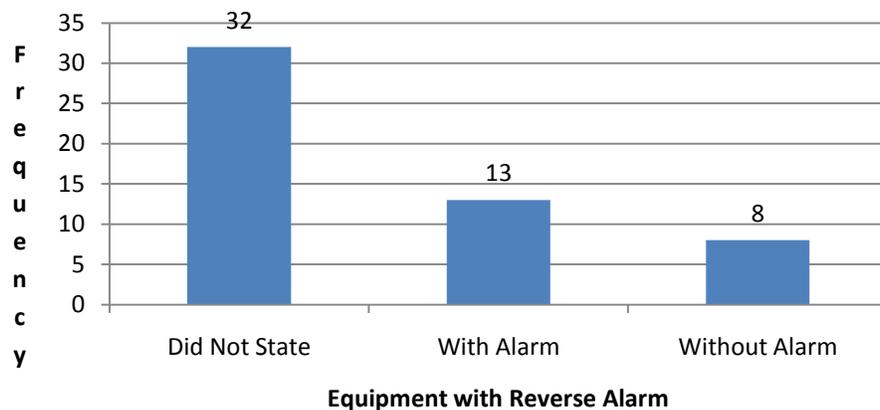
Figure 4-24. All other equipment with reverse alarms (53 cases)

Figure 4-24 below shows the total number of visibility-related fatalities for all remaining equipment types and the status of their reverse alarm at the time of the accident. The majority of the cases reported did not state whether or not the vehicle was equipped with a reverse alarm at the time of the accident. Thirteen cases indicated that the vehicle was equipped with a reverse alarm at the time of the accident and eight cases indicated that there was no reverse alarm present.

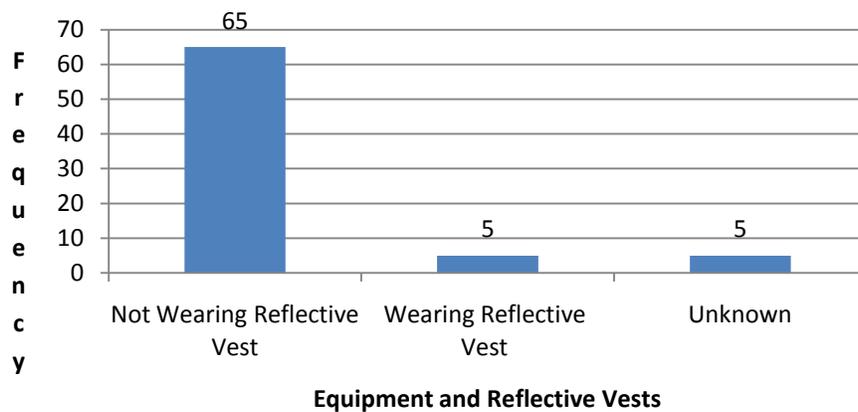
Figure 4-25. All other equipment and reflective vest use (75 cases)

Figure 4-25 below shows the total number of vision-related fatalities for all remaining types of equipment and whether or not the decedent was wearing a reflective vest at the time of the accident. There were 65 reported fatalities in which the decedent was not wearing a reflective vest at the time of the accident. There were 5 reported cases in which the decedent was wearing a reflective vest at the time of the accident and 5 cases in which the status of the reflective vest was unknown.

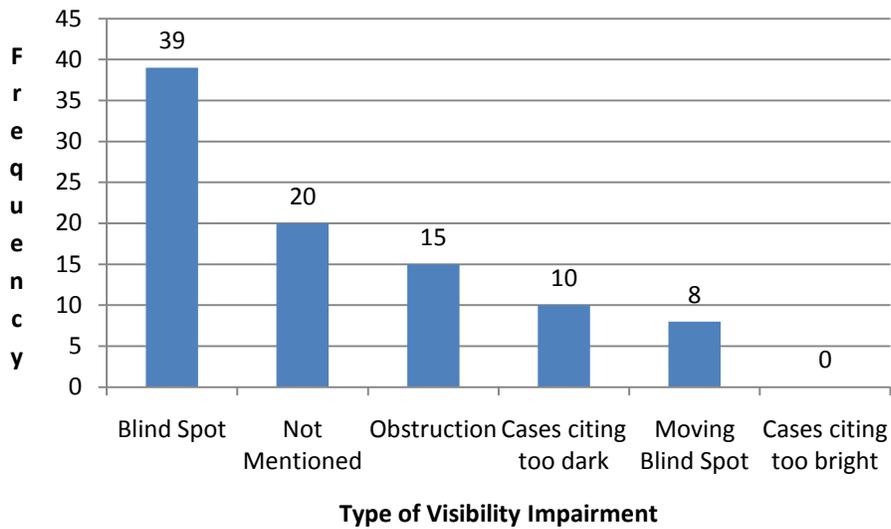
Figure 4-26. Causes attributed to all other equipment fatalities (92 cases)

Figure 4-26 below shows the total number of vision-related fatalities involving all other types of equipment and the stated cause of the accident. Blind spots were the most commonly cited cause of accidents with 39 total occurrences. There were 20 cases in which the cause attributed was not mentioned. There were 15 cases where obstructions were cited as the cause, ten cases in which the lighting being too dark was cited as the cause and eight cases where a moving blind spot was cited as the cause. There were no cases that cited the lighting being too bright as the cause of the vision-related fatality.

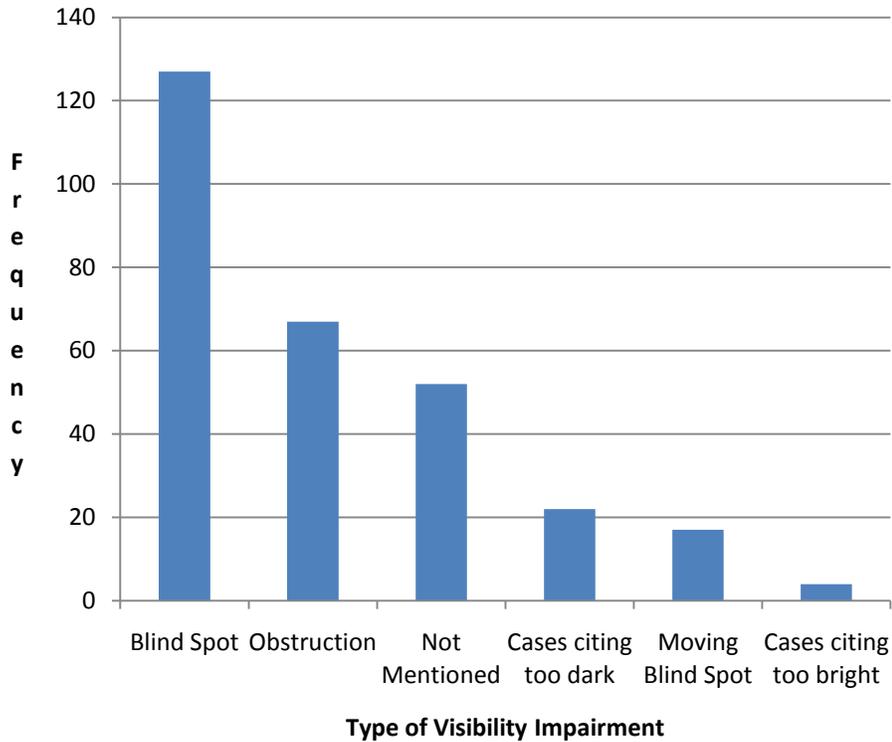
Figure 4-27. All vision related fatalities involving all equipment (289 cases)

This next section is dedicated to the analysis of all vision-related fatalities for all types of construction equipment combined. Figure 4-27 shows the total number of vision-related fatalities for all types of equipment and the cited cause of the accident. The most frequently cited cause of vision-related fatalities for all types of construction equipment was the presence of blind spots. Blind spots were cited as the cause of nearly 130 visibility-related fatalities. Obstructions were the second most frequently cited cause of visibility-related fatalities with 68 fatalities attributed to this cause. There were over 54 cases reported in which the cause of the visibility impairment was not mentioned. There were 21 fatalities attributed to the lighting conditions at the time of the accident being too dark and only three cases where the lighting conditions were too bright.

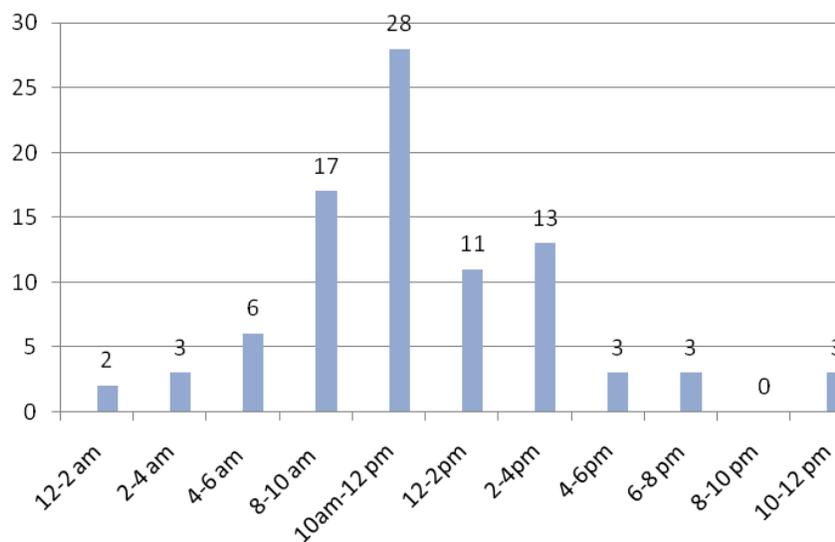
Figure 4-28. Vision related fatalities with reported time of occurrence (89 cases)

Most heavy construction equipment contains headlights for operating in less than optimal lighting conditions and it is important that they are utilized at appropriate times. Figure 4-28 below shows the total number of visibility-related fatalities and the time of day that they occurred. The hours of 10am through 12 pm were the most common times in which visibility related fatalities occurred. There were 28 vision-related fatalities that occurred during this time frame.

There were 17 visibility-related fatalities that occurred between the hours of dusk and dawn. For the purposes of this study dusk through dawn is defined as 6pm through 6am. This number represents nearly 20% of all vision-related fatalities for all types of construction equipment studied.
