DAMAGE EVALUATION OF GLASS FIBER REINFORCED POLYMER DECKS USING  
ACOUSTIC EMISSIONS

A THESIS PRESENTED TO THE GRADUATE SCHOOL  
OF THE UNIVERSITY OF FLORIDA IN PARTIAL FULFILLMENT  
OF THE REQUIREMENTS FOR THE DEGREE OF  
MASTER OF ENGINEERING

UNIVERSITY OF FLORIDA

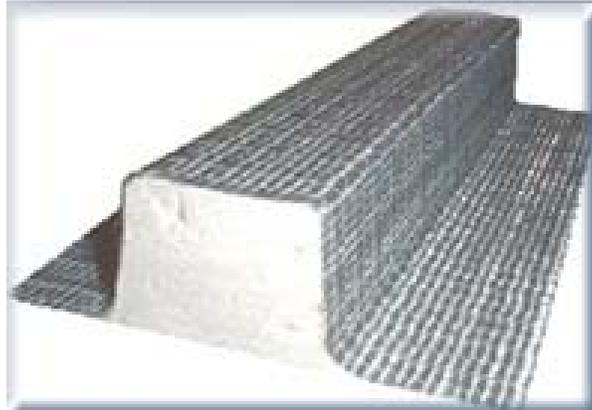
Figure 2-3. Preform sample beam used by Structural Composites of Melbourne (performs.com).

Stay-in-place preforms are used in the wet lay-up assembly process to support the wet mats during the curing process. They are made from polyurethane foam molded into the desired shape to create the cross-section. This method was developed for the boating industry (Figure 2-3). The assembly process is similar to the wet layup process but utilizes foam forms, which are made of 2 pound per cubic foot floatation-grade polyurethane foam, to hold the shape of the cross-section until the resin (preforms.com 2011). The deck is manufactured with threaded sleeves that are used to attach the deck to the bridge superstructure with clips.

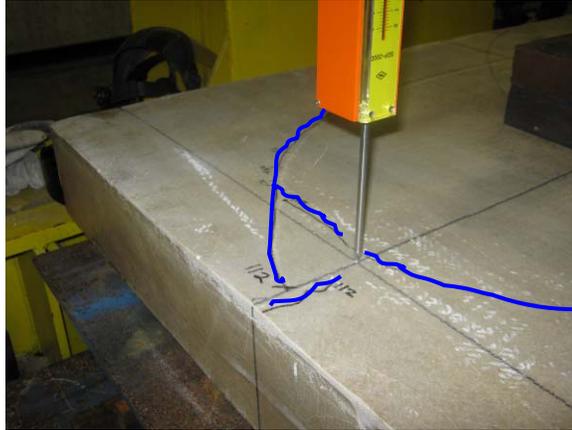
Figure 6-11. B\_P cracks at failure load.

During the ultimate strength test, cracks formed around the load point in the top panel (highlighted in Figure 6-10). As load was increased, the cracks grew parallel to the span and eventually merged over the supports when the ultimate capacity was reached Figure 6-11. Post ULT inspection of the specimen indicated that the bottom soffit of the sample was intact and that the top surface retained a bowl-shaped permanent deformation, indicating that the interior webs were also permanently deformed.
