LONG SPANS WITH TRANSPORTABLE PRECAST PRESTRESSED GIRDERS

NATASSIA R. BRENKUS

A THESIS PRESENTED TO THE GRADUATE SCHOOL
OF THE UNIVERSITY OF FLORIDA IN PARTIAL FULFILLMENT
OF THE REQUIREMENTS FOR THE DEGREE OF
MASTER OF ENGINEERING

2013

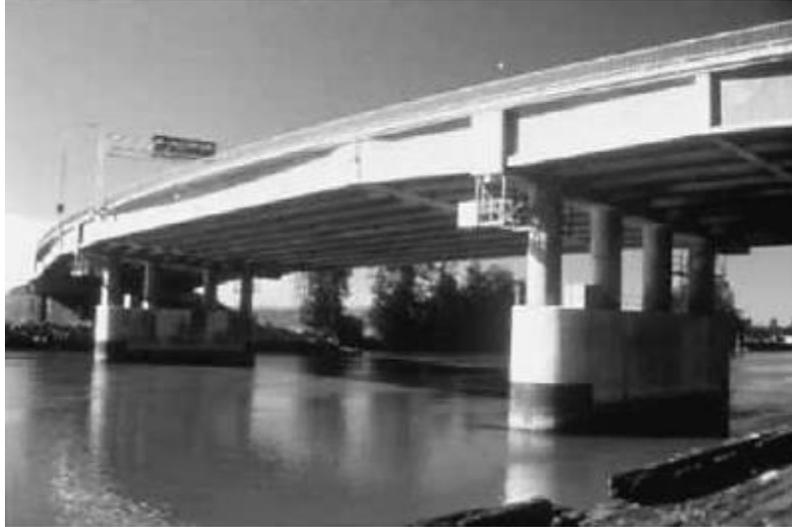
Figure 2-2. Curved roadway constructed with spliced girders (Abdel-Karim and Tadros 1992b)

One significant benefit of spliced long-span precast concrete girders is their ability to accommodate curved alignments (Figure 2-2). When a curve in the roadway is required, the splice location can be situated in order to provide a point of curvature between short segment lengths (PCI 2004). Similarly, spliced segments can be arranged such that the placement of the piers avoids obstacles on the ground, such as railroad tracks, utilities or other roadways (Castrodale and White 2004). Because the designer has more flexibility when specifying span lengths and locations of piers, spliced construction allows the placement of piers and spans as necessary for the geometry of the road (Weigel et al. 2003; PCI 2004).

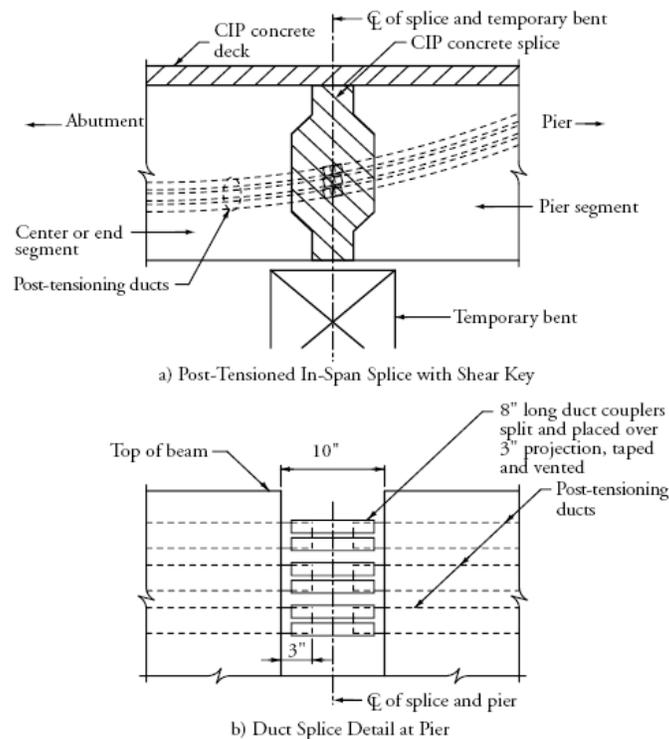
Figure 2-4. Post-tensioned CIP splice (PCI 2004)

Several issues must be considered when employing a post-tensioned cast-in-place splice. Frequently, standard I-girder sections must be modified to provide enough space for the PT duct, longitudinal reinforcement, shear stirrups, and code-mandated concrete cover; Florida bulb-tees with modified webs are commonly used in precast, prestressed spliced I-girder spans (Abdel-Karim and Tadros 1992; Ronald 2001). Accurate alignment of the PT duct is important to reduce the prestress losses caused by

friction. Rotation of the ends must be controlled by design to limit camber. Care must be taken not to damage the post-tensioning duct during erection; a damaged PT duct cannot be properly grouted. Without fully grouted tendons, the splice may incur additional prestress losses due to friction and may have reduced durability over its lifespan (FDOT 2004). Furthermore, care must be taken to completely seal the coupling zone and PT duct to prevent leakage of the post-tensioning grout and corrosion of the reinforcing steel (PCI 2004; FDOT 2004).

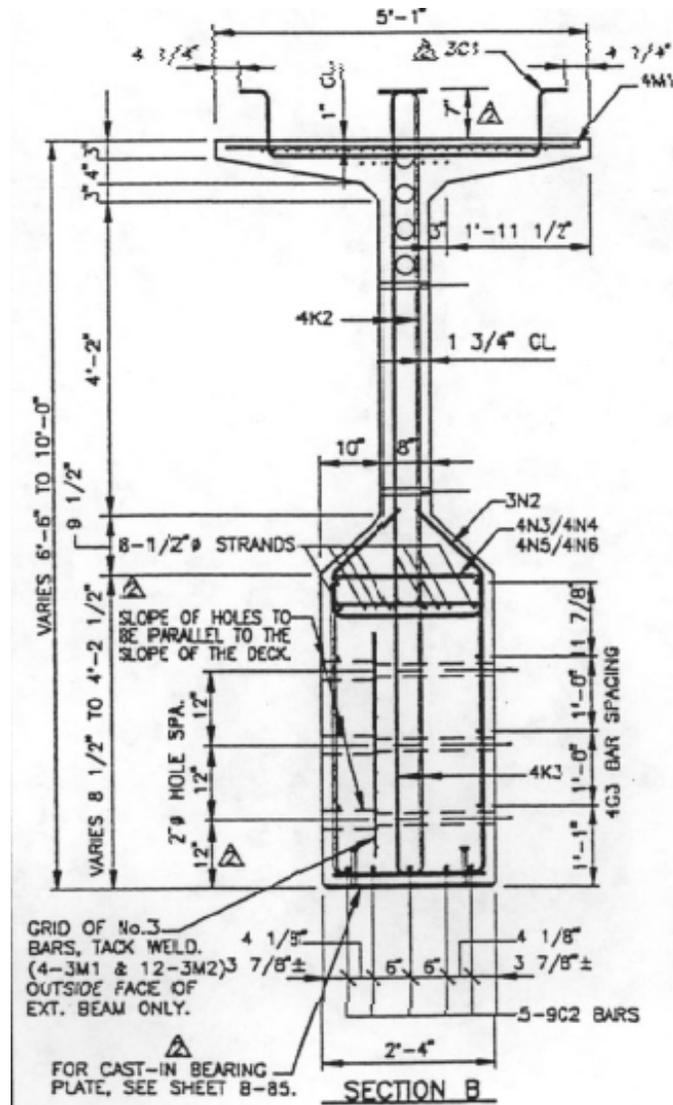
Figure 2-6. Gandy bridge splice connection detail (FDOT 1999)

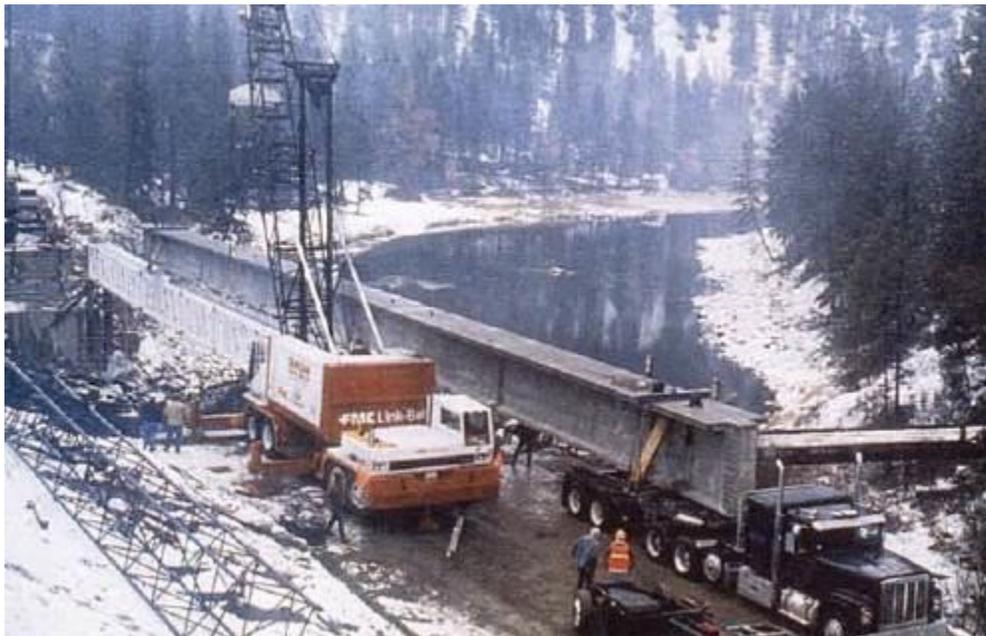
Figure 2-9. Launching assembled girder using trolley (Nicholls and Prussack 1997)

If the weight of an assembled girder is excessive, or if site conditions do not allow the girder to be lifted, the entire girder assembly may be loaded onto a rolling trolley and moved laterally into place along a rail on an adjacent temporary structure. After sliding the girder onto the temporary support, two cranes, one on each end of the span, can then place the girder over the supports. An example of this procedure, as done during the construction of Rock Cut Bridge, is shown in Figure 2-9 (Nicholls and Prussack 1997; Joint PCI-PTI Committee 1982). For more details, see Nicholls and Prussack, 1997.

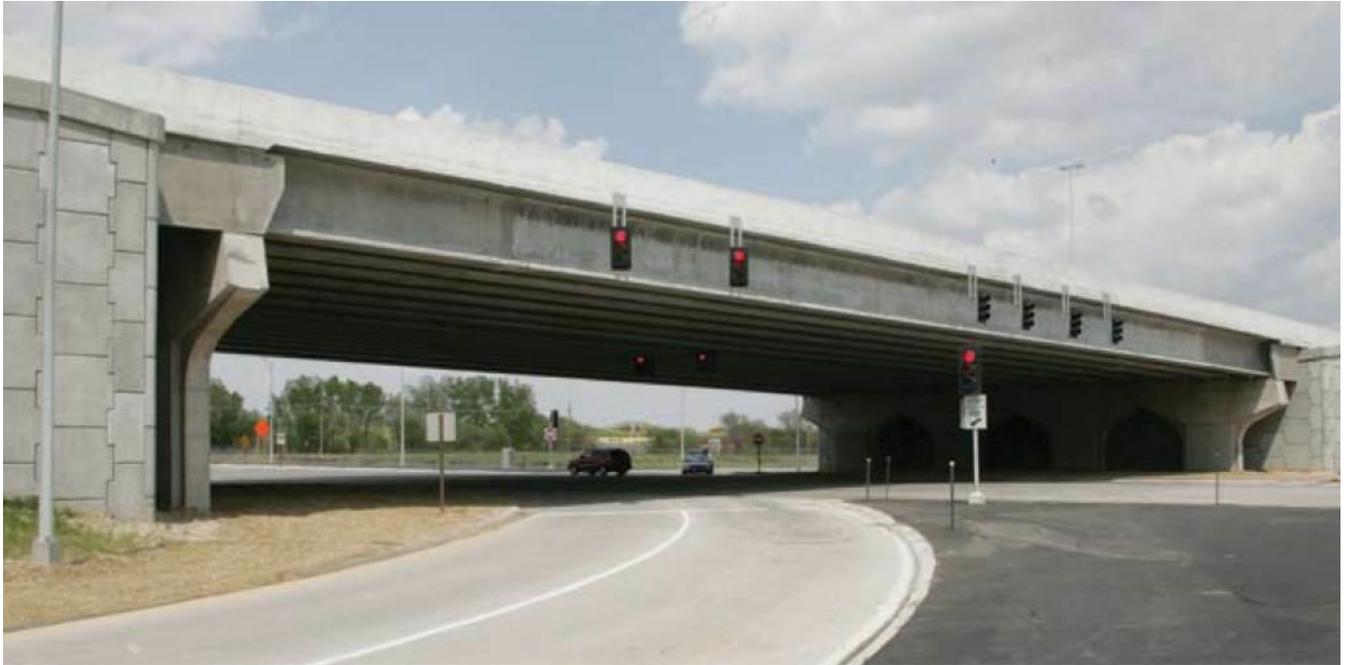
Figure 2-12. 204th Street Bridge (Jaber et al. 2006)

The design of the 204th Street Bridge (Figure 2-12) is the closest example of the system type targeted by this research. The simple-span single point interchange, as described by Jaber et al. (2006), consisted of 14 girder lines constructed as two structures (for each lane of traffic). Two short end segments were bridged together with a long center segment to span a total of 207 ft.

Splicing of the segments was completed mid-air, using temporary towers to provide support at the joint. The authors describe as one of the most challenging design aspects the determination of the girder elevations at the splice locations so as to provide a smooth riding surface and to prevent sag in the girder-soffit profile. Screw jacks were used to refine the girder elevation as required. The precast concrete girders were spliced together with a cast-in-place joint, aligning the post-tensioning ducts running through each segment. After the closure pour reached the specified strength, the assembled precast girder system was post-tensioned along its entire length. (Jaber et al. 2006)

The splices were designed to resist zero net tension. No special reinforcement was detailed in the splice area. To prevent tensile stresses in this area during the service life, prestressing was specified to provide adequate precompression. The specified compressive strength at the joint was less than that required in the girders; conventional concrete was adequate for the closure pour. (Jaber et al. 2006)

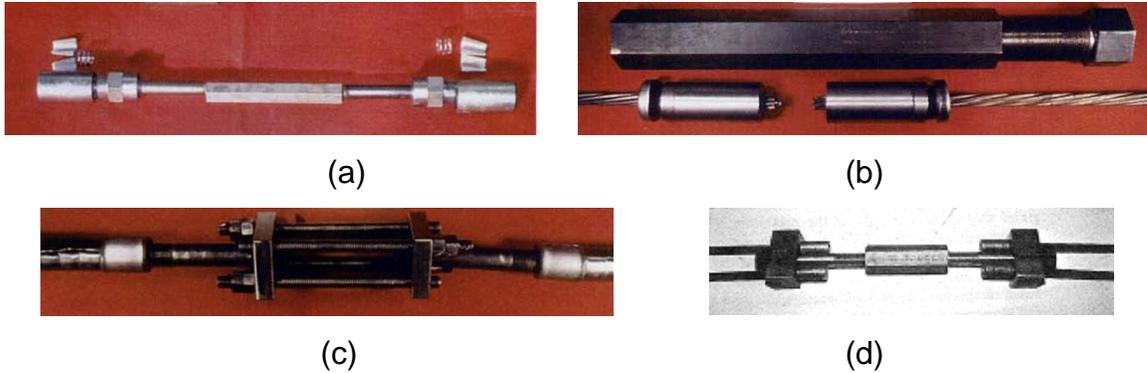
Figure 2-13. Prestressing strand coupler types: (a) turnbuckle-style, (b) Alberta, (c) swaged for single strand, (d) swaged for two strands (Zobel and Jirsa 1998; Shanafelt and Horn 1985)

Prestressing strand couplers provide an economical and time-effective solution for restoring prestress force to severed strands of moderately damaged girders. Figure 2-13 shows several examples.

Zobel (1998) investigated four mechanical couplers (Figure 2-13), evaluating their ease of installation and performance as a repair mechanism in a girder previously in service which had been removed brought to the lab for testing. Mock repairs were conducted to investigate the feasibility of repairs using the different coupler types.

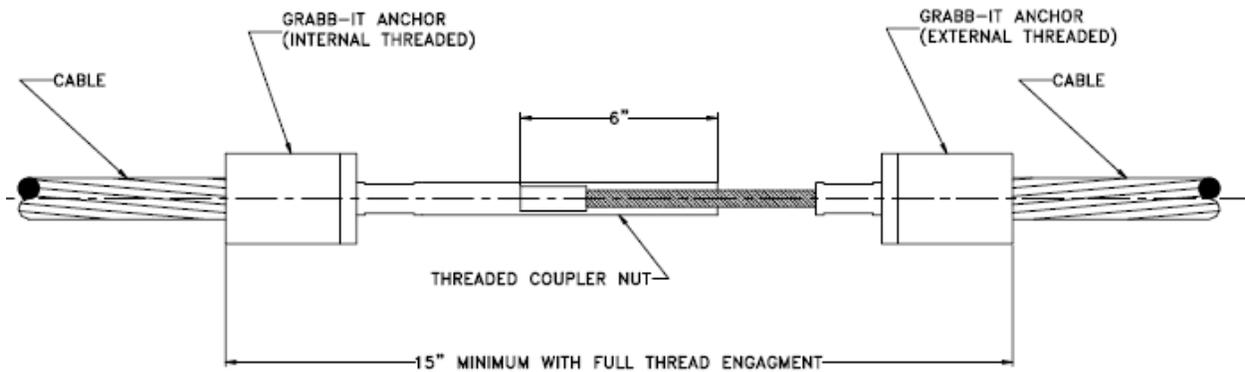
Figure 2-14. Turnbuckle-style coupler (FDOT 2010c)

Figure 2-14 shows the strand repair coupler currently permitted by FDOT (Bridge Maintenance and Repair Handbook 2012) for repair of damaged strand in prestressed concrete girders. It is adjustable and 0.5-in. dia. versions of this coupler have been used to repair damaged prestressing strand in concrete girders for approximately the past thirty years (Waheed et al. 2005). The 0.5-in. dia. coupler has been used to repair bridges in several states. No problems have been reported post-repair (Waheed et al. 2005; Johnson 2011). Figure 2-15 shows a damaged girder in Ontario that was rehabilitated with couplers (Ministry of Transportation of Ontario 2011).

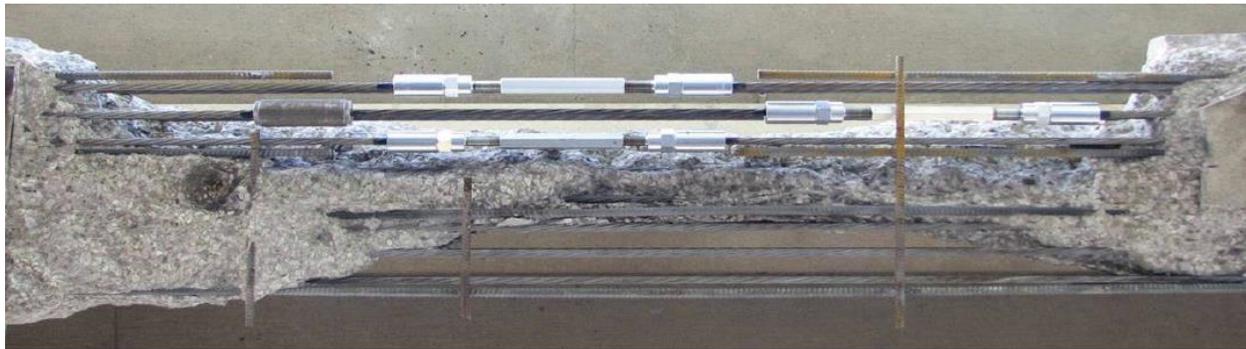
Figure 2-15. Repair of severed strand using a coupler (Ministry of Transportation of Ontario 2011)

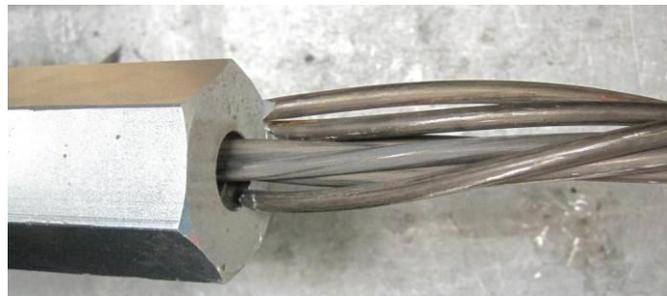
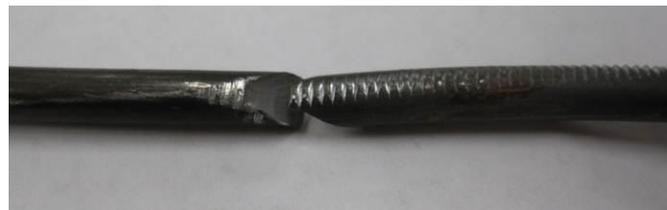
Figure 4-3. Strand rupture of 0.6-in. dia. coupler

Two tension tests were conducted on the 0.6-in. dia. couplers to be used in the proposed splice design. The first test was performed at the FDOT State Materials Office. In this test, the coupler was used to splice two lengths of 0.6-in. dia. 270-ksi lo-lax prestressing strand. One end of each strand was prepared with white glue and fine sand prior to the test, in accordance with ASTM A1061; the sand-prepared end was gripped by the wedge grips of the test machine (ASTM A1061 2009). Load was applied at a displacement-controlled rate of approximately 0.2 in./min. The test ended when the strand ruptured near the top wedge of the coupler device (Figure 4-3(a)) at an applied tensile load of 53.6 kip, or 91% of the strand's specified ultimate strength. At rupture, the prestressing strand stress was 247 ksi; though near the proportional limit of lo-lax strand, the stress-strain plot of the coupled device shows that the prestressing strand did not exceed this point, and did not begin to yield prior to rupture. The strand ruptured at notches caused by the wedges (Figure 4-3(b)).

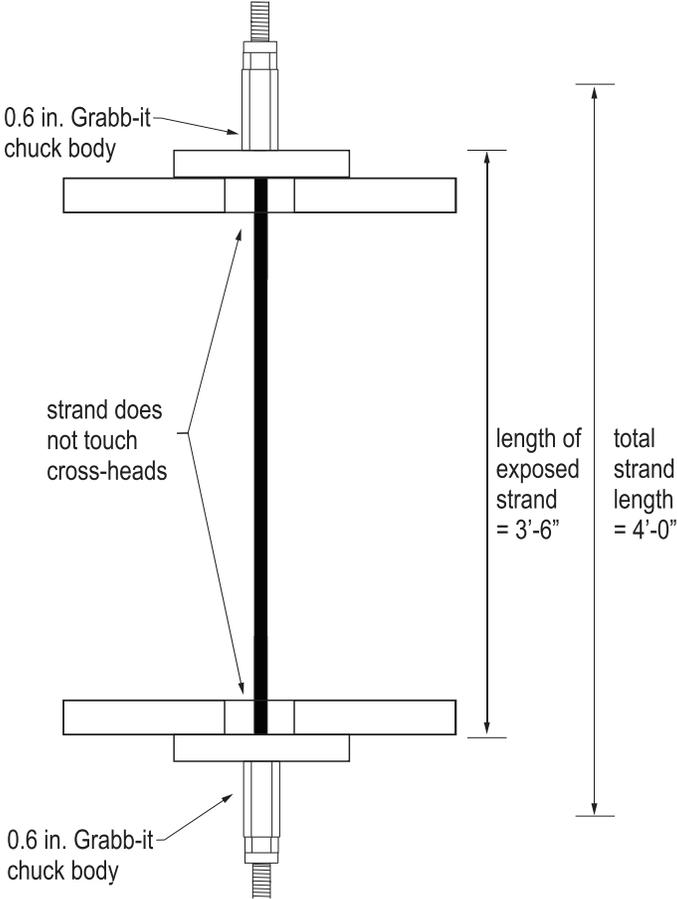
Figure 4-4. UF tensile test set-up of 0.6-in. dia. coupler

For comparison purposes, a second test was performed at the UF laboratory in accordance with the static testing requirements of AC303 from the International Code Council Evaluation Service (ICCES) for post-tensioning anchorages (ICCES 2011). In this test, the chuck bodies were disconnected from the turnbuckle and attached to the ends of the prestressing strand - similar to tests of strand chucks (Figure 4-4).

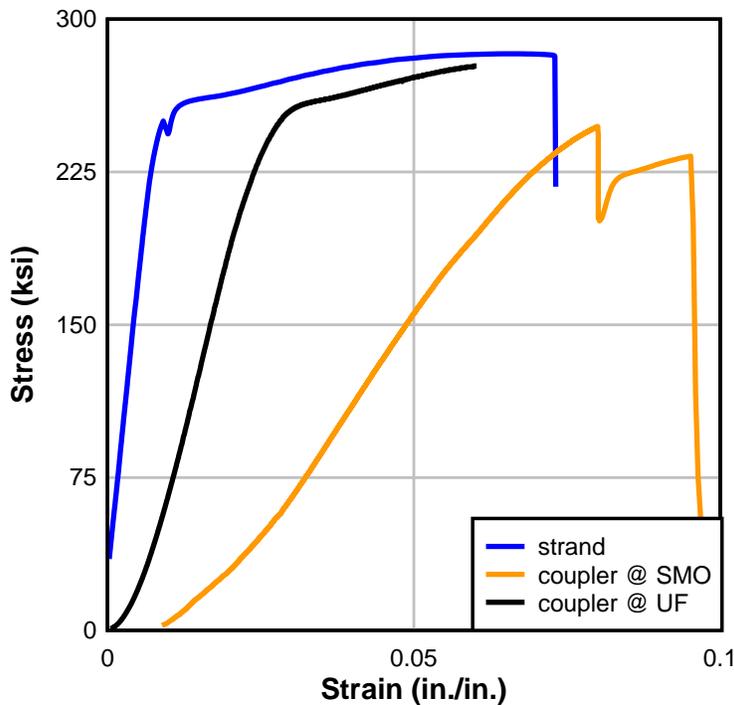
Figure 4-5. Comparison of 0.6-in. dia. coupler and strand behavior

Figure 4-5 shows the stress-strain plot for the two tensile tests of the coupler with strand. Also shown is the stress-strain plot for just the strand (uncoupled), tested per ASTM A1061 (2009).

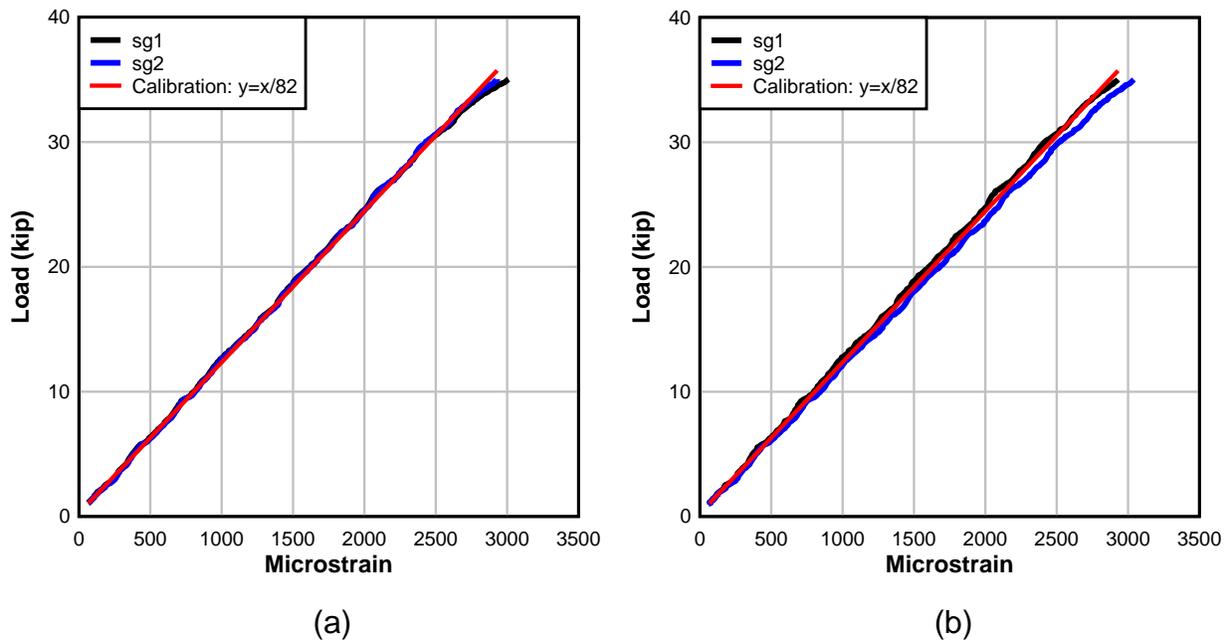
Figure 4-8. Coupler strain gage calibration (a) specimen 1 and (b) specimen 2

Figure 4-8 shows the plot of the load versus microstrain of the two coupler strain gages. The two strain gages on the couplers produced very consistent readings as load was increased, indicating that there was very little bending of the coupler occurring. The strain readings also indicate that the coupler was behaving linear-elastically at the tested load range. Also shown in the plot is the approximate linear curve-fit used to relate the coupler strain to an applied tensile load. This relationship was used in later data analysis to relate measured strain in the coupler to strand load.

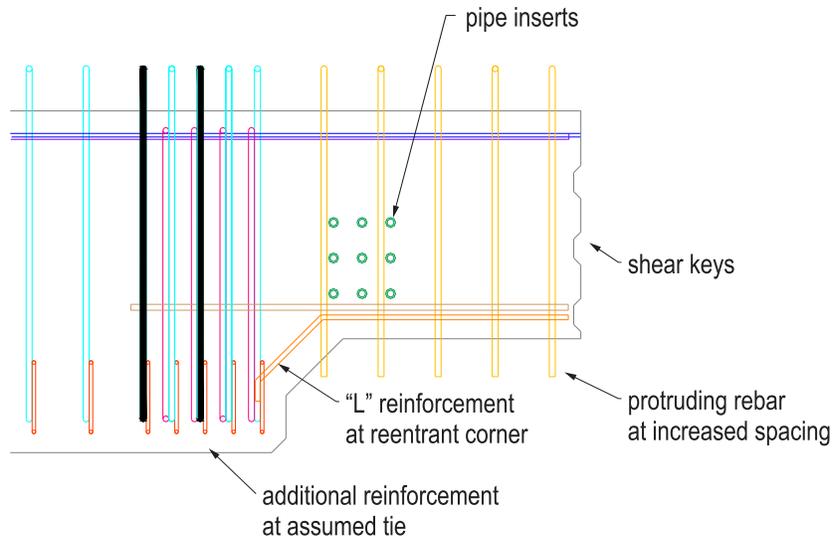
Figure 5-3. Detailing considerations

Special detailing was included the segments to be spliced to accommodate personnel during the splice assembly, to prevent cracking, and to provide additional strength capacity. Special detailing for the joint area included shear keys, additional rebar around the notched area of the bonded segment, and special stirrups. Additionally, the geometry of the splice area was also considered. This section covers these detailing considerations. Figure 5-3 shows the key detailing considerations of the joint area.

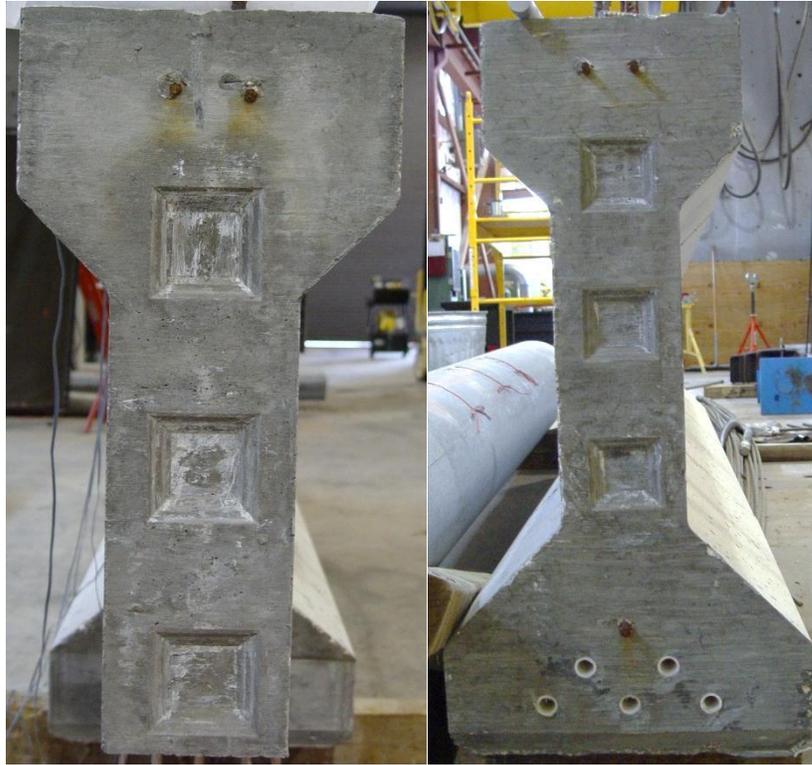
Figure 5-5. Shear keys in test specimen

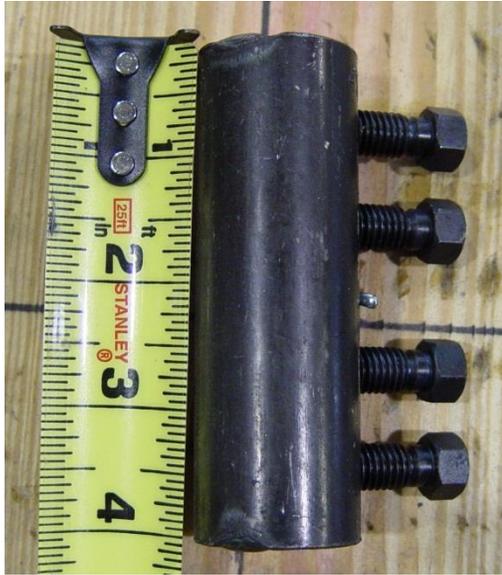
Figure 5-6. Rebar coupler

The selected rebar coupler is a commercially available product which does not require preparation of the rebar. It mechanically connects two pieces of rebar, using a series of screws to engage each rebar piece. Serrated guide rails within the coupler provide additional mechanical grip. A cotter pin serves to set the length of each rebar within the coupler. The rebar coupler is shown in Figure 5-6.

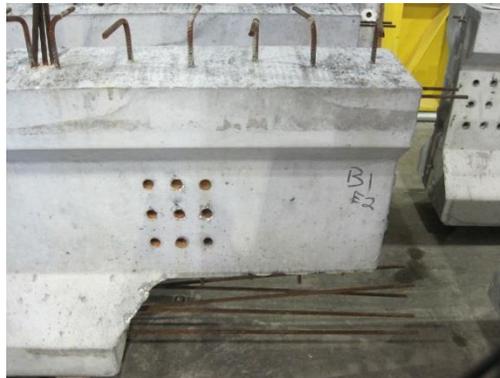
Figure 5-7. Protruding strand

Prestressing strand protruding from the bonded segment was detailed to extend into the coped area approximately 26 in., in order to ensure adequate length for later strand splicing. The strand was protected during the precasting and storage by the wooden block-out.

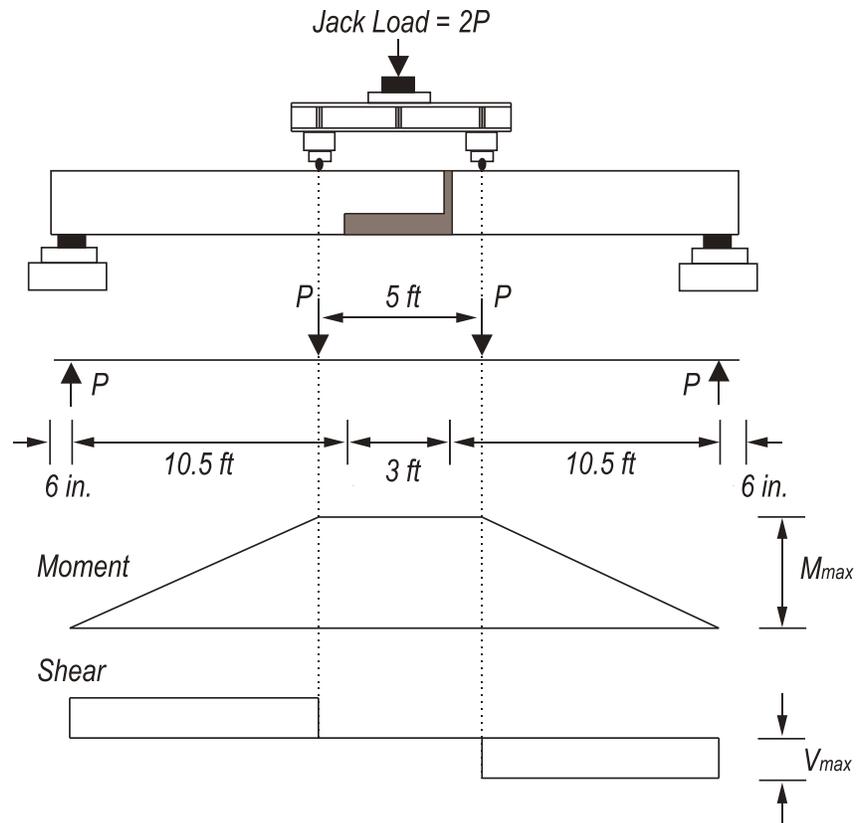
Figure 5-8. Flexure test set-up

A four-point bending set-up, with the splice region encompassed in the constant moment region, was chosen to investigate the flexural behavior of the test specimen. The 5-ft distance between the load points was selected to encompass the entire splice region. The general flexural test set-up is shown in Figure 5-8.

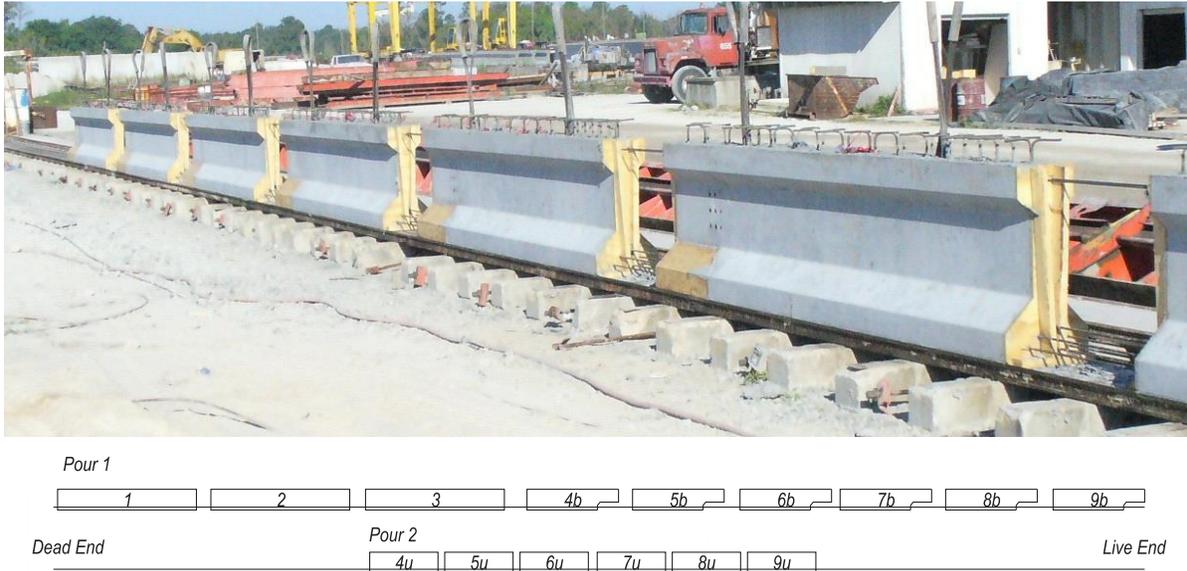
Figure 6-1. Bed layout

To reduce the likelihood of strand recoil during detensioning, segments for the first pour were arranged in the bed as shown in Figure 6-1; segments were located close to one another, but away from the abutments.

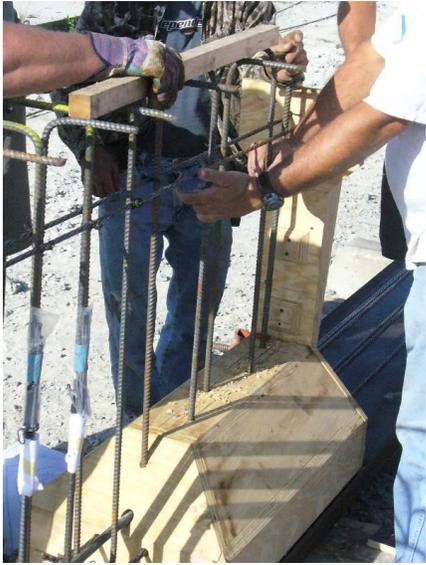
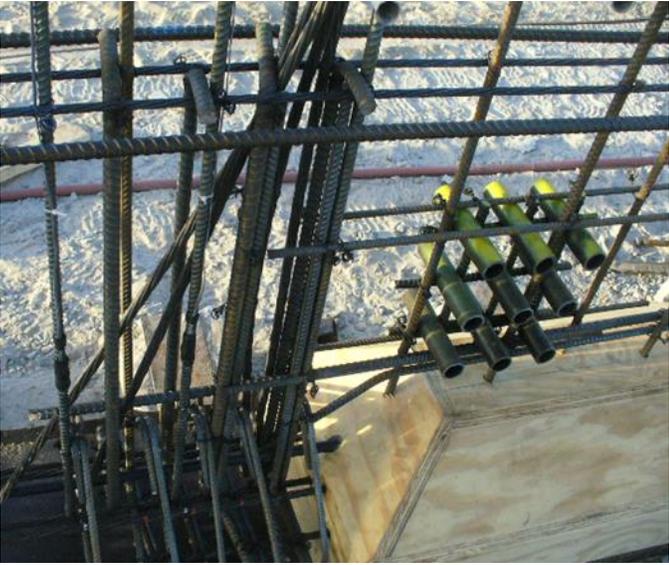
Figure 6-2. Coped region of bonded segments (a) stirrup placement and (b) pipe insert

The pipe assembly was then leveled and supplementary reinforcing bars were tied in to further secure the pipe insert placement. Following the installation of the pipe inserts, the side forms were locked into place. The pipe assembly fit snugly against the side of the forms to prevent intrusion of paste during concrete placement.

Small diameter (#3) rebar was used in the pipe insert, in an effort to reduce the steel congestion in this area and allow the concrete to flow around the pipes. The rebar also acted as a convenient tie location when positioning the pipe inserts in the steel reinforcement. Stirrup locations in the region of the pipe inserts were adjusted (spacing in the area was increased) to avoid conflicts with the pipes. Twelve pipe inserts were fabricated by the FDOT Structures Lab and provided to the precaster as assembled units. The pipe inserts were installed at the precast yard during the stirrup placement. Installation of the pipe inserts is covered in Section 6.1. The pipe insert can be seen in Figure 6-2 and Figure 5-3.

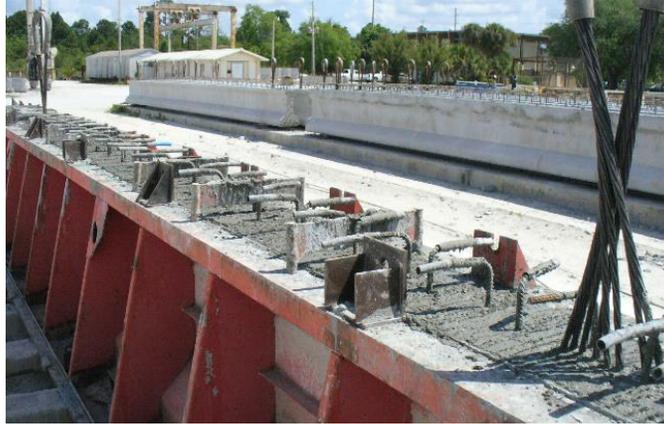
Figure 6-3. Segments after concrete is cast with top roughened for deck placement

A high slump concrete mixture was used to ensure good flow around the congested areas near the pipe inserts. The same concrete mixture design was used for both pours; the mix design and field properties are provided in the FDOT report. The concrete was consolidated with internal and side-form vibrators. Care was taken near instrumented rebar to ensure gage integrity. The tops of the beams were roughened for future deck placement and the bed was covered with tarps for the curing period. The dates of strand stressing, casting and detensioning are given in Table 6-1.

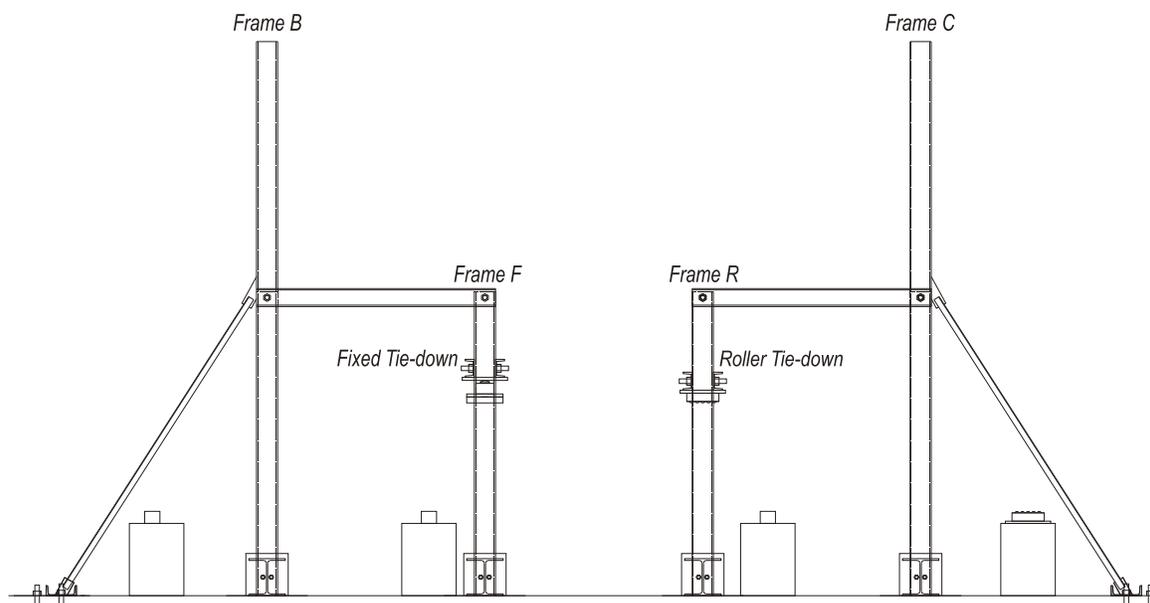
Figure 6-4. Elevation of assembly frames

Pushing the segments apart with hydraulic jacks placed eccentric to the strand centroid created an internal moment. This internal moment caused uplift that was resisted by the structural steel frames and tie-down connections shown in Figure 6-4. Four steel frames were positioned and bolted to the strong-floor using 1.5-in. diameter threaded rod. Two interior frames were used as tie-downs, resisting the uplift force during the stressing procedure. All four frames were designed to resist beam roll-over and to guide the longitudinal movement of the rolling segment during stressing. Tie-down connections were positioned and welded onto their respective frames. The fixed tie-down connection was constructed of steel plate with a load button receiver welded to a pair of channels bolted to Frame F. The roller tie-down connection was constructed by welding a Hilman roller to a steel plate, which was then welded to a pair of channels bolted to Frame R. To ensure smooth translation of the rolling beam, the Hilman roller was leveled prior to welding it to the frame.

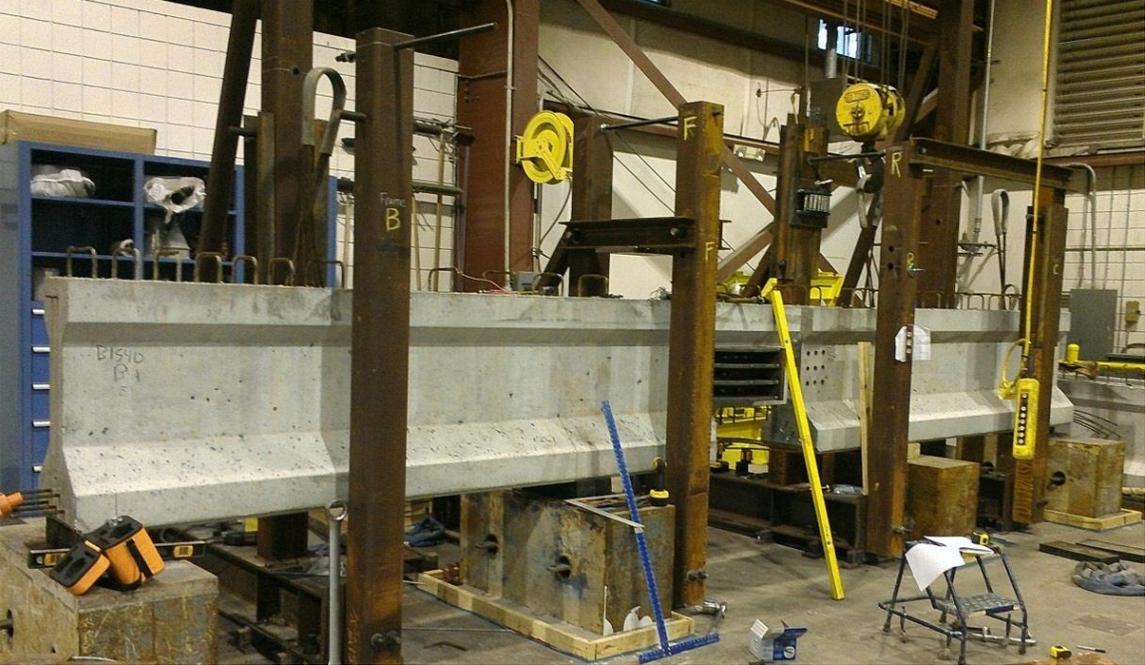
Figure 6-5. Photo and schematic of splice assembly frame and beam segments

Figure 6-5 shows the placement of the segments along with the strand couplers, beam brackets, and stressing jacks. Segments were maneuvered into position within the assembly frames and set down on their respective supports. The bonded segment was supported at both ends by wooden blocks set on steel blocks. The left end of unbonded segment was supported by a wooden block set on a steel block; the right end of the bonded segment was supported by a Hilman roller welded to a steel block. During the stressing procedure, the beam segments lift off the temporary supports; wood was selected to allow their easy removal.

Once the beam segments were aligned, the wooden cribbing was adjusted to allow unrestrained longitudinal movement of the segments along the segment's main longitudinal (same direction as the beam span). The load cell at the fixed tie-down was slid into position and the load button was unthreaded to touch the load button receiver.

Proper alignment of this tie-down was critical to prevent rotation of the bonded segment, and to ensure accurate readings in the load cell. The prestressing jacks (Enerpac CLL 504s) were placed into the bracket cradles on each side of the segments. Hydraulic hand pumps were attached and set aside.

Six spliced beams were assembled in the laboratory. Each specimen was arranged in the assembly set-up as shown in Figure 6-5. Each of the six splice assemblies was instrumented for evaluation of the splice technique and the effect of splicing on the precast segments. Strain, strand slip, load at the fixed tie-down, longitudinal opening at the splice location, and vertical displacement were monitored throughout the stressing of the spliced strand. Four 200 mm displacement transducers were used to monitor vertical displacement. One was placed over each of two exterior bearing to measure the support displacement and one was placed at each of the two tie-down locations. Five strand slip gages were placed on one end of each strand to monitor strand slip. For all but the first splice assembly, strain gages were placed on the flat face of the coupler turnbuckle to indirectly monitor strand load. Load was recorded in conjunction with the strain, strand slip and displacement data. A single vibrating wire gage at midspan of the bonded segment was monitored during loading, with readings taken manually at specified intervals during the strand stressing procedure.

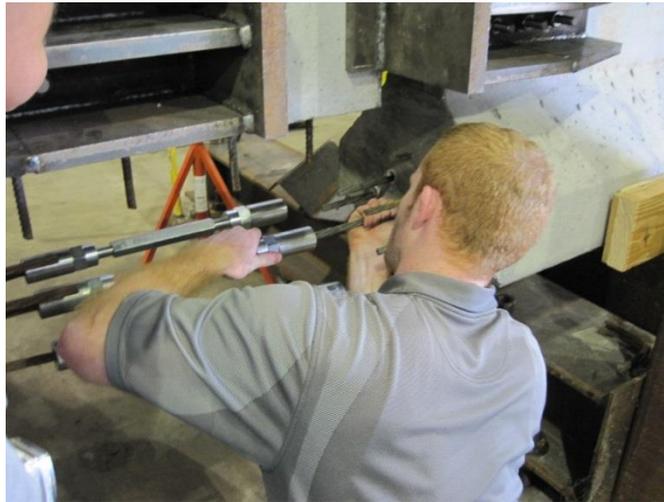
Figure 6-6. Coupler installation on unbonded strand

Strand couplers were adjusted to have approximately 1 in. of thread visible on either side of the turnbuckle, to ensure adequate length for later adjustment. Couplers were first installed on the strand protruding from the bonded segment. Engagement of the wedges in the coupler was checked by hand. Couplers were then attached to the strand protruding from the unbonded segment (Figure 6-6). Engagement of the coupler wedges was again checked by hand. At this point, the coupled strands were not taut in the closure pour region and occasionally appeared to bend across the closure pour length (Figure 6-7). Next, rebar couplers were attached to the rebar protruding into the notch. The couplers were used to attach the bottom hook of the stirrups in the splice region (Figure 6-8).

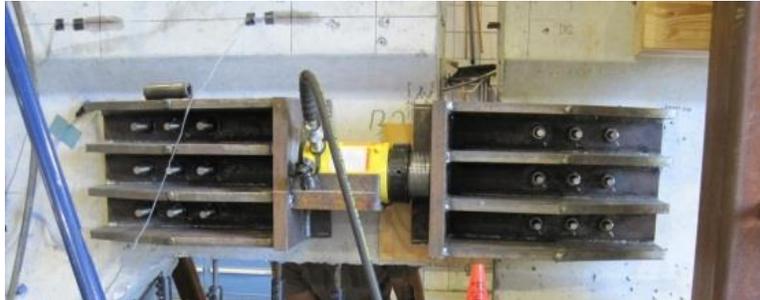
Figure 6-9. Extend plunger

Next, hardware was attached to the end of the unbonded segment. With the string-pots loose, the prestressing jacks were simultaneously pressurized until they engaged the brackets on each side of the unbonded segment. The lock-nuts were engaged and hydraulic pressure was released from the jacks. This was done to prevent translation of the unbonded segment on the Hilman roller during attachment of the hardware and initial adjustment of the coupler turnbuckles.

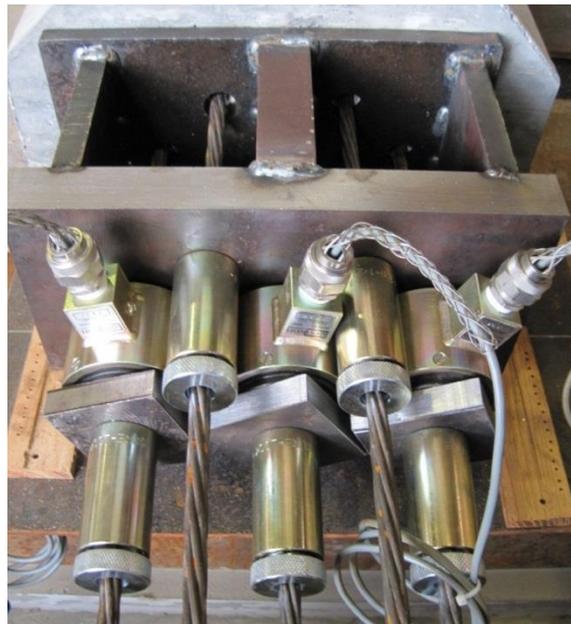
Figure 6-10. Detensioning chair, chucks, and load cells on the unbonded segment

The detensioning chair (Figure 6-10) was then threaded onto the protruding strand from the unbonded segment. The chair was shimmed to the proper height and leveled to provide clear passage of the prestressing strand through each hole. Chucks, load cells, and anchor plates were then installed.

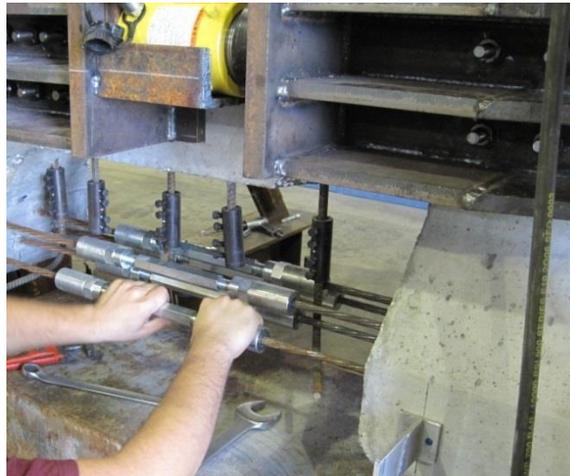
Figure 6-11. Tightening the turnbuckles to seat detensioning chair

Prestressing strand couplers were then tightened to hold the detensioning chair against the unbonded segment (Figure 6-11.). One person was required to adjust each turnbuckle in the closure pour until the coupled strand was taut while the second person

monitored and adjusted the alignment of the detensioning chair, the load cells and the prestressing chucks. Proper positioning of the hardware included clear, unrestrained passage of the prestressing strand through the detensioning chair and the load cells; unobstructed placement of each prestressing chuck relative to one another; and flush seating of the detensioning chair on the end of the beam.

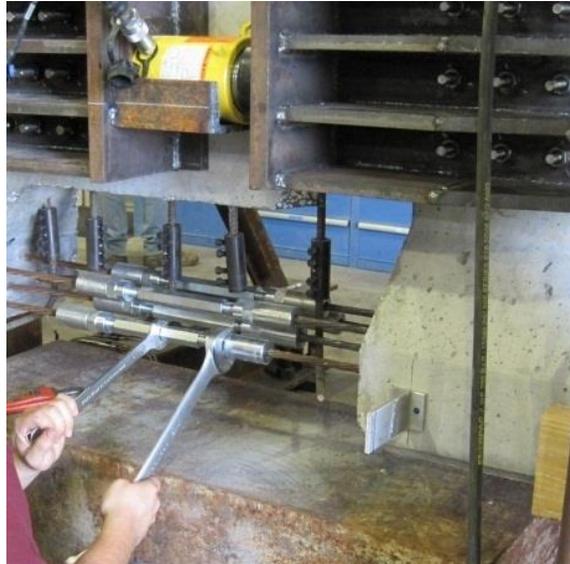
Figure 6-12. Tightening the turnbuckles

With unbonded strands secured with chucks at both ends, an initial load was put into each strand to straighten the prestressing strand across the closure gap, and to provide an “even” starting point for later stressing. This was done by adjusting the turnbuckles on each coupler, alignment of the detensioning chair was monitored to ensure that the protruding strand passed clear through the detensioning chair and the load cells without obstruction. In addition, the load cell and coupler strain gage output were monitored. Alignment of the load cells was monitored to ensure that were bearing evenly on the detensioning chair and the prestressing chucks. Approximately 1 kip of load was achieved in each strand, or approximately 100 microstrain per coupler. Equalization of the force in each strand was an iterative process, requiring several

adjustments to each turnbuckle, as each adjustment affected the force in the nearby strands.

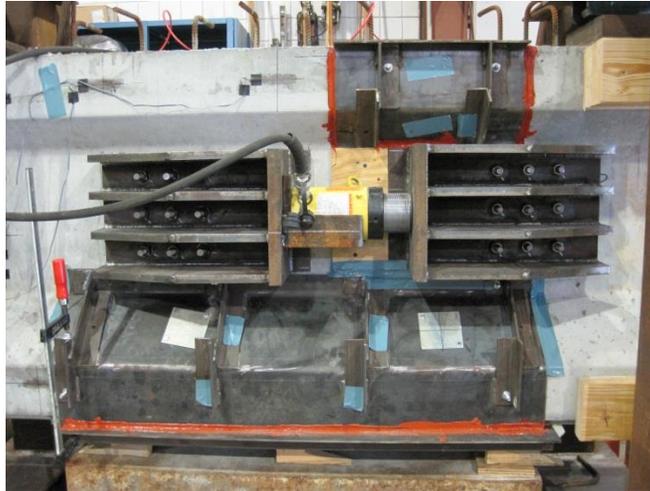
Figure 6-14. Closure pour formwork in place

Formwork for the closure pour was then attached to the beam segments (Figure 6-14). The closure pour formwork consisted of two forms for the top flange, two forms for the bottom flange, a long form for the bottom of the beam and small pieces of plywood for the region between the actuators. Side forms were attached to the precast beam using expansion anchors and concrete screws. The bottom form was wedged into place, supported underneath by a steel support block. Seams were caulked and/or duct taped with foam backer rod to prevent leakage during the pour (Figure 6-15).

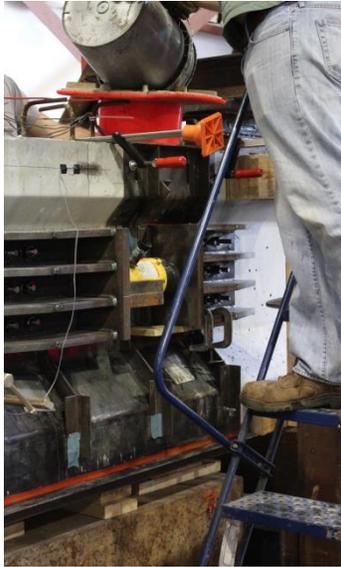
Figure 6-16. Pouring the closure

Concrete was lifted using 5-gal. buckets and tremmied into the closure with the aid of a plastic traffic cone (Figure 6-16). The cone was wedged deeply into the form at the start of the pour, and as the concrete level rose, the cone was slowly extracted to mitigate segregation of the mix and void formation.

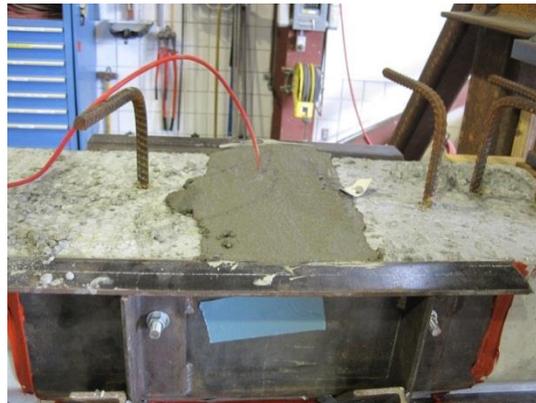
Figure 6-17. Top of finished closure pour

A hand-held vibrator was used to vibrate the accessible parts of the pour; however, limited vibration of the closure concrete was possible due to hardware congestion and the placement of instrumentation.

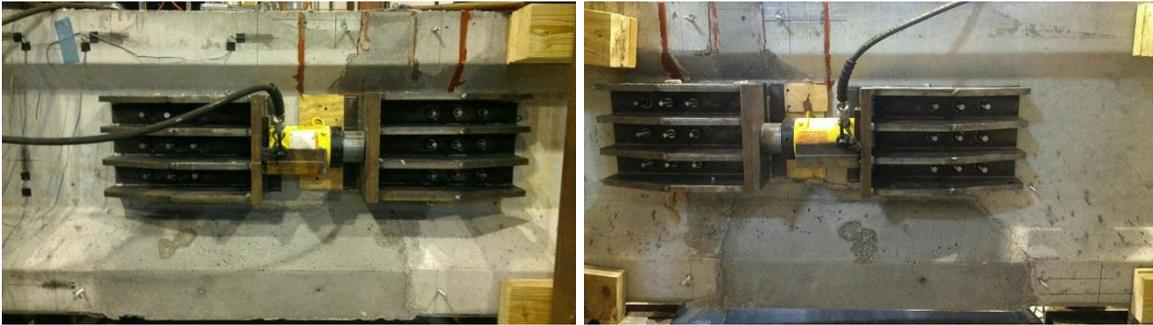
Figure 6-18. Formwork removed (specimen X1 shown)

The concrete was allowed to cure until the tested compressive strength—as determined by ASTM C39 tests of 6X12 cylinders made from concrete from the same delivery—reached approximately 8500 psi (ASTM C39 2010). This limit was chosen to

make sure the concrete developed some tensile strength prior to removal of the prestressing actuators (during which a small amount of tension is introduced into the joint). The formwork was then removed from the splice region (Figure 6-18).

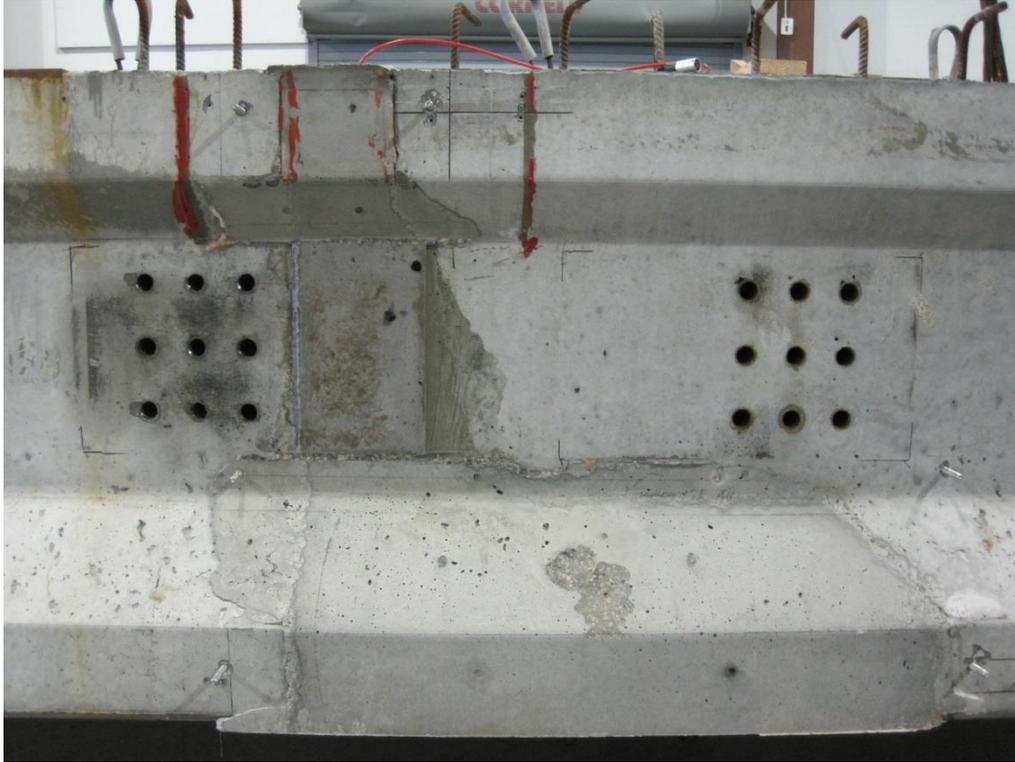
Figure 6-19. Splice complete

Tie-down forces were then released. A jack was placed under the beam as near to the support under the bonded segment as possible. The inner support points (wooden supports) were removed to reduce restraint. The jack under the bonded segment was pressurized until the neoprene pad under the beam could be removed. Pressure was then released, which lowered the beam end sufficiently to remove tie-down forces at frames F and R. The stressing brackets were removed and the assembled beam was removed from the assembly frames, completing the splice procedure.

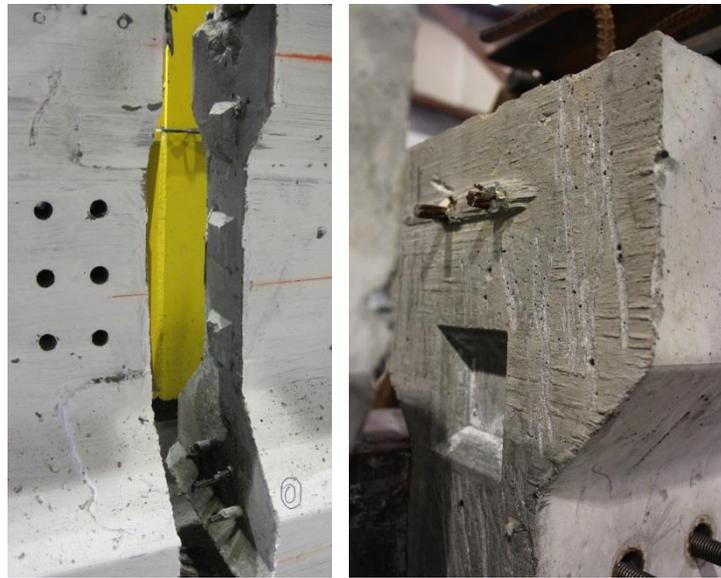
Figure 6-20. Closure face:(a) bond at vertical interface X1 (b) scoring of SU

- After the first two splice assemblies (X1), the precast faces of the closure pour of the remaining spliced beams (SU, SU2, F1 and F2) were scored using a cutting disk. This was done based on the clean break occurring in specimen X1, shown in Figure 6-20(a) (the first assembled beam).

- Epoxy was not used in the first three splice assemblies (X1, SB, SU). Figure 6-20(a) shows the closure after demolition; it can be seen that—for the most part - the closure pour concrete broke away cleanly at the joint. In later specimens (SU2, F1 and F2), an epoxy (Master Builders Concrete Liquid LPL) was used to improve the bond.

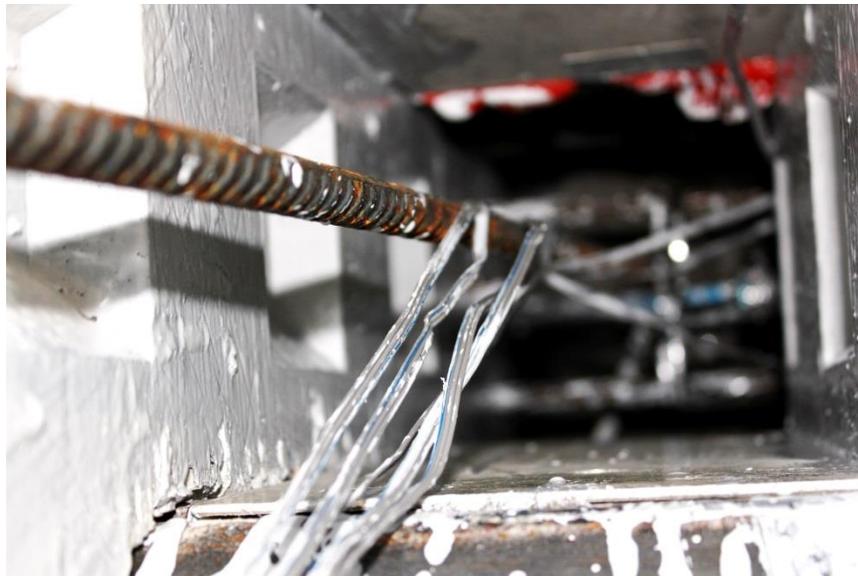
Figure 6-22. Epoxy in closure pour

Figure 6-22 shows view of the epoxy application. Approximately 10 minutes prior to the arrival of the closure pour concrete, the epoxy was mixed and applied to the joint. The epoxy was applied from above and below the beam, using a bristle paintbrush. Care was taken to cover the entire surface area with a generous coat. Following the application of the epoxy, the closure was poured; the pour was completed within one hour of epoxy application.
