LONG SPANS WITH TRANSPORTABLE PRECAST PRESTRESSED GIRDERS

NATASSIA R. BRENKUS

A THESIS PRESENTED TO THE GRADUATE SCHOOL
OF THE UNIVERSITY OF FLORIDA IN PARTIAL FULFILLMENT
OF THE REQUIREMENTS FOR THE DEGREE OF
MASTER OF ENGINEERING

2013

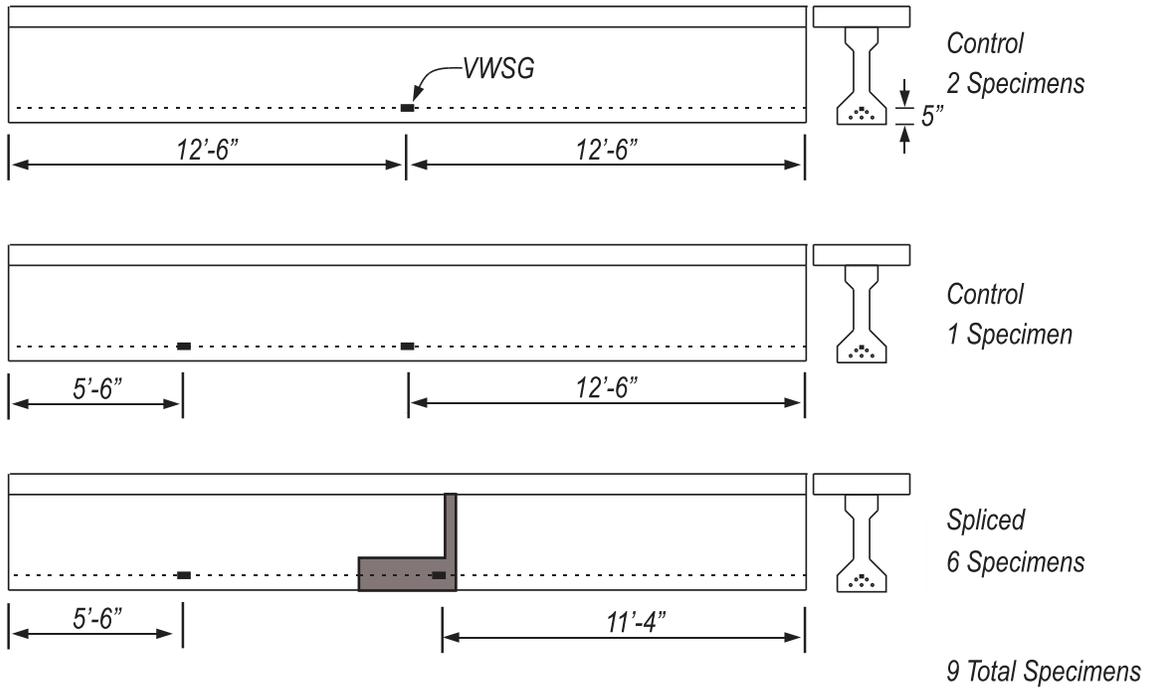
Figure 7-2. Placement of VWSG

During the splice assembly in the laboratory, a gage was installed near the midspan of the full spliced beam length prior to the closure pour. In all cases, the VWSG was installed at the approximate height of the strand pattern centroid. The locations of the VWSGs are shown in Figure 7-2. To ensure each VWSG remained at the set height, cable ties were used to attach the VWSG to the prestressing strand as shown in Figure 7-3.

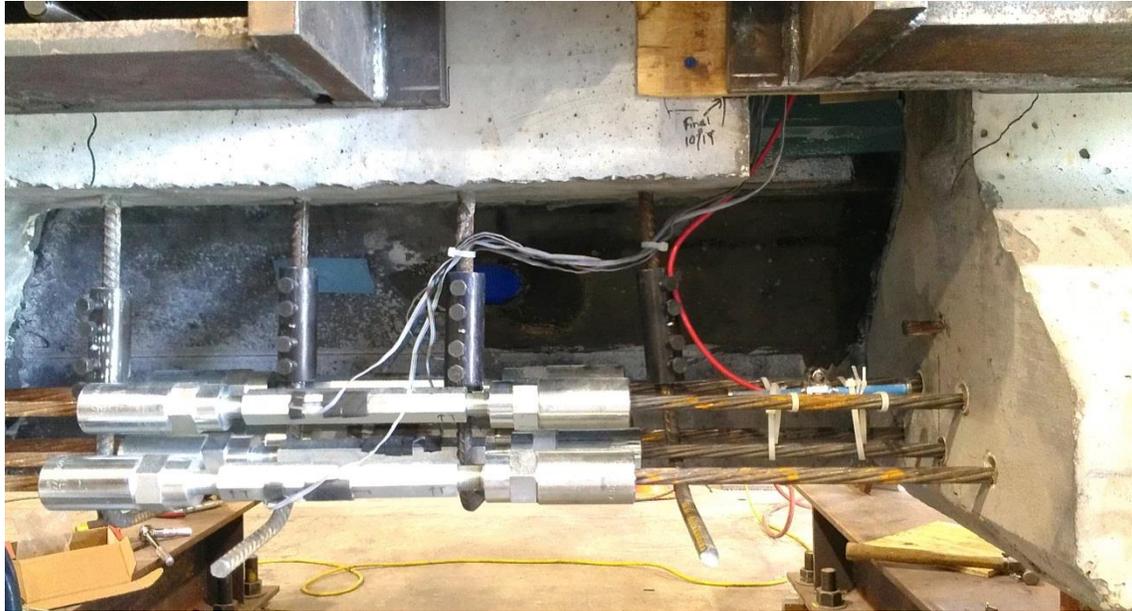
Figure 7-4. Splice assembly: Instrumentation in closure joint

The coupler strain gages (on the face of the turnbuckle with a lead wire coming out) and the VWSG (the blue gage to the right) in the closure pour are shown in Figure 7-4. Strain gages are shown in Figure 7-5.

Two stirrups were instrumented with strain gages (S01 and S02) and placed within the precast segments during construction as described in Section 0. An external strain gage (S25) was also placed on the concrete surface of the precast segments prior to the splice assembly procedure at the same location along the beam length. This gage was used to verify the readings of the stirrup gages and to check the assumption of perfect bond between the rebar and the precast concrete. Based on the perfect bond assumption, the strain measured in the concrete should be approximately equivalent to the strain in the ties. Figure 9-8 shows the measured strain for the three strain gages versus the average strand load for the stressing of specimens X1 and SU. The gage locations are shown in Figure 7-4.

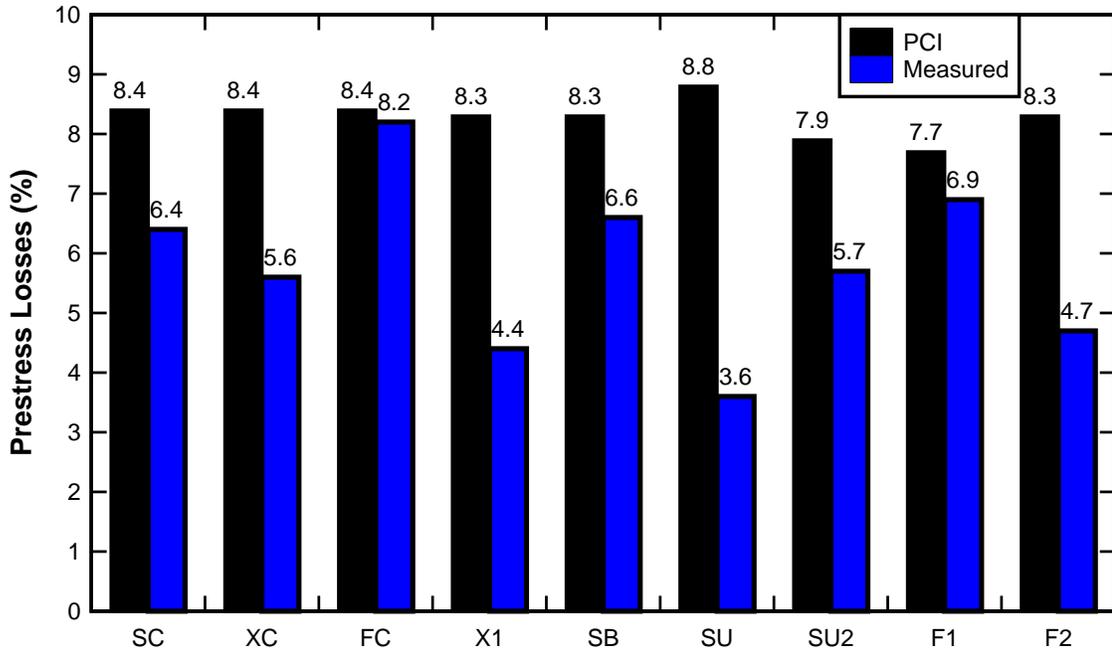
Figure 8-2. Measured prestress losses vs. PCI

Figure 8-2 compares the measured and PCI predicted losses. In all cases, the PCI predicted prestress loss is greater than the measured loss. Overestimation of prestress losses by PCI has been observed by other researchers (Onyemelukwe et al. 2003).

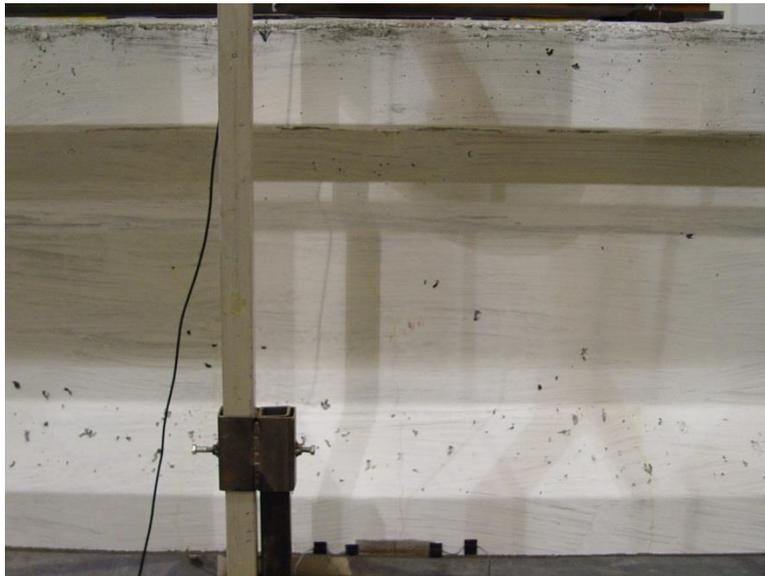
Figure 8-3. Decompression strain gages

opened, the slope of the load-strain plot changed, indicating that the pre-compression caused by the prestress force had been overcome. This method has been described by Pessiki et al. (1996).

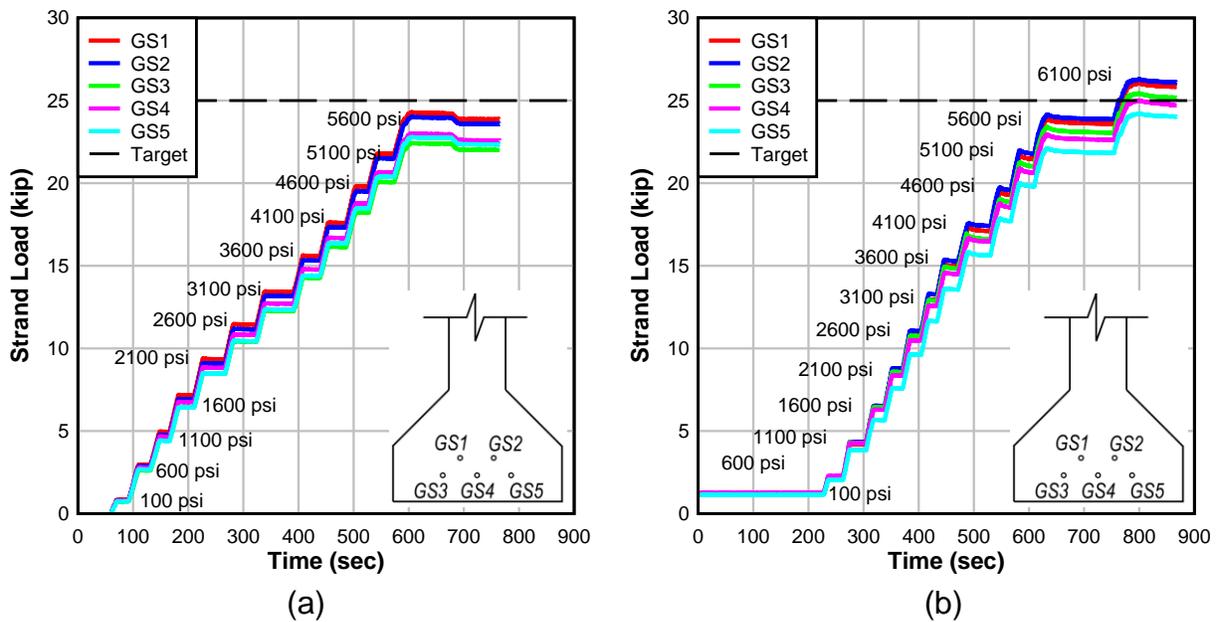
Figure 9-4. Strand load based on calibrated coupler strain for (a)SU2 and (b)F2

position was approximately 1/4-1/8 in. and was affected by the tightness of the system, i.e., how well the channels were tied down to the precast segments prior to the stressing of the strand. The moment generated caused the top strands to typically develop more prestress force than the bottom row strands; this relationship is also seen in the strand load as measured by strain gages on the couplers. Figure 9-4 shows the calculated strand force, based on a calibrated strain gage versus time.

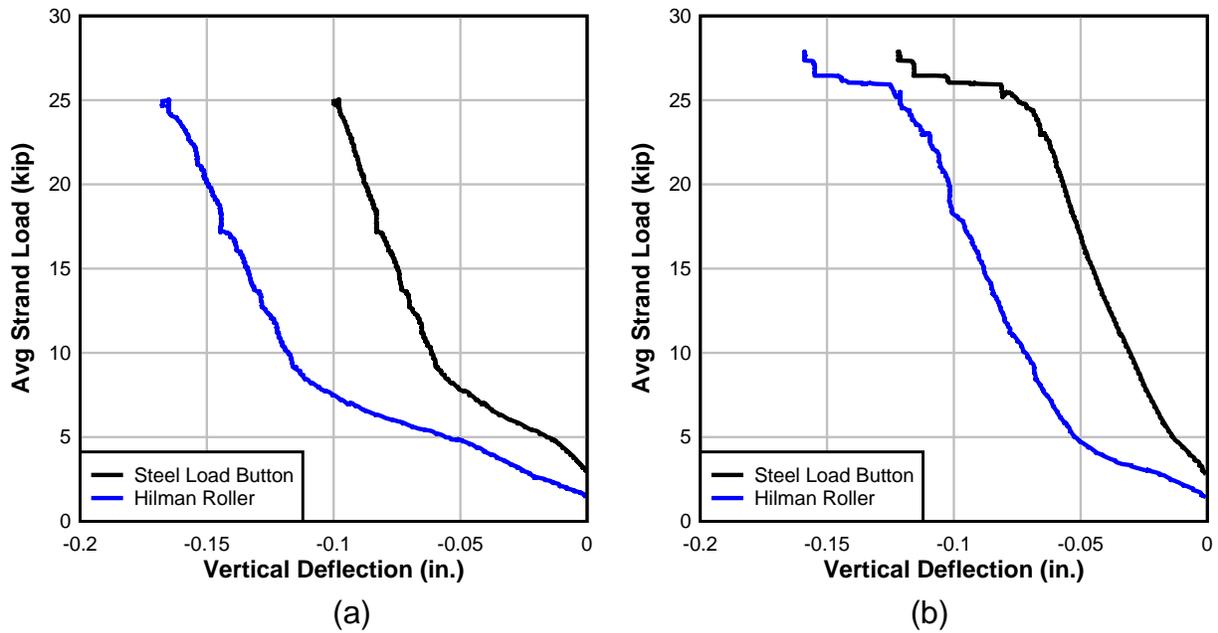
Figure 9-5. Tie-down deflections: (a) SB and (b) SU

The magnitude of these vertical movements was affected by the conditions at each restraint. In each case, the roller tie-down—which consisted of a steel Hilman roller displaced upward more than the fixed tie down—which consisted of a neoprene pad and a load cell. An example is shown in Figure 9-5. The slackness of the rollers in the roller tie-down allowed more vertical movement than the neoprene of the fixed tie-down.

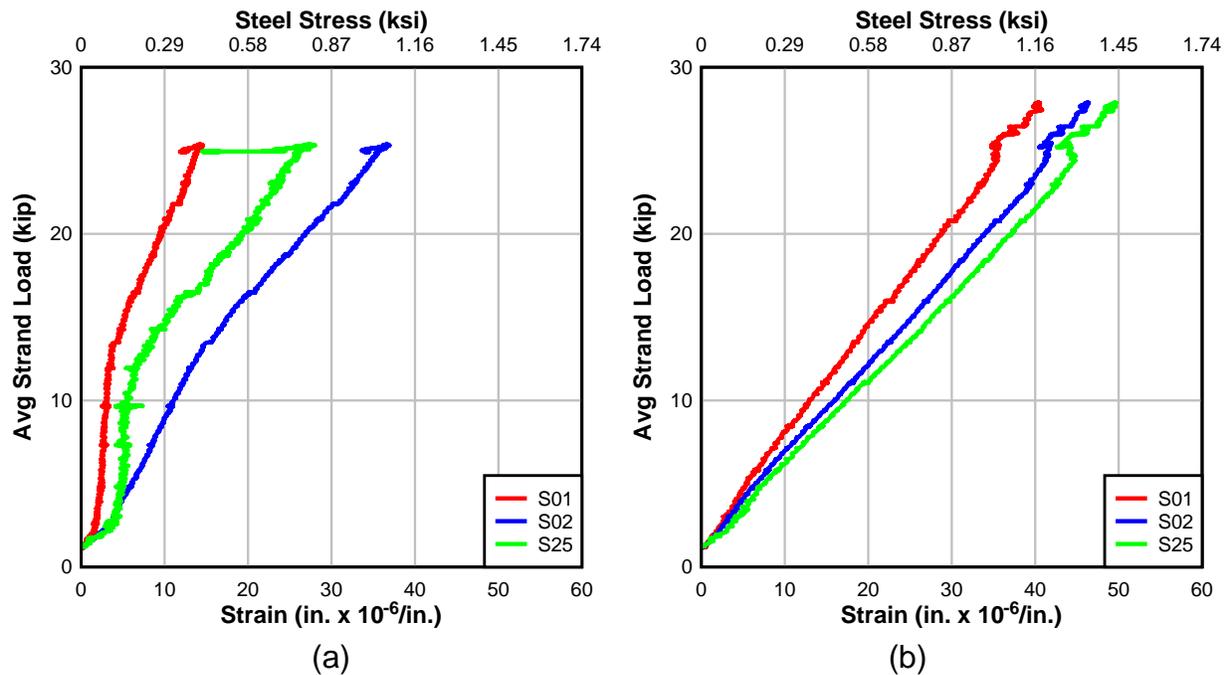
Figure 9-8. Tie strain (a) X1 and (b) SU

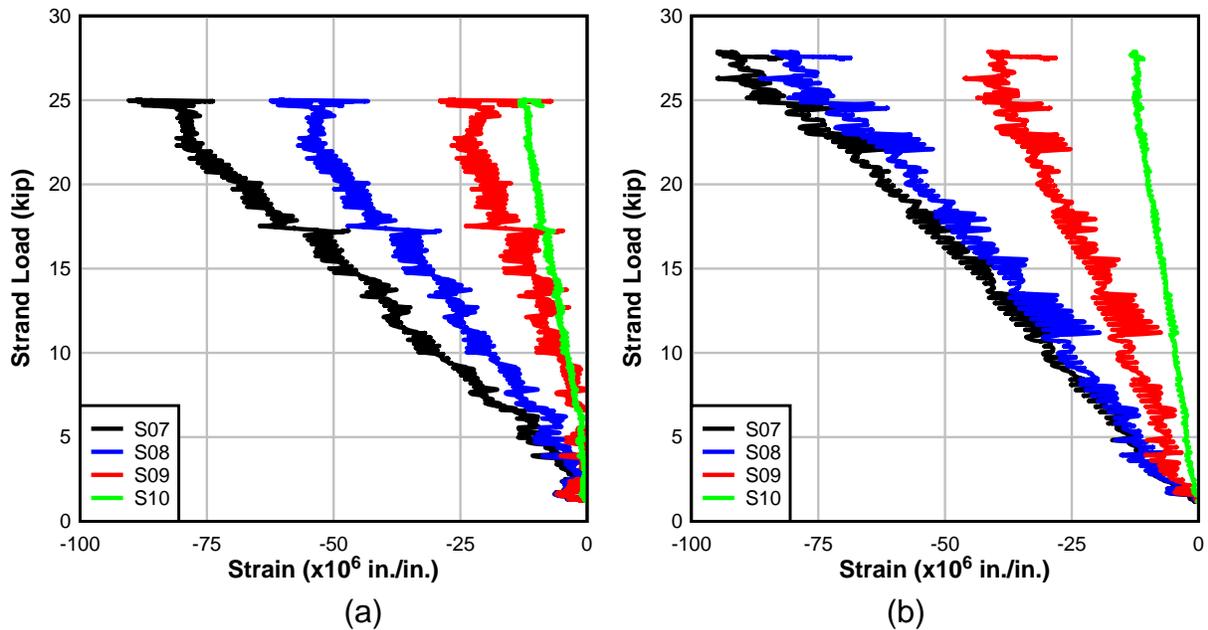
Figure 9-9. Strain in top flange for (a) SB (b) SU

Figure 9-9 shows a plot of the strain measured by gages along the beam top flange versus the average strand load. Also shown in the figure are the gage locations and the assumed strut-and-tie model. This field of strain gages was placed to approximately determine the node location of the compressive strut, i.e., the location of the compressive strut node nearest the tie-down. Because the angle of the strut is assumed and unknown, these measurements were taken to simply visualize the region affected by the compressive strut introduced during the stressing procedure.

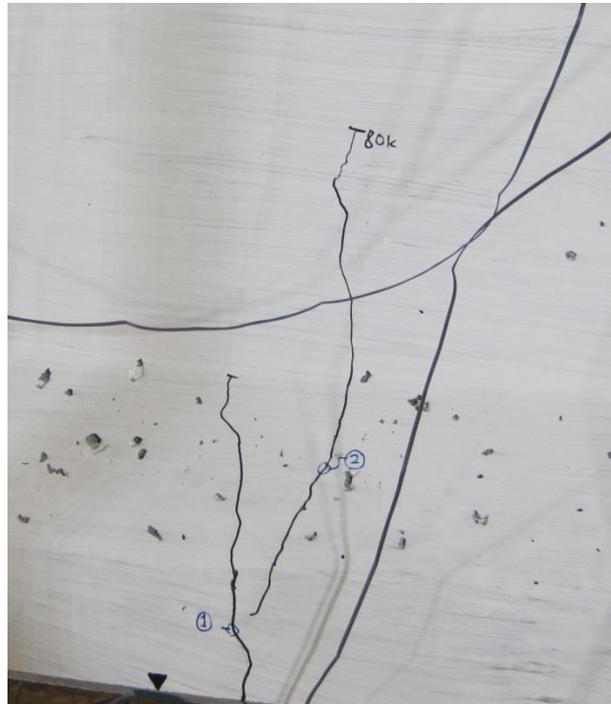
Figure 10-2. XC: First crack at midspan

measured; the crack was 0.015 in. wide at approximately 3 in. from the bottom of the beam (point 1) and 0.005 in. wide at point 2, as shown in Figure 10-2.

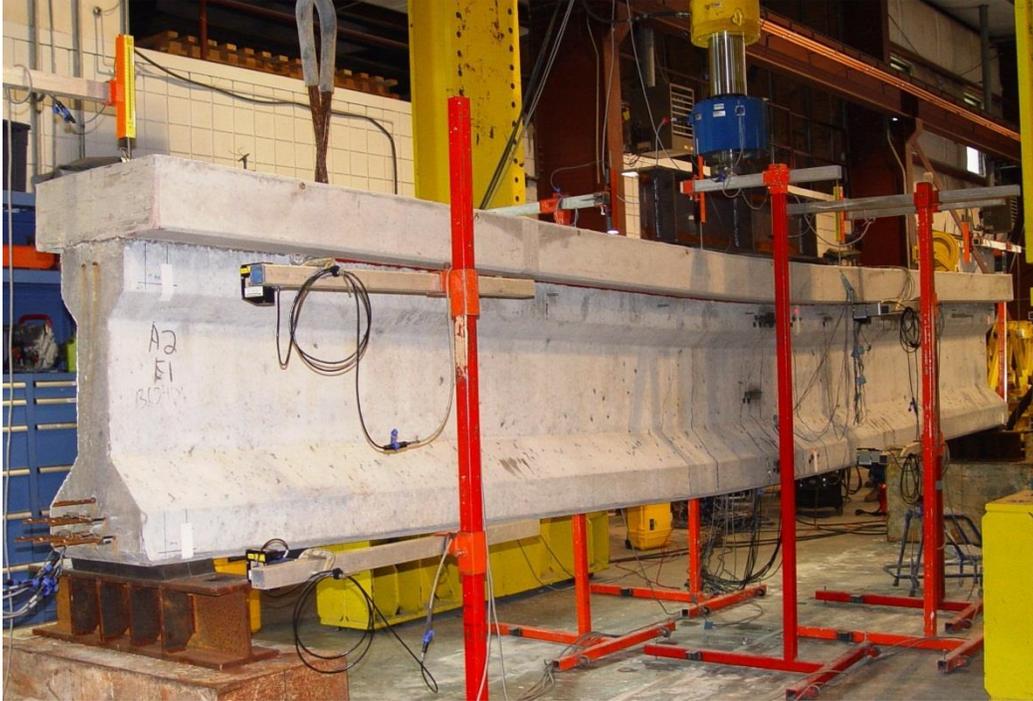
Figure 10-3. XC: Permanent set

As XC was loaded beyond cracking, sudden minor load decreases occurred periodically until the midspan deflection reached just less than 1 in. These decreases indicated flexural crack formation and were confirmed with audible cracking sounds and visual observations. Although the peak load had not been reached, the test was terminated at a deflection of approximately 4 in. (maximum load of 158 kip) to avoid damage to instrumentation. After the applied load was removed from the beam, a permanent set of 2.38 in. was measured at midspan (Figure 10-3).

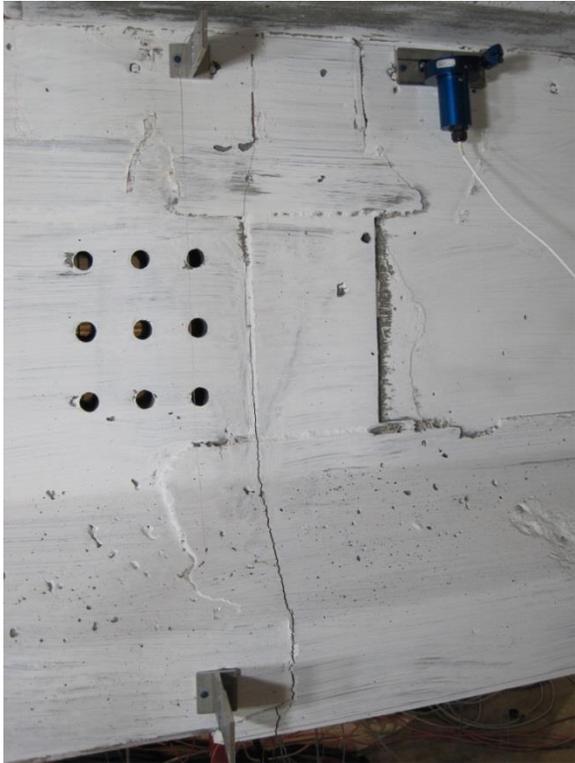
Figure 10-7. X1: Vertical crack at interface

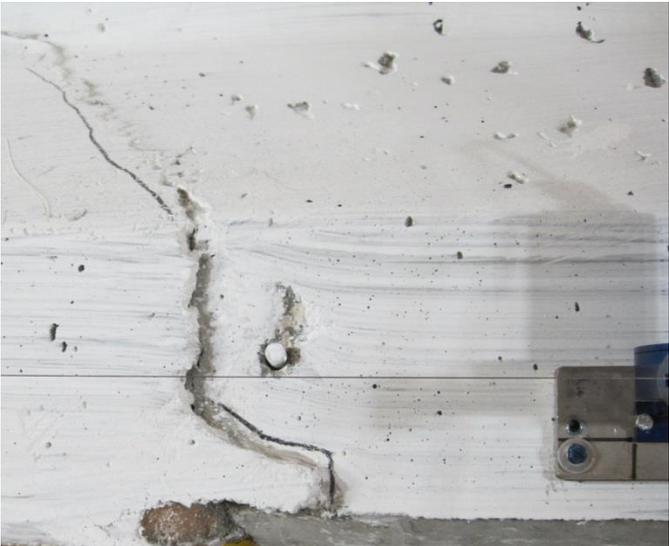
Figure 10-8. X1: Superficial cracks at overlap

At 68 kip, a single crack was visually observed at the vertical interface of the unbonded precast and the closure pour (Figure 10-7). Note that this was the only crack at this load; other inconsistencies in the white-wash seen in the figure are from incomplete white-wash application or rough surfaces of the concrete. Prior to 68 kip,

only superficial cracks where the closure pour overlapped the precast concrete were noted (Figure 10-8).

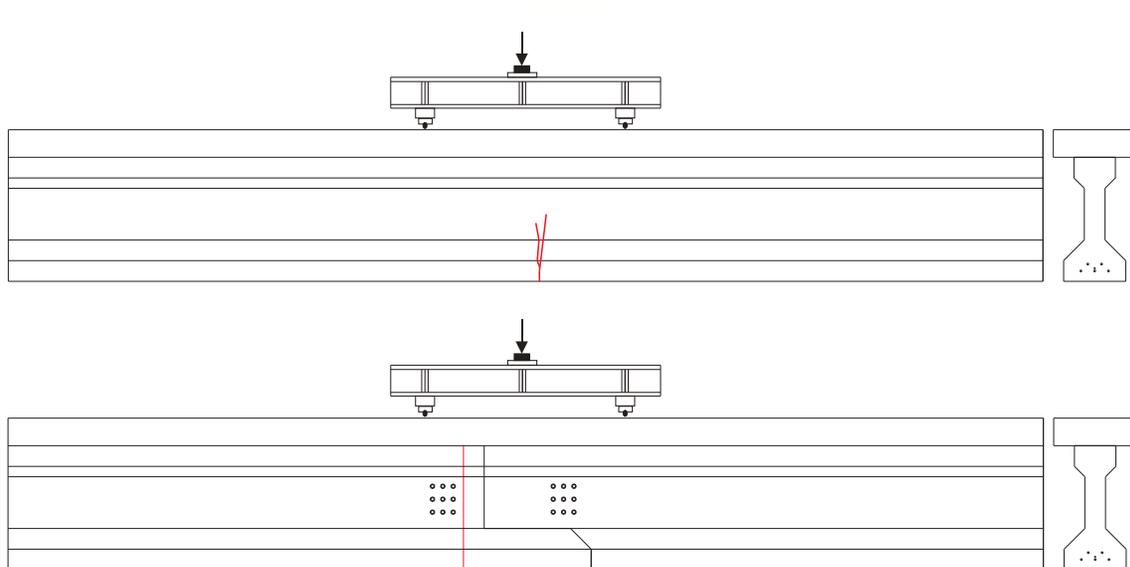
Figure 10-13. XC vs. X1: first crack

between the load points. X1's first crack, however, occurred at the vertical face of the closure pour (Figure 10-13).

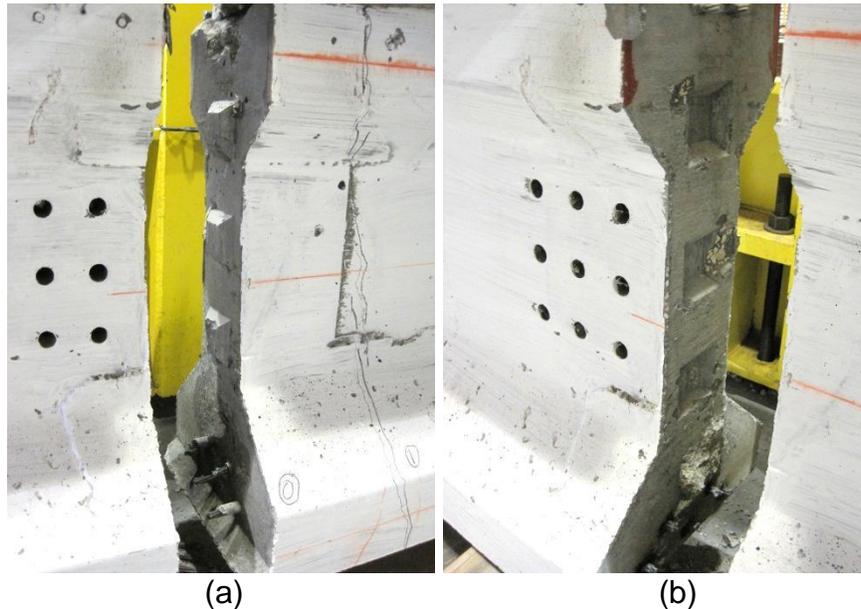
Figure 10-14. Dry joint interface post-demolition, looking at (a) the closure pour, (b) the precast

It can also be observed from Figure 10-14 that the shear keys exhibited little damage, indicating that the keys had sufficient strength to transfer shear across the interface.

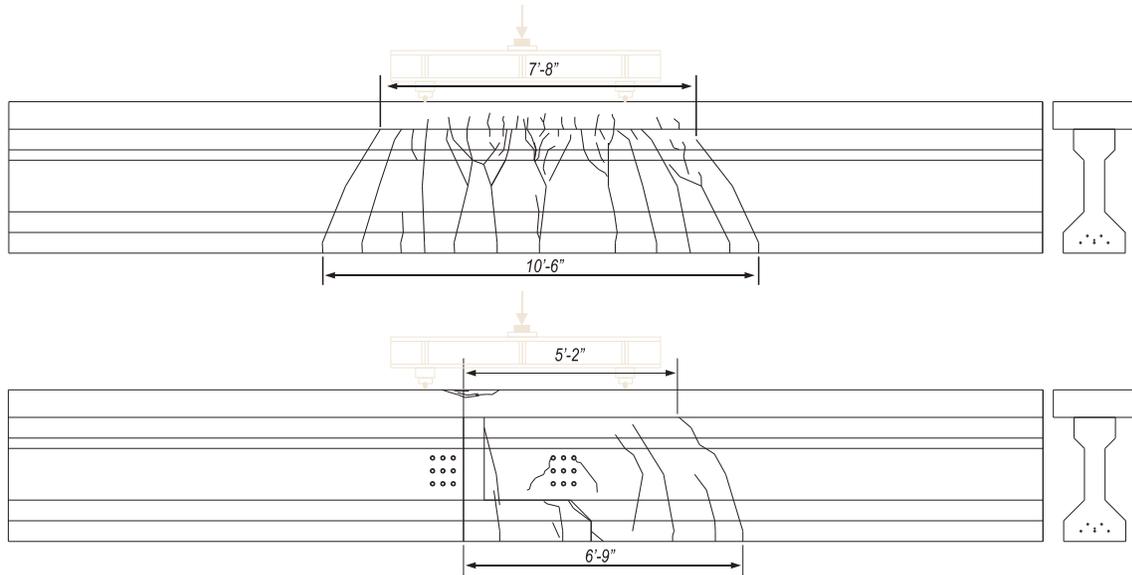
Figure 10-15. XC vs. X1: final cracking patterns

As loading progressed, XC cracks were noted to be uniformly distributed between the load points, which is typical of bonded prestressed beam behavior (Figure 10-15). Conversely, X1 behaved more like an unbonded, prestressed beam: the crack pattern focused around a single crack at the end of the unbonded length with some flexural cracks in the bonded segment.

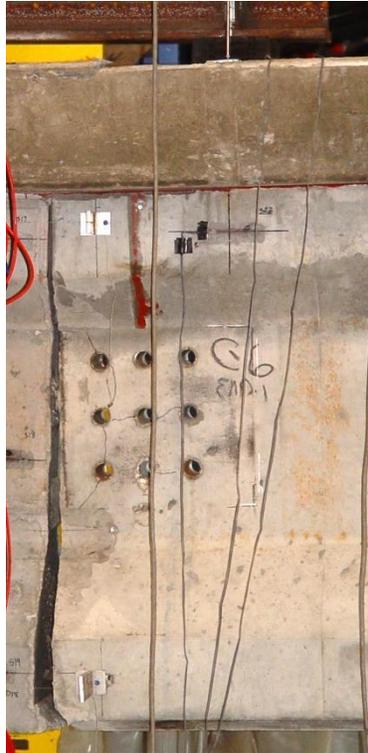
At the maximum load, the four cracks contained in the interface opened a combined amount of approximately 1.4 in. at the mid-height of the bottom flange. As shown in Figure 10-17, most of the crack opening occurred at the joint.

Figure 10-17. X1: Opening at joint during test

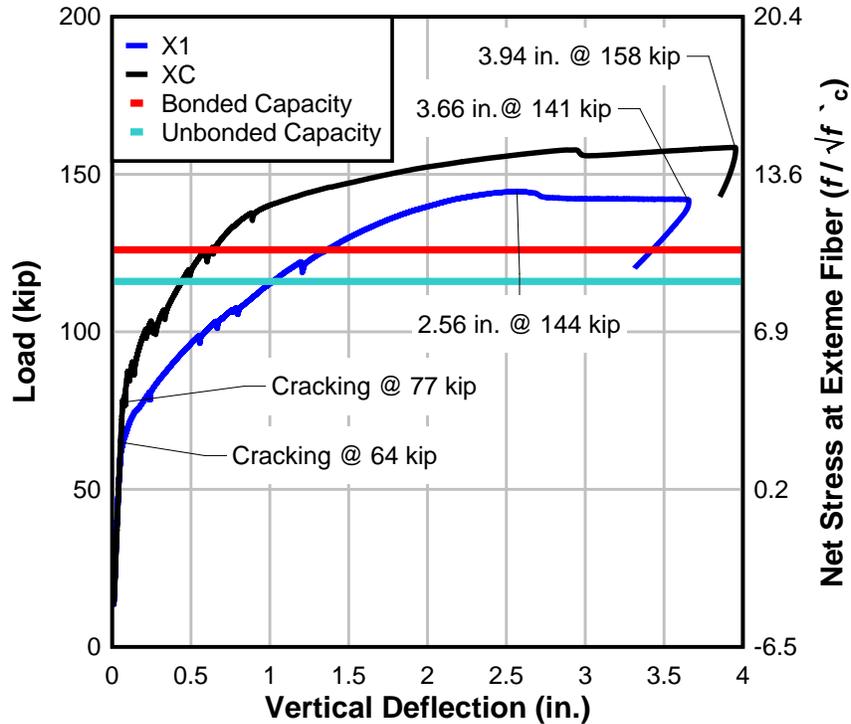
Figure 10-19. XC and X1: Flexural Strength

The computed flexural strength is compared to their respective load-displacement plots in Figure 10-19. The strength was computed in accordance with AASHTO-LRFD using specified materials of 4.5 ksi deck concrete and 270-ksi prestressing steel. The predicted bonded moment capacity at 0.003 concrete compressive strain was 631 kip-ft, which corresponds to an applied load of 123 kip. For both XC and X1, the peak load exceeded the predicted design strength of a bonded prestressed member. Considering the cracking behavior and failure mode of the spliced specimen X1, the AASHTO-LRFD capacity was also calculated assuming the steel strands were unbonded. The calculated moment strength, assuming all five strands were unbonded, was 589 kip-ft, which corresponded to an applied load of 114 kip. X1 exceeded the anticipated capacity of an unbonded section.

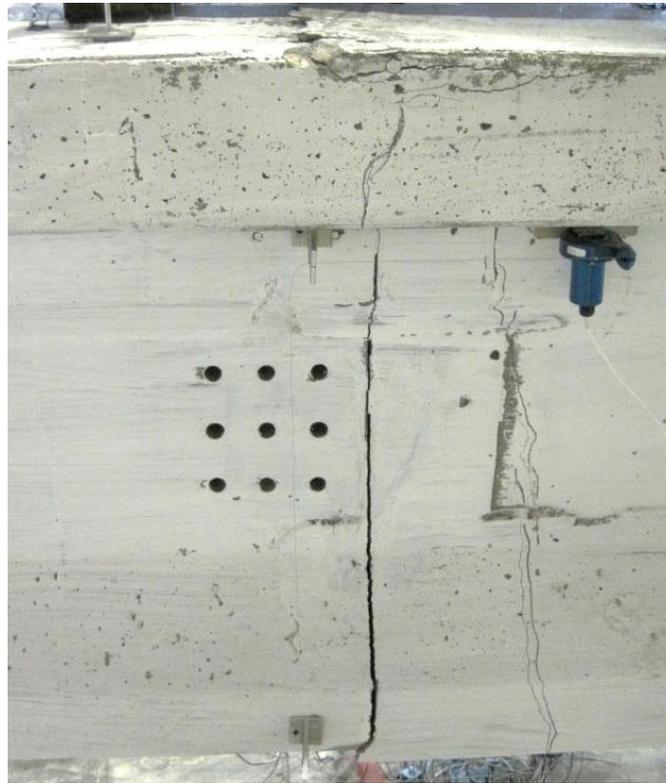
Figure 10-20. Damage to X1 following testing with spalled concrete in compression zone and wide, permanent crack

At the maximum applied load of 145 kip, the beam continued to deflect without resisting additional load. The midspan deflection at the maximum applied load was approximately 2.6 in. with a permanent set 0.75 in. upon load removal. X1 exhibited a tension-controlled flexural failure as the deck concrete crushed (Figure 10-20).

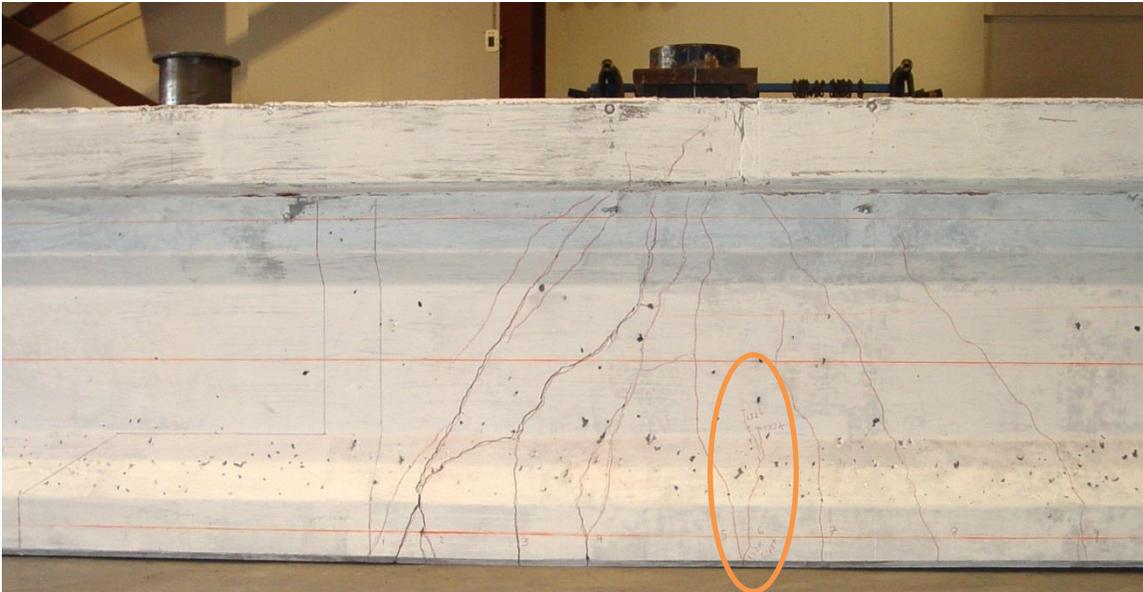
Figure 11-2. SC: Crack pattern

The first visible crack was a flexural crack which occurred at 128 kip. It formed approximately under the load point (Figure 11-2). While SC is a homogenous precast specimen, the location of what would be the closure pour in a spliced beam has been sketched onto the beam to provide a reference for discussion.

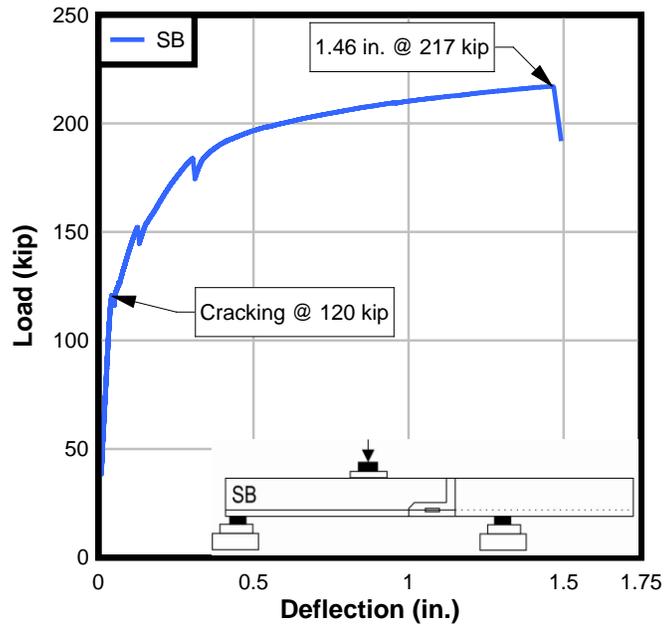
Figure 11-4. SB: Ultimate

Figure 11-4 shows the load-displacement plot of the spliced test specimen loaded with the load applied to the bonded segment. This is referred to as specimen SB - the spliced specimen constructed of bonded segment 5b and unbonded segment 5u (Figure 6-1). The plot indicates that, as load was applied, SB exhibited linear-elastic behavior up to a cracking load of approximately 120 kip; a crack was visually observed at this load. The first visible crack was a flexural crack located approximately under the load point. The load was held at 120 kip and the crack was marked. The first crack is circled in Figure 11-5.

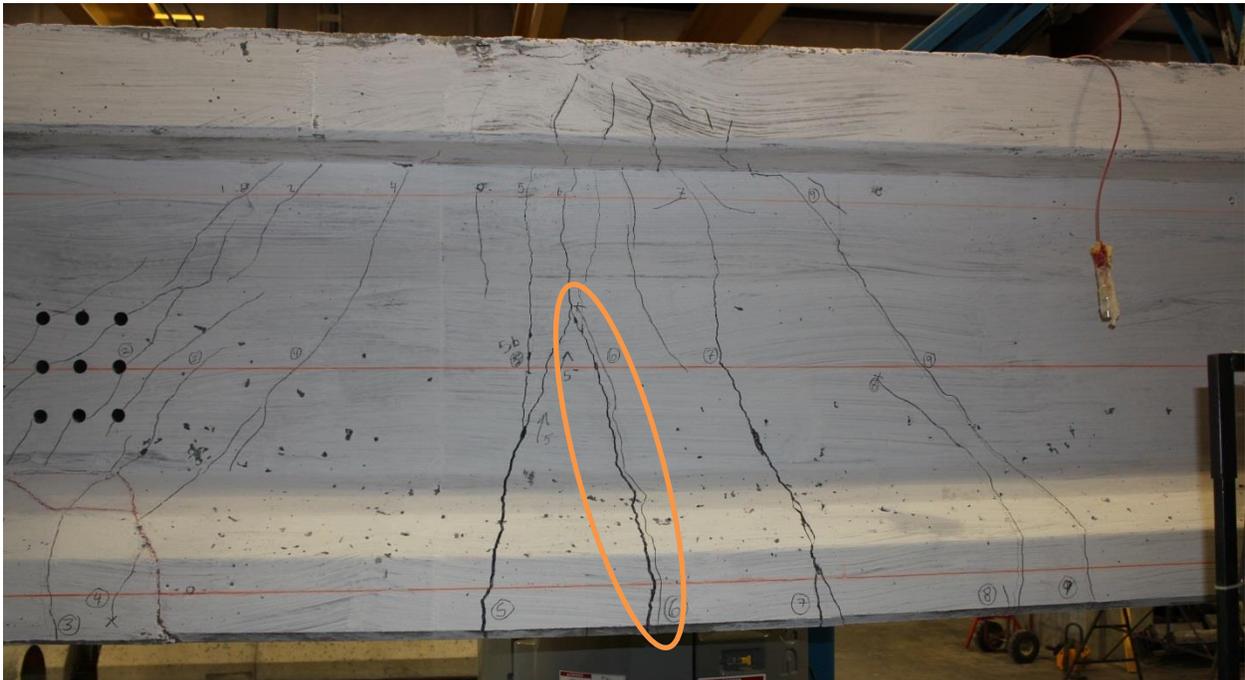
Figure 11-5. SB: First crack

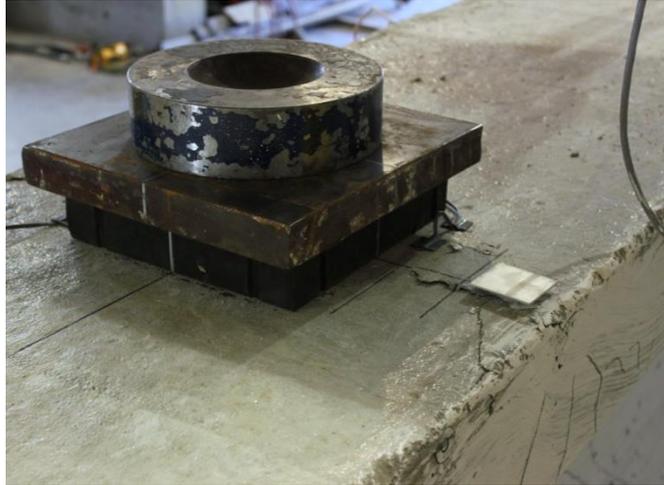
The peak load was approximately 217 kip when the deck failed in compression under the load point (Figure 11-7); a maximum deflection of 1.5 in. occurred at the load point at the ultimate load.

Figure 11-7. SB: Deck at failure

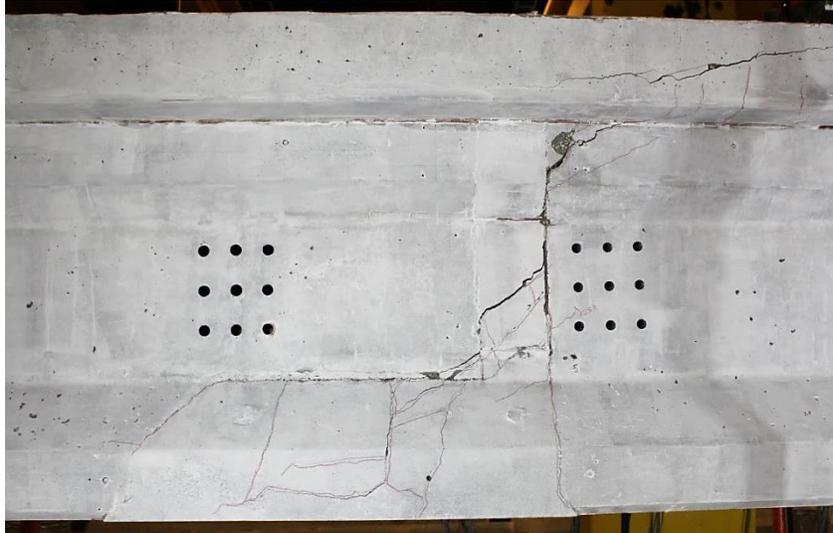
Figure 11-11. SU: Joint at failure

As load application continued, the cracks propagated diagonally toward the load point. At 130 kip, an opening of the joint was observed at the vertical interface between the closure pour and the unbonded segment. SU exhibited a slightly reduced stiffness, until approximately 140 kip. Where a crack crossed a joint interface, the crack changed direction to follow the path of least resistance, i.e., the dry joint. From 140 kip to 185 kip, the load-deflection nearly plateaued, revealing marked reduction in specimen stiffness. Once the compression concrete was lost (through cracking of this region), the unbonded segment suddenly slipped downward. At the peak load of 185 kip, SU deflected approximately 0.6 in. at the load point. A shear failure mode was observed as the crack at the vertical interface propagated until a slip occurred between the closure pour and the unbonded precast segment. A torsional rotation of the top flange away from the bottom flange was observed. Figure 11-11 shows the spliced region cracking after failure.

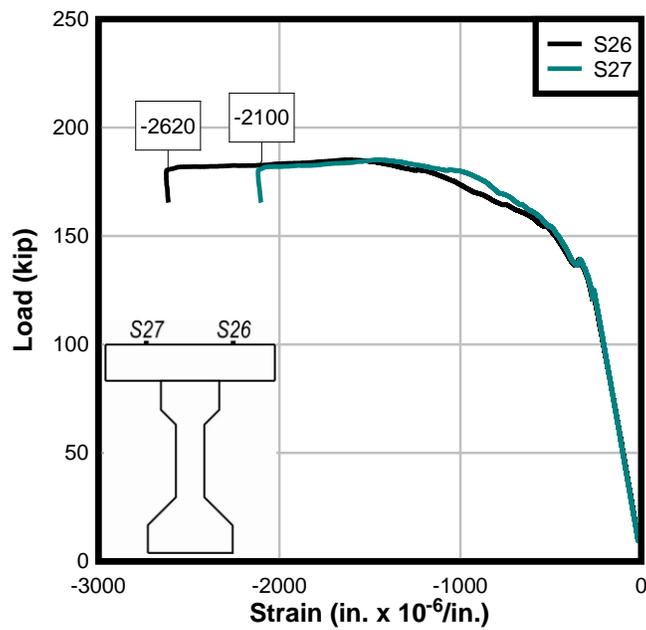
Figure 11-12. SU: Strain at load point

Compressive strain measured in the deck concrete at the load point did not reach 0.003 (Figure 11-12).

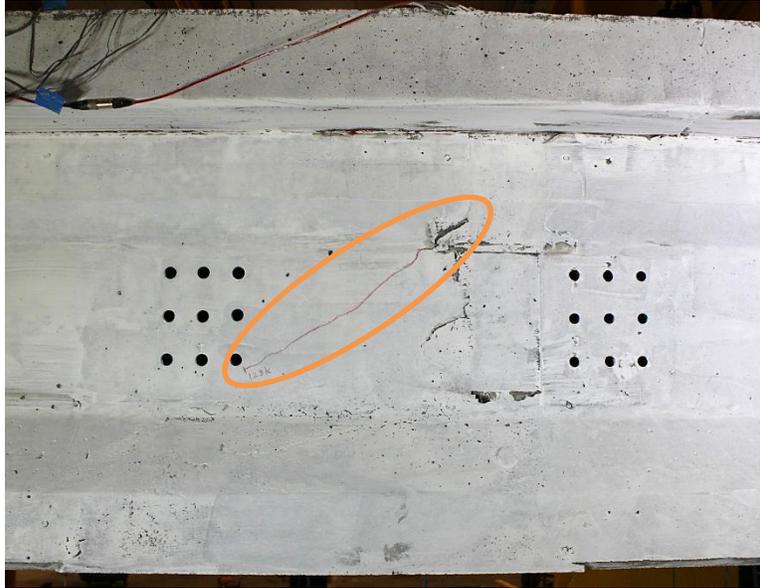
Figure 11-14. SU2: First crack

The first visible crack was a web-shear crack which formed in the precast concrete near the joint (Figure 11-14). At the cracking load, the crack affected only the precast concrete, halting at the closure pour.

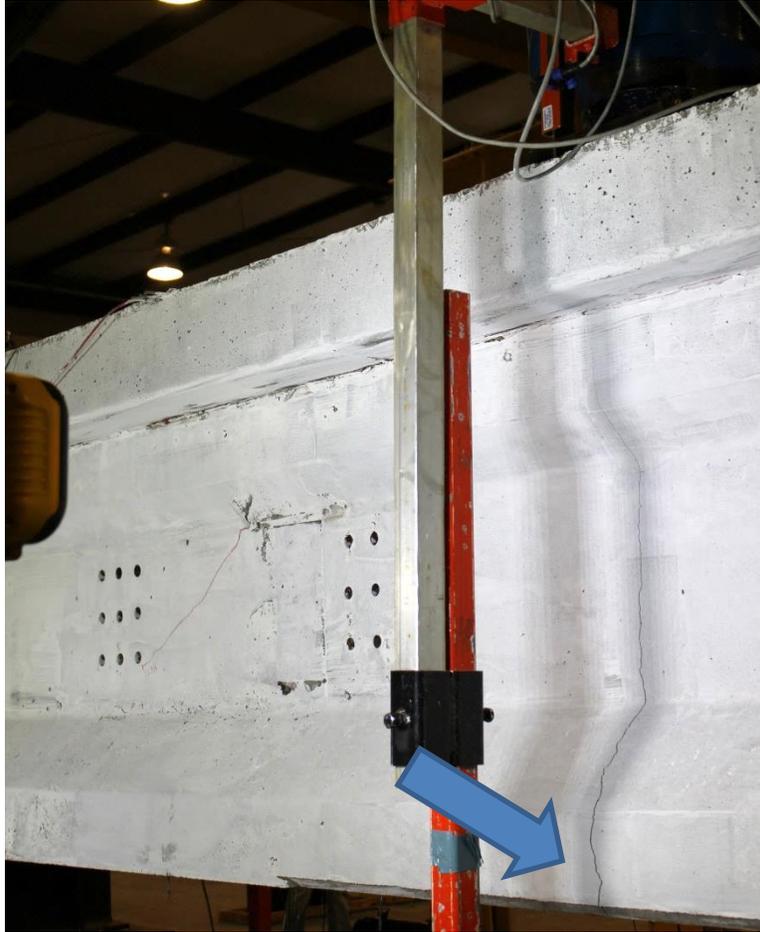
Figure 11-15. SU2: Flexural crack at 149 kip

As additional load was applied, SU2 exhibited reduced—but nearly equal-stiffness, until approximately 149 kip. At 149 kip, a major load decrease of approximately 18 kip occurred when a flexural crack formed directly under the load point (Figure 11-15).

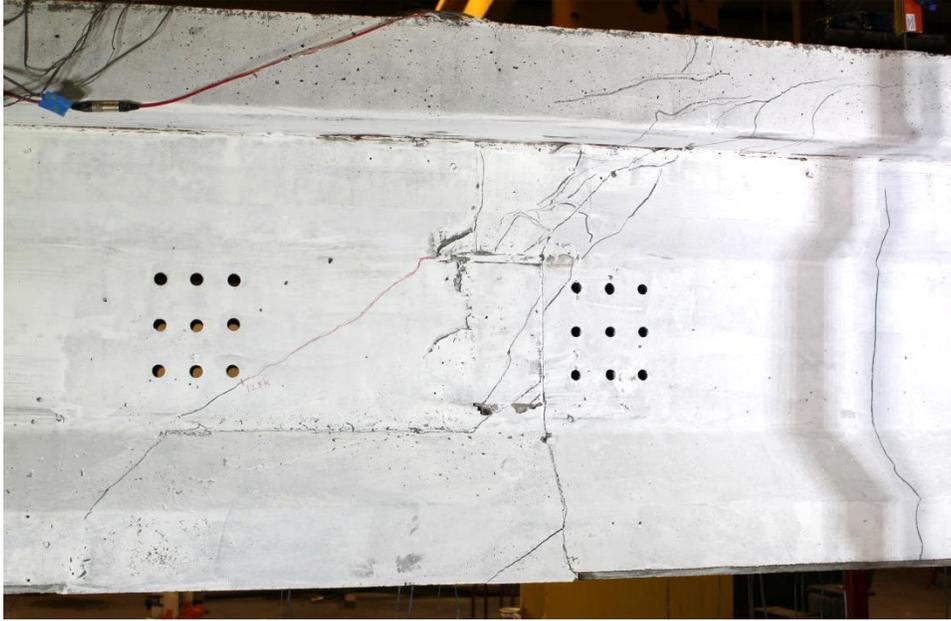
Figure 11-16. SU2: Joint at failure

At the peak load of 202 kip, SU2 deflected approximately 0.6 in. at the load point. A combined flexural-shear failure mode was observed as the main flexural crack under the load point continued to open and the web-shear crack (the first crack) propagated diagonally toward the load point; slip between the two segments at the vertical interface of the closure joint was again observed, similar to the test of the SU specimen (Figure 11-16).

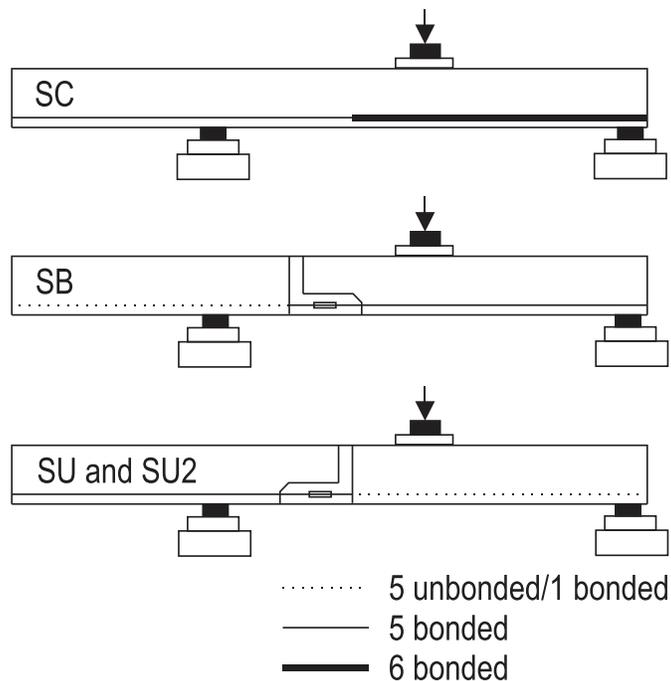
Figure 11-18. Bond patterns of shear tests

To aid the discussion of the shear specimens' service and cracking behavior, Figure 11-18 compares the test set-ups of the SC, SB and SU specimens and provides each specimen's bond pattern. As illustrated in the figure, several spliced specimens were tested, varying the orientation of the bond pattern to encompass the behavior of each side of the spliced beam. A single control specimen—with continuously prestressed, bonded strand—was oriented in the direction of most interest, based on the spliced specimen results. The chosen orientation of the control specimen (SC) placed the end with five bonded strands under the load point similar to the load tests of SU and SU2. The orientation of SC matched the quantity of strands in the shear span, but not the bonding pattern, to SU and SU2.

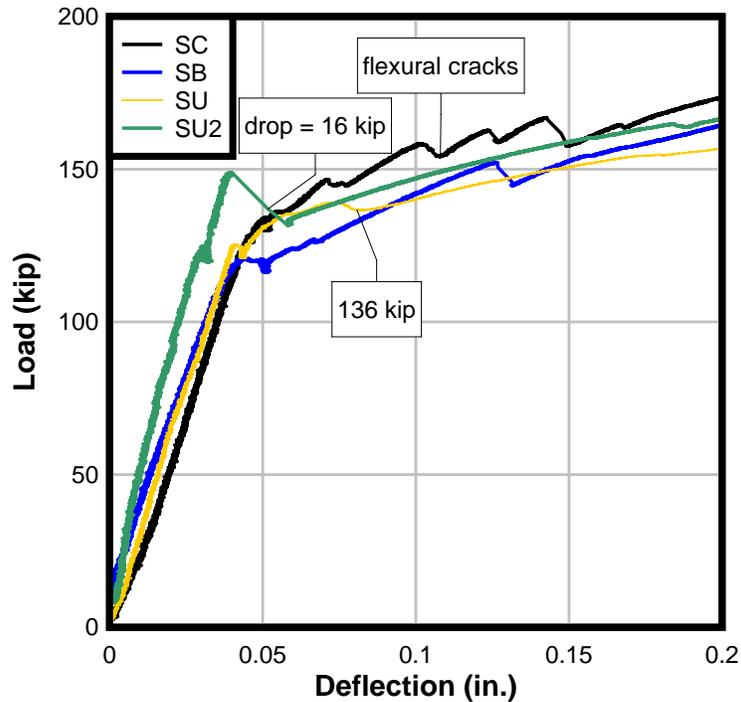
Figure 11-19. Shear comparison: Elastic behavior

To highlight the elastic behavior the shear specimens, Figure 11-19 shows the load-displacement plot up to a deflection of 0.2 in.

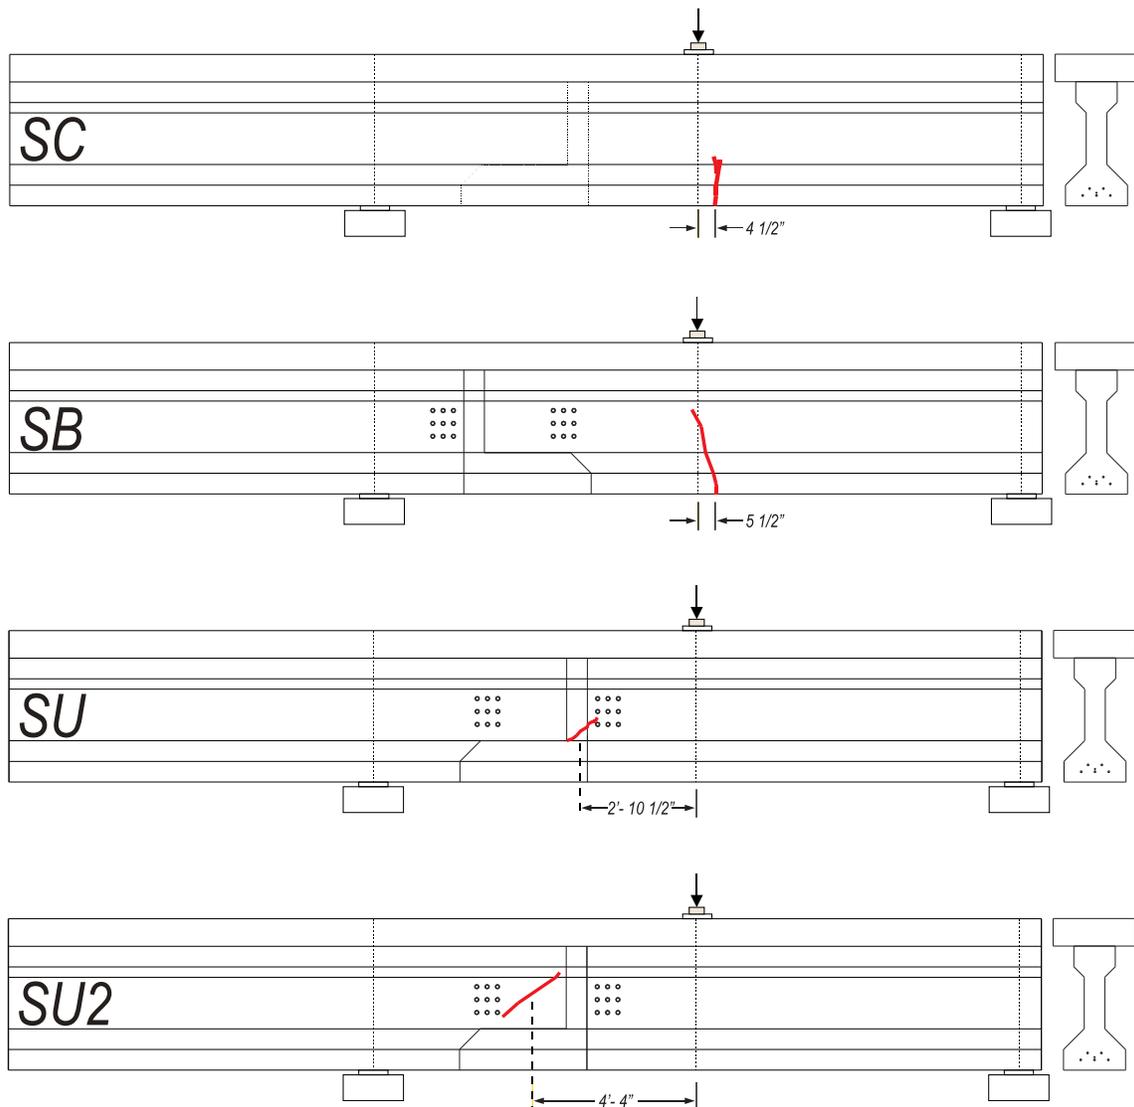
Figure 11-20. Shear specimens: First crack locations

Figure 11-20 shows the first crack location of each shear specimen. The first crack is shown as a thick red line.

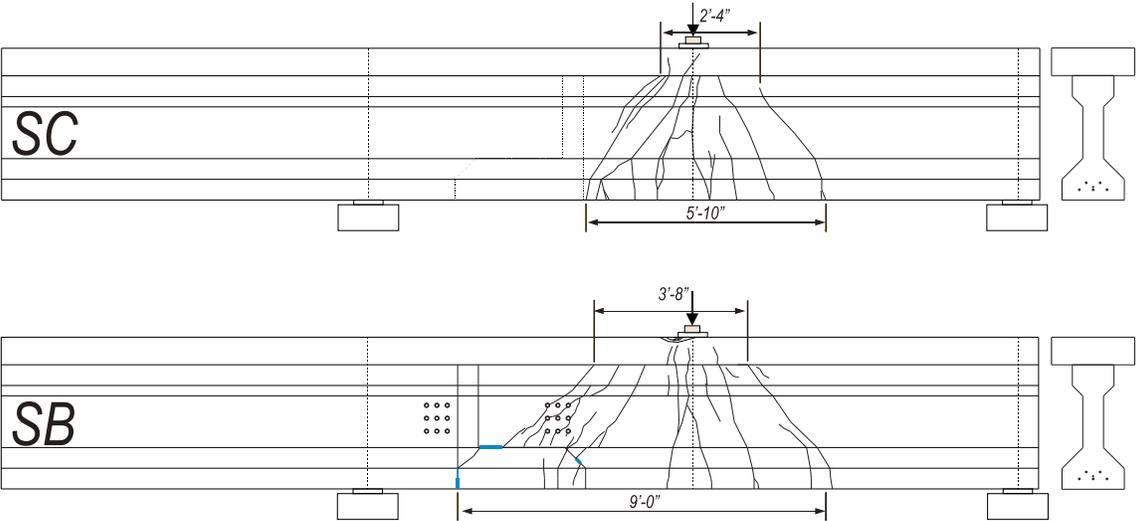
Figure 11-21. SC vs. SB: Crack pattern

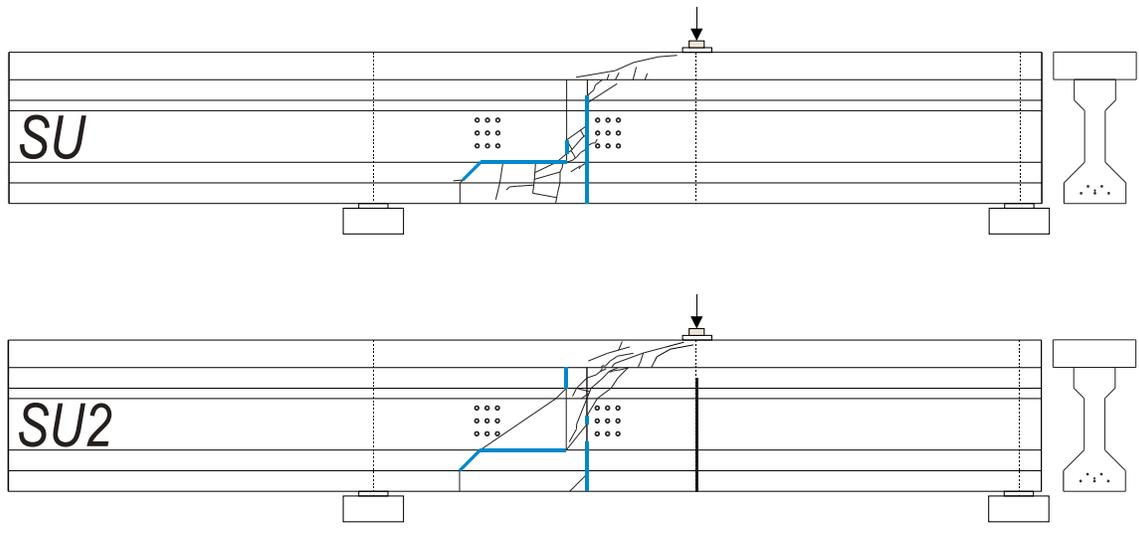
Figure 11-22. SU vs. SU2: Crack pattern
