LONG SPANS WITH TRANSPORTABLE PRECAST PRESTRESSED GIRDERS

NATASSIA R. BRENKUS

A THESIS PRESENTED TO THE GRADUATE SCHOOL
OF THE UNIVERSITY OF FLORIDA IN PARTIAL FULFILLMENT
OF THE REQUIREMENTS FOR THE DEGREE OF
MASTER OF ENGINEERING

2013

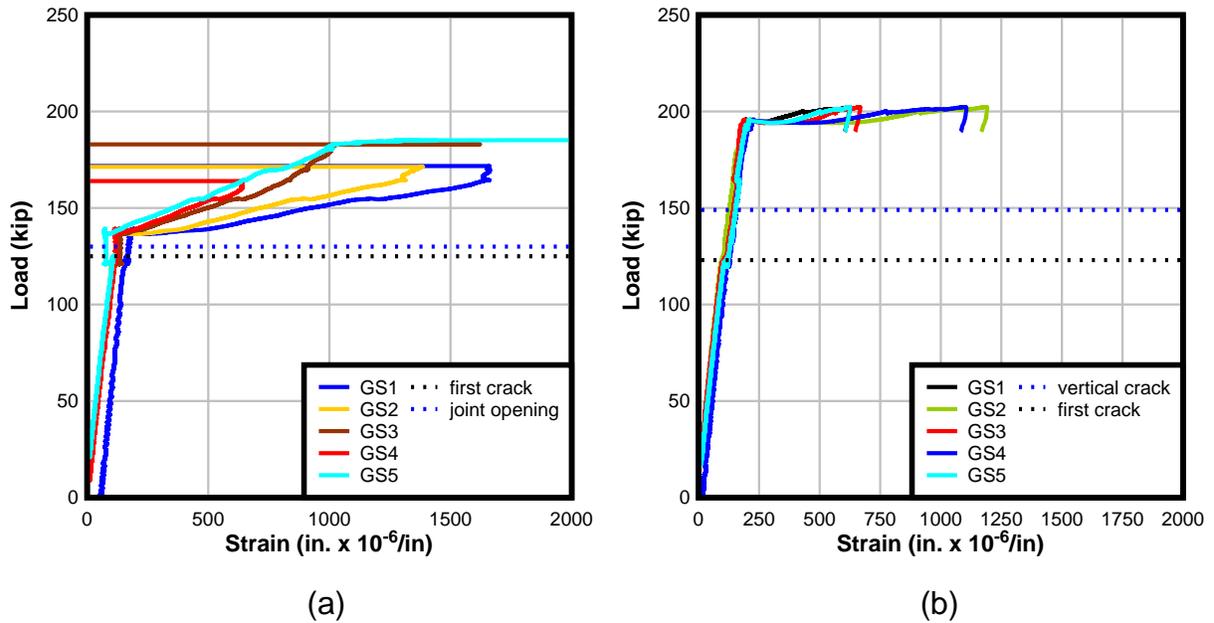
Figure 11-25. Coupler strain gages: (a) SU and (b) SU2

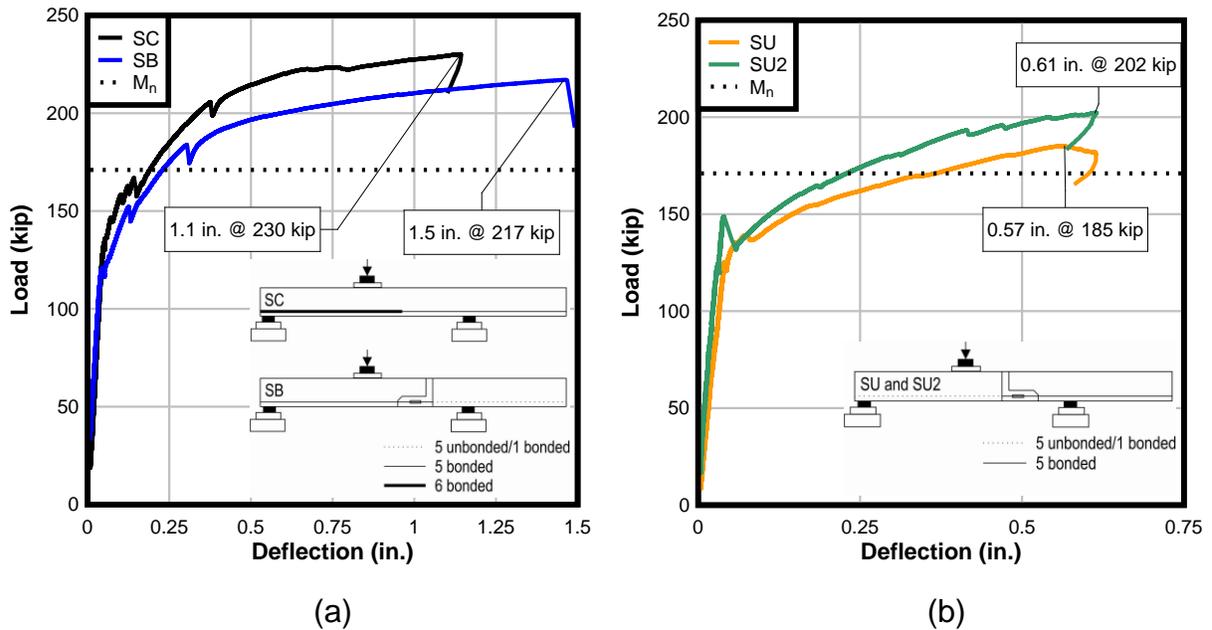
Figure 11-28. Ultimate behavior: (a) SC and SB and (b) SU and SU2

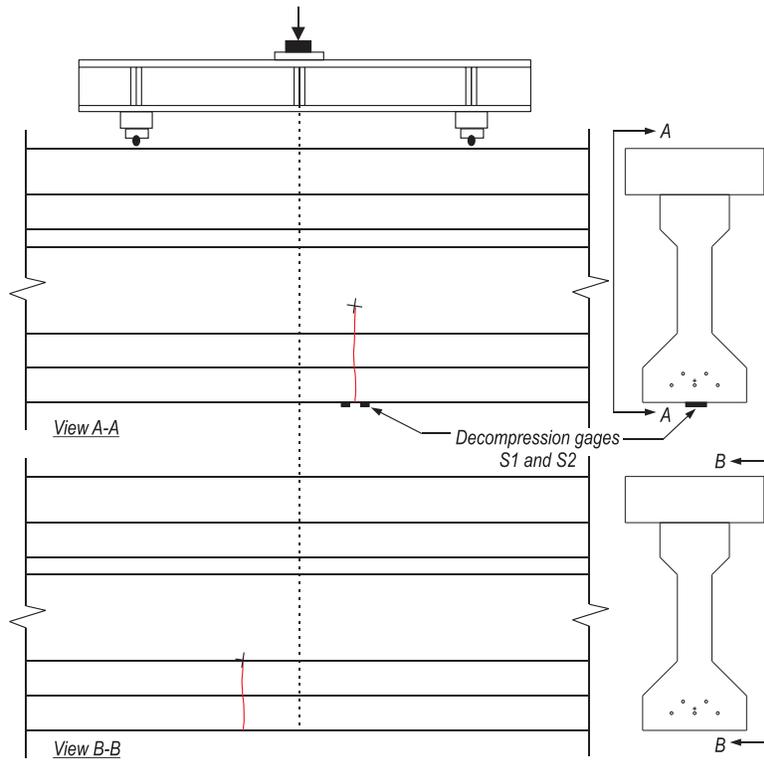
Figure 12-2. FC: First crack

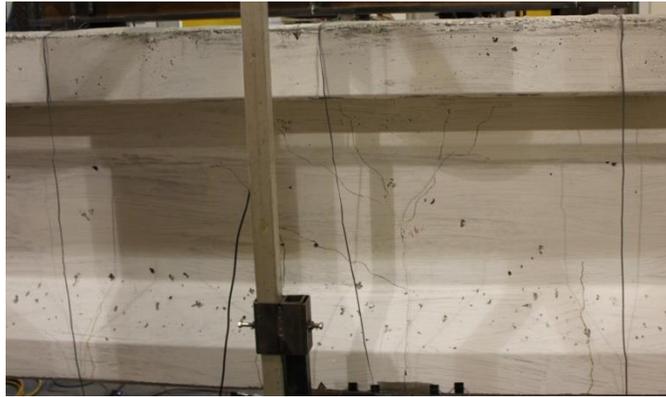
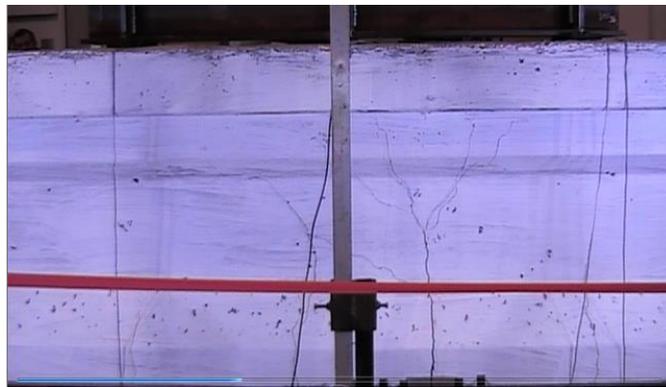
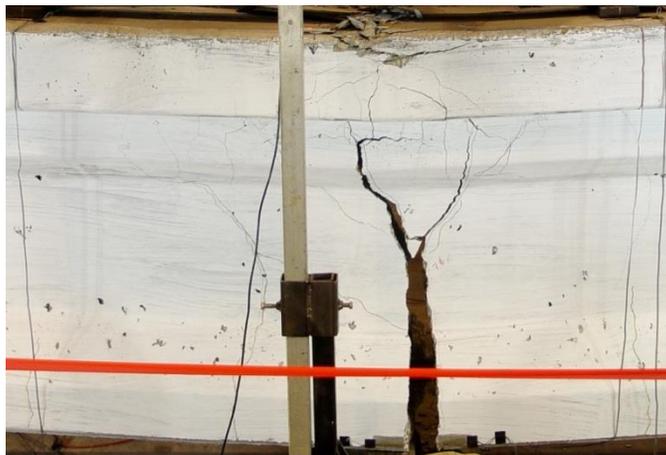
Figure 12-6 shows the load-displacement plot of the ultimate strength test of FC. Before initiating the load test, the specimen had several cracks, which extended from bottom to top of the precast; the cracks did not appear to extend into the deck. These cracks were located within the constant moment region of the test set-up and can be seen in Figure 12-7(a).

Figure 12-7. FC crack progression at (a) no load; (b) ultimate (c) second loading

At approximately 77 kip, several loud reports were heard, indicating that prestressing wires had fractured. A load loss of more than 15 kip triggered the preset MTS interlock, and load application was halted. Ultimate load was approximately 77 kip and occurred at a beam midspan deflection of approximately 0.3 in. Upon removal of the load, the beam continued to carry its own self-weight (Figure 12-7(b)), but exhibited a permanent set of 0.25 in.

The interlocks were removed and the specimen was reloaded, achieving a maximum load of 68 kip. At 68 kip, more reports were heard and the specimen hit the floor. Figure 12-7(c) shows the specimen after termination of the second loading.

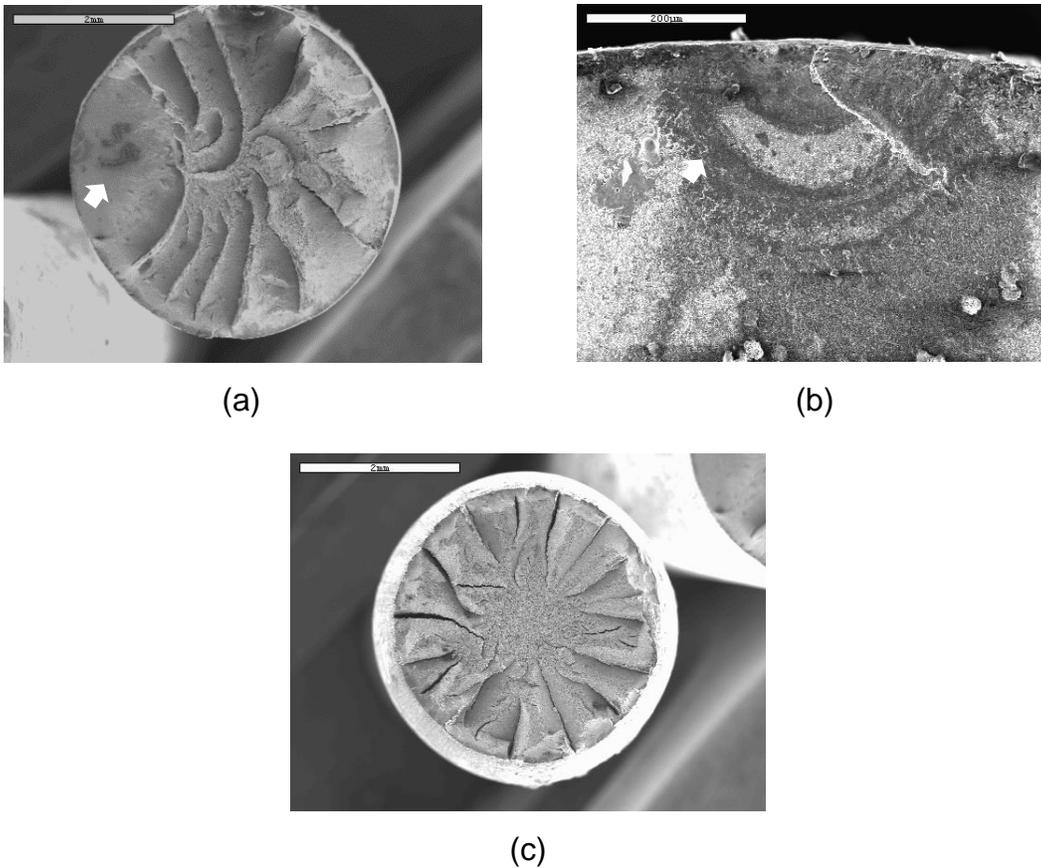
Figure 12-9. FC strand showing (a) fatigue (20X) (b) fatigue (200X) (c) yield (20X)

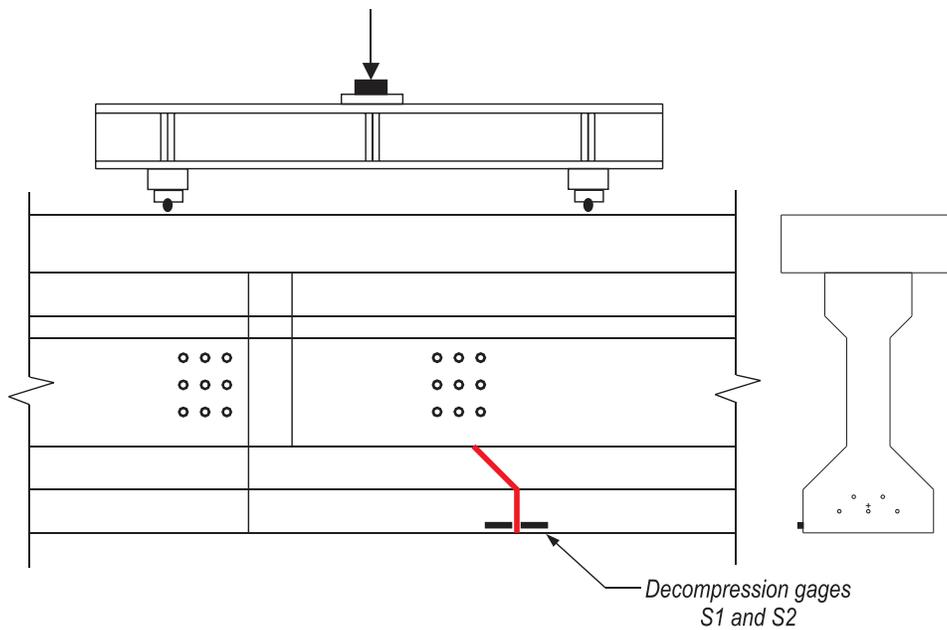
Figure 12-11. F1: Joint opening

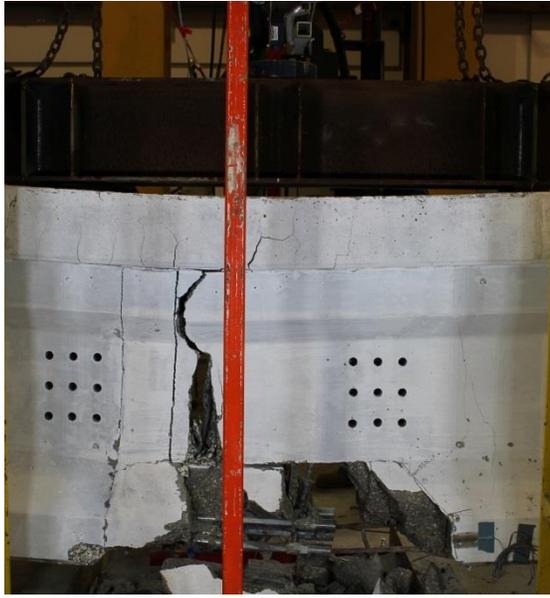
At approximately 141 kip, the specimen reached ultimate load when strands ruptured near the first crack and the beam hit the floor. At failure, the principal flexural crack closed indicating that the couplers provided anchorage for the unbonded tendons to remain stressed. Figure 12-19 shows F1 after failure.

Figure 12-19. F1: Post-failure

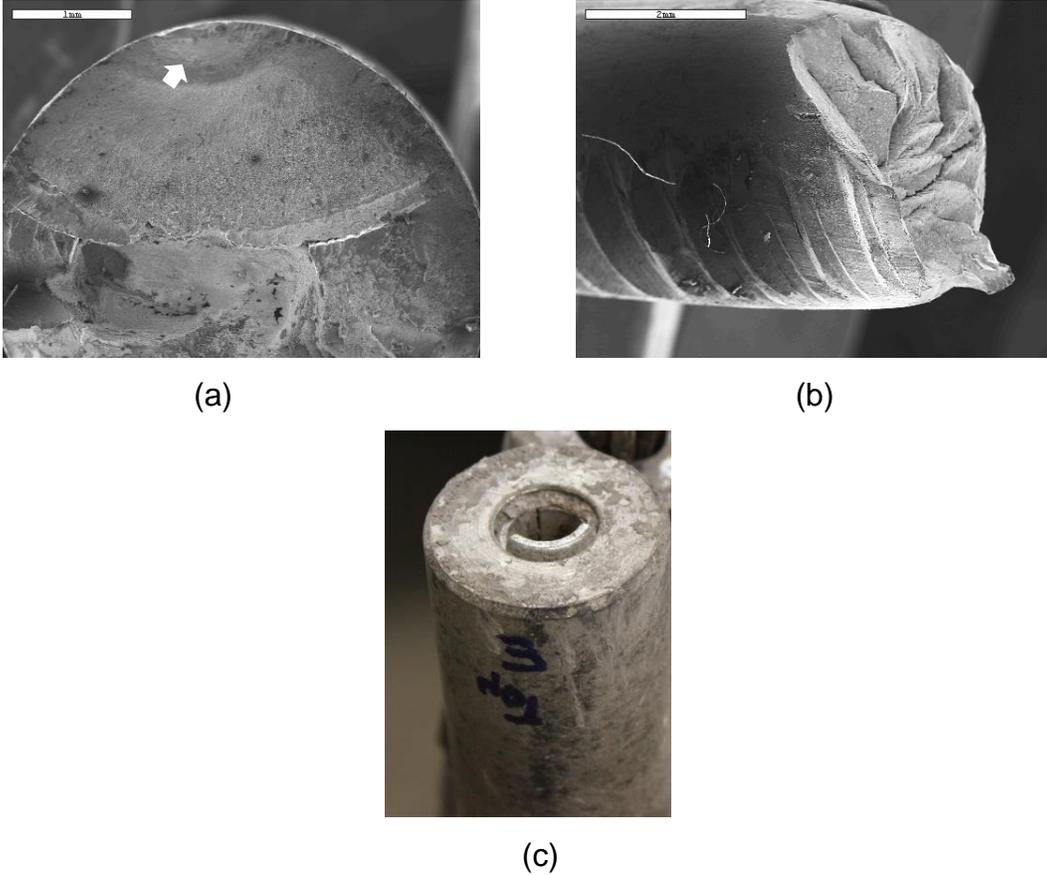
Figure 12-21. F1: (a) top strand showing fatigue (40X) (b) failure at teeth (20X)
(c) improper wedge seating

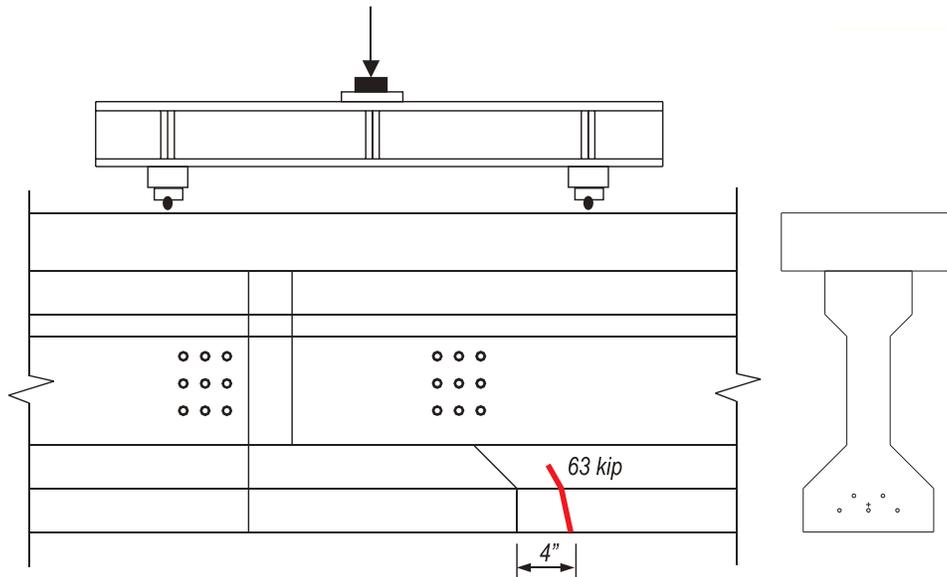
Figure 12-23. F2: First crack

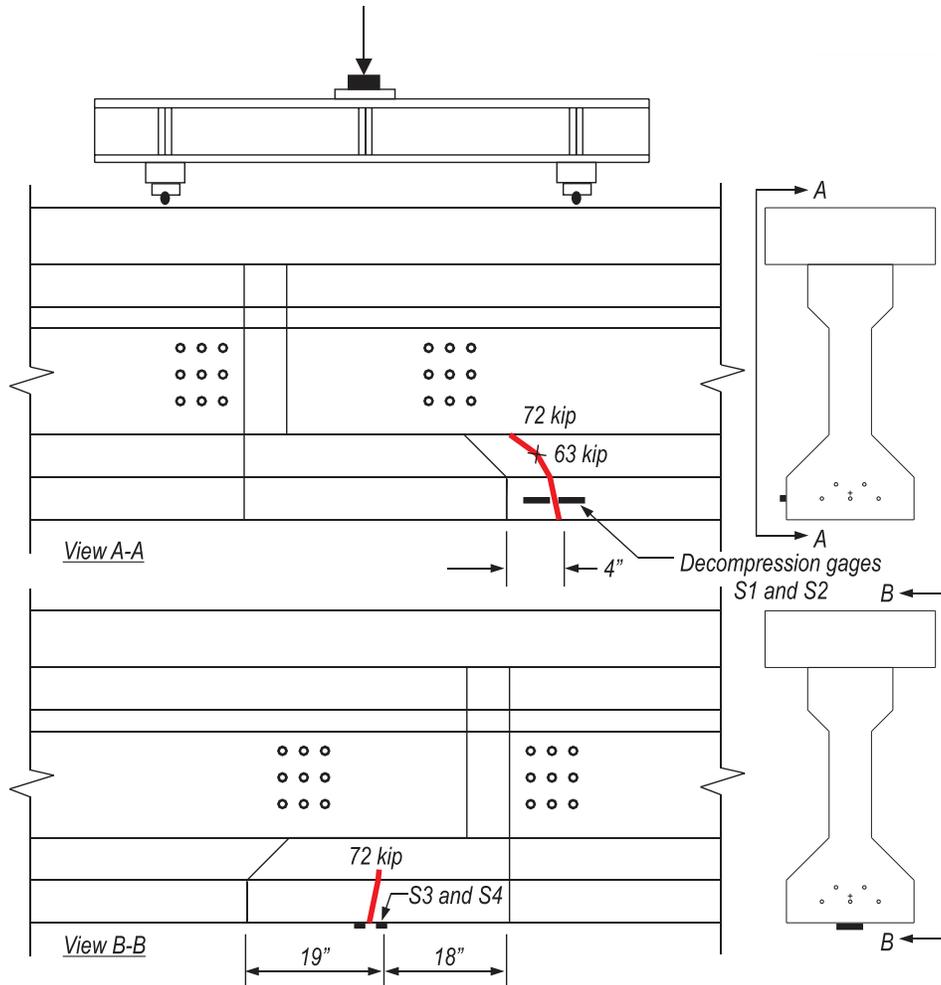
Figure 12-25. F2: First cracks with strain gages

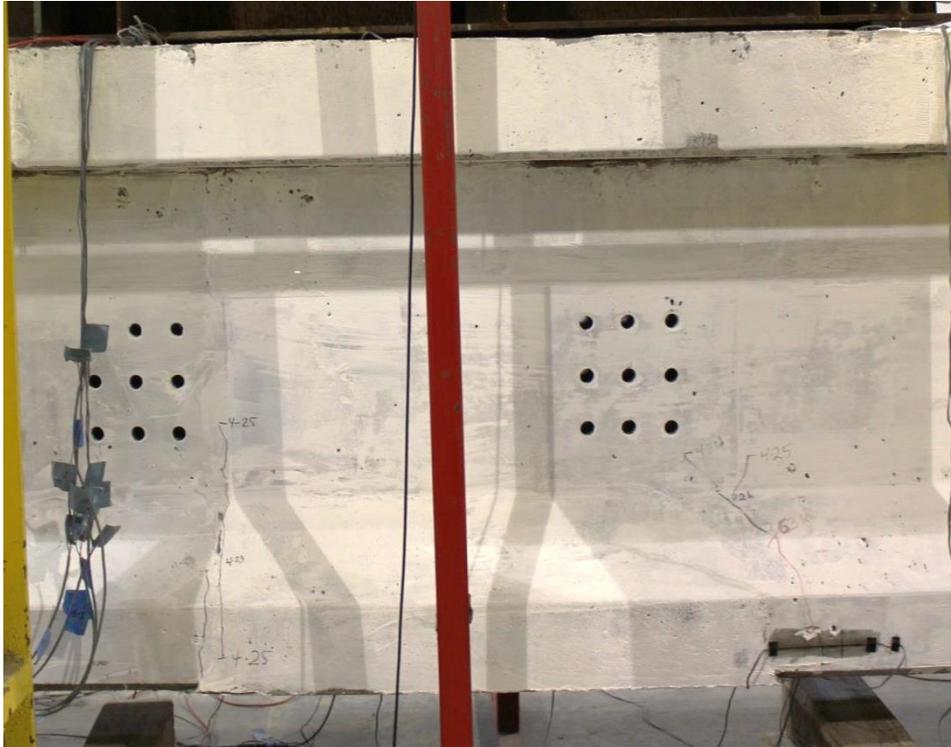
Figure 12-29. F2: Cracking after 2 million cycles

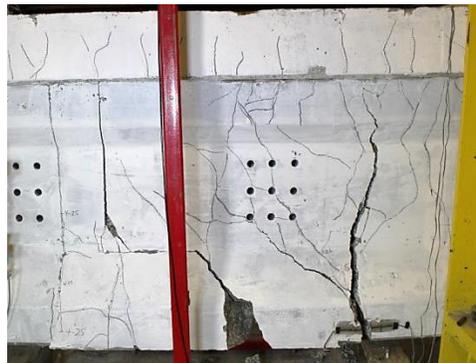
Figure 12-31. F2 crack progression at (a) 70 kip, (b) 137 kip, and (c) ultimate (cracks marked)

As ultimate load was approached, the opening at the vertical interface widened significantly—about 1 in. at the bottom - with an apparent hinge just below the deck (Figure 12-31). As load application continued, the significant flexural crack at the vertical interface of the closure pour (which had opened around 1.7 million fatigue cycles) propagated up to the deck and allowed the specimen to experience significant vertical deflection. The vertical interface crack opened more than 1 in., as the specimen approached the ultimate load. At approximately 140 kip of load and 2.5 in. of displacement, the specimen reached ultimate strength, and several strands fractured. Strand fracture was audible and was visually confirmed by inspection of the specimen post-failure.

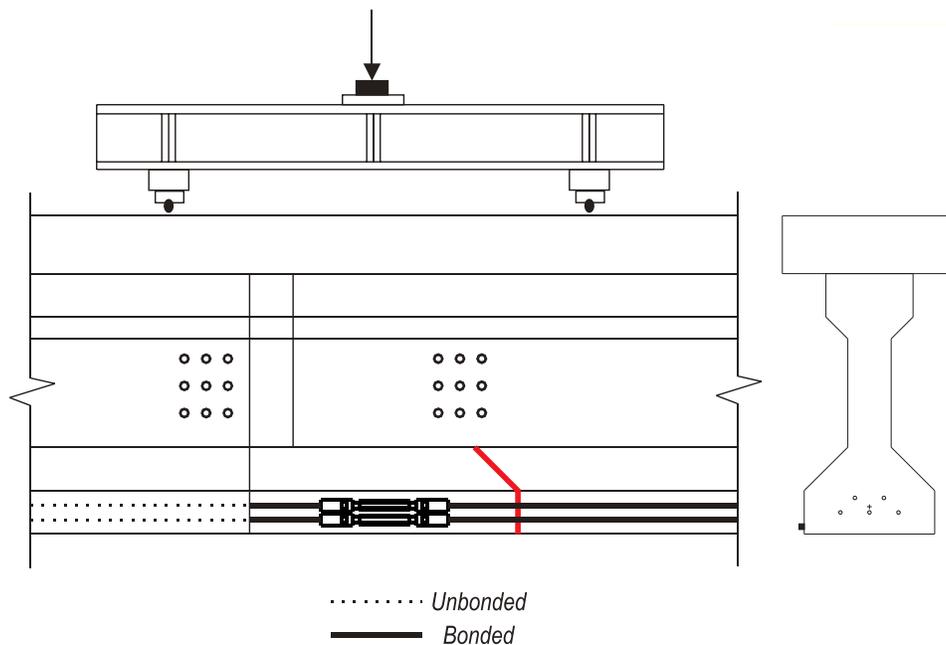
Figure 12-34. F1: Cracks at start of fatigue

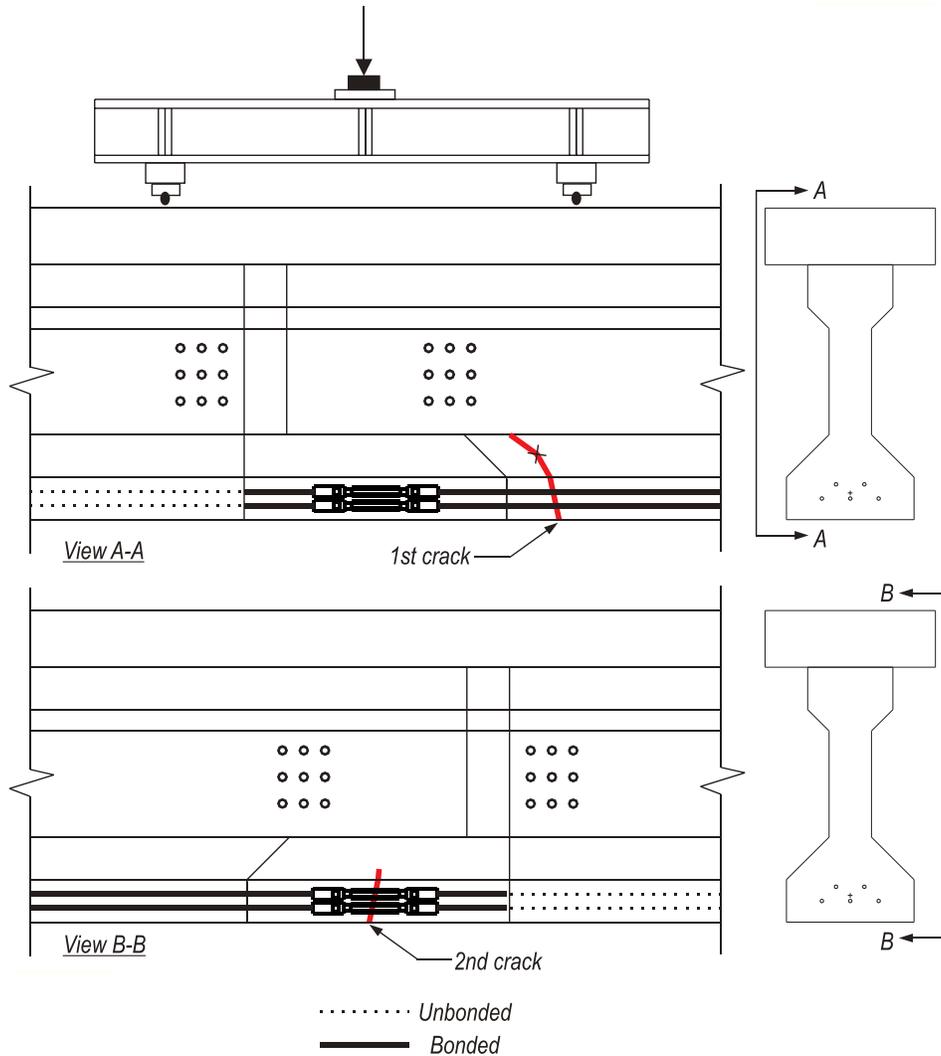
Figure 12-35. F2: Cracks at start of fatigue

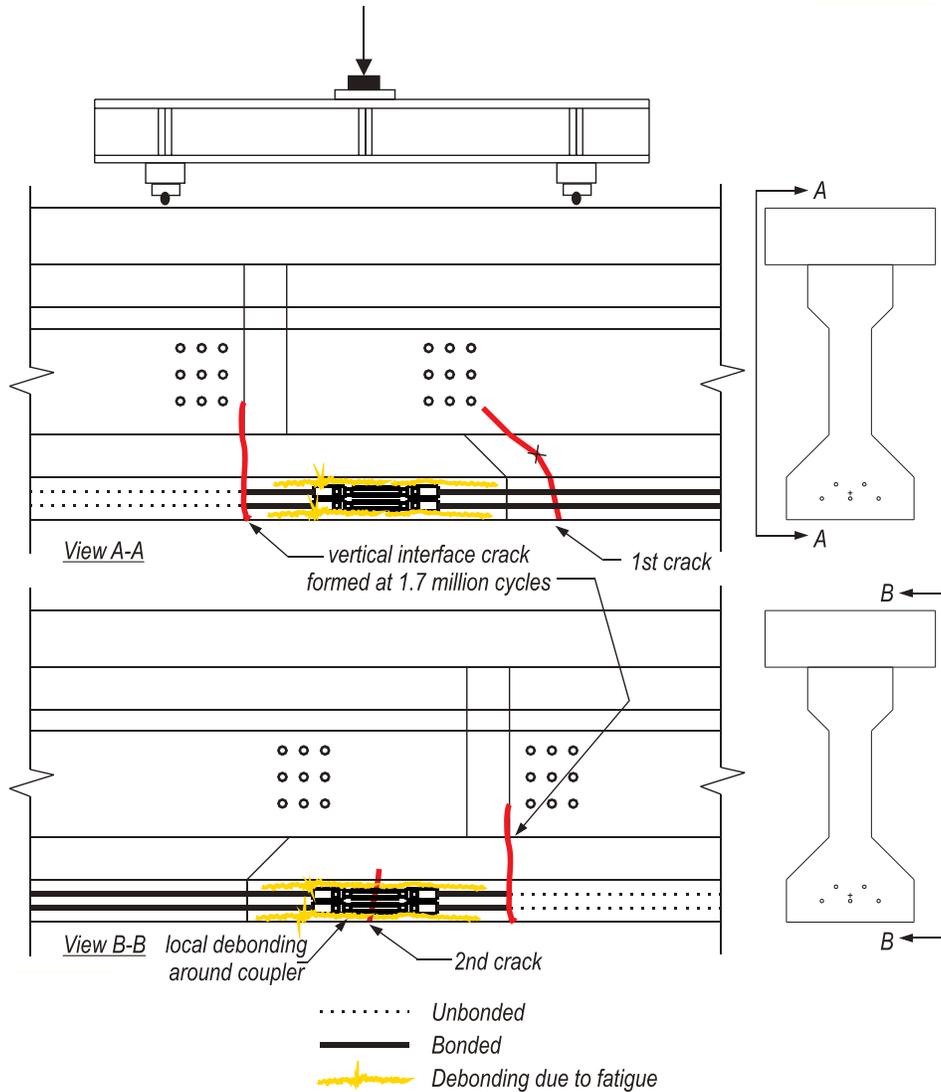
Figure 12-36. F2: Section degradation due to fatigue

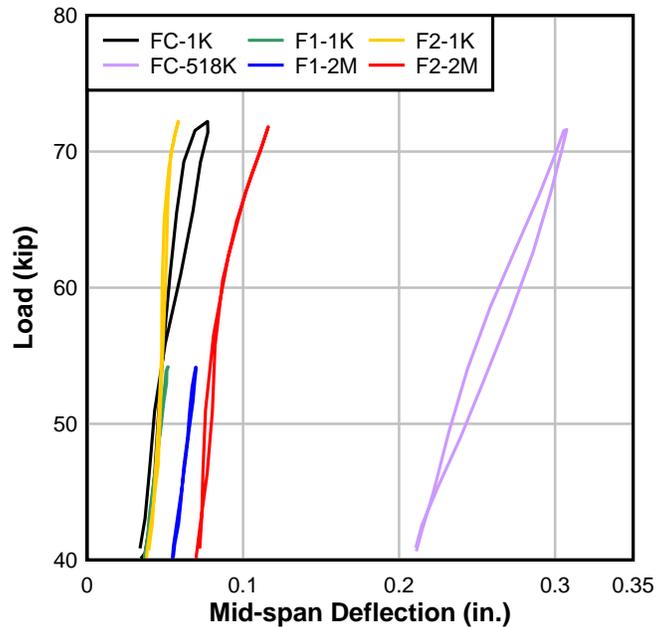
Figure 12-37. Fatigue: Deflection at start and end of tests

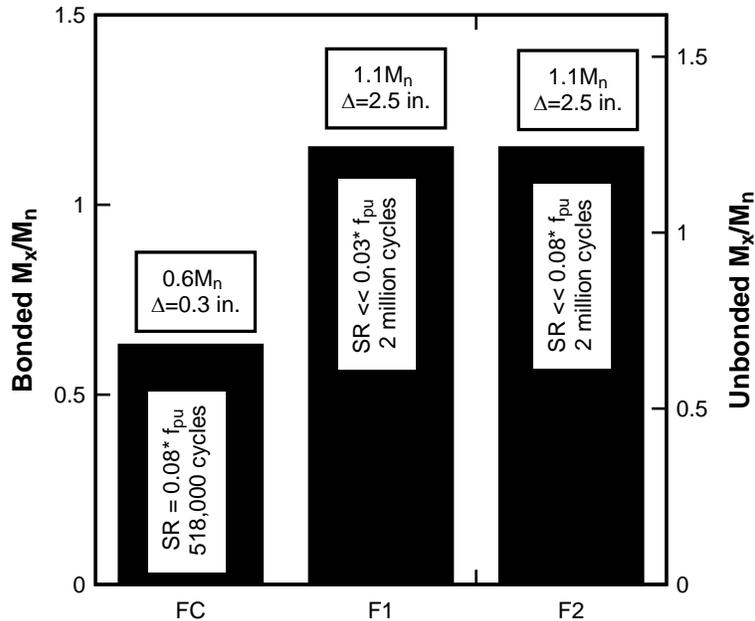
Figure 12-39. AASHTO: FC, F1, and F2

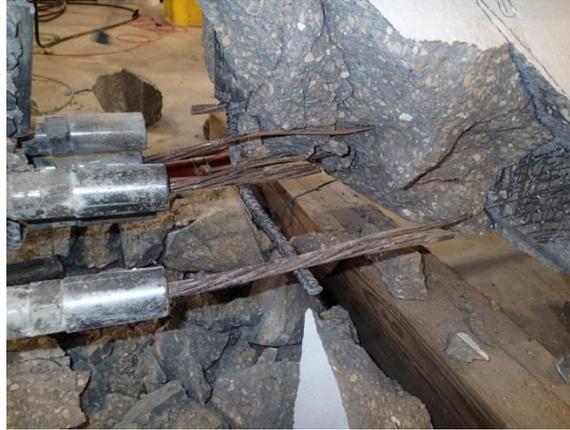
The location of the primary crack affected the strand rupture and ductility at ultimate. In the ultimate load test of F1, the crack at the notch interface became the location of strand rupture at ultimate load. In post-failure inspection of F1, it was observed that a single top row strand had slipped completely from the wedge. Post-failure inspection revealed that the wedge had improperly seated (Figure 12-43). All but one wire of the other top row strand remained engaged by the coupler; this strand ruptured at the notch crack. The bottom row of strands ruptured at the crack location (Figure 12-42).

Figure 12-42. F1: Post-failure

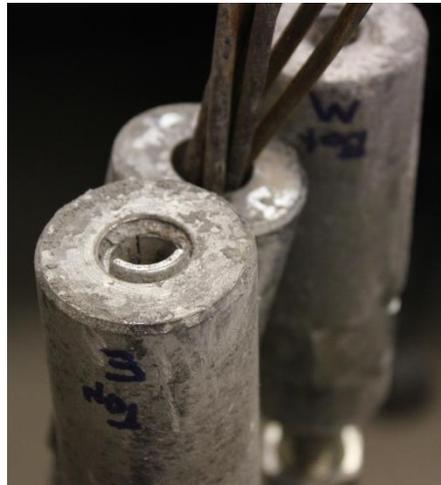
Figure 12-43. F1: Wedge seating

Evidence of improper seating of one wedge in specimen F1, perhaps resulting in notching of the strand and affecting the fatigue capacity. Figure 12-43 shows the coupler from one of the top row strands from specimen F1. The wedge was improperly seated, with concrete slurry holding it in place.

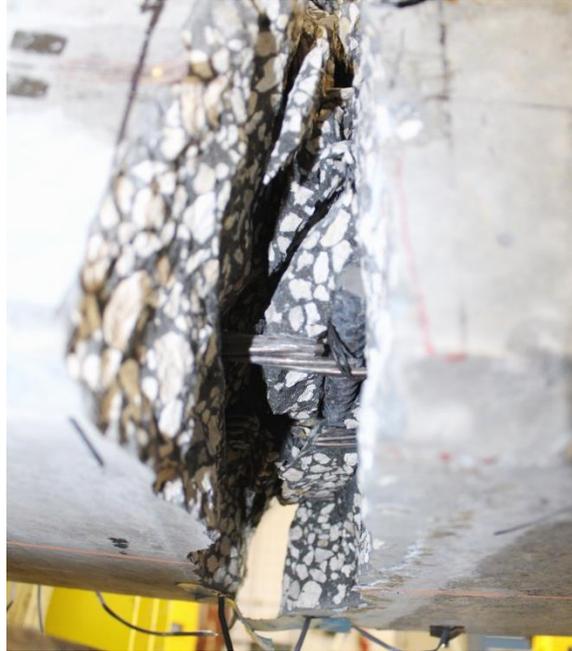
F2's strand ruptured at the primary crack location shown in Figure 12-23, approximately 14 in. away from a Grabb-it face. The ruptured strands are seen in Figure 12-44. It can be observed in the picture that the strand rupture has occurred at a rebar location; inspection of the strand found evidence of fretting between the rebar and the bottom row prestressing strand initiated the fatigue wear at this location (Figure 12-45).

Figure 12-44. F2: Post-failure

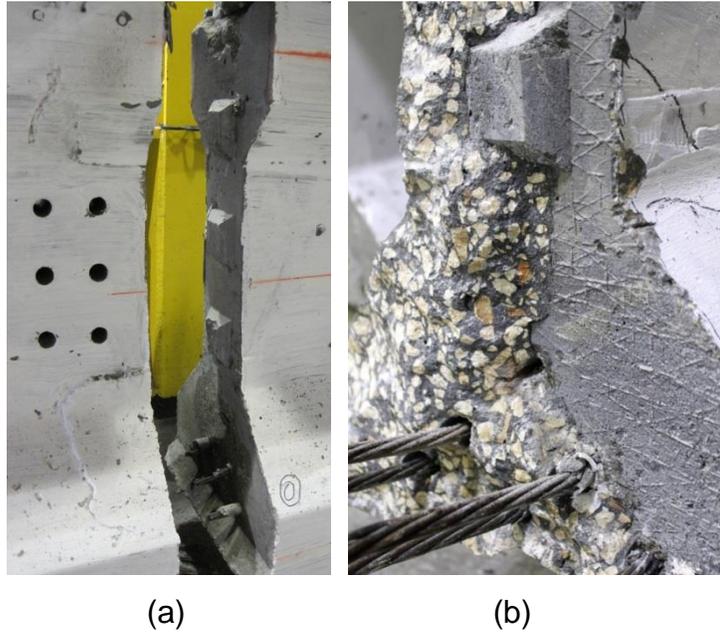
Figure 13-1. Bond at vertical interface (a) X1 and (b) F2

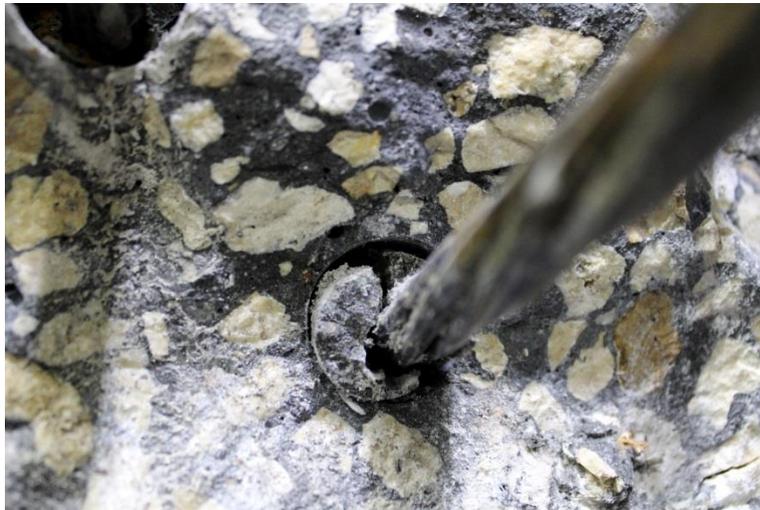
- Observed evidence of intrusion of the closure pour concrete into the unbonded segment's PVC sheathing. This indicates that the self-consolidating concrete used in the closure pour was sufficiently flowable to penetrate and potentially affect the behavior of the unbonded length.

Figure 13-2. F2: Concrete intruding into unbonded length

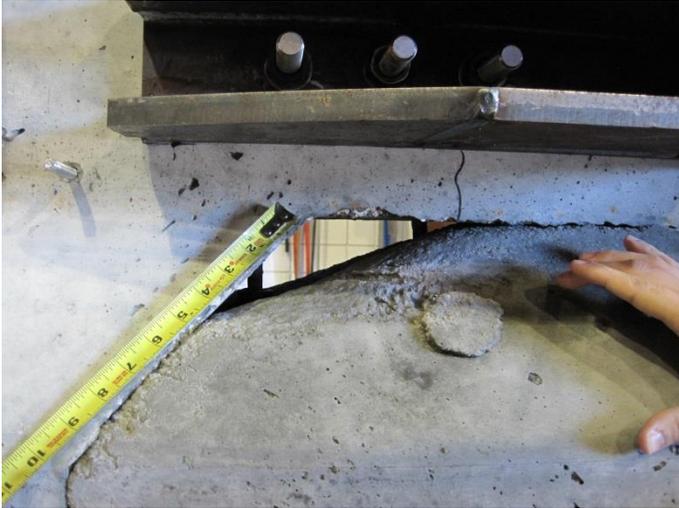
- Self-consolidating concrete worked well, with enough flowability to form a voidless pour, so long as the form sides were vibrated using a hand-held vibrator. In one splice assembly (SB), hand-held vibrators were not used, resulting in a void at the reentrant corner of the splice region (Figure 13-3). The void was repaired prior to testing.

Figure 13-3. SB: Void at reentrant corner

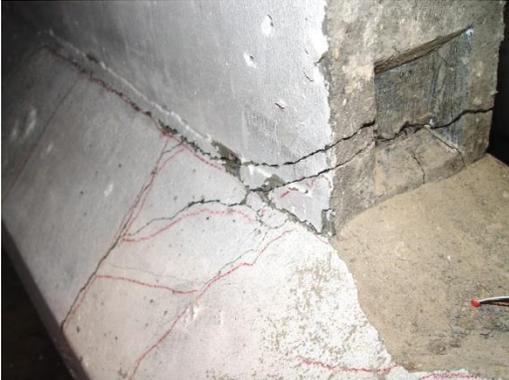
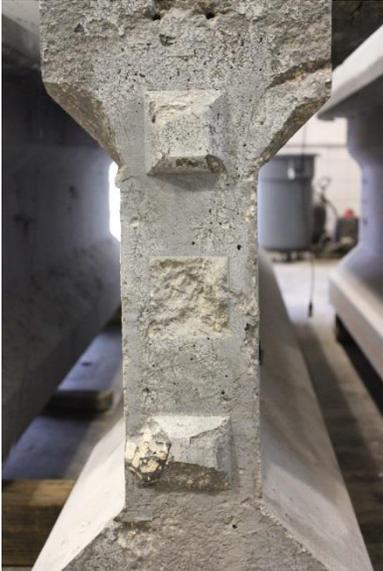
- Shear keys were observed to be effective when the specimen was tested in a high V/M ratio set-up with the unbonded length under the load point (both tests SU and SU2).

Figure 13-4. Shear keys (a) SU and (b) SU2
