WINDBORNE DEBRIS MISSILE IMPACTS ON WINDOW GLAZING AND SHUTTER
SYSTEMS

A THESIS PRESENTED TO THE GRADUATE SCHOOL
OF THE UNIVERSITY OF FLORIDA IN PARTIAL FULFILLMENT
OF THE REQUIREMENTS FOR THE DEGREE OF
MASTER OF SCIENCE

UNIVERSITY OF FLORIDA

2009

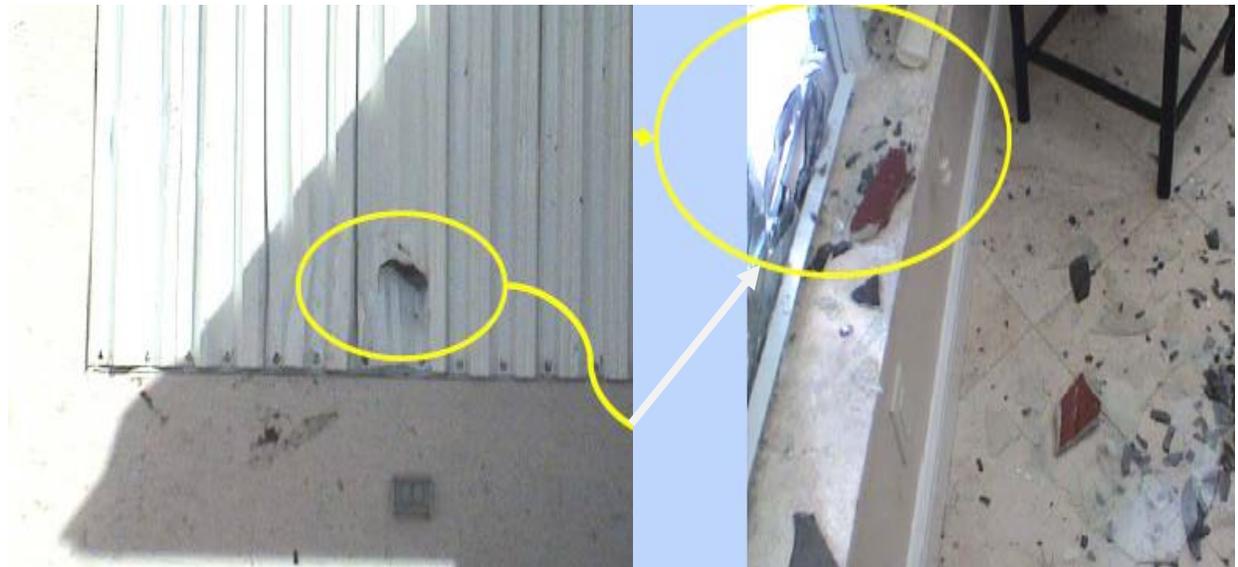
Figure 1-3. Window shutter damage due to Spanish tile. (Reinhold 2005)

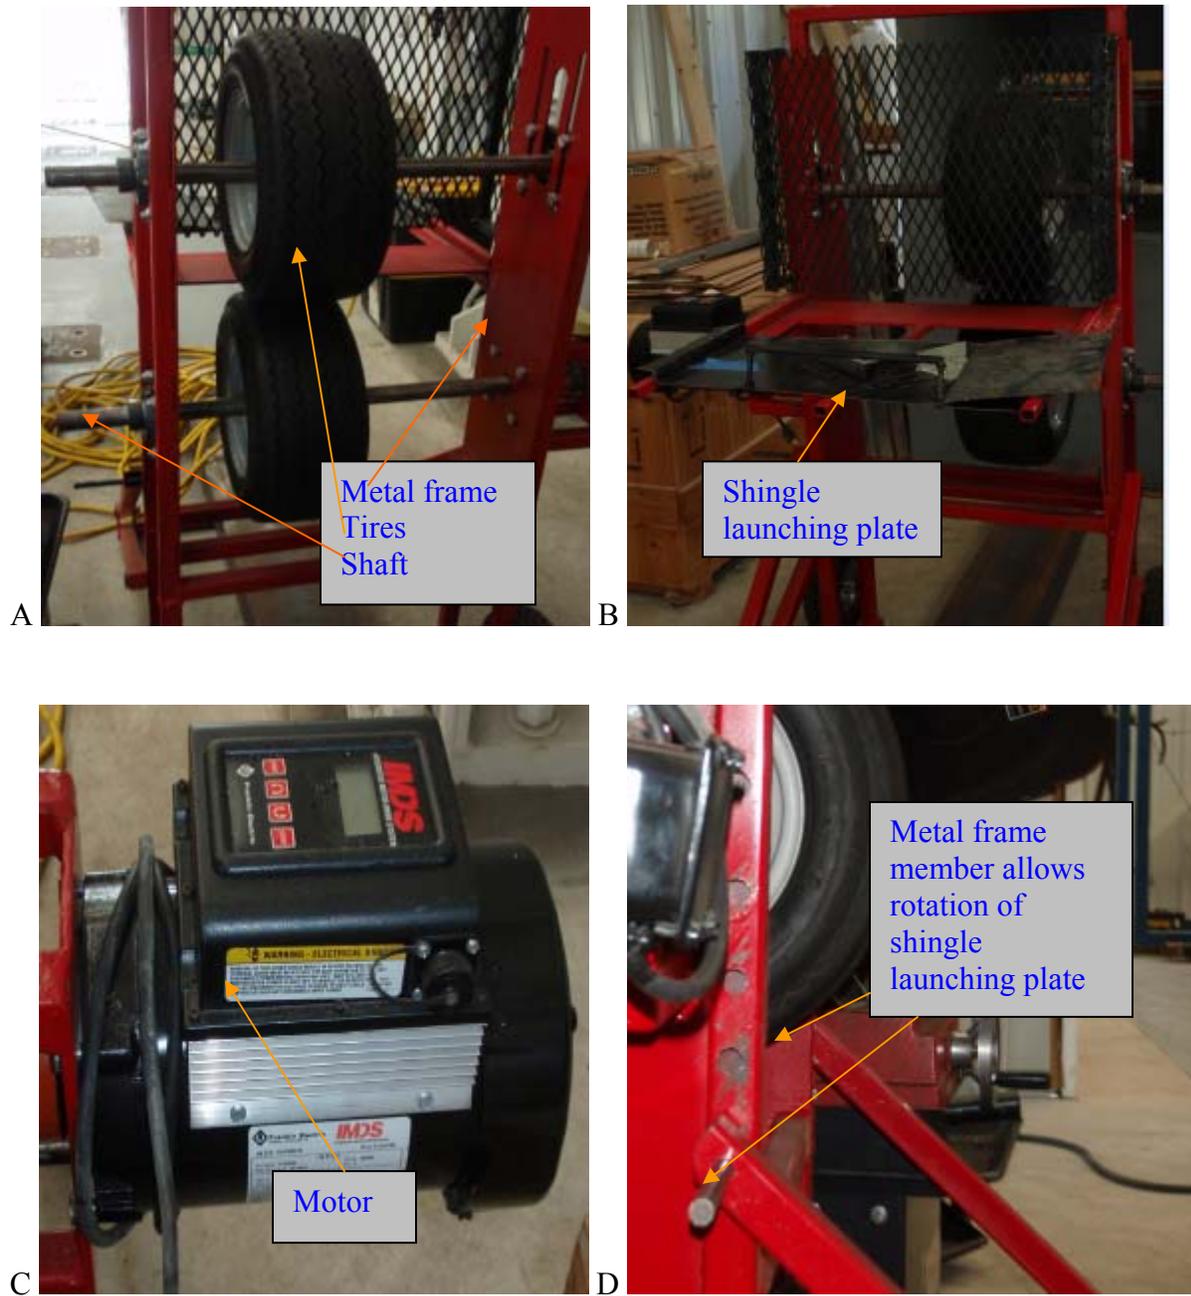
Figure 3-2. Shingle missile launcher. A) Full view of launcher. B), C), D) Different units of launcher.

The shingle launcher was designed to propel asphalt shingle missiles of various sizes at various speeds over a short distance into a glass specimen. The design was inspired by a baseball pitching machine. Two vertically oriented rubber tires of 0.19 m (7.5 in) radius contact each other at the treads, and a 0.75 KW (1 hp) Franklin Electric AC induction motor spins the bottom tire, which causes the top tire to contra-rotate (Figure 3-2). The shingle specimens are slowly fed into the gap on a flat plate (tray) into the grip of the spinning tires. The rotation of the tires accelerates the shingle until it is expelled on the opposite side. A motor controller allows the angular velocity of the tires to be adjusted from 250 to 2400 RPM, which in turn determines the velocity of the projectile. The tray can be adjusted to create at least two flight modes: (1) one axis autorotation (Autorotation mode) and (2) tumbling, the latter of which causes the shingle to strike the target on its flat side. The impact location can be changed by rotating and tilting the shingle launcher as required.

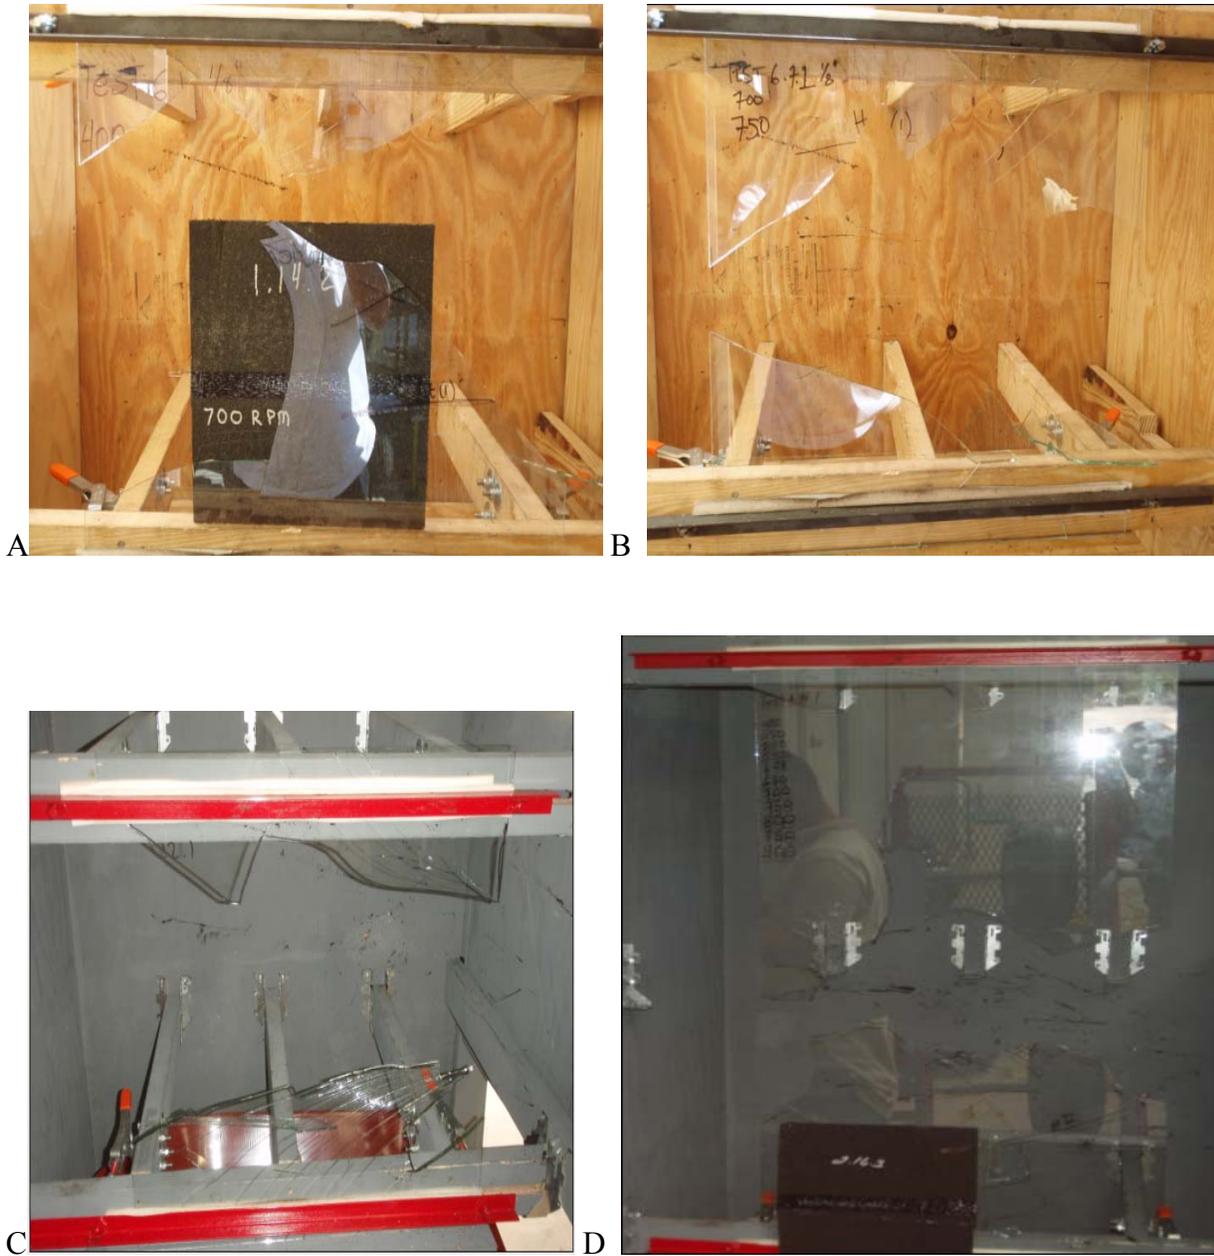
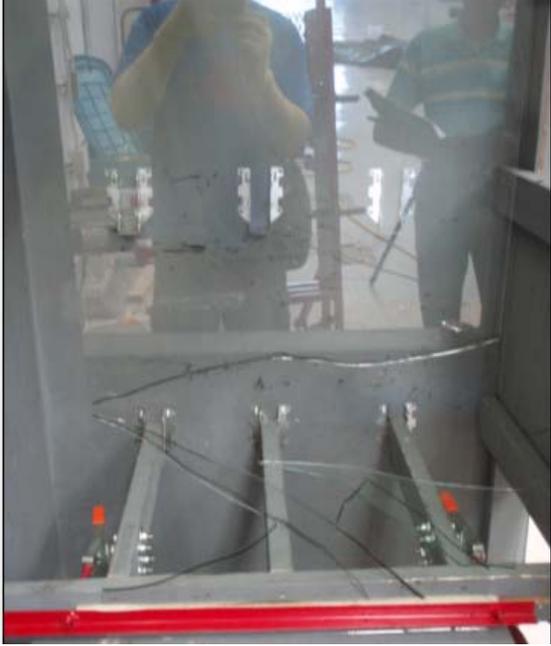
Figure 3-3 Common glass breakage patterns A) 2x2 1/8" annealed glass (700 RPM). B) 2x2 1/8" annealed glass (800 RPM). C) 2x2 1/8" annealed glass (450 RPM). D) 2x4 1/8" annealed glass (900 RPM). E) 2x4 1/8" annealed glass (750 RPM).

Figure 3.3 Continued.

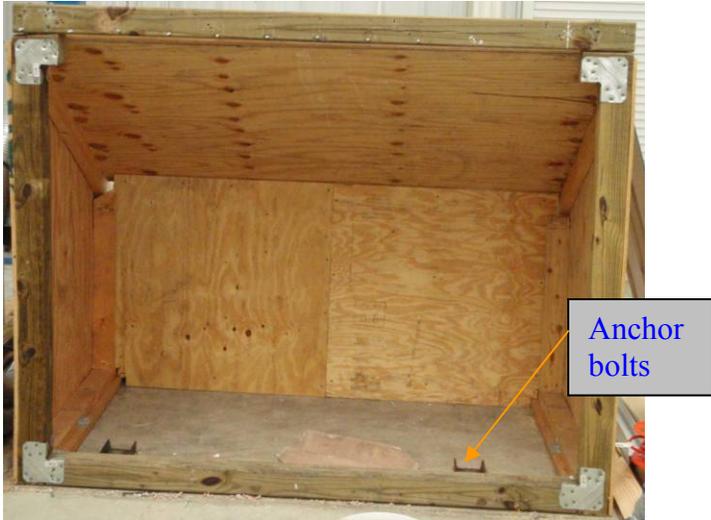
Figure 4-1. Reaction frame.

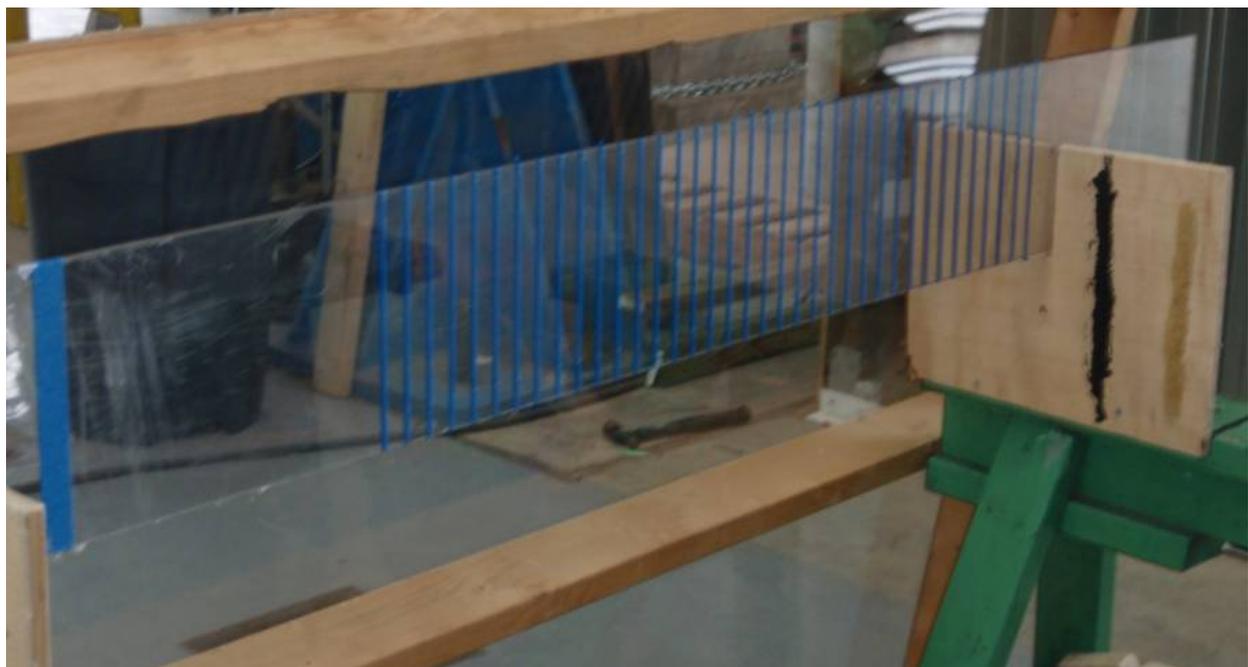
Figure 4-4. Board marked with reference lines spaced at 2.54 cm (1 in)

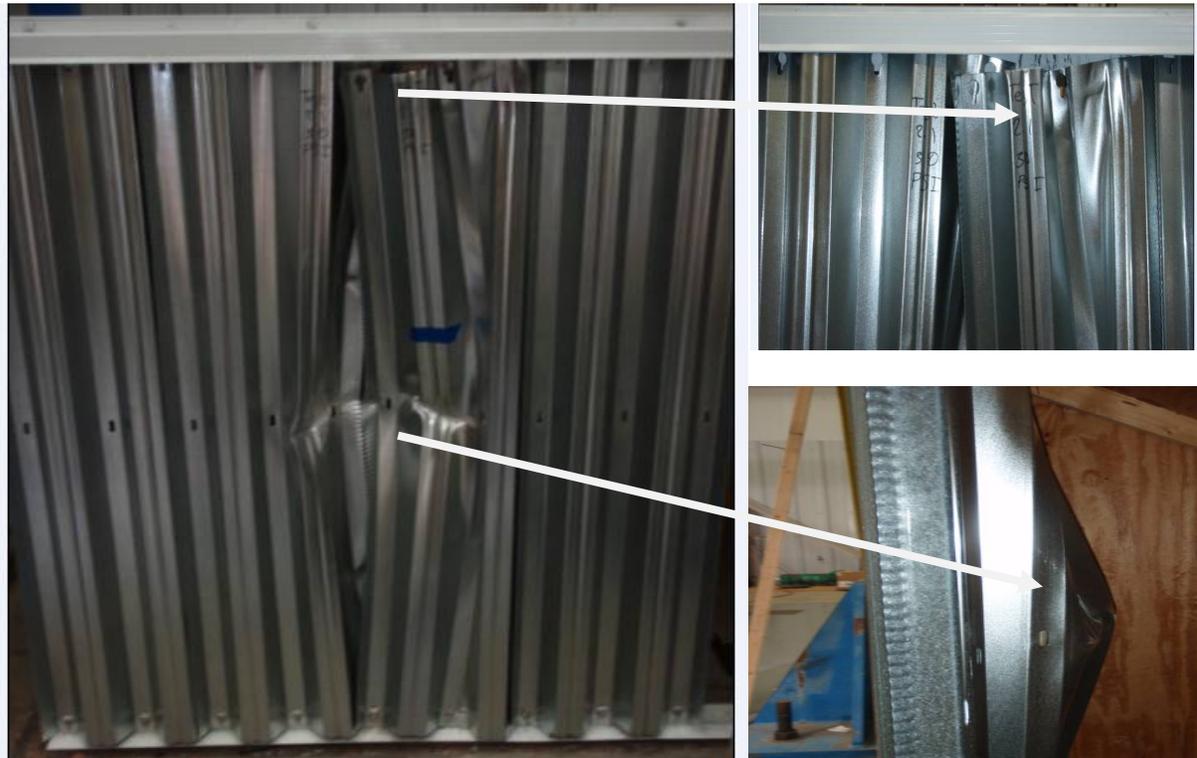
Figure 4-6. Tile missile impact test for H-box assembly, center shot (Test A-1)

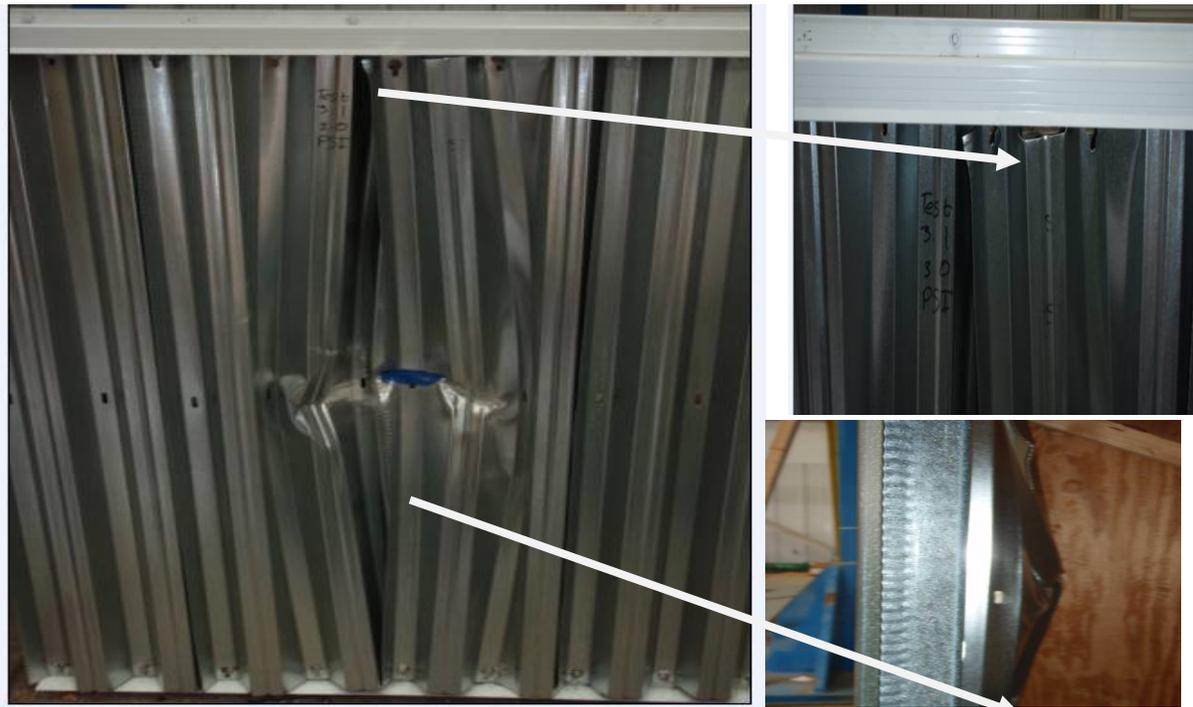
Figure 4-7. Tile missile impact test for H-box assembly, seam shot (Test A-2)

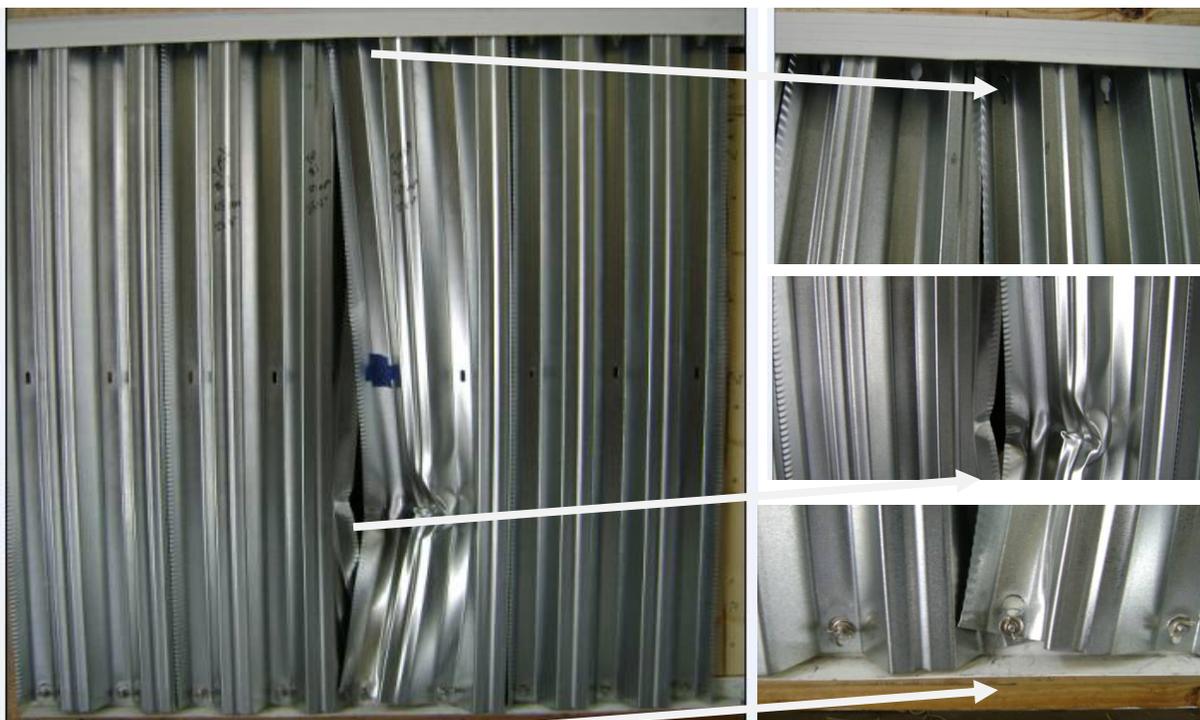
Figure 4-8. 2X4 lumber missile impact test for H-box assembly, seam shot (Test B-1)

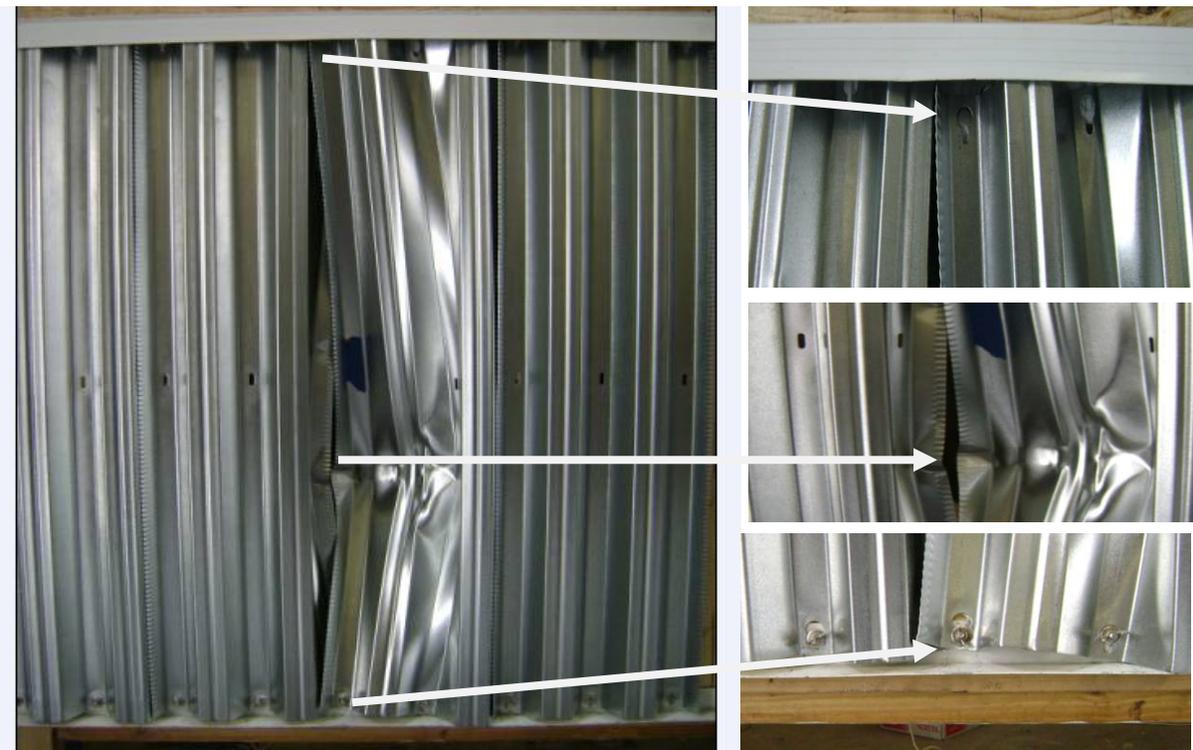
Figure 4-10. 2X4 lumber missile impact test for H-box assembly, seam shot (Test B-3)

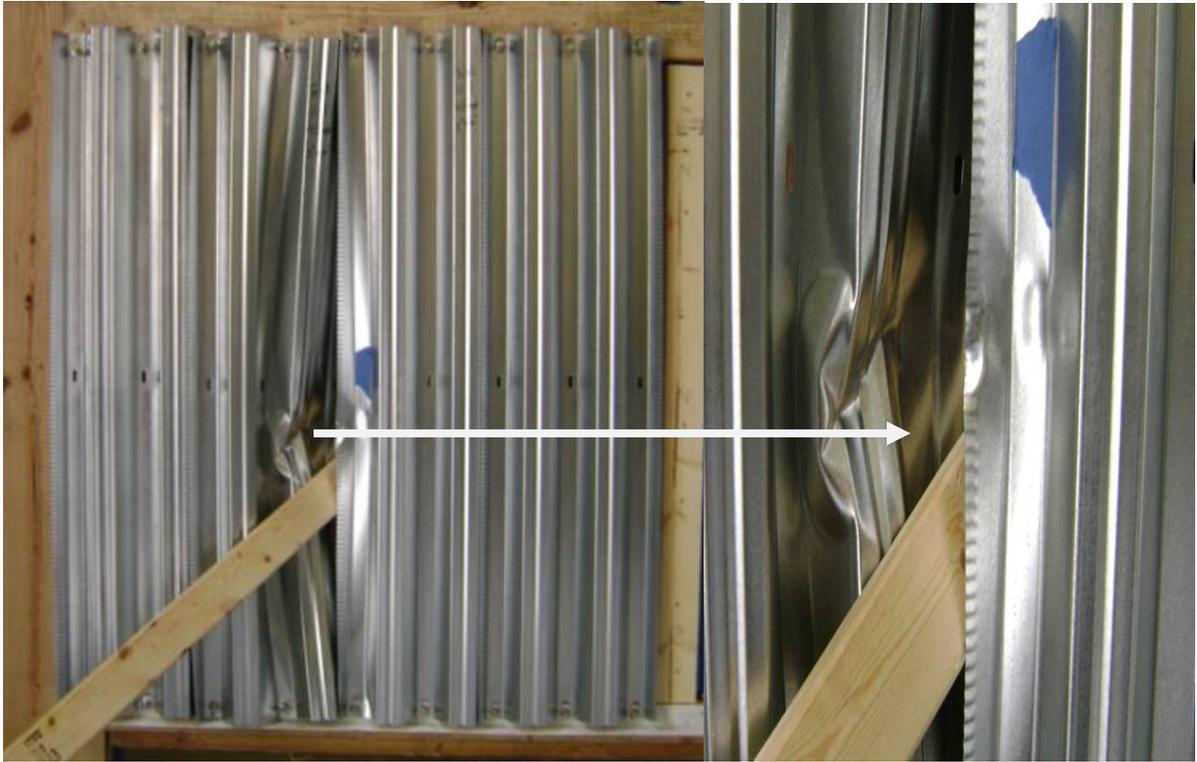
Figure 4-13. 2X4 lumber missile impact test for direct mount assembly, seam shot (Test D-1)

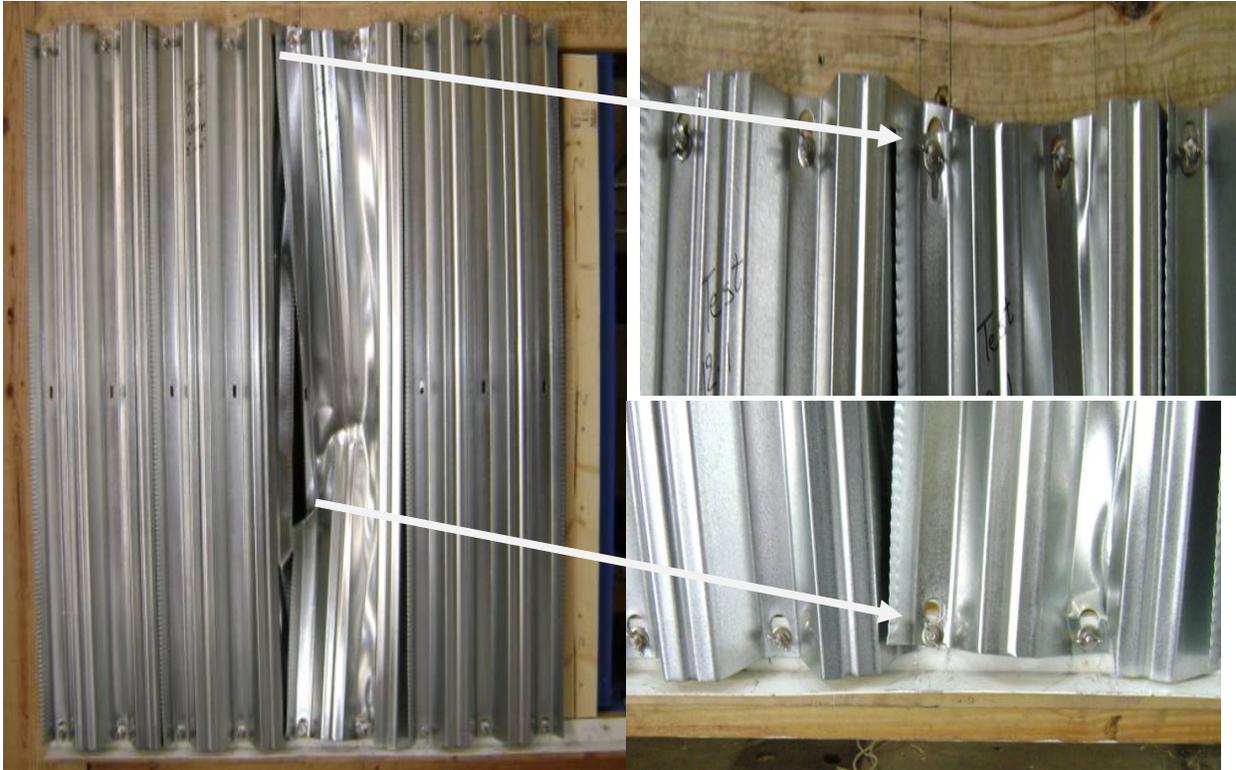
Figure 4-14. 2X4 lumber missile impact test for direct mount assembly, center shot (Test D-2)

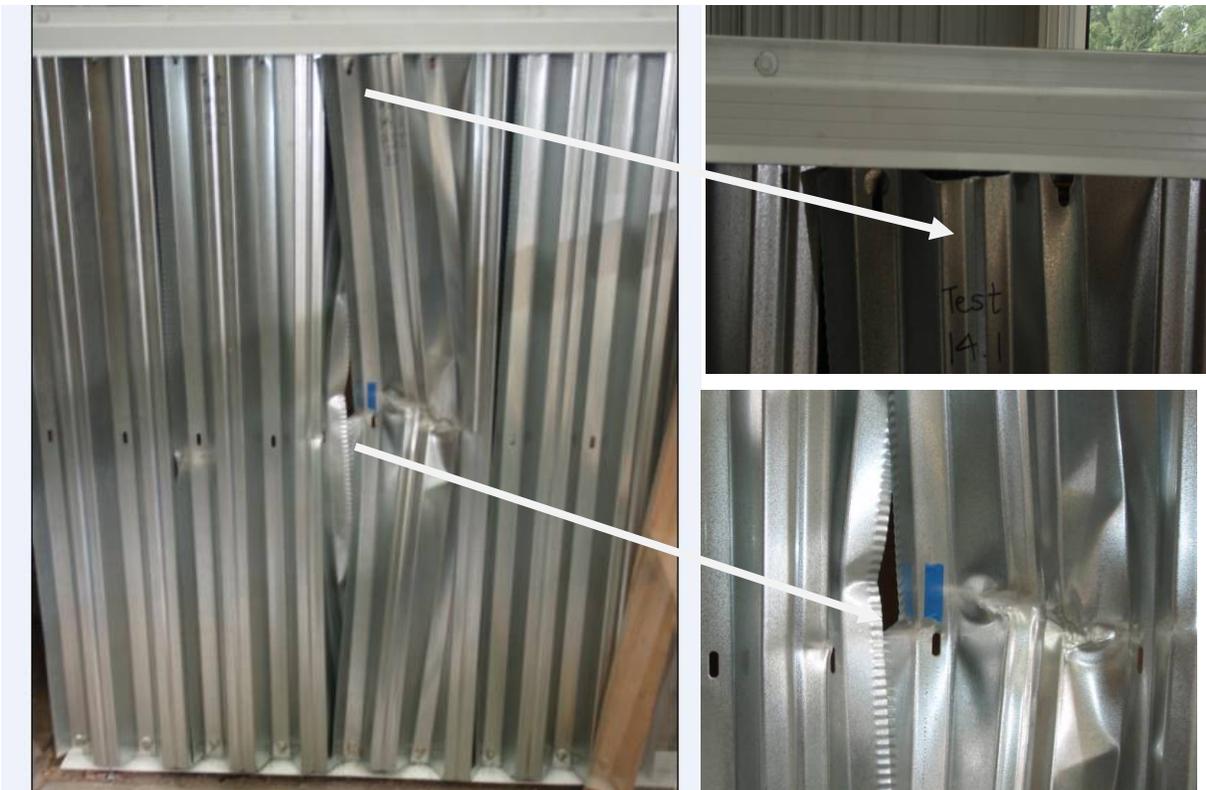
Figure 4-16. Tile missile impact test for H-box assembly, seam shot (Test E-2)

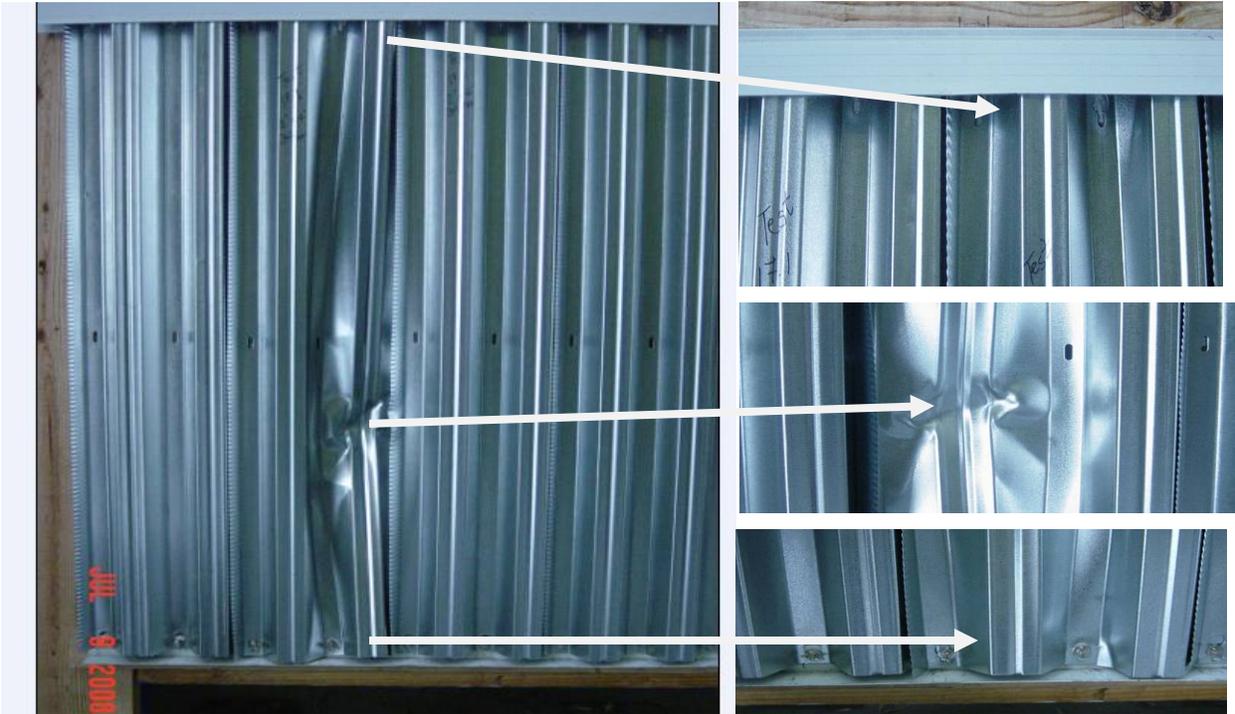
Figure 4-18. 2X4 lumber missile impact test for H-box assembly, seam shot (Test F-2)

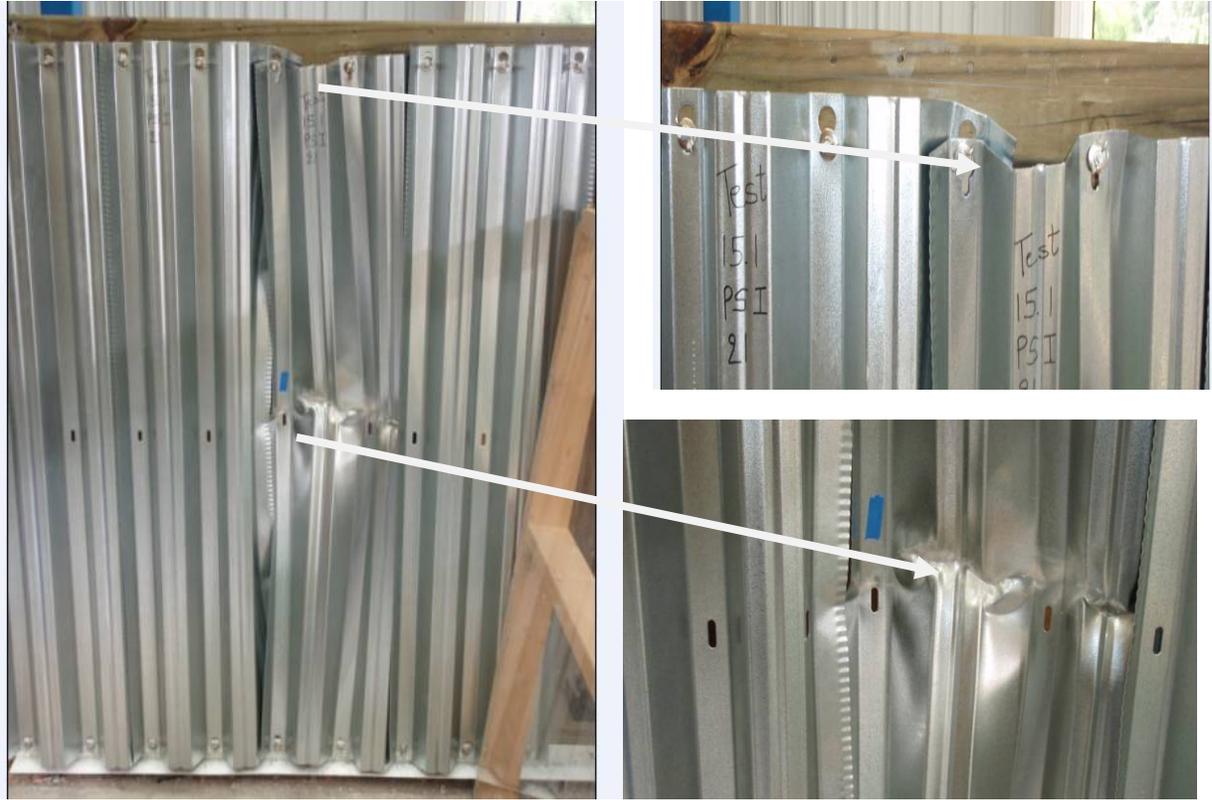
Figure 4-19. Tile missile impact test for direct mount assembly, seam shot (Test G-1)

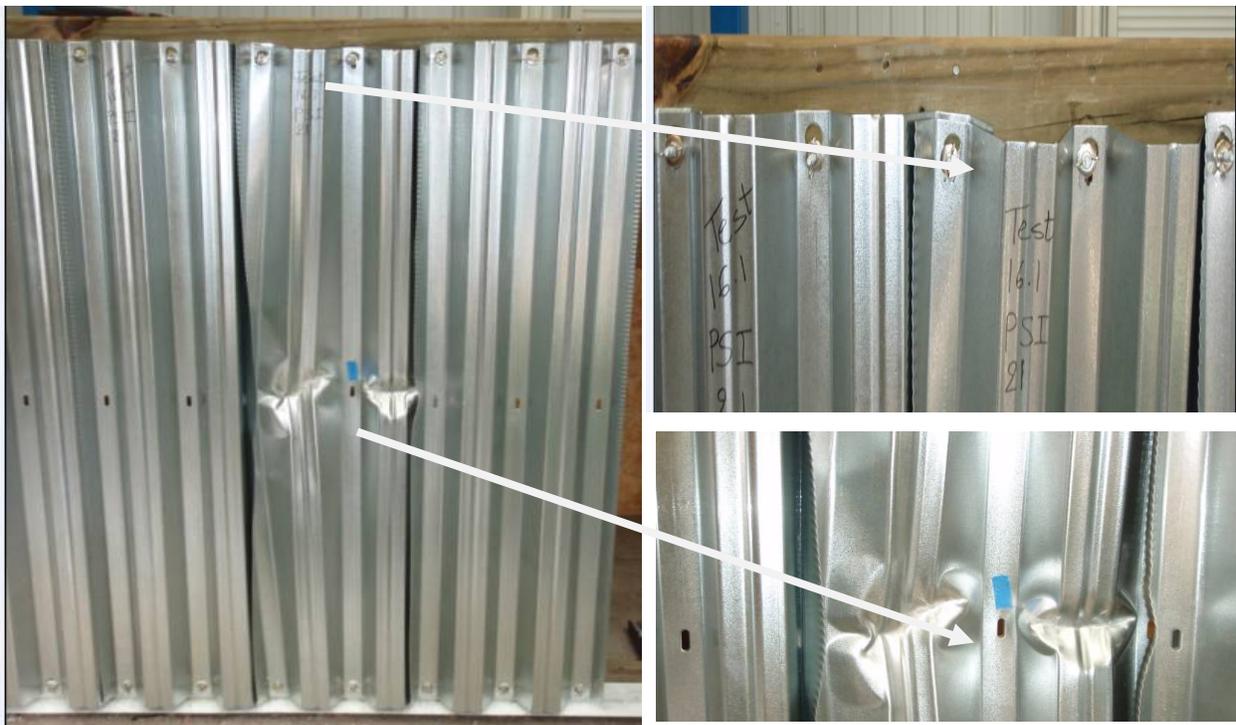
Figure 4-20. Tile missile impact test for direct mount assembly, center shot (Test G-2)

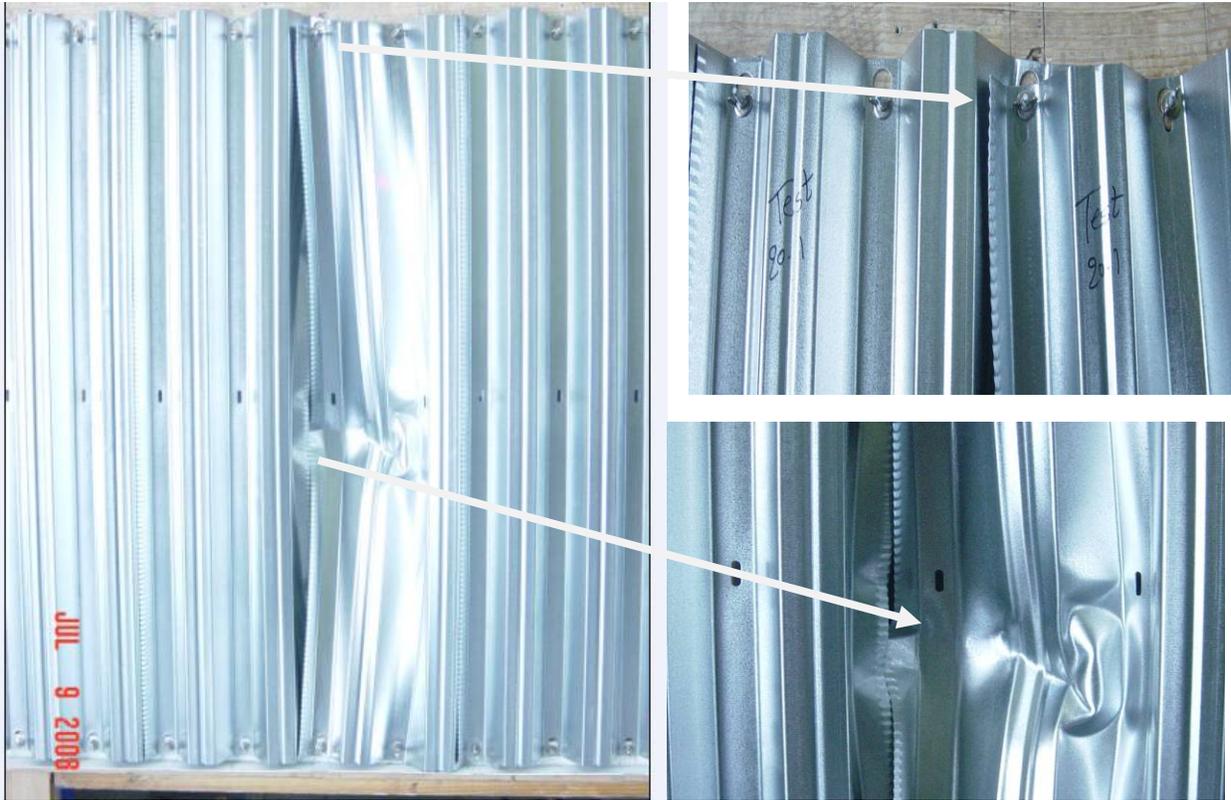
Figure 4-22. 2X4 lumber missile impact test for direct mount assembly, seam shot (Test H-2)

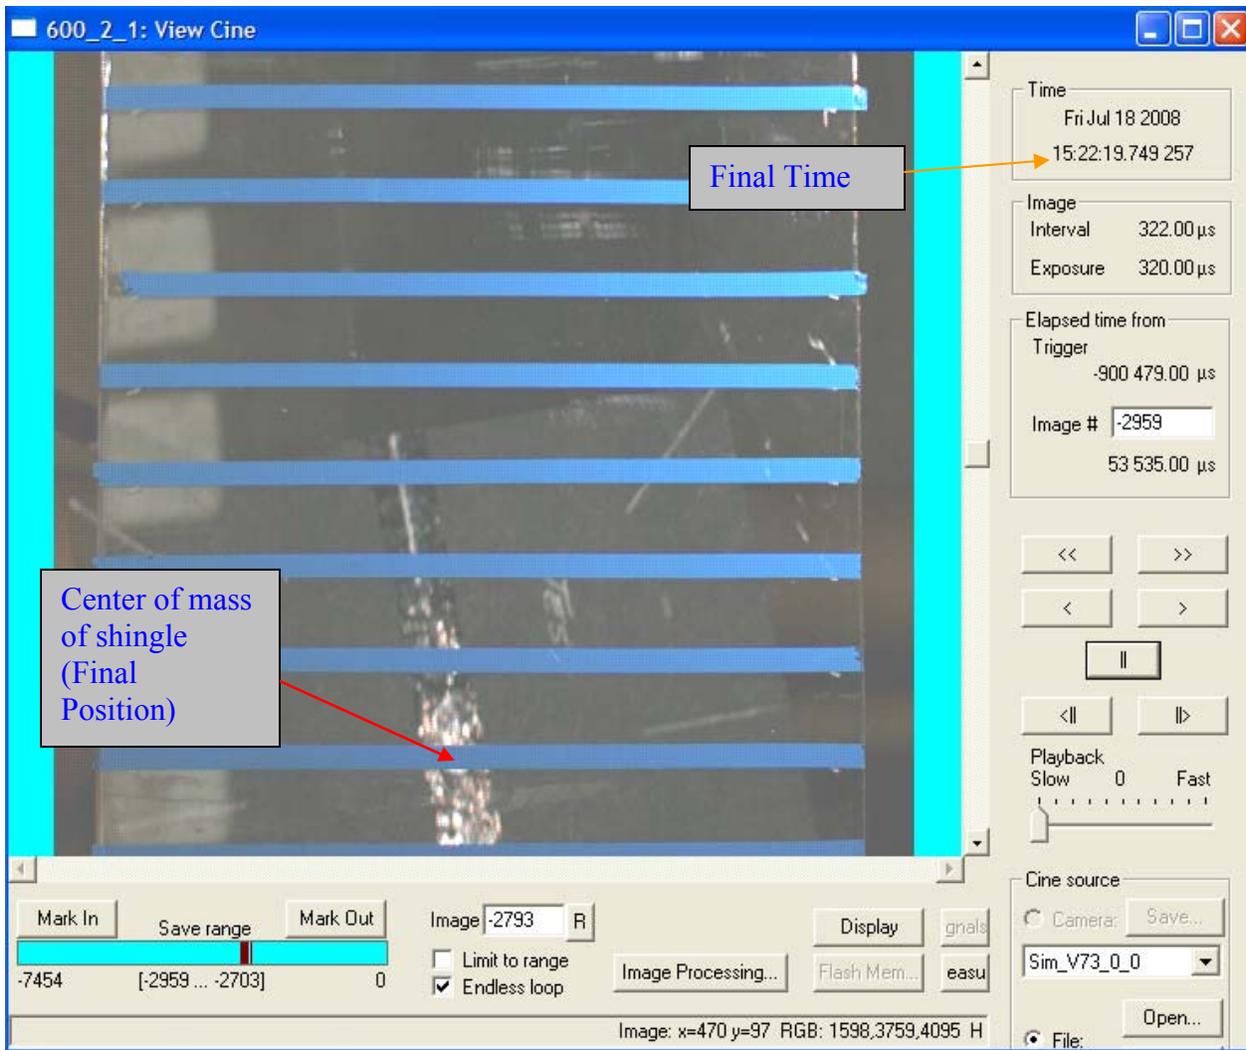
Figure B-2. Calibration of full weight new shingle velocity at 600 RPM. A) Typical view of shingle in high speed camera at position I. B) Typical view of shingle in high speed camera at position II.

Figure B-2 Continued.
