DOCUMENTATION OF RUINS  
AT THE WYLLY PLANTATION  
CLIFTON, NEW PROVIDENCE ISLAND  
BAHAMAS

November 1993

By  
CVE  
Caribbean Volunteer Expeditions  
Box 388, Corning, New York 14830

For  
Bahamas Department of Architves  
Ministry of Education

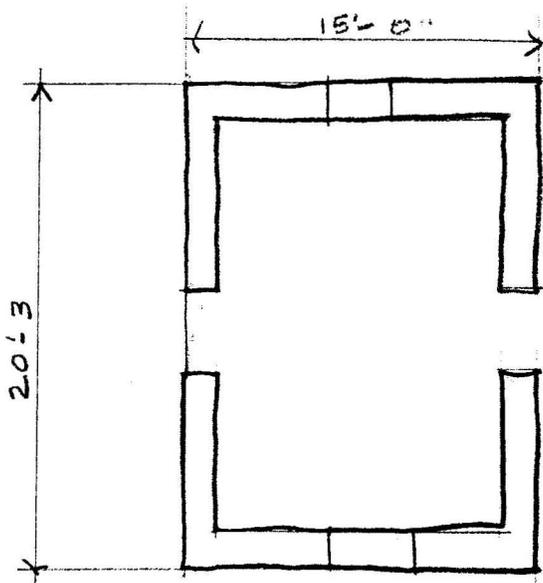
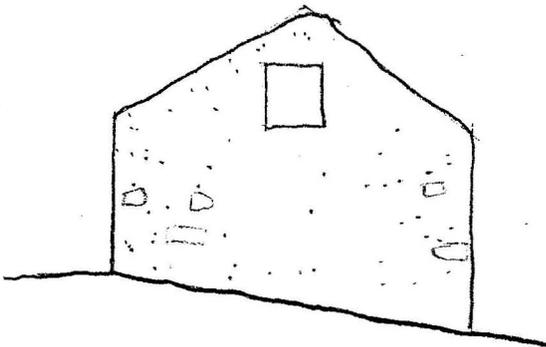
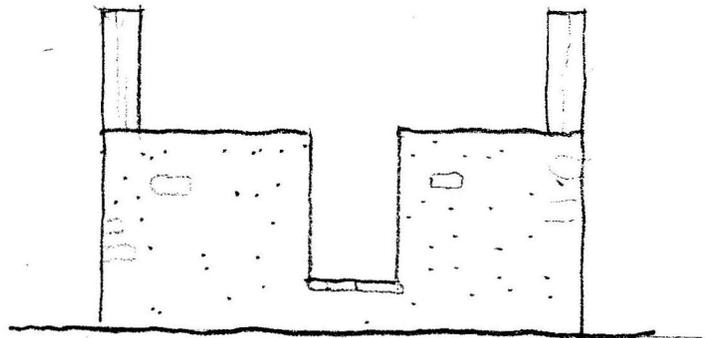
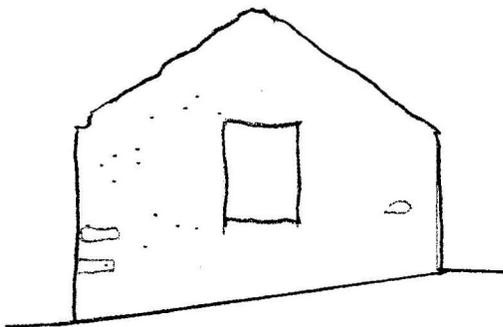
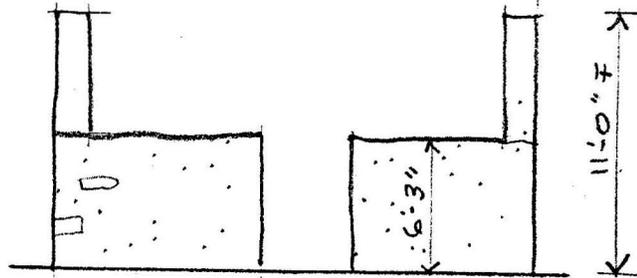
BUILDING # 1 SLAVE HOUSING	Scale: 1/8" = 1'-0"	Date: 11/1993
WYLLY PLANTATION CLIFTON, NEW PROVIDENCE ISLAND BAHAMAS		
Measured and Drawn by: Caribbean Volunteer Expeditions Box 388, Corning, New York 14830 USA

**Building #1.** This building measures 15 feet x 20 feet with 18 inch wide plastered stone walls. This building is in fairly good condition, with all four walls intact. A high window exists in the north gable end, as well as a window opening in the south end.

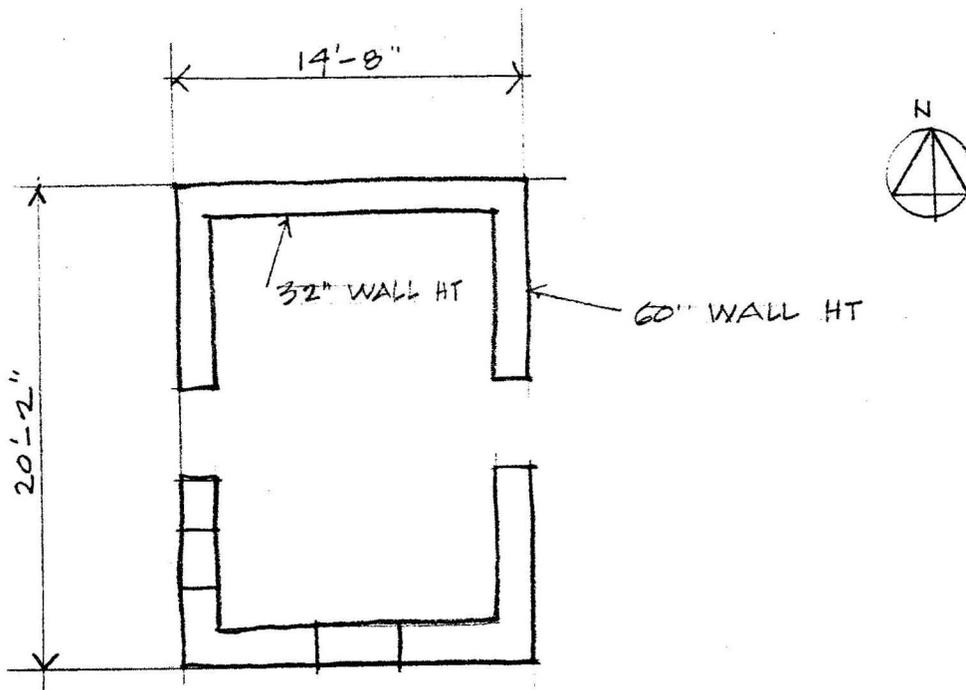
PLAN: BUILDING # 3

**Building #3.** Again we find a 15 feet x 20 feet rectangular building, with plastered stone walls 18 inches thick. The northern wall had been heavily damaged and was only 32 inches high; no gable remains on the south wall.

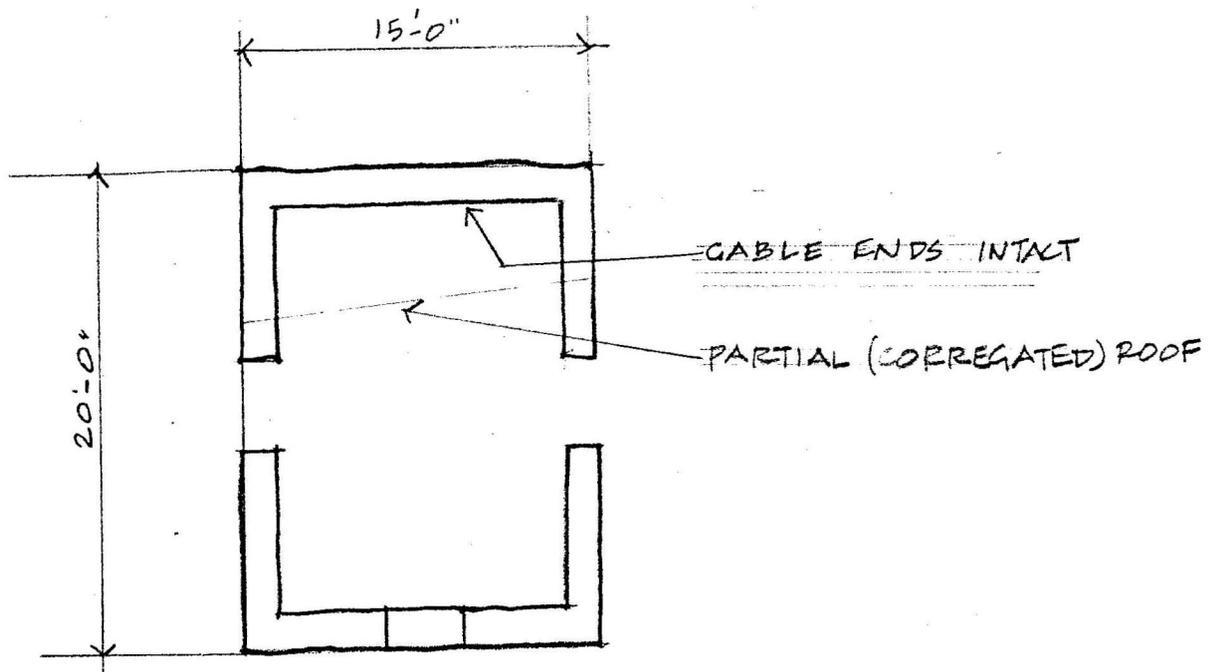
PLAN: BUILDING # 4

**Building #4.** This building, again, 15 feet x 20 feet, is in the best condition of all these ruins. Rafters and corrugated siding (modern) exists on part of the roof. The building has the usual east and west doorways and a south facing window. The gable ends are intact. The building was heavily overgrown and measurements were too difficult to undertake with out substantial clearing,

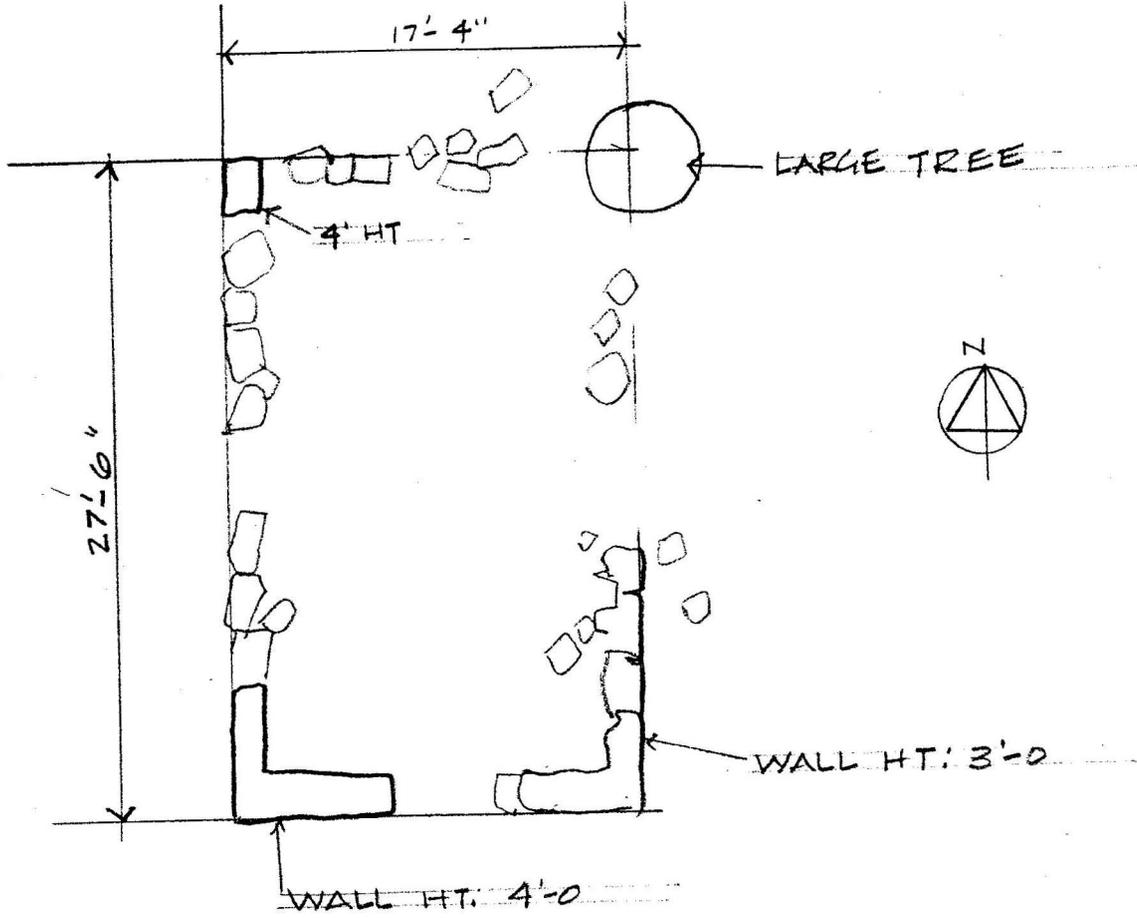
PLAN: BUILDING # 5

**Building #5.** This building is in poor condition with only a few four feet high wall fragments from the southwest and northwest corners remaining. Foundation edges remain and the building appeared to be larger than the first four dwellings - about 27 feet 6 inches x 17 feet 4 inches outside dimensions.

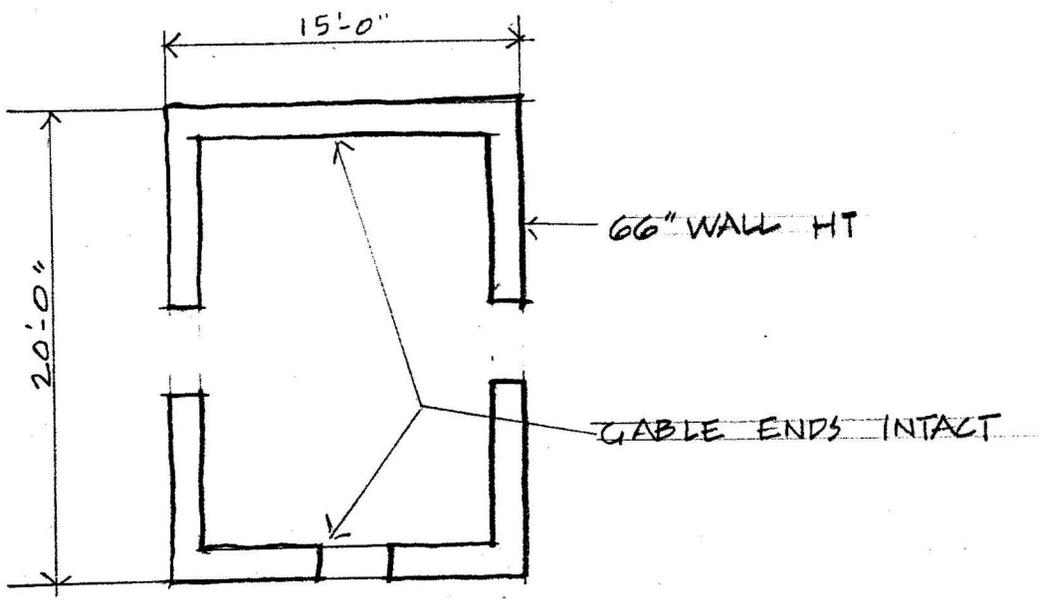
PLAN: BUILDING #6

**Building #6.** This 15 feet x 20 feet building is also in fairly good condition with its east and west wall gable ends 5 feet 6 inches high. The building was heavily overgrown as was #4, 5, 7, and 8, and measurements and photographs were difficult.

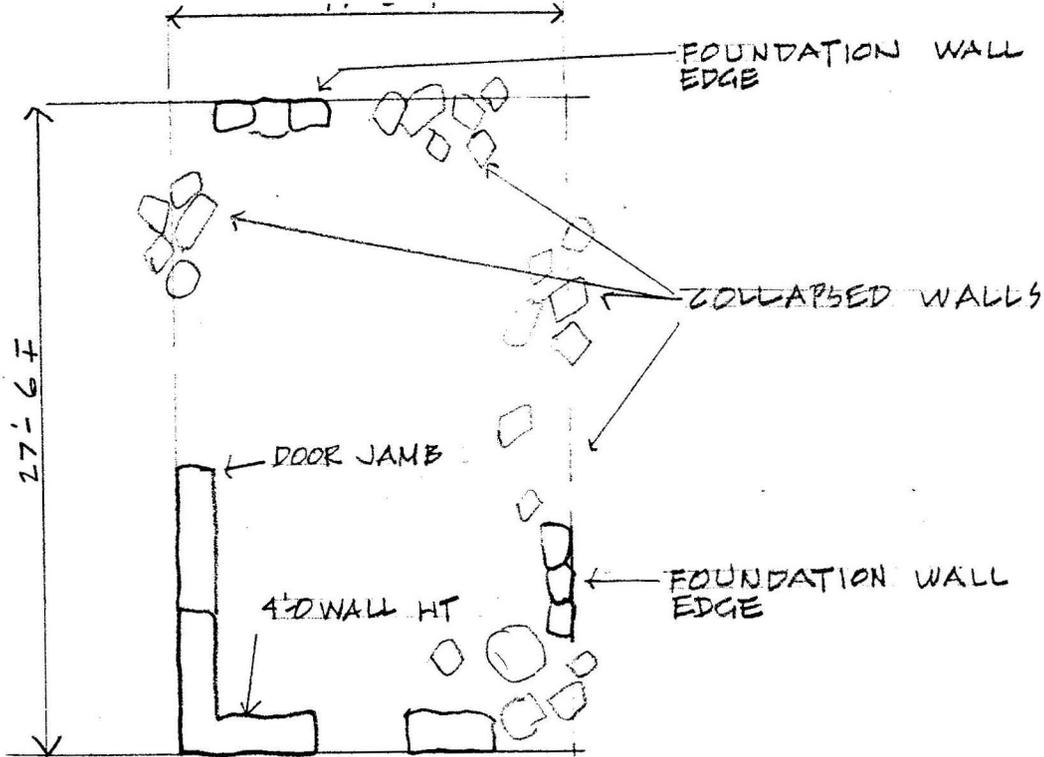
PLAN: BUILDING # 7

**Building #7.** This building is in poor condition with only 4 foot high fragments existing on the south and west walls. The building appears to have been 27 feet 6 inches long and 17 feet wide -larger than some of the other buildings.

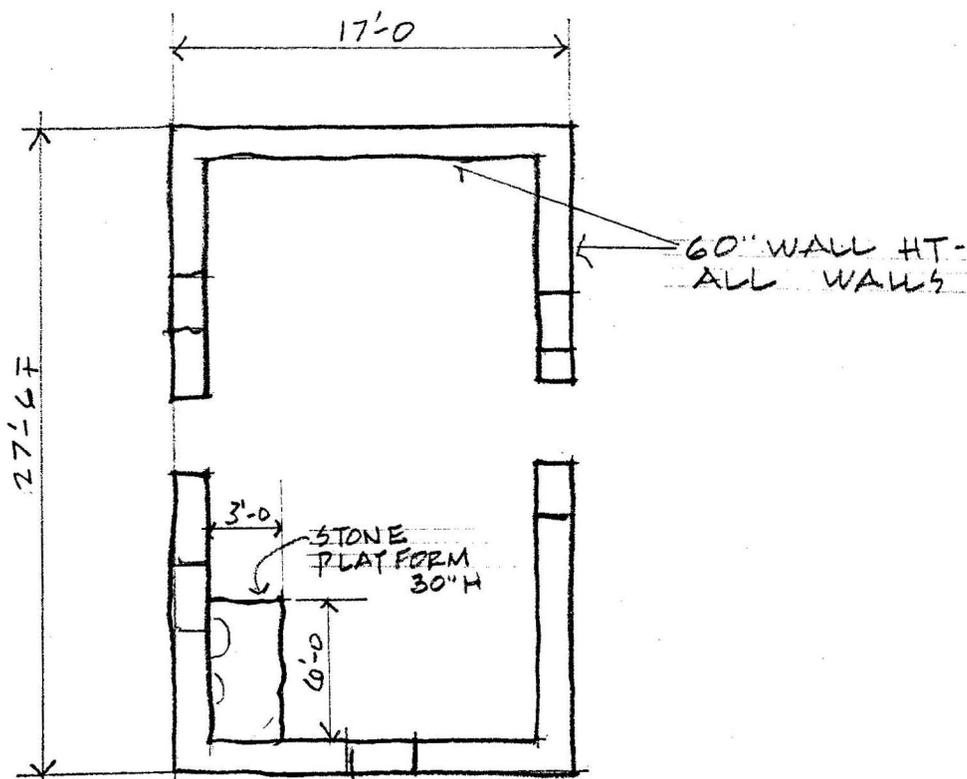
PLAN: BUILDING # 8

**Building #8.** This building is 24 feet directly west of Building #7. It is in quite good condition with 5 foot high walls on four sides. The tops of the north and south walls are flat, which indicates that there were no masonry gable ends.

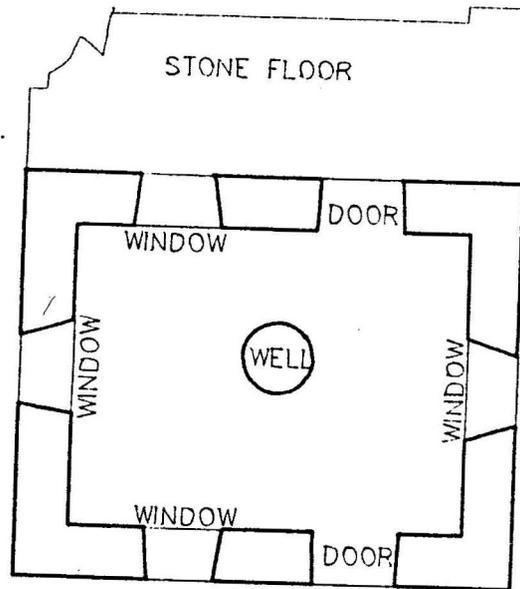
BUILDING # 10 OUT BUILDING

**Building # 10 - Building.** This building as located north and a little to the east off the Main House. The plan is 16'-9" by 20' - 10" in dimension. The walls are comparatively in good condition and there is no indication of a gable end. There is in indentation (well?) in the interior on the floor, which is cut stone. On the north side is a stone floor on grade, which may

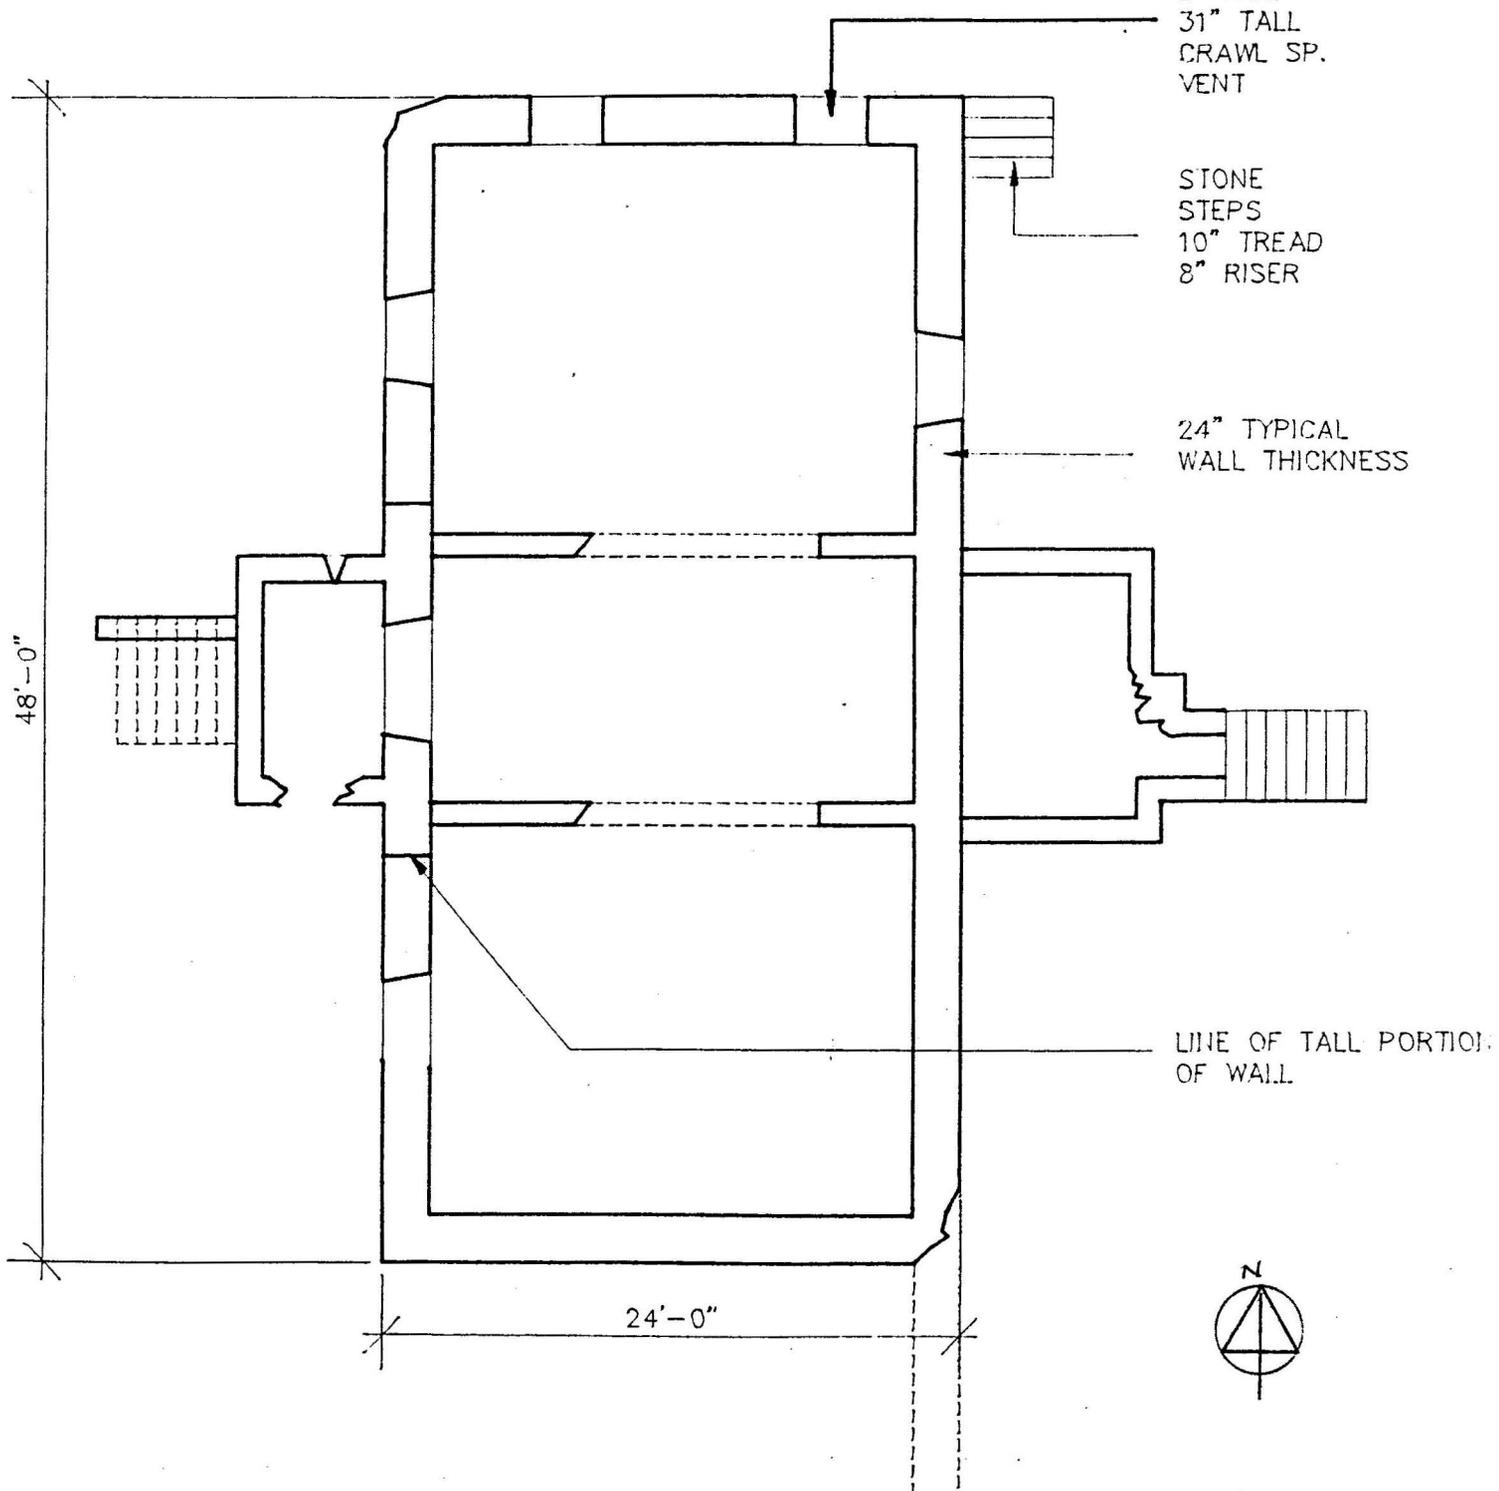
BUILDING # 12 PLANTATION HOUSE	Scale: 1/8" = 1'-0"	Date: 11/1993
WYLLY PLANTATION CLIFTON, NEW PROVIDENCE ISLAND BAHAMAS		
Measured and Drawn by:	Caribbean Volunteer Expeditions Box 388, Corning, New York 14830 USA

**Building # 12 Plantation House.** This building is 48 feet long by 24 feet wide, with 2' - 11" thick interior walls dividing the space into three sections. The west elevation has a 10' - 3" wide porch with a 5' - 3" wide stair centered on the 48 foot elevation. A 5' - 2" wide door opening is also centered at the top of the porch. On either side of the door are walls rising approximately 10' - 8" from the sill. The east elevation is further deteriorated and has a porch with a 45" wide stone staircase which is off center. There is another 45" wide stair which leads to the out-buildings. To the south of the building is a good deal of rubble which appeared to have been walls that started at the building's corner. The building is mainly constructed of cut stone approximately 5" tall and 20" long with a plaster finish. A cut keystone was found that made up the lintel above the crawl space vent opening.
