**HISTORIC BUILDINGS
HAMPSTEAD ESTATE
DOMINICA**

AUGUST 2000

By Caribbean Volunteer Expeditions
Box 388, Corning NY 14830

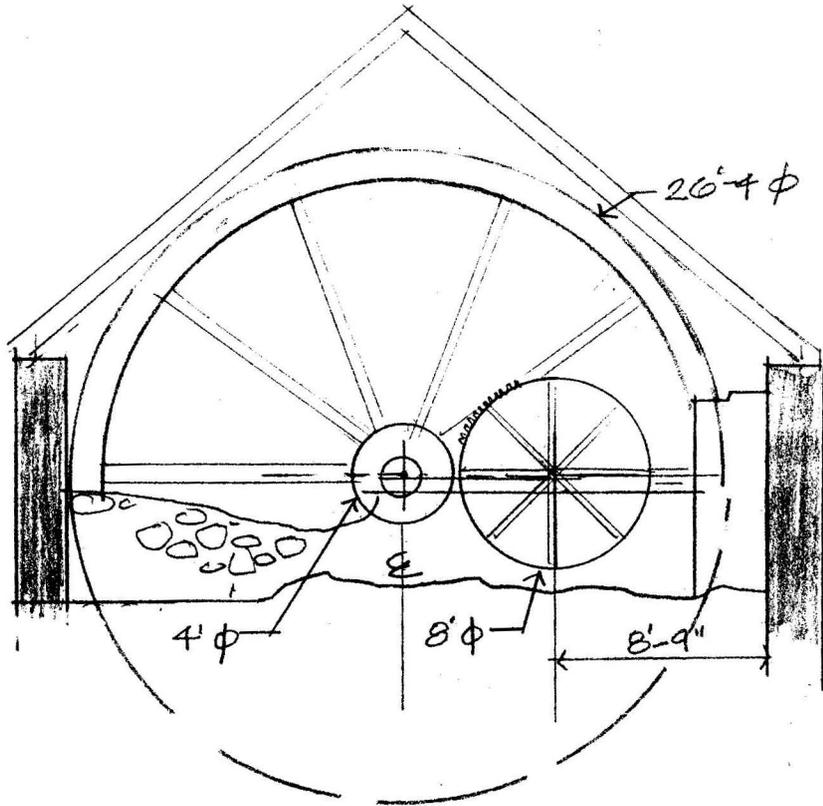
Building A
Hampstead Water Wheel
Dominica Aug. 2000

This building and the water wheel are the most important historic features on the site, and stabilization and restoration of these should be the first priority. The walls are in relatively good condition, with some cracks, but need stabilization-pointing, and the replacement of missing stones. There are trees and plants growing

from the walls, and the roots are damaging the walls. These should be removed carefully. The deteriorated roof needs to be removed; a new roof structure should be installed, using the same timber structure and galvanized roofing. This roof will help stabilize the walls, and preserve the machinery inside. The machinery should all be cleaned up; making the water wheel operational would be a major undertaking, and may not be necessary.

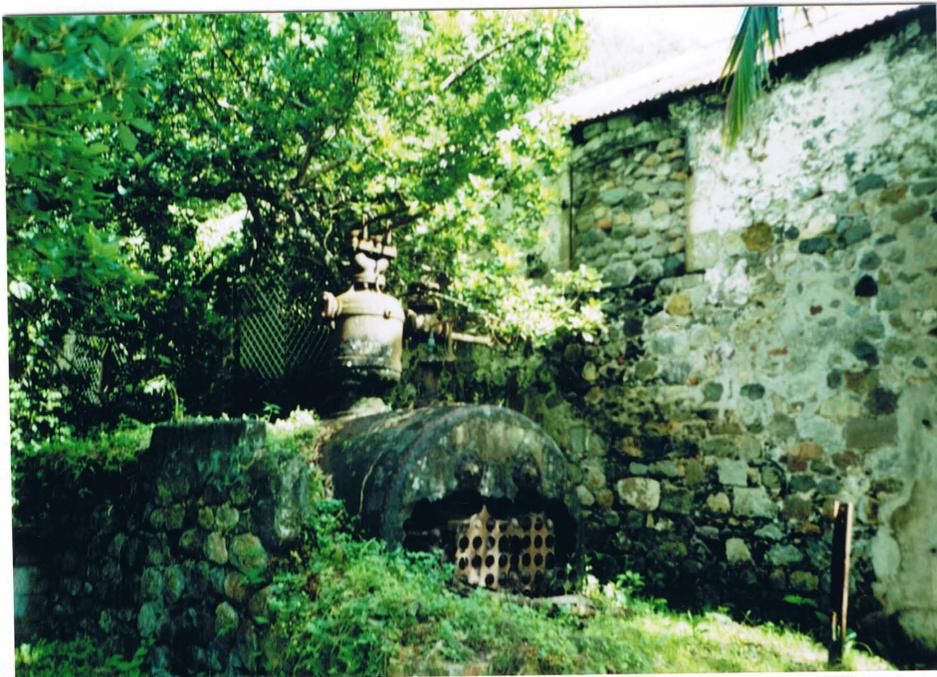
F- Still

- **Description**
To the east of the storage building is a boiler with small still on top.
- **Condition and Recommendations**
These pieces of machinery should be cleaned up, and stabilized. The recent concrete block and concrete counter should be removed.
