**ANDREW VERSUS HUGO – DAMAGES TO
RESIDENTIAL COMMUNITIES**

UFL/COEL-93/001

Andrew Versus Hugo - Damages to Residential Communities

Coastal and Oceanographic Engineering Department

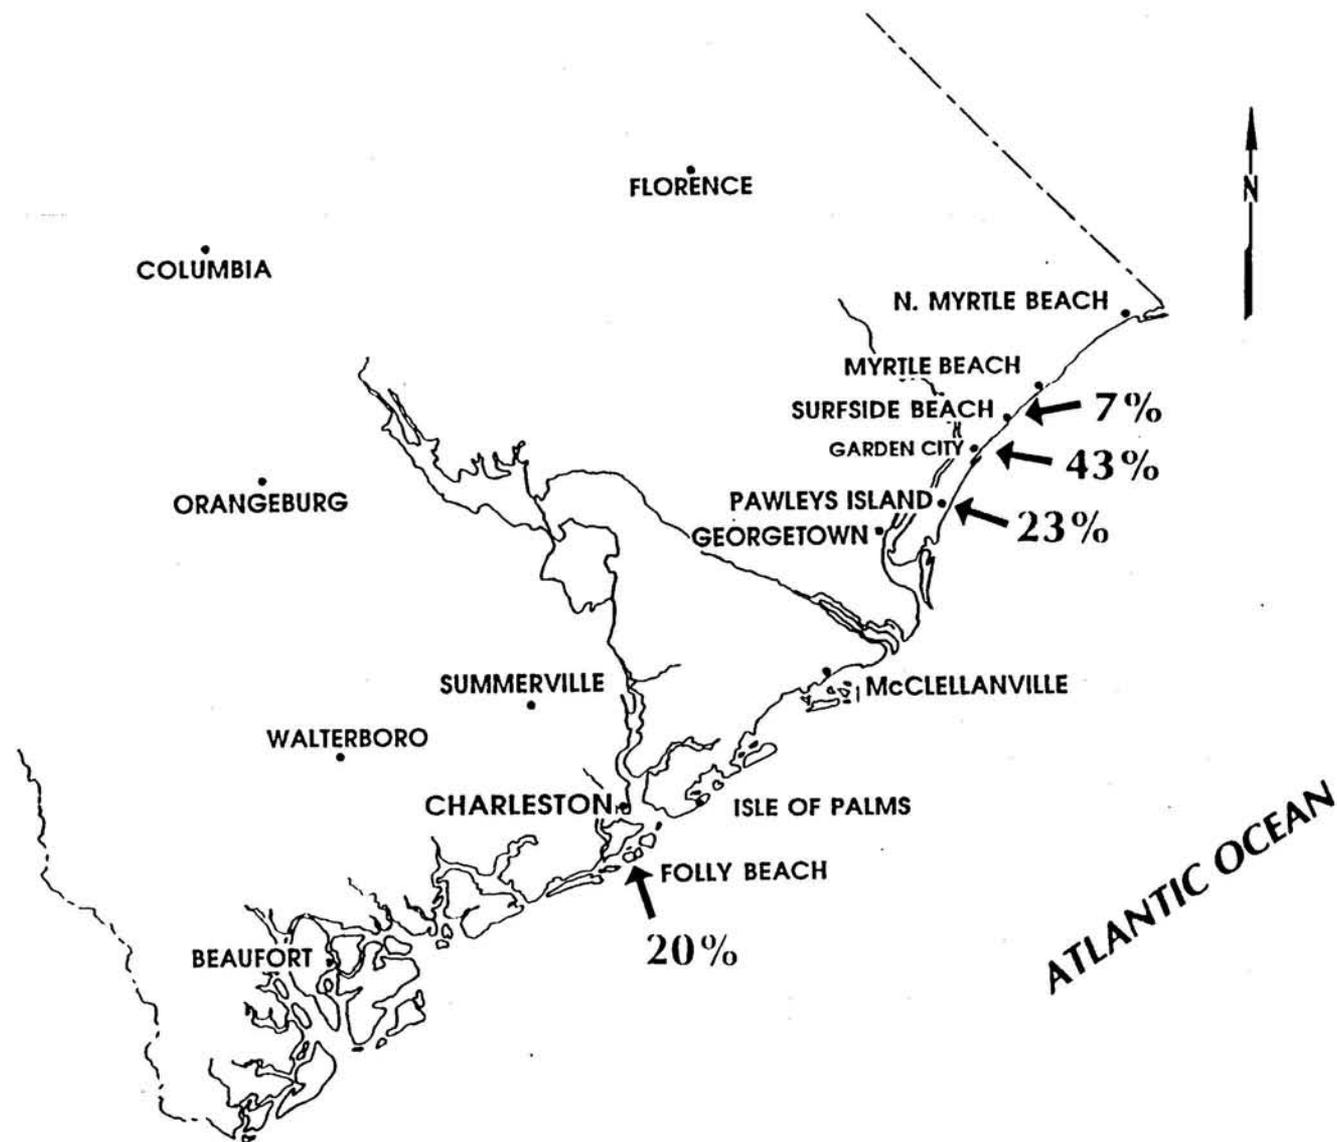
A total of 14,014 structural units were officially listed as destroyed by Hurricane Hugo at an estimated cost of \$700 million. A destroyed structure is defined as one in which the structural damage is greater than 66.67%. Structures sustained lesser degrees of damage clearly far exceeded this number. Most of the damage occurred along a 100-mile or so coastal belt from Folly Beach (south end) to Myrtle Beach (north end). Damage tapered off rapidly beyond this limit although could still be found 30 miles into North Carolina coast. Figure 2 lists the percentage of destroyed structures along this coastal belt. While undoubtedly the combined wind and water forces caused the destruction the latter was the dominant factor. That is, if the wind

Fig. 2. Percentage of destroyed structures along South Carolina coastal region by Hugo (source of information, South Carolina Coastal Council).

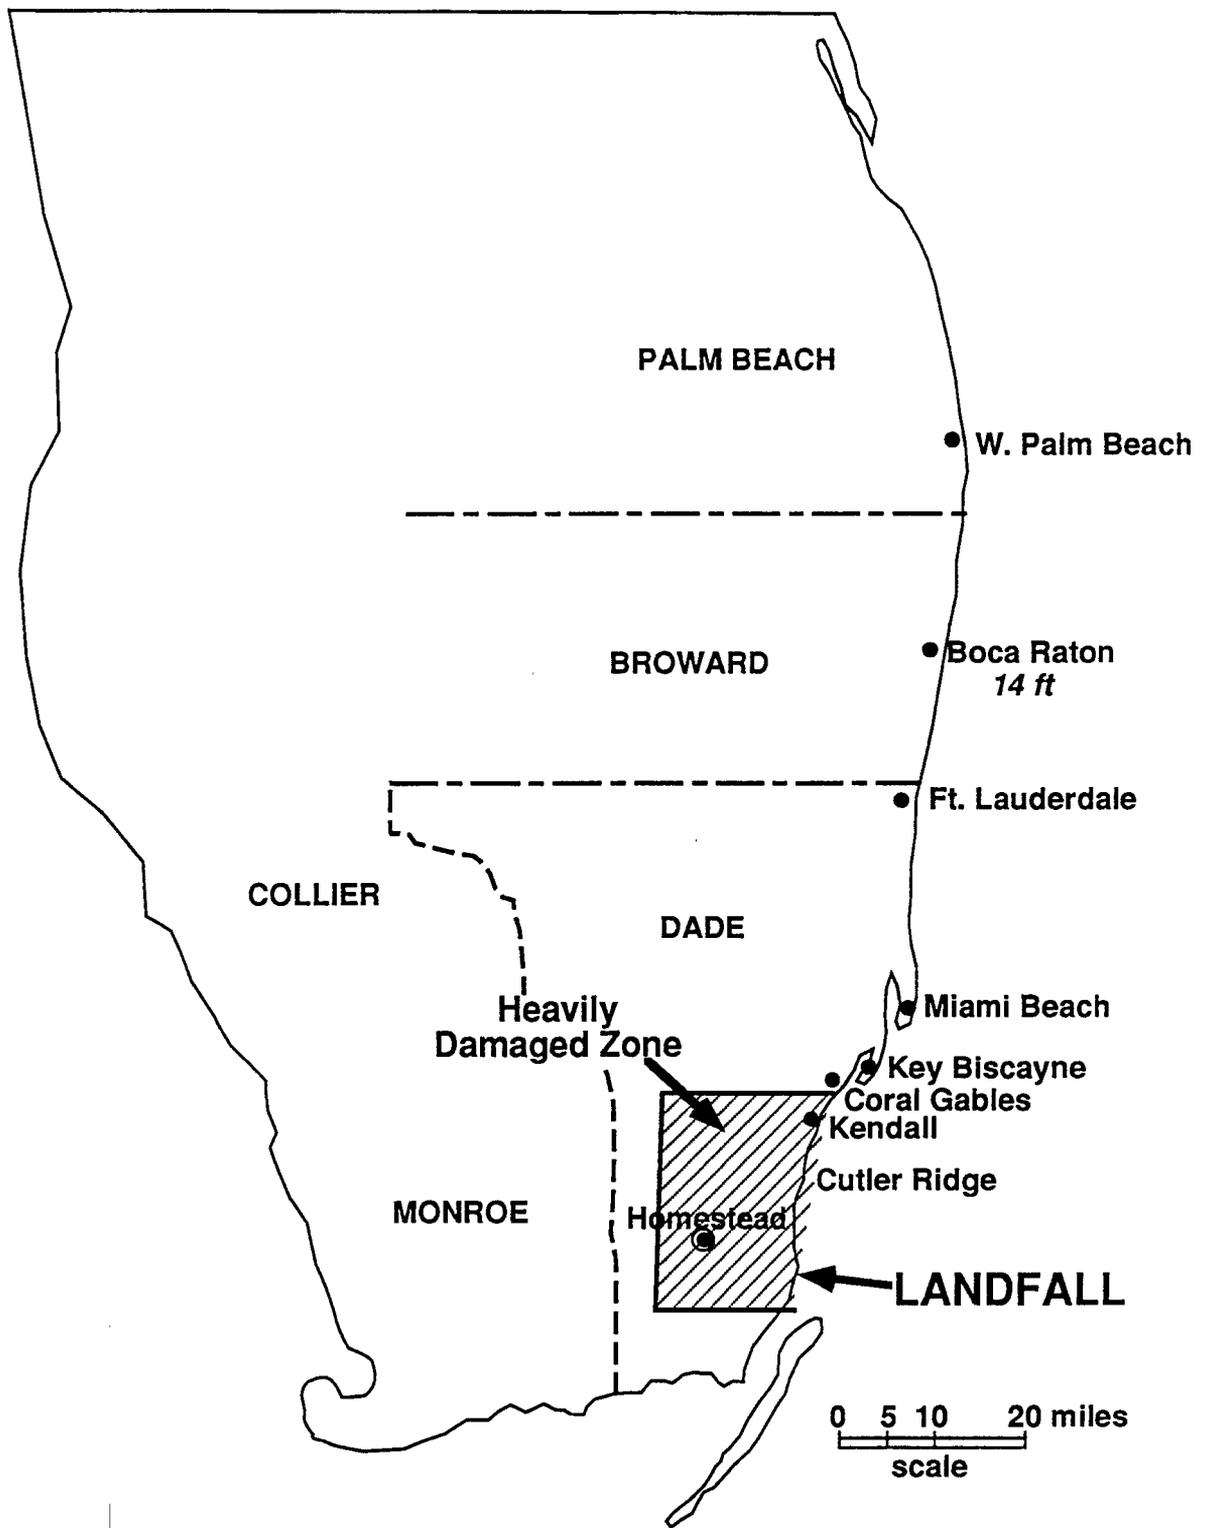
Unlike Hugo where structural damage occurred almost perpendicular to the hurricane path along a long coast belt, Andrew's damage zone was concentrated in a 22x22 mile square region mainly on the north side of the hurricane track from the landfall location. Figure 4

Fig. 3. Zone sustained heavy damage of residential-type structures by Andrew.

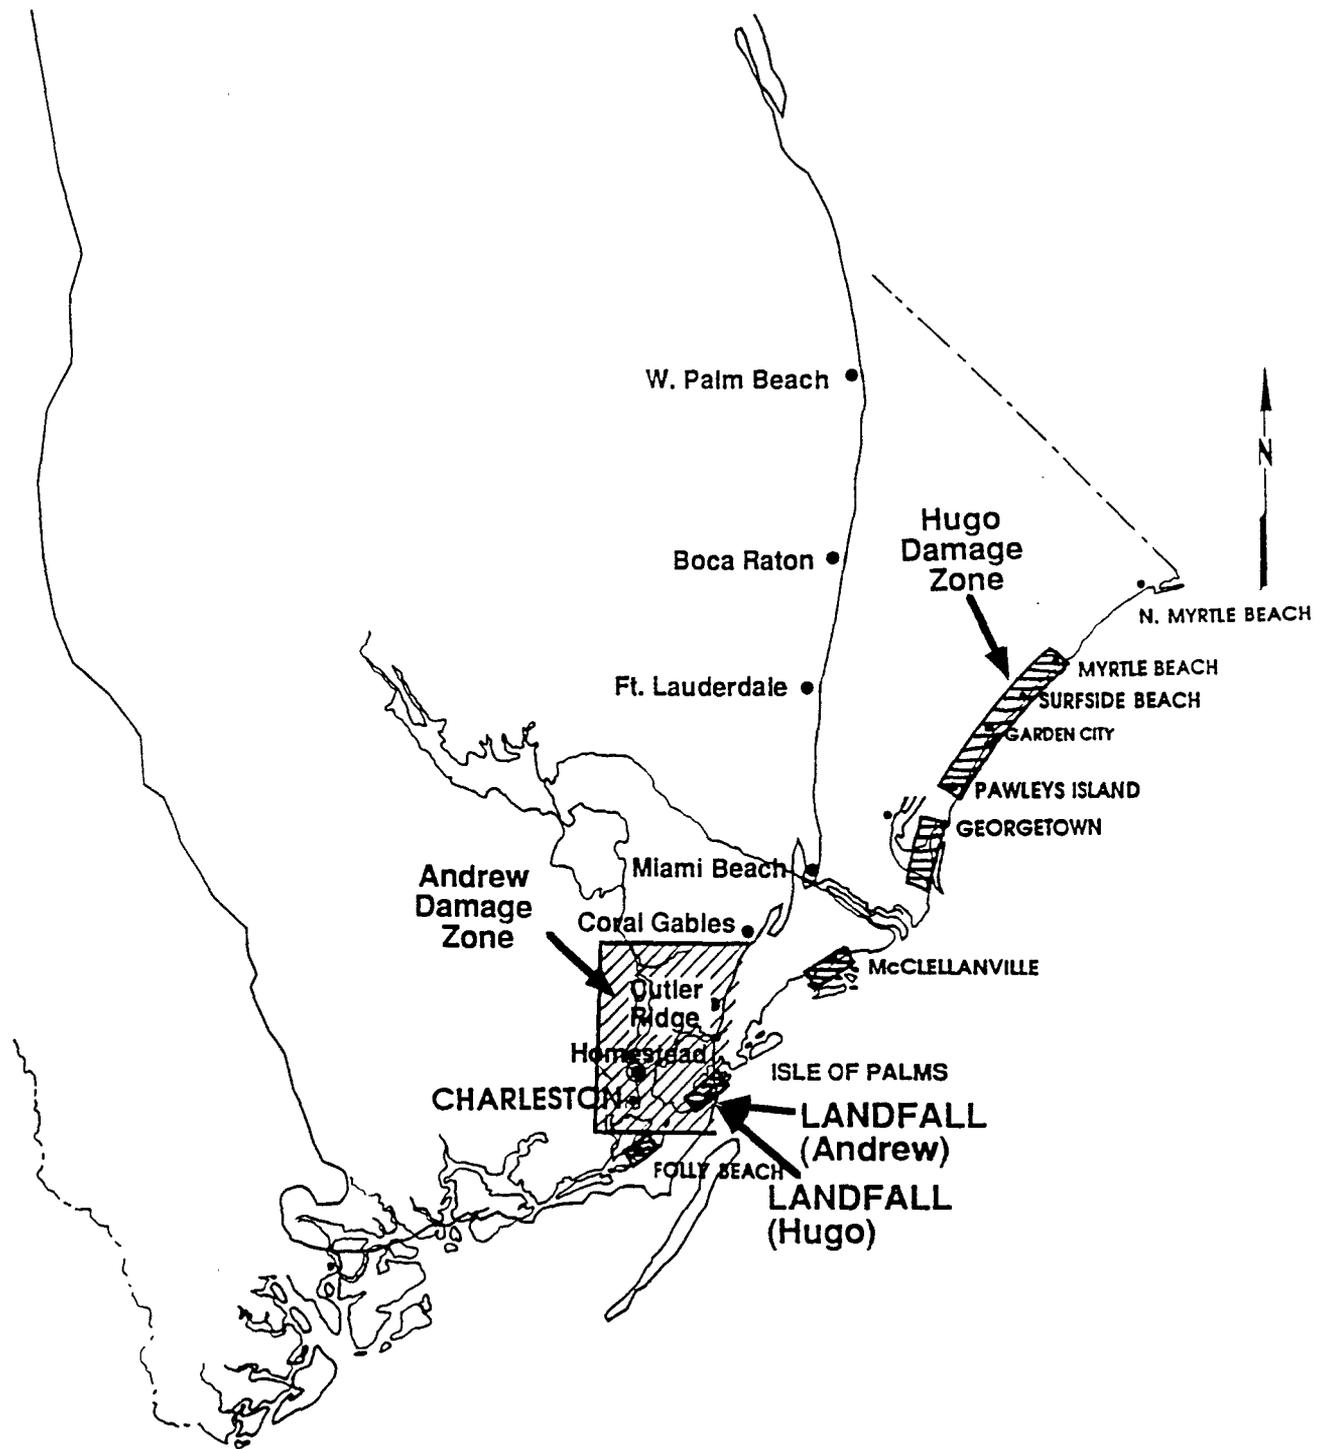
Fig. 4. Comparison of damage zones by Hugo and Andrew.

delineates and compares the sizes and shapes of the damage zones associated with these two hurricanes.

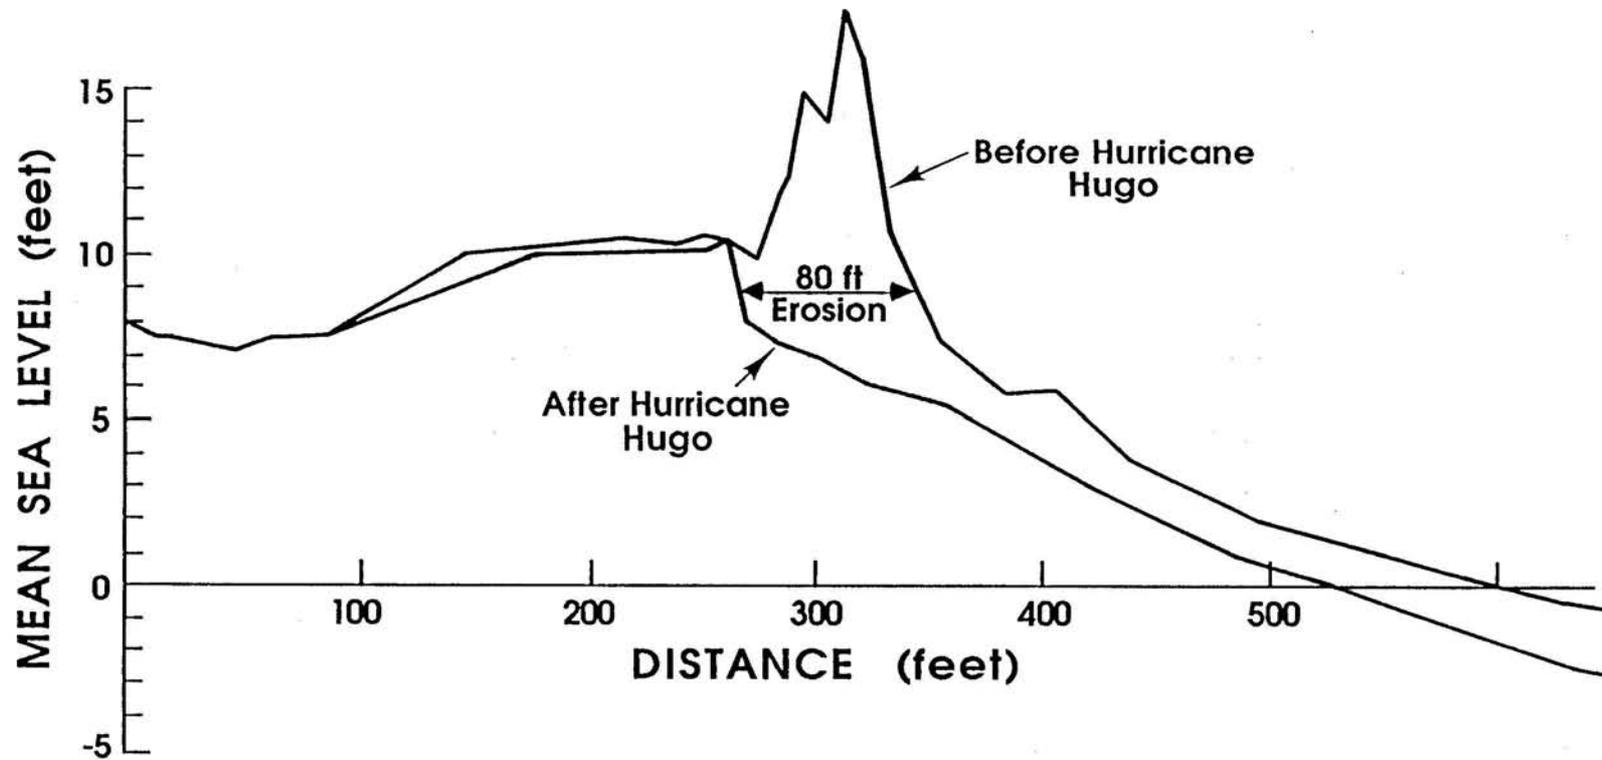
NORTH MYRTLE BEACH

Hurricane Hugo caused extensive beach erosion along a 140 mile stretch of the South Carolina coast (Stauble et.al 1990). The primary dune line along almost the entire stretch of coast south from Folly Beach to Little River Inlet disappeared, except for a few well-developed dunes on Debidue and Pawleys Island. This sand was transported up to 400 ft inland as overwash, offshore, and alongshore. Figure 5 shows a profile of erosion in Myrtle Beach where the dune loss was 85 ft. Washover was over 2 ft deep in some areas along Surfside Beach (Fig. 6). Debris was everywhere above high tide line. A significant portion of the coastal structures including wooden and concrete seawalls, stone revetments, wooden and stone groins was heavily damaged or completely destroyed. Stones from revetments were thrown around by waves, breaking sliding doors and windows or even walls.

Fig. 5. An example of beach erosion profile in Myrtle Beach due to Hugo.

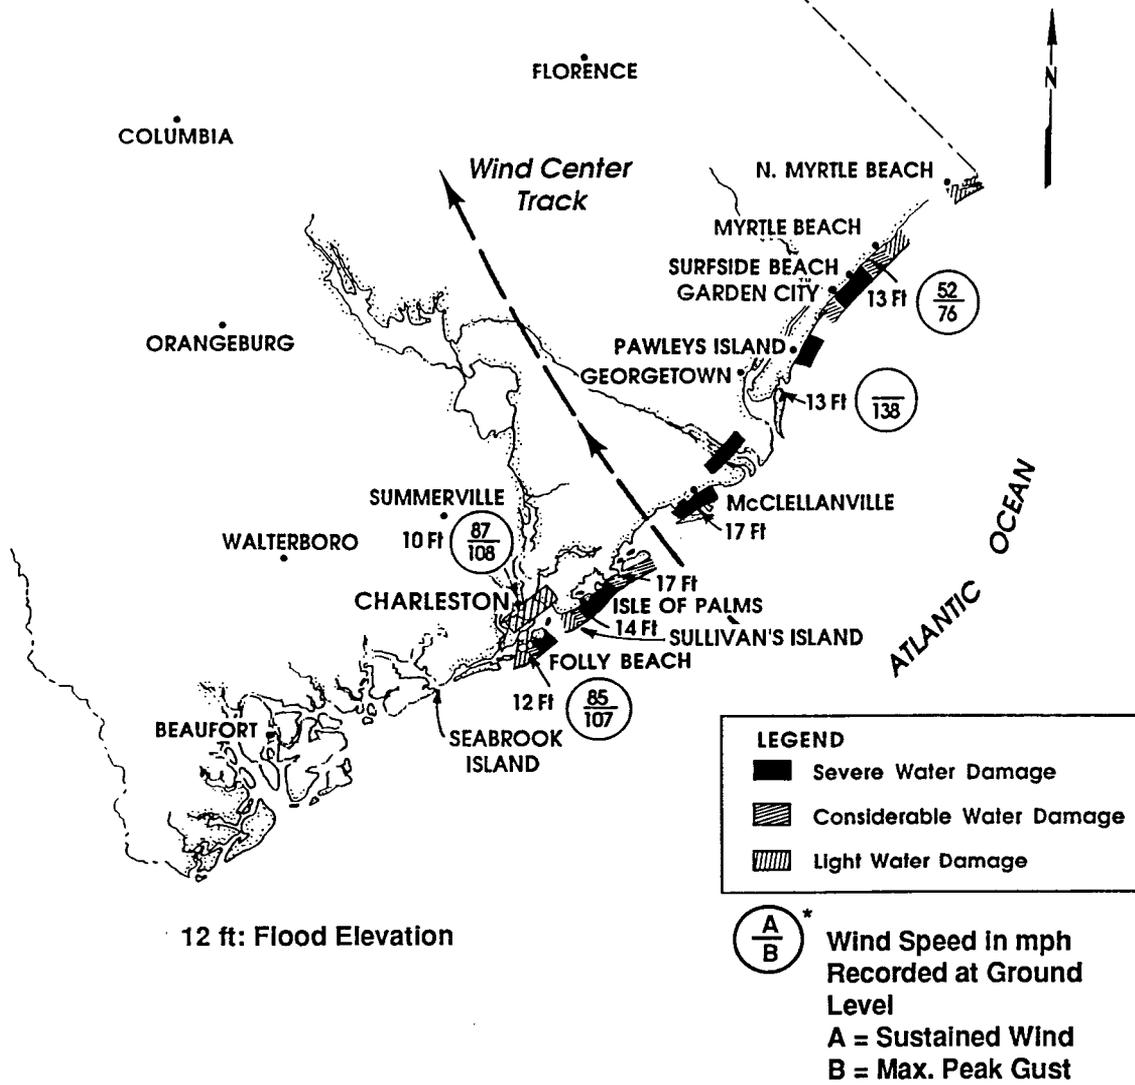
Storm surges and waves are two major causes of waterfront structure damage and beach erosion. Both hurricanes made landfall at high tide compounding the rise of water levels. For Hugo, the storm surges and highwater levels were fairly well documented by a number of agencies. Figure 13 shows the highwater marks from the Federal Insurance Administration and the associated level of damages along the South Carolina coast. Garcia, et.al. (1990) also compiled and published the measured highwater level elevations from Kiawah Island to Winyah Bay as shown in Fig. 14. These two values were in general agreement; some differences did exist owing to probably local influences. On the basis of these data, the highest water mark was put at 20.2 ft. Andrew's highwater mark surveys were not complete at this moment. The preliminary storm tide height results along western shore of Biscayne Bay as published by the U.S. Geological Survey are also given in Fig. 14. The maximum value was given as 16.9 ft off Cutler Ridge. The surge level tapered off rapidly towards both sides. On the south end of Key Biscayne in the Cape Florida national park, the highwater level was determined to be 9.4 ft. At north end of Miami Beach, a tide gage recorded highwater level of 6.0 ft with respect to MLLW on August 24, 5:15 EDT. This is the only location where the water level time series is available. The storm surges induced by Andrew were less than that by Hugo, both in terms of magnitude and duration, and affected a much smaller area.

Fig. 13. Highwater marks and general damage assessment along S.C. coast under the influence of Hugo (surge and wind information from Federal Insurance Administration, 1989).

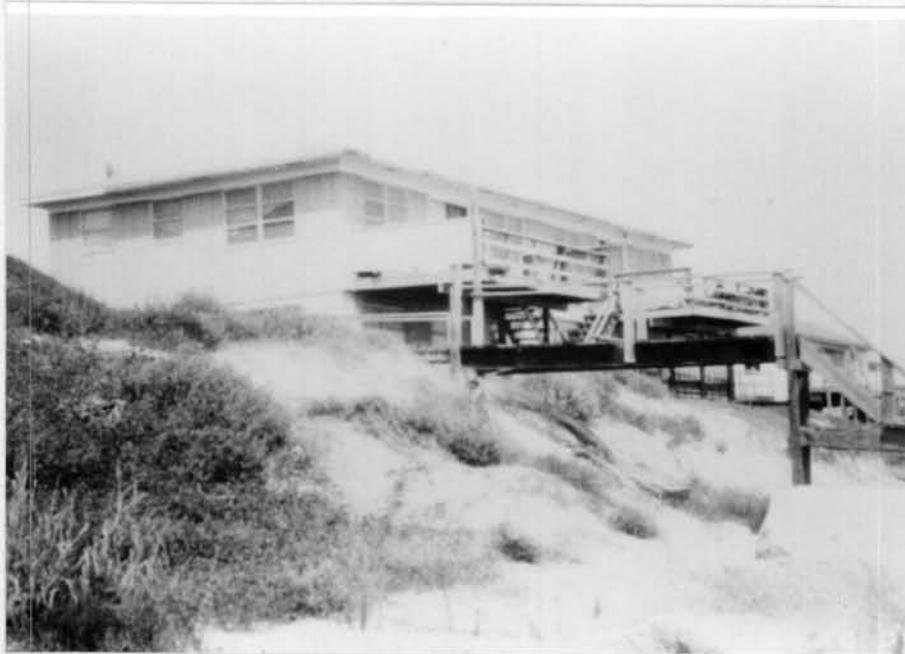
Figure 27 shows that erosion has exposed the pile foundation of this frame structure. Figure 28 shows the foundation material being completely scoured away around a bulky shallow footing. Shallow pier footings were exposed and eventually uprooted as shown in Fig. 29. Figure 30 shows the comparison of a residential structure before and after Hugo. The extent of the dune erosion was estimated to be about 60 ft in this case, exposing the structure in a vulnerable position. In addition to foundation scouring, erosion also led to the crumbling of porch slabs and garage floors and exposing utilities such as sewer lines, telephone lines, water mains and septic tanks.

Finally, when waves overtop a structure or run up on a beach, the water motion becomes translatory like a bore. The momentum carried by this bore-like motion is one of the main forces breaking through walls and doors on the ground floor (Fig. 34) and causing appurtenant structures such as beach access ramps to crush into the main structure (see Fig. 30).

Fig. 30. (a) Photo taken prior to Hugo.

Fig. 30. (b) After Hugo the protective dune was gone and the access ramp was washed into the house due water force.

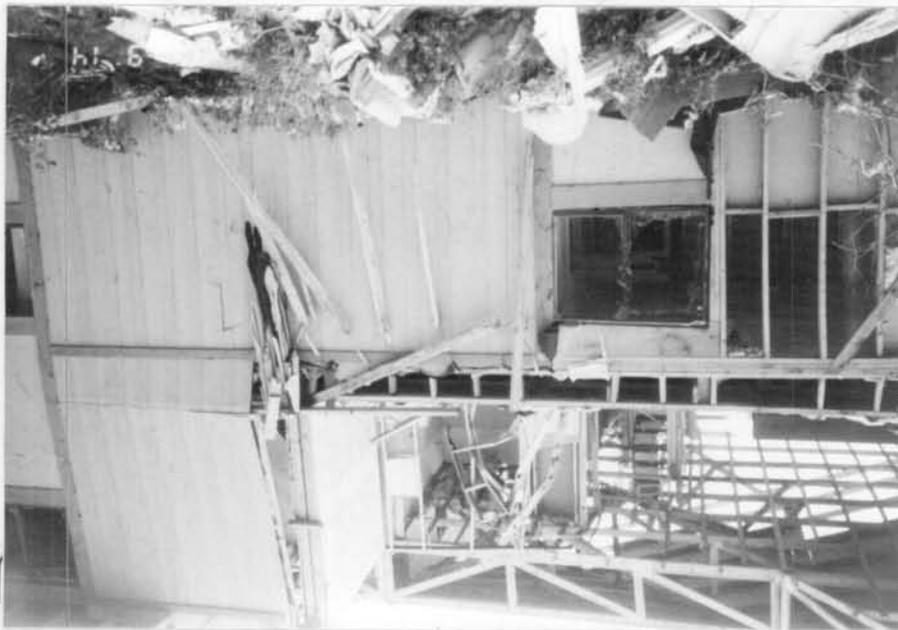
Failure of framed structure walls was mainly due to inadequate connections. Wall frames are usually nailed to the base and to connecting wall frames. Metal strips should be used to provide added shear strength but were not always found in the damaged structures. The common mode of failure was the separation of the entire wall panel from the base as shown in Fig. 42. Here, it is also revealed that the metal strips, all on one side, did not provide any added resistance to negative pressure, nor to moment. The gable-end non-loadbearing walls on the second floor of two-story frame structures were particularly prone to this mode of failure. This probably was the leading factor causing major structural damage. Failures that can be attributed directly to inadequate building material were not common but did exist. Figure 43 shows practically all the exterior wall panels in this multi-story building failed. The wall frames were covered with a layer of Styrofoam and a layer of masonry cladding. This structure was an exception to multi-story buildings which, in general, fared well in terms of structural damage. It is an example of the worst. In residential structures, failures due to inadequate material were more prevalent. Figure 44 shows the material failure of exterior wall panel made of manufactured board.

Fig. 44. Damage to exterior wall due to inadequate material strength of the manufactured board.

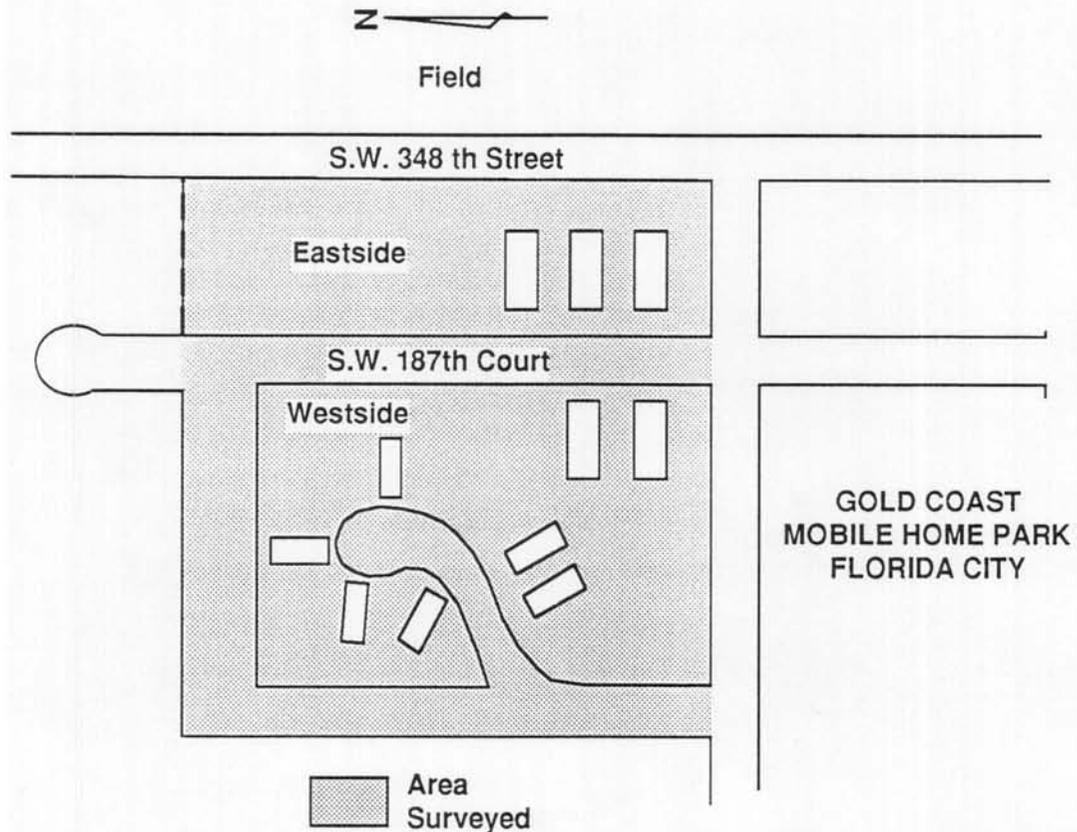
Most of the mobile home units in this cluster are along the east and west sides of 187 ct. which is aligned in a N-S orientation such as shown in the Fig. 45. Therefore, the broadsides of these units are mainly N-S oriented. On the basis of visual survey, the west end of the units, in general, sustained heavier damage than the east end. For those units separated from the foundation, they usually fell broadside towards north. The trees in the adjacent field mostly fell towards east. Therefore, judging from the failure orientations, strong wind was from west or south-west, or the park is located close to, but on the left hand side of the wind track.

Fig. 45. Sketch of the mobile home park surveyed after Andrew.
