Approach

The Navy and Marine Corps Aviation and Aviation Maintenance Safety Magazine

Approach- MECH

2016 Volume 61, No. 3

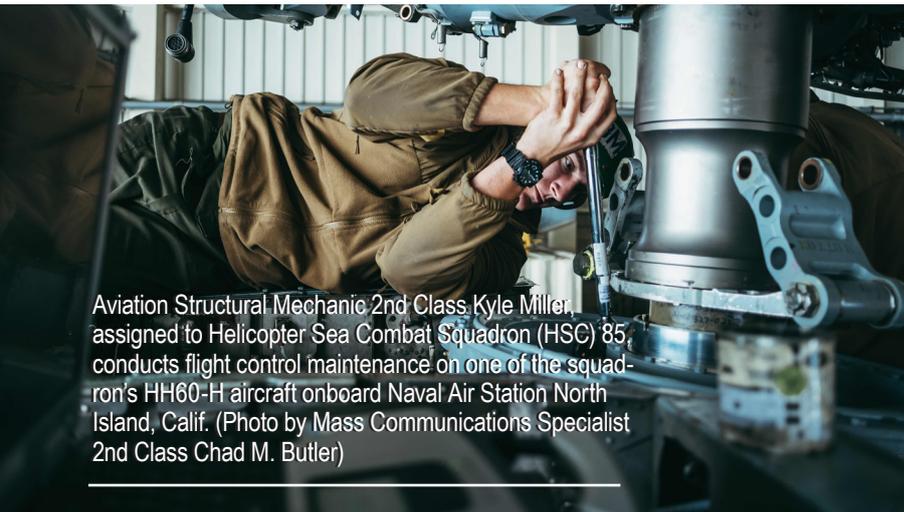
Aviation Structural Mechanic 2nd Class Kyle Miller, assigned to Helicopter Sea Combat Squadron (HSC) 85, conducts flight control maintenance on one of the squadron's HH60-H aircraft onboard Naval Air Station North Island, Calif. (Photo by Mass Communications Specialist 2nd Class Chad M. Butler)

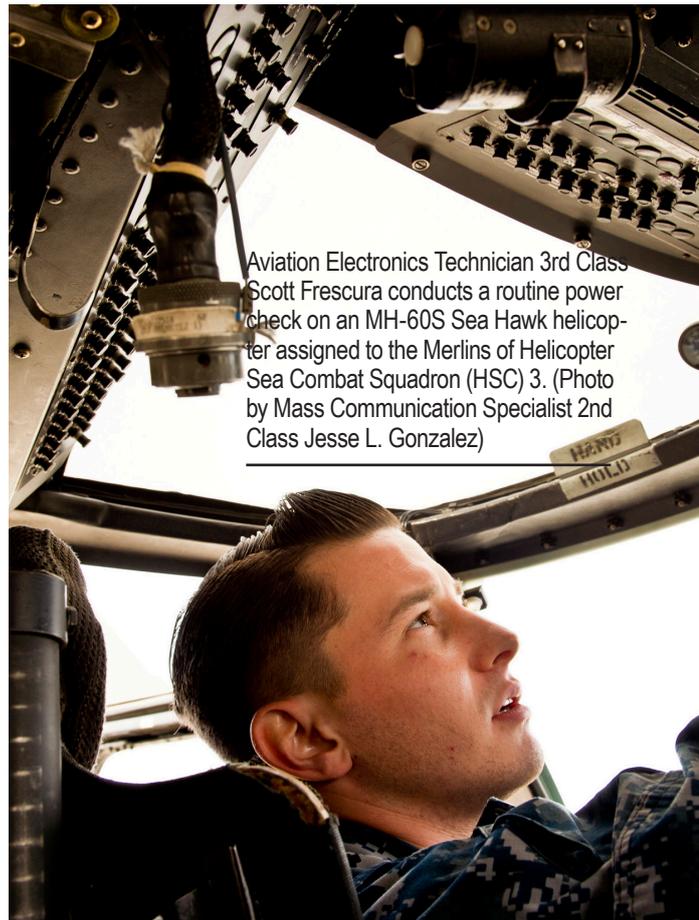
Aviation Electronics Technician 3rd Class Scott Frescura conducts a routine power check on an MH-60S Sea Hawk helicopter assigned to the Merlins of Helicopter Sea Combat Squadron (HSC) 3. (Photo by Mass Communication Specialist 2nd Class Jesse L. Gonzalez)

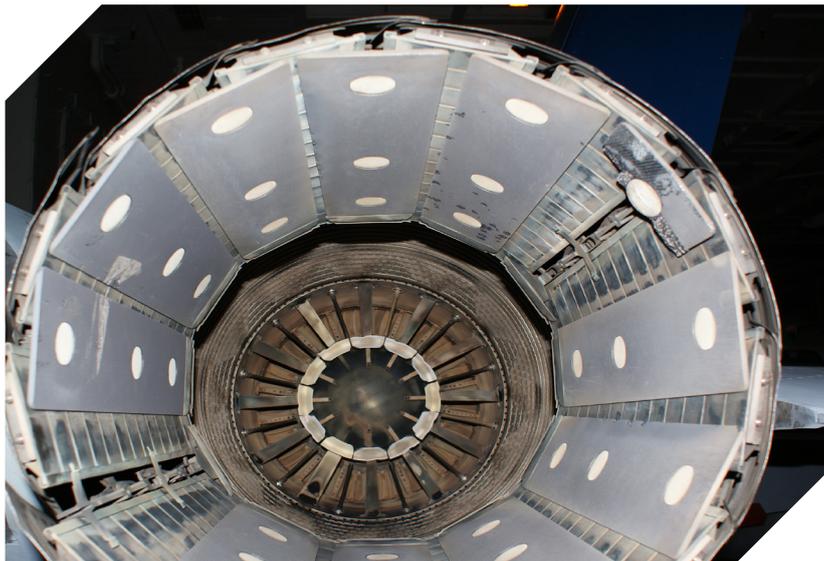
Damage to a starboard engine variable exhaust nozzle left maintainers in a state of confusion during a routine check. They later discovered that a loose one-fourth inch nut was responsible for the damage. (Photo courtesy of VFA-192)

Back on the ship, as soon as 300 landed and moved to the hangar bay, the exhaust covers were installed, hiding the damaged VEN. After discovering the

missing seals, we immediately notified maintenance control. Quality assurance (QA) promptly began their investigation. As for the damage, both the power plants shop and QA agreed that a loose one-fourth inch nut was responsible for the damage. We believed that the nut was not tightened all the way and the force of the exhaust dislodged the eight o'clock secondary seal. When it came loose, it hit the 2 o'clock position which loosened that secondary seal, and in turn, flung it across and hit the nine and 10 o'clock position. Quality assurance's investigation, along with the day check maintenance crew, discovered a secondary flap and base were also damaged.

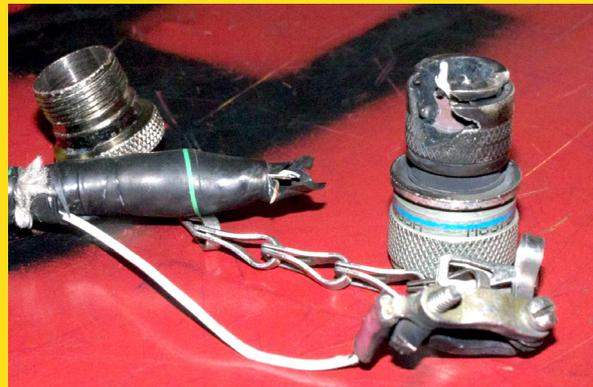
During a routine blade fold switch adjustment, an aviation electrician's hand was electrocuted. The intense heat and force of the arcing caused the external power cable attachment to melt and detach. (Photos courtesy of HSC-14)

During a deployment, an aviation electrician (AE) was completing a routine blade fold switch adjustment as part of a phase-D inspection. The aircraft was in the hangar bay, connected to external power while the AE attempted to adjust the blade fold switch with a blade fold test unit box. While on top of the aircraft, the AE pulled the test box by its external power cord for extra slack with their right hand. As the AE tugged for more slack with their right hand and held the test box with their left hand, the shell back connecting the power cord to the test box arced and electrocuted the AE. Due to the intense heat and force of the arcing, the external power cable attachment melted and completely detached from the box. As a result, the AE looked down

During the ensuing investigation, it was determined the AE shop had previously repaired the blade test set power cord. The cord had undergone a 56-day inspection, just four days earlier, passing all applicable tests with no known discrepancies. However, since the previous repair was on the internal wiring, there was no way to determine that the wires had twisted, which eventually led to the short at the shell back.

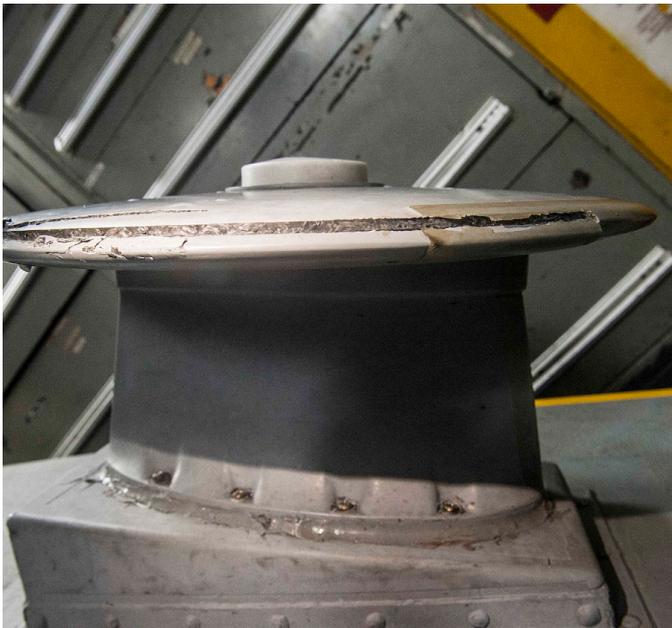
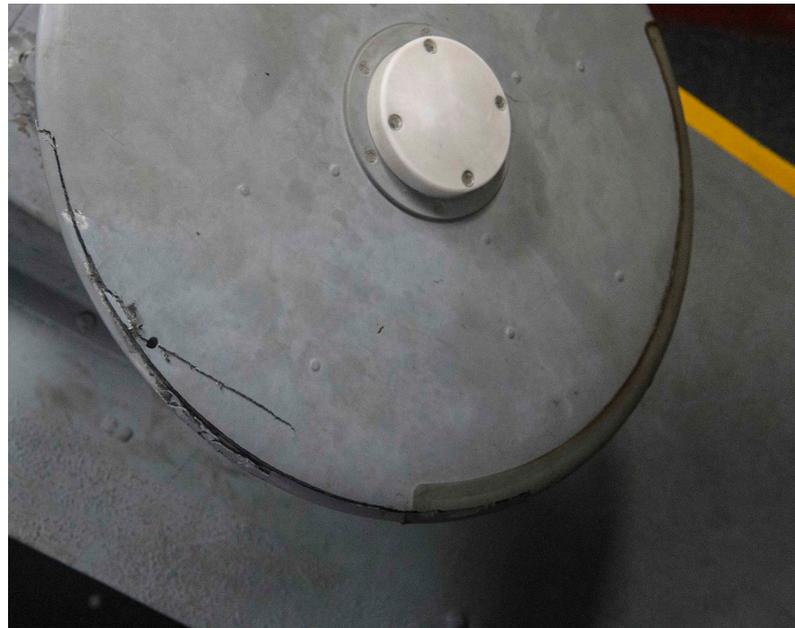
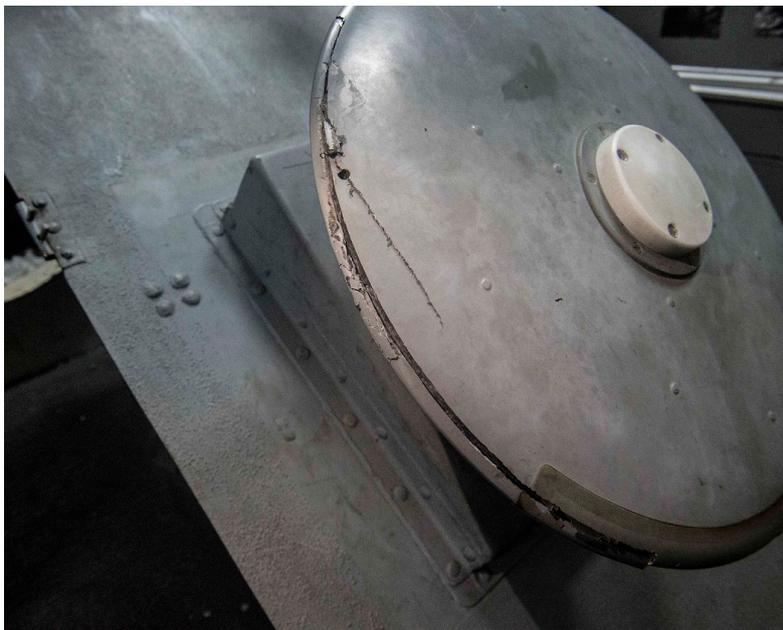
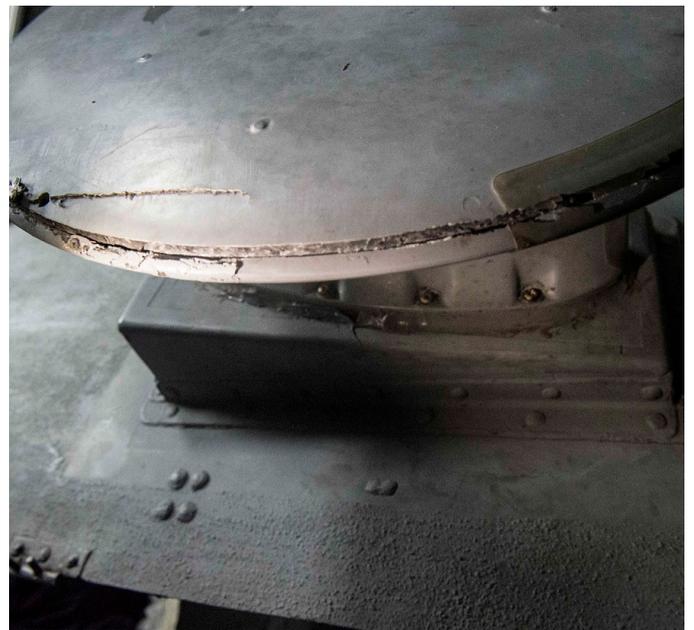
The images above show the damage to the rotor blade mentioned in the article. The cost could have been upwards of \$200,000 but it was repairable and went from a class C to class D mishap. (Photos courtesy of HSM-51)

The damage caused to the SATCOM antenna alone would have been a downing gripe on the aircraft but the larger issue was the damage to the rotor blade. The rotor

blade had some chips on the trailing edge with some smaller dents throughout. The blade failed the coin tap test and was well out of dent limits on what is allowable on a rotor blade. The cost of replacing a single main rotor blade is \$200,000, leading to classification as a class C ground-related mishap. Fortunately, the damage to the blade was depot level repairable, driving the monetary cost down and the mishap class to drop from a C to a D.
