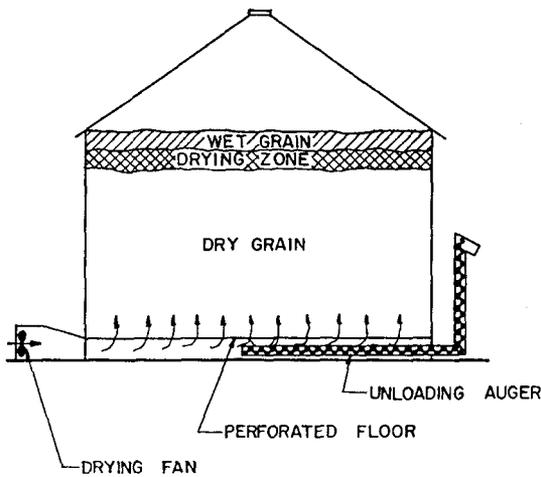
Figure 15. When checking grain previously dried in the bin, examine points near the surface to make sure all the grain has dried.

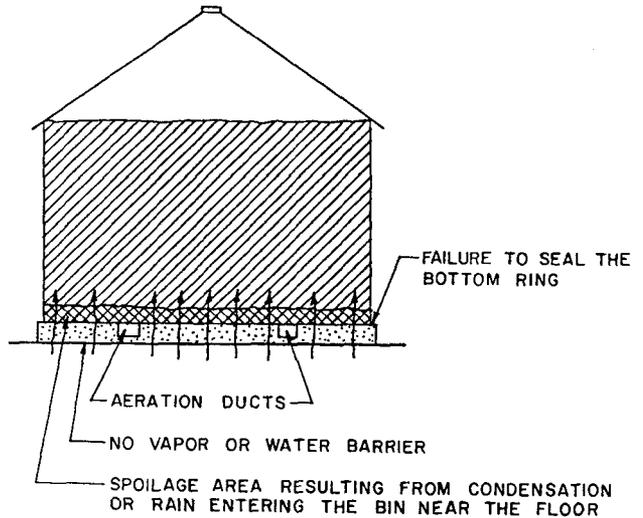
Figure 17. A sheet of plastic should be placed under the concrete floor during bin construction to serve as a vapor and water barrier and prevent the rewetting of grain.

When bin floors are constructed, a layer of plastic should be placed under the concrete floor to serve as a vapor barrier to prevent water from condensing on the floor and wetting the grain. Likewise, sealing the side wall and roof and the bottom

ring on the concrete slab will prevent rain from wetting the grain. Spoilage will generally be found near any point where wetting occurs (Figure 17).

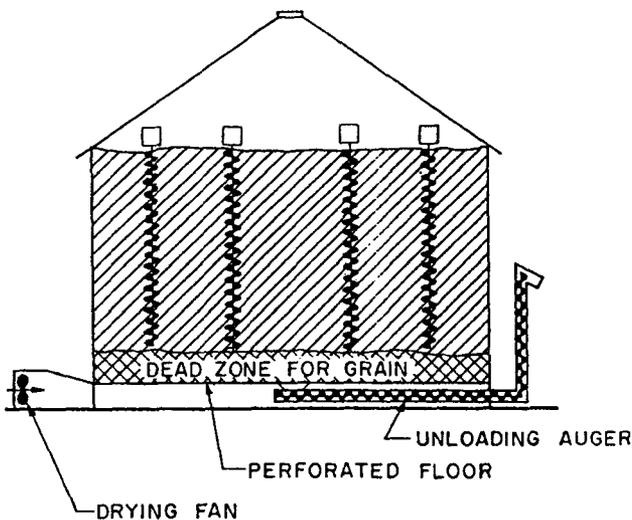
Figure 16. A "dead zone" may be found under the stirring augers which may lead to faulty conclusions concerning the average moisture content of grain in the bin.

Stirring devices break up the drying zone so that the entire mass of grain tends to dry more uniformly, thereby reducing the problem near the surface of the grain. However, grain near the floor of the bin where the stirring auger cannot reach may be severely overdried. A sample taken from this "dead zone" area may lead to a faulty conclusion concerning average moisture content (Figure 16).

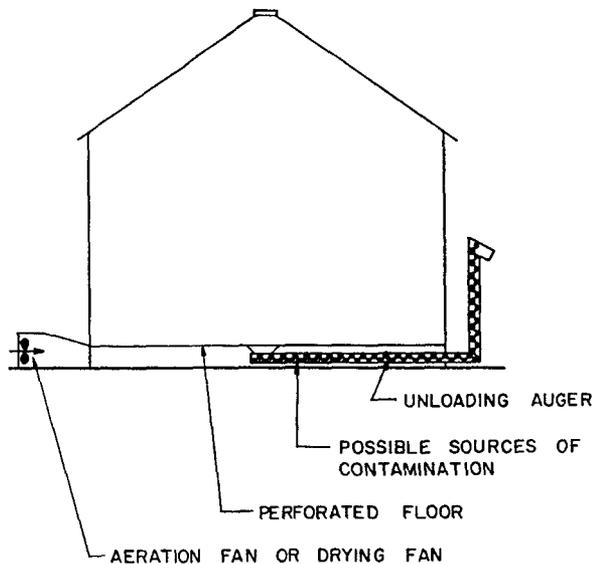
Figure 18. The unloading auger should be cleaned before the bin is filled to reduce chances of mold or insect infestation.

The unloading auger should be cleaned before grain is placed in a bin or after a partial unloading. Otherwise, when the grain is unloaded, the sample taken from the truck may indicate contamination by mold or insects at a level higher than that actually present inside the bin (Figure 18). Also, water may collect inside an auger and wet the grain left from a previous unloading.
