**HISTORICAL MORPHODYNAMICS
OF INLETS IN FLORIDA**

Models for Coastal Zone Planning

Sea Grant Project No. R/C-S-23
Technical Paper 55
Florida Sea Grant College

January 1990

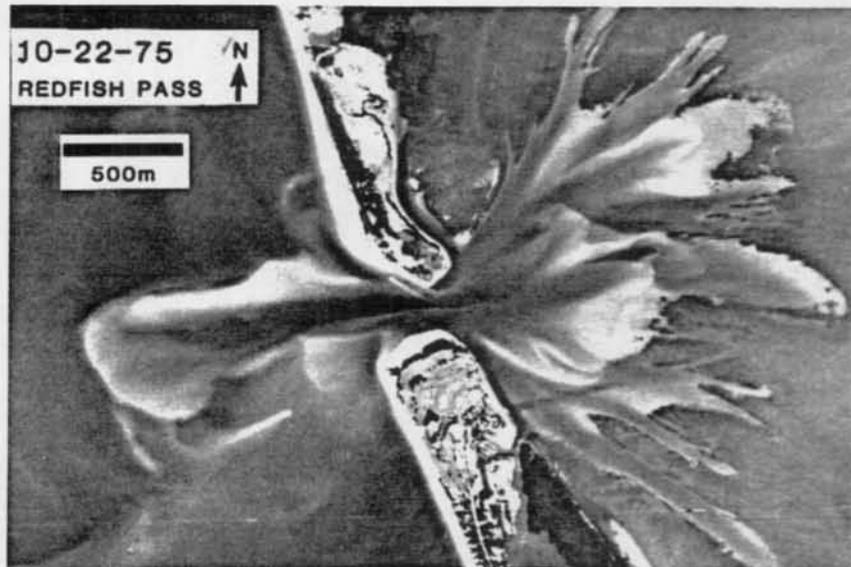
Figure 6.- Vertical aerial photograph of Redfish Pass (Lee County) in 1975. This inlet is tide-dominated with a distinct main-ebb channel and an ebb-tidal delta oriented perpendicular to shore. Marginal-flood channels are also present.

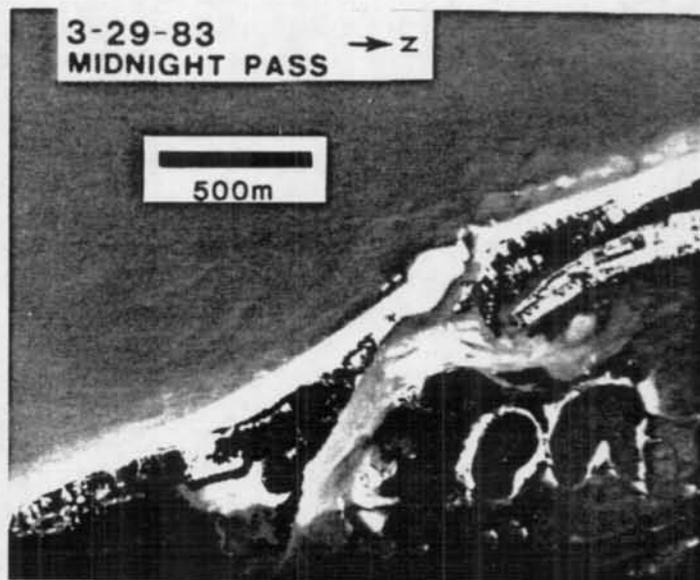
Figure 9. - Vertical aerial photograph of Midnight Pass (Sarasota County) in 1983. A wave-dominated morphology is displayed with an unstable channel and nearly nonexistent ebb-tidal delta.

In 1972, Midnight Pass (Fig. 10) had a mixed-energy offset morphology. A distinct main-ebb channel and ebb-tidal delta were present. By 1983, Midnight Pass (Fig. 9) had migrated northward and displayed a wave-dominated morphology with an unstable channel and a greatly reduced ebb-tidal delta. Davis et al. (1987) attributed the change in Midnight Pass to a decrease in tidal prism caused by dredging of the intracoastal waterway in 1963 and 1964 through the bay served by Midnight Pass. The dredged channel directed tidal flow north and south through the bay and away from the pass.

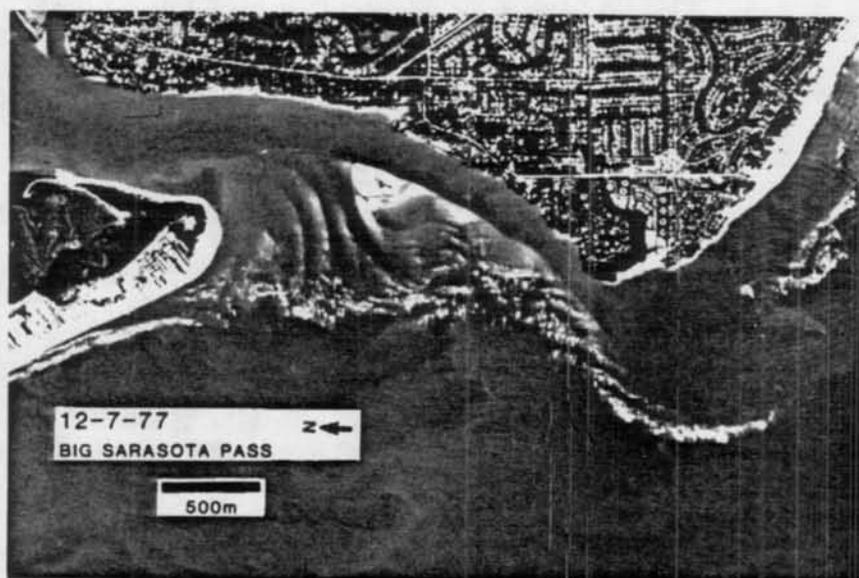
Figure 11.- Vertical aerial photograph of Big Sarasota Pass (Sarasota County) in 1977. This pass is an example of mixed-energy conditions with a prominent downdrift offset and intertidal shoals in the inlet opening.

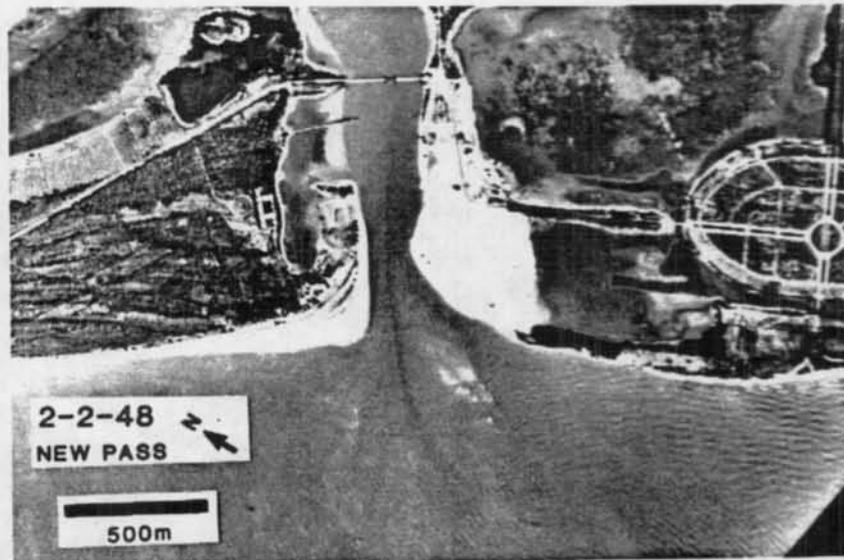
Figure 13.- Vertical aerial photograph of New Pass (Sarasota County) in 1948. New Pass has a mixed-energy straight morphology.

In 1948, New Pass (Fig. 13) displayed a mixed-energy straight morphology. An increase in southerly littoral drift caused a mixed-energy offset morphology to develop by 1957 (Fig. 15). A reversal in littoral drift direction caused New Pass to return to a mixed-energy straight morphology by 1983 (Fig. 16).

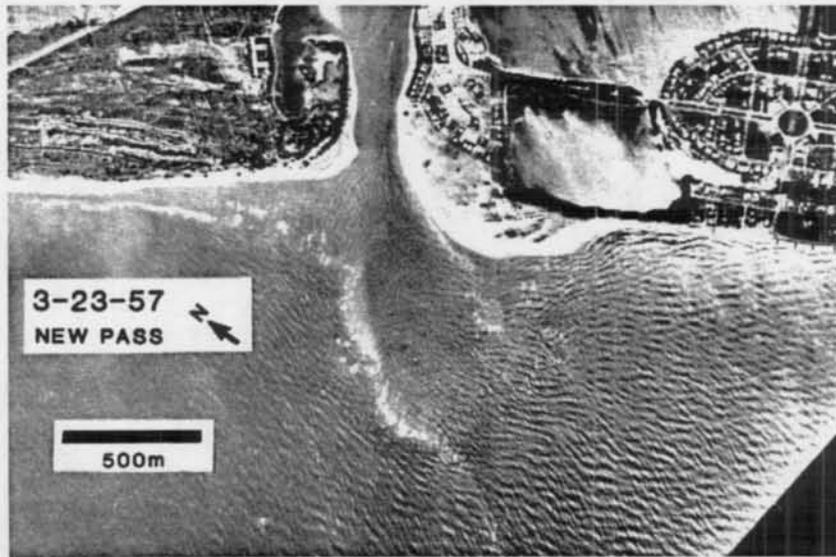
Figure 15.- Vertical aerial photograph of New Pass (Sarasota County) in 1957. New Pass has a mixed-energy offset morphology. The shift from a straight morphology in 1948 (Fig. 13) to an offset morphology in 1957 was accomplished by an increase in southerly littoral drift.

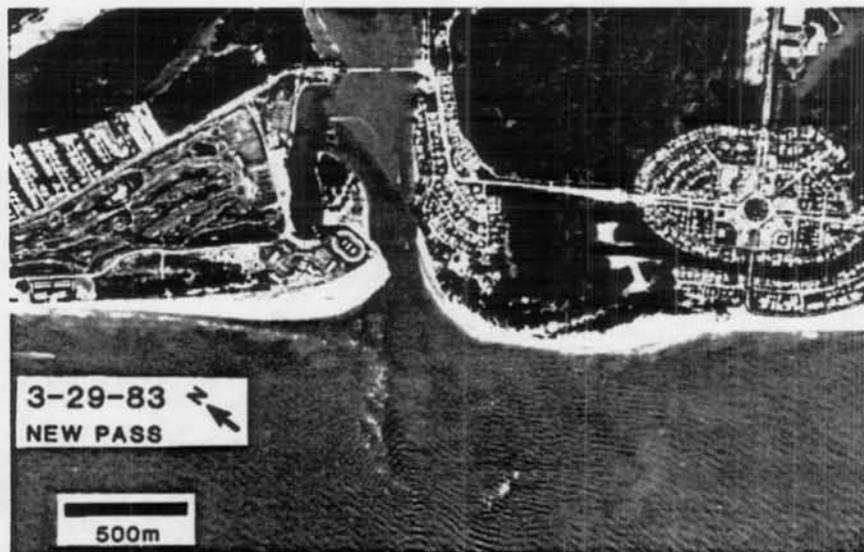
Figure 16.- Vertical aerial photograph of New Pass (Sarasota County) in 1983. A restoration of northerly littoral drift eliminated the offset morphology present in 1957 (Fig. 14).
